SOIL INVESTIGATION REPORT

**PROPOSED HOUSING DEVELOPMENT PROJECT
Coral Spring, Trelawny, Jamaica.**

**NHL Engineering Limited
29 Munroe Road
Kingston 6, Jamaica**

March 13, 2012

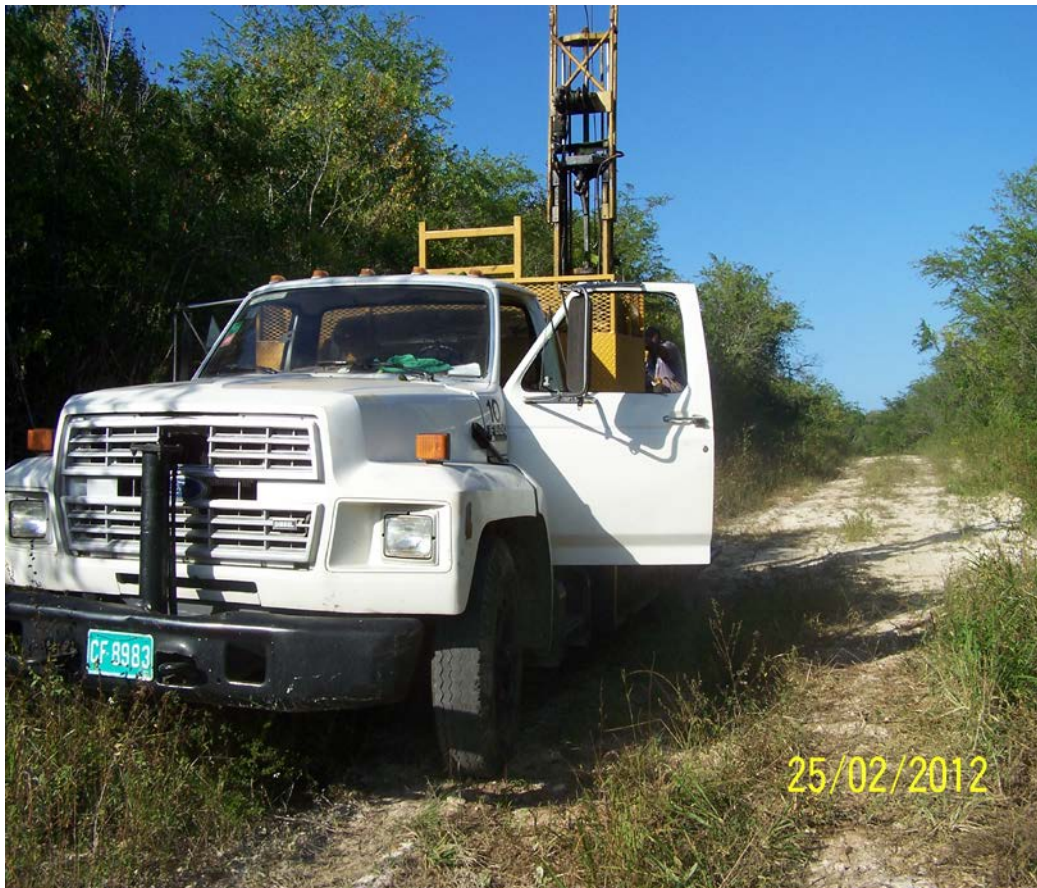
PLATE 1 PICTURE SHOWING EXISTING SITE CONDITIONS IN THE VICINITY OF BH #1

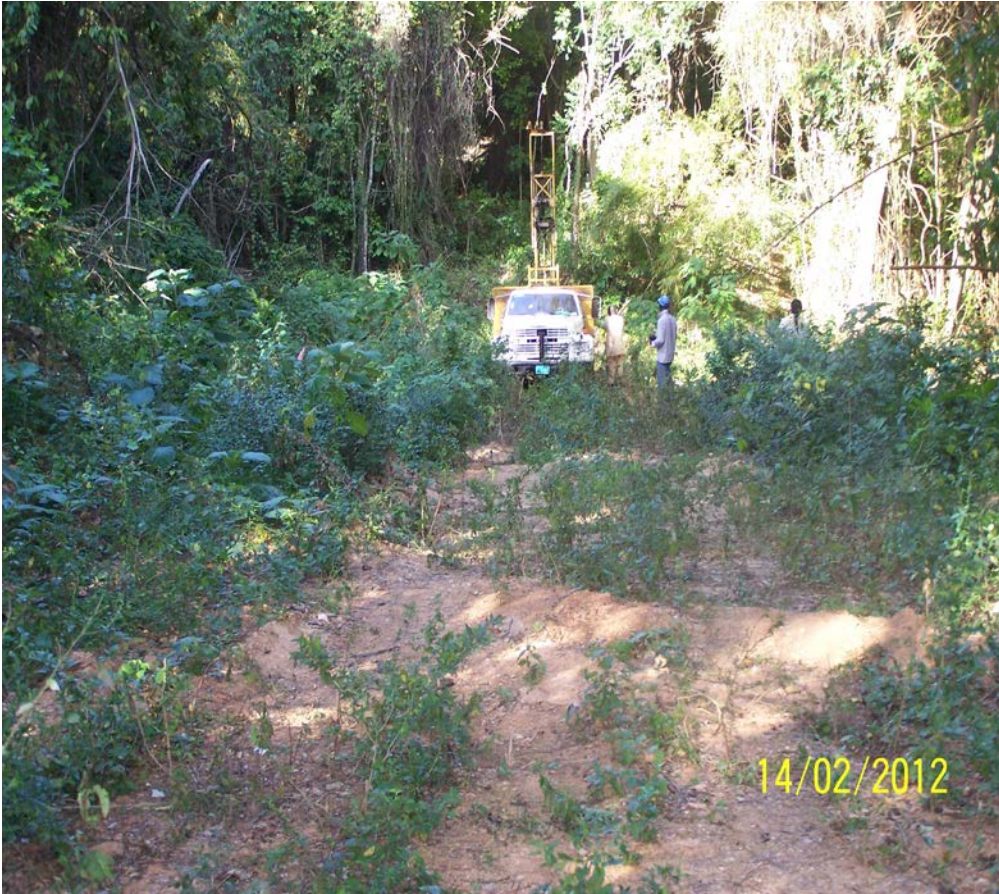
PLATE 2- PICTURE SHOWING EXISTING SITE CONDITIONS IN THE VICINITY OF BH #3

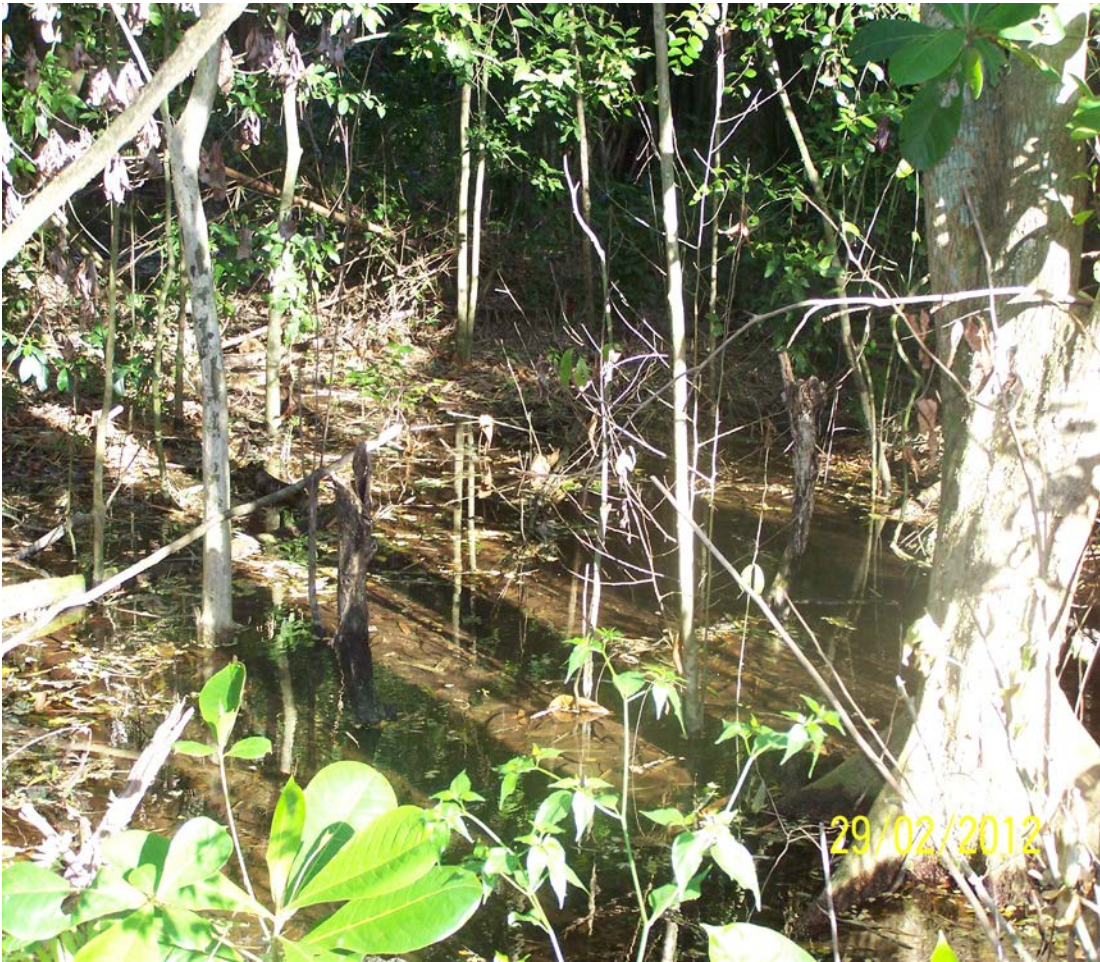
PLATE 3- PICTURE SHOWING EXISTING POND IN THE VICINITY OF BH #3

No ground water was encountered during the sampling exercise, however after overnight rainfall, the pond was recharged and groundwater was observed in Borehole 3 at 17 ft below ground levels. Groundwater was observed flowing into the pond from an apparent aquifer on the southern hills of the site.

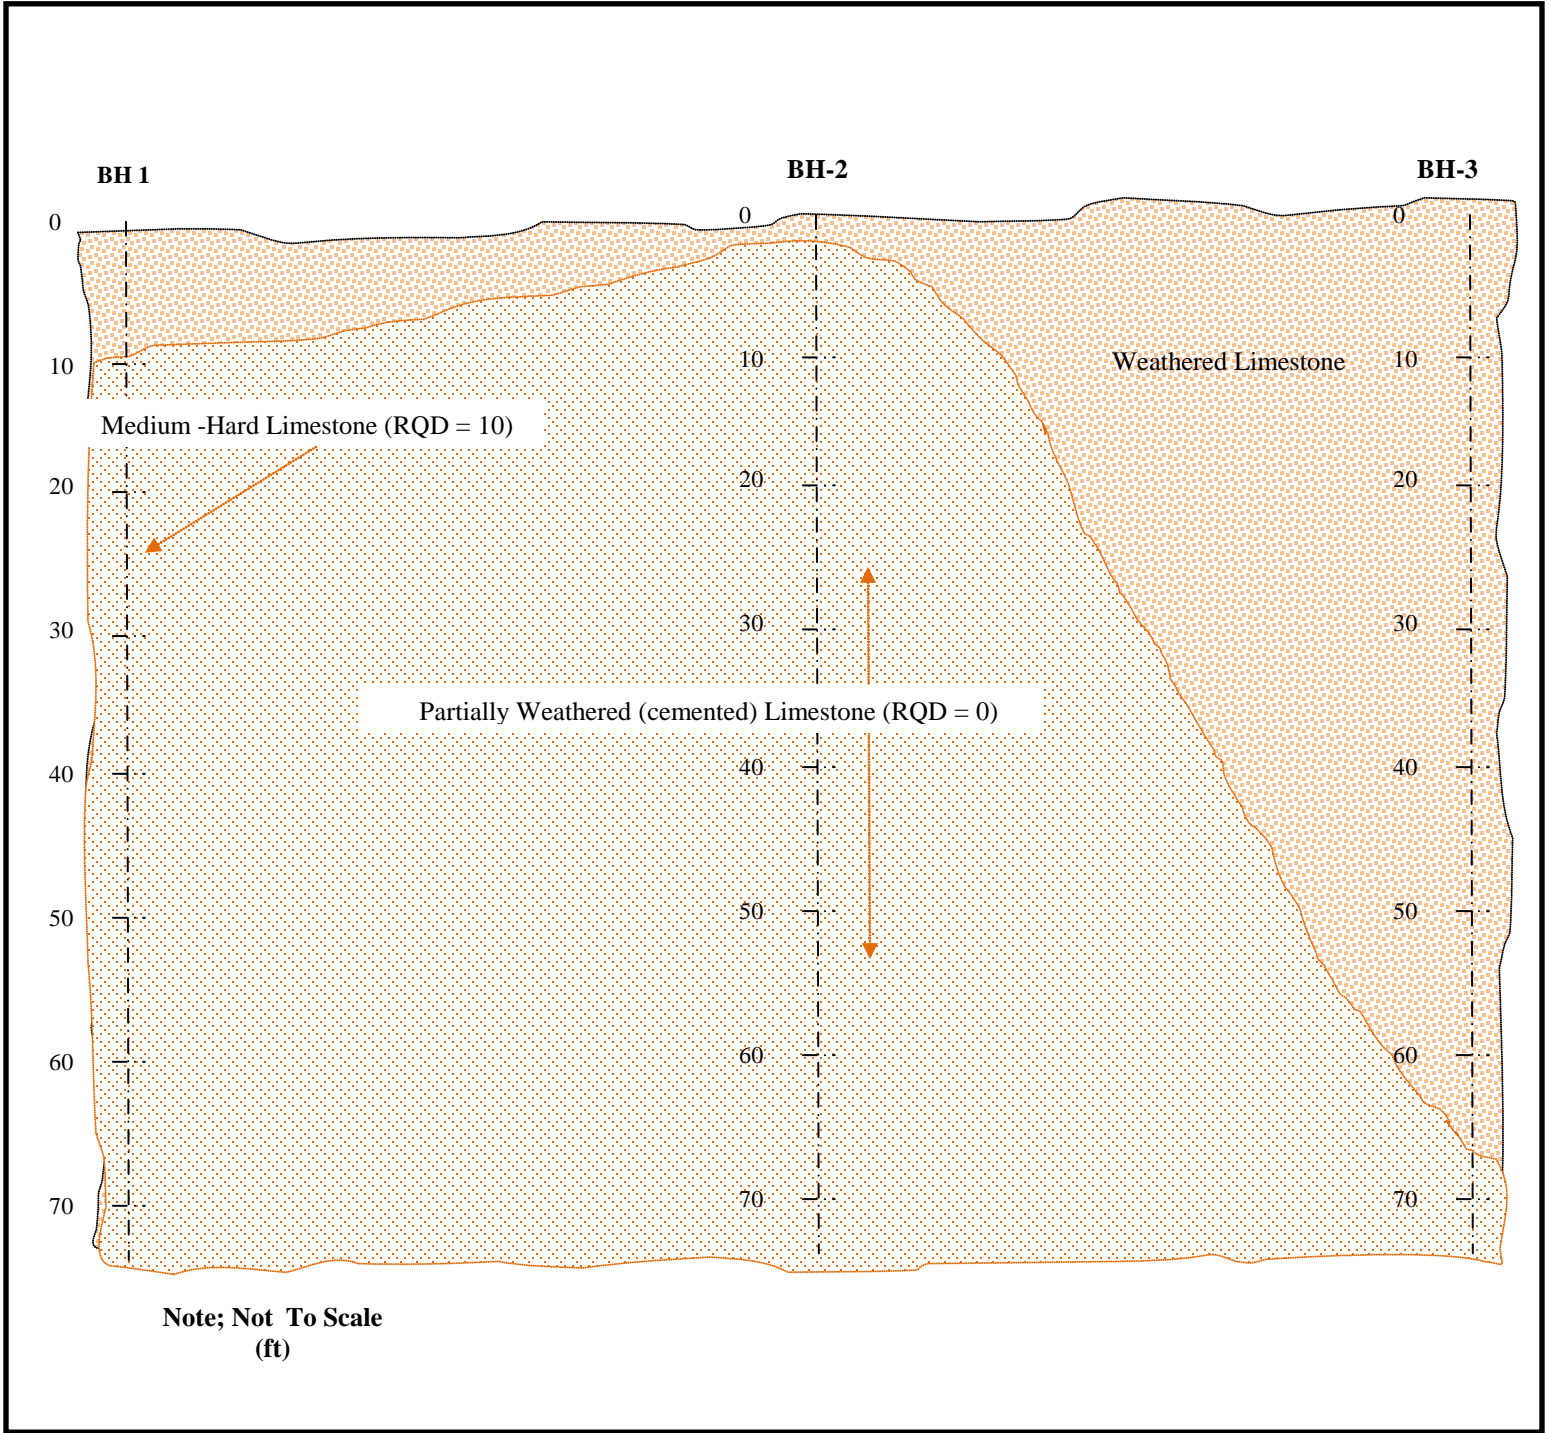
FIG. 4.1 PRESUMPTIVE PROFILE ; BHs# 1, 2 & 3

The subsoil layers applicable for evaluating engineering behavior and construction concerns can be characterized as two (2) distinct types (see typical site profiles below). The types are as follows:-

- 1) The Compact to v.Dense Gravelly C-F Sands (weathered limestone) + Clays
Depth Range; Variable
Average $N_{55} = 25$
Borehole #, 3

- 2) The Soft to Medium Limestone Rock Formation
Depth Range; Variable
RQDs (avg.) = 15%
Borehole #s, 1, 2, 4, 5 and 7

The Presumptive profiles drawn below are based on the results of the field sampling to date. The profiles are used to illustrate the dominant layers that are likely to significantly impact design and construction, they however are not intended to provide exact information between the boreholes location by extrapolation.

The horizontal distribution of the very dense weathered limestone and the upper rock formation indicates that the use of shallow foundations for the proposed structures is suitable.

- i) Small Differential deformation problems across the varying soil material on site within the vicinity of BH3 and BH4
- ii) Foundation excavation problems within the hard rock formation
- iii) The possible existence of unidentified cavernous rocks below building.

With regards to buildings, the use of isolated conventional shallow pad and Beam foundation appears suitable across the site unless evidence of localized solution cavities have been encountered.
