**Assessment Of Flooding And
Bank Erosion At Berridale,
Rio Grande, Portland, Jamaica**

Ridge to Reef Watershed Project

February 7, 2005

David J. Miller and Ryan Ramsook
for
The Marine Geology Unit
Department of Geography and Geology
University of the West Indies
Mona Campus
Kingston 7, Jamaica

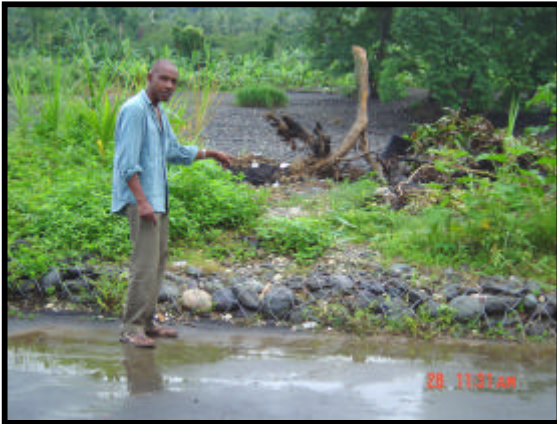
The main flood prone area in Berridale occurs immediately downstream of a pronounced meander bend of the river (Figure 1a), where the outer concave bank has been protected by gabion baskets. During high river discharges, the Rio Grande bursts its banks at this point to engulf the gabions and flood the road behind them. Figure 1b shows a local resident indicating where the gabion baskets were breached during the Hurricane Ivan flooding, while in figure 2 he estimates the height of the floodwaters which inundated the road. At this locality, the road level is at least 4.0-4.5m above normal river stage.

Figure 1b. Berridale resident, Mr. Miller, indicates where the gabion baskets were breached during the Hurricane Ivan flooding.

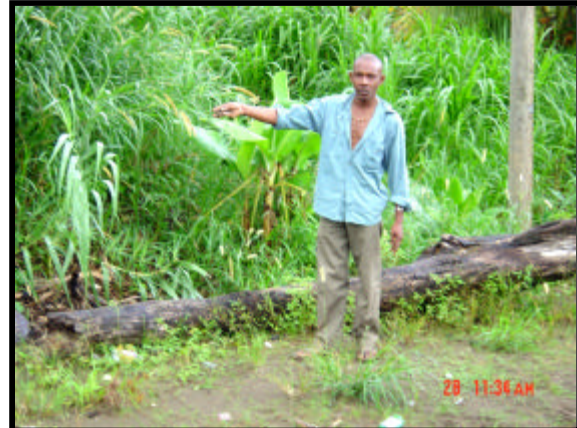
Figure 2. Mr. Miller estimates the height of floodwaters which inundated the Berridale main road.

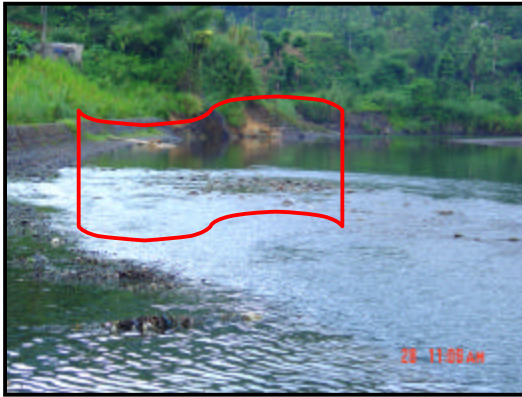
Bank erosion is commonplace along the entire river reach in the Berridale area. It is prevalent at meander bends, particularly on the outer concave bank of the river; though it is not confined to bends (Figure 3), but also occurs on relatively straight reaches on both the left and right banks of the river, especially where the channel contains medial braid bars (Figure 4).

Figure 3. Extensive bank erosion (bank collapse) on cultivated terraces of the Rio Grande River at Berridale.

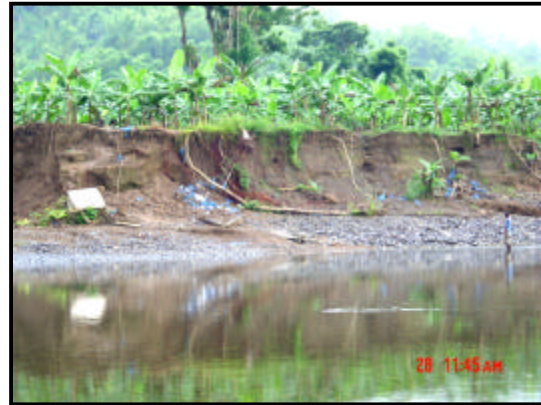
Figure 4. Extensive bank erosion on relatively straight reaches of the Rio Grande River at Berridale.

Bank erosion on the straight reaches of the river around Berridale is associated with flood events, where the channel is at bankfull- discharge or where floodplain inundation occurs at stages higher than bankfull. The banks are easily erodible as they consist of non-cohesive sediments, which are not particularly well-protected by riparian vegetation. Some straight reaches are also associated with medial- and braid-bars, dividing the channel in two threads and diverting them towards the channel banks. This leads to a concentration of flow towards the banks, leading to undermining and collapse, especially at high flow.

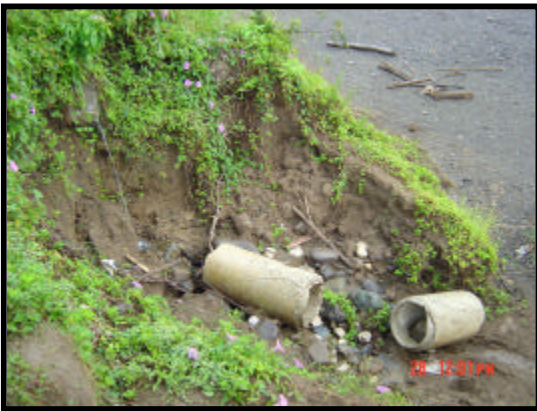
Bank erosion and undermining has also led to the destruction of physical infrastructure marginal to the river, such as drains and sewer lines (Figures 5 and 6).

Figure 5. Destruction of physical infrastructure induced by bank erosion at the Berridale Rafters Rest.

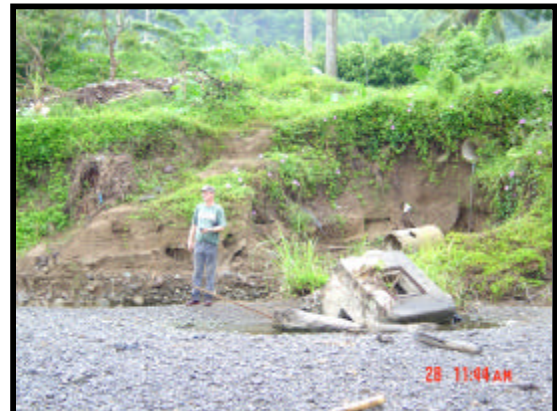
Figure 6. Destruction of physical infrastructure induced by bank erosion at the Berridale Rafters Rest.

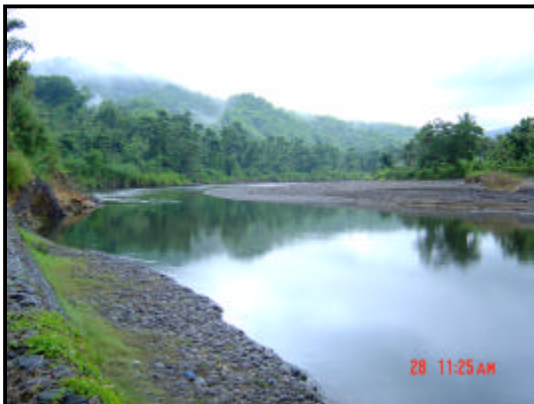
Meandering rivers and meander-braid transition channels have the ability to migrate across their floodplains as a result of selective bank erosion on the outer bend and deposition on the inner bend as point-bars. The channel cross-section at a meander bend is normally asymmetrical, where the stream is deeper on the outer concave bank. The line of maximum stream velocity and depth, or thalweg, becomes concentrated on the outer bank, such that the greatest stream velocities, stream power and water pressure are experienced at the concave bank. In addition to the thalweg being concentrated on the outer bank, intense secondary circulation cells in the form of helical flow also develop at meander bends, leading to an excess of water pressure on the outer bank and a deficit on the inner bank. A zone of flow separation also occurs immediately downstream of the axis of the meander, on the inner convex bends, leading to the development of a shear layer, with spiral vortices, reducing the effective width of the main current and concentrating water flow towards the outer concave bank. The net effect of the concentration of water on the outer bank is erosion, while point-bar deposits are laid down on the corresponding inner bend, where lower velocities, stream power and water pressures are experienced (Figures 7 and 8).

Figure 7. Meander bend erosion on the right bank of the Rio Grande River, 150m north of Rafters Rest, Berridale.

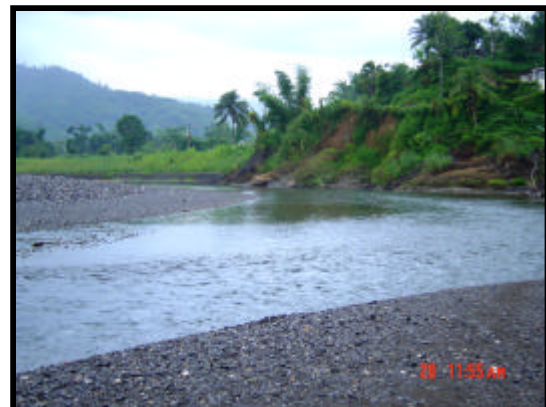
Figure 8. Meander bend erosion on the right bank of the Rio Grande River, 240m north of Rafters Rest, Berridale.

Within the area most prone to flooding, downstream of the main meander bend, gabion baskets have been recently constructed to extend from the level of the road to the bed of the channel (Figures 8 and 9). The baskets protrude into the channel itself by some 5-6m, presumably to act as a buffer to flow and to reduce the asymmetry of the channel. Vegetation has also been planted in conjunction with the gabion baskets (Figure 8).

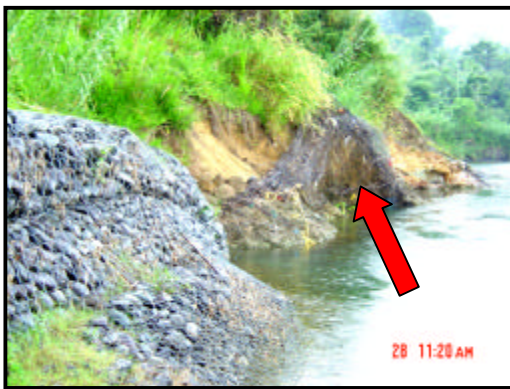
Figure 9. Gabion baskets recently constructed, along the right bank of the Rio Grande River. To the immediate right, ruptured gabions are exposed by an erosion scar.

It is recommended that the damaged gabions on the right bank of the river be replaced, while areas of bank erosion on the left bank could be stabilized by planting riparian vegetation.

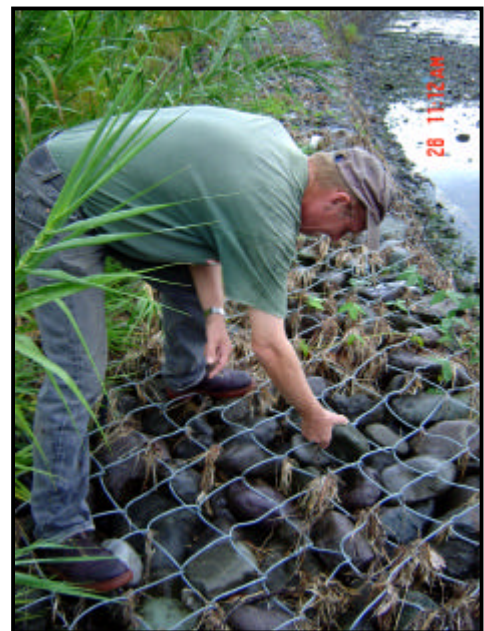
Figure 10. Dr. David Miller demonstrates the poorly constructed nature of gabion baskets at Berridale. Here, mesh size > cobble and boulder material

These gabion baskets are well-located as they afford some protection to the outer meander bend. However, they are poorly constructed, as the cobble and boulder material used to fill the baskets is commonly finer than the mesh of the holding basket (Figure 10). Gabion baskets are generally filled with materials from the local area to reduce haulage costs, in this case rounded river cobbles and boulders. It is best to use rounded materials when infilling gabion baskets to minimize damage to the steel mesh, however a finer mesh should have been used in this instance to conform to the grain size of the material locally available. Some of the gabions are already useless and undermined because they have totally (Figure 11), or at least partially, lost their infill. Many of the older gabions upstream of the main meander bend have also been ruptured by natural processes, such as bed load bombardment during flood events. Some gabions around the sand mining operation at Berridale may have been damaged by mining

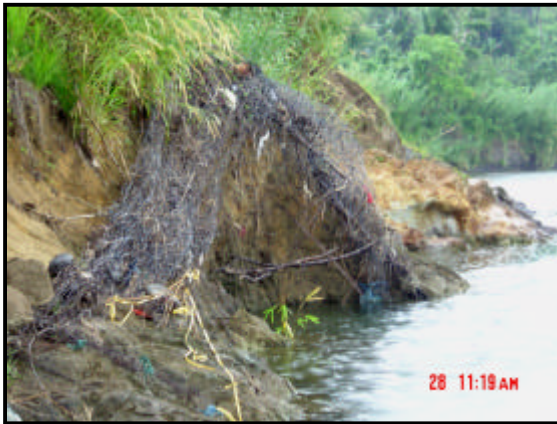
Figure 11. Ruptured gabions induced by massive bank collapse on the right bank of the Rio Grande River at Berridale.

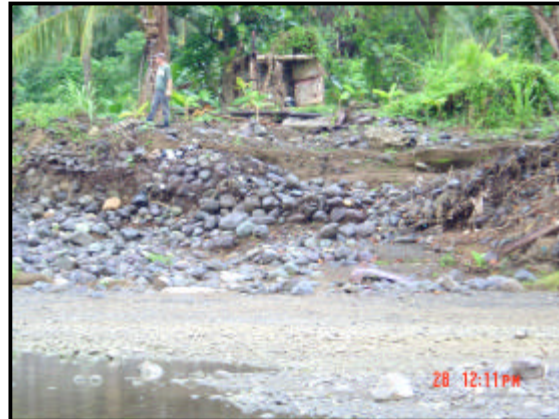
machinery during the stockpiling and loading of sand and gravel, leaving a substantial area of the right bank vulnerable to meander-style bank erosion (Figure 12) .

Figure 12. Damaged gabions around the sand mining operation at Berridale induced by stockpiling and loading of sand and gravel.

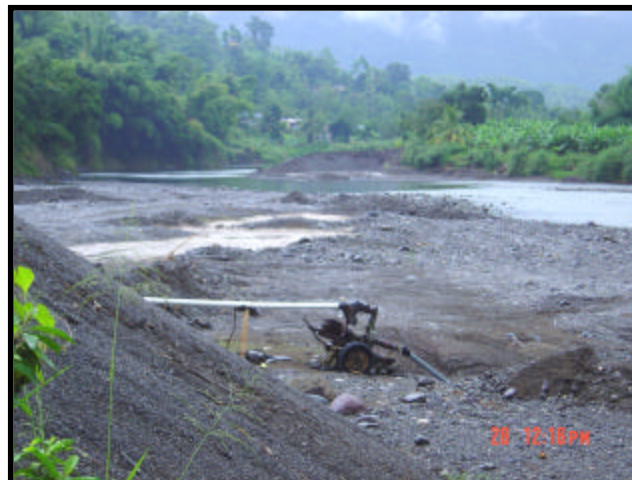
Figure 13. Mining operation at Berridale. To the immediate left, deliberate diversion of the river course to facilitate mining activities is evident.

The mining activity on the right bank of the Rio Grande River at Berridale may create a net shift in erosion concentration on the right bank meanders, thus proliferating bank undercutting, though bank erosion was no more prevalent at or downstream of the mining operation compared to upstream. Erosion of the left bank opposite the mining operation is evident and the may be related to a deliberate diversion of the river course to facilitate the mining of a large lateral bar (Figure13).
