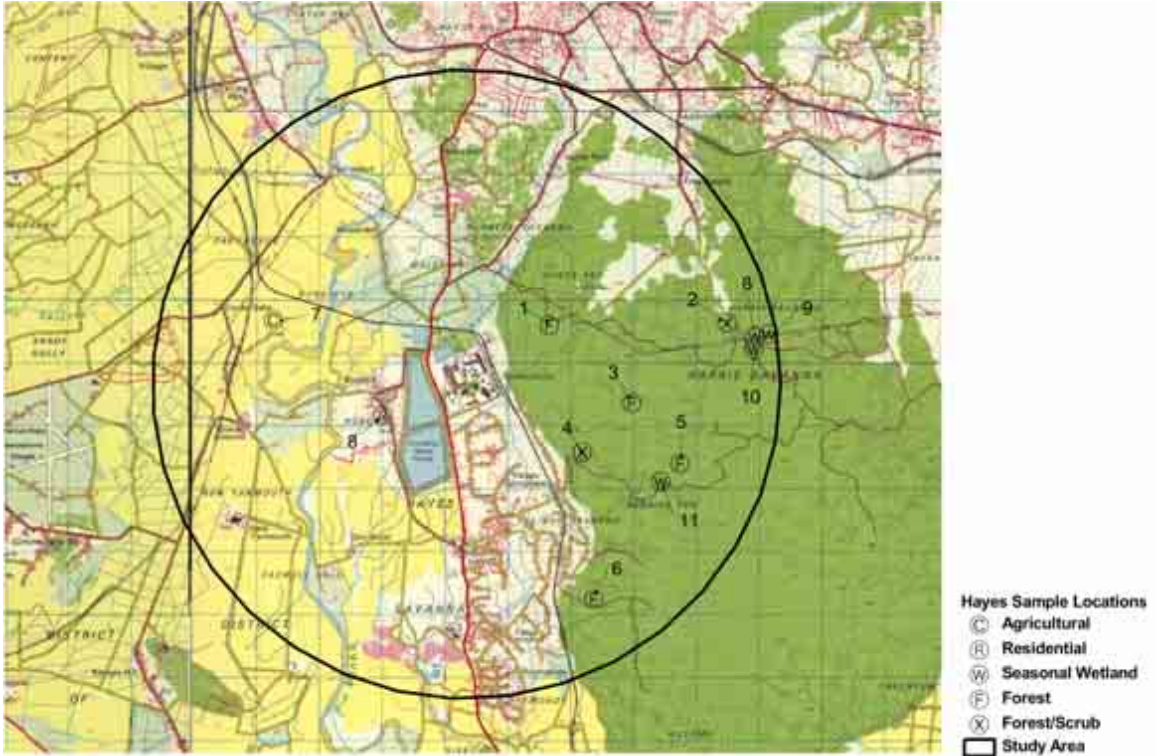
FIGURE 3-20: : MAP SHOWING SAMPLE LOCATIONS AT HAYES, CLARENDON

The map and table below shows sample locations and coordinates at Hayes.

TABLE 3-20: COORDINATES OF SAMPLE SITES AT HAYES, CLARENDON (COORDINATES CORRESPOND TO 1:50,000 METRIC MAP)

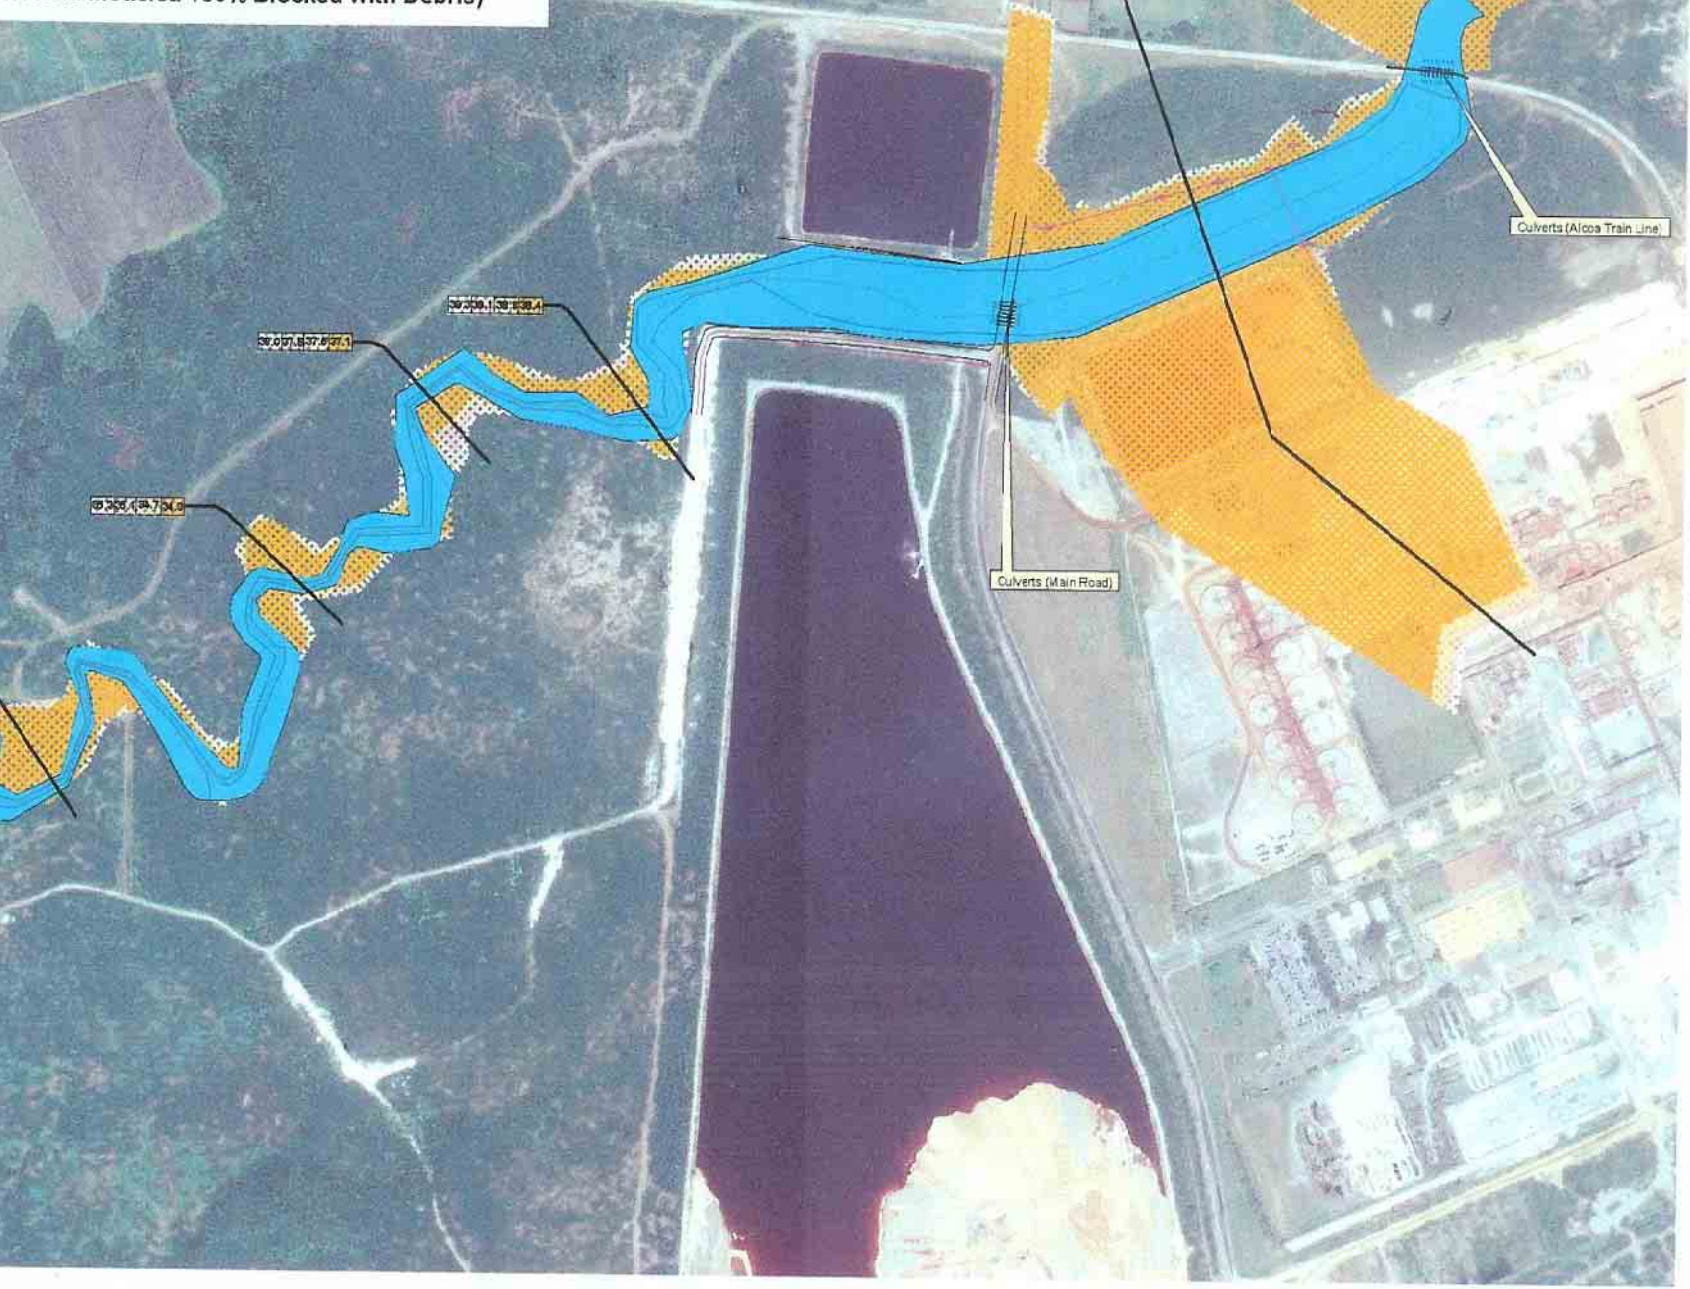
FIGURE 3-23: OUTCOME OF SCENARIO 2

Maximum 24hr Rainfall (mm)	217		269		308		347	<p>Datum: JAD20C1 Coordinate System: WGS 1984 Projection: Lambert Conformal Conic Central Meridian: -77 Latitude of Origin: 18 Standard Parallel 1: 18 Standard Parallel 2: 18 False Easting: 750000 False Northing: 650000</p>	<p>Scale 1:3,500</p> <p>Topographic Base Map: MICROSAT Satellite Image (2001)</p>	<p>LOCATION MAP</p>	<p>WEBBERS GULLY FLOODPLAIN MAPPING PROJECT</p> <p>Prepared by: L. Barrett, Engineer/Hydrologist</p> <p>Assisted by: H. Thomas, Dir. Resource Management A. Hardek, Water Resources Engineer E. Douglas, Senior Assistant Hydrologist H. Roper, Assistant Hydrologist</p>	<p>CLIENT: ALCOA MINERALS JAMAICA, NC. (JAMALCO) KIER/CC</p> <p>PART OF WEBBERS GULLY AND RIO MINHO RIVER FLOODPLAIN MAPPING</p> <p>Water Resources Authority Hope Gardens P.O. Box 91 Kingston 7 Jamaica</p> <p>Date: June 2005</p>
Maximum 24hr Rainfall (mm)	217												
	269												
	308												
	347

Flood plain Maps (Figure 1-1, Figure 3-23, and Figure 3-24) show the outcome of the above scenarios.

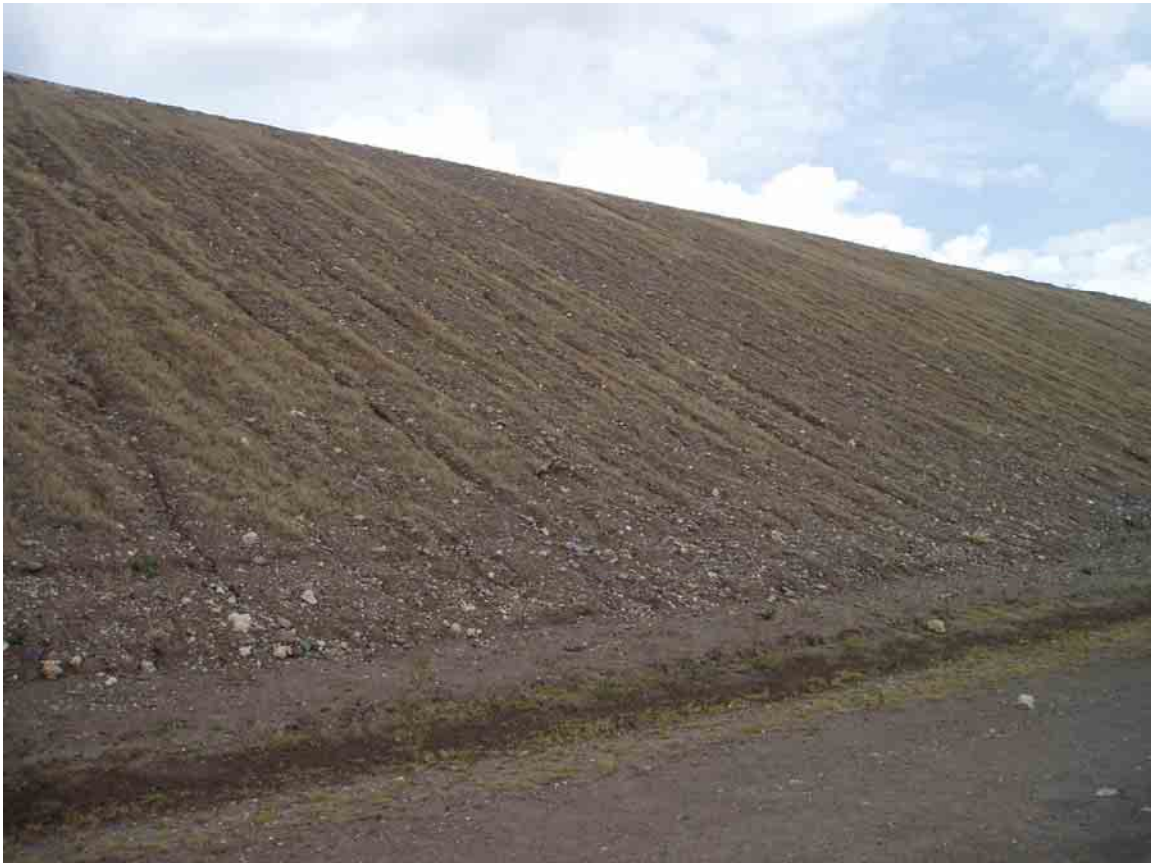
FIGURE 3-26: GRASS COVERING SLOPE OF DYKE OF RESIDUE DISPOSAL AREA.

The design and construction of the dykes impounding the present RDAs appear to be sound, with no reports of slumping or collapse. The slopes of the dykes are subject to erosion from rainfall, taking the form of vertical runnels. The attempts to control or reduce this erosion through the planting of grass appear to be successful where the grass has caught. On the east-facing slopes the grass cover is well-developed (Figure 3-26), but on other slopes the cover is still incomplete.
