PROPOSED SEAGRASS RELOCATION AND REPLANTING AND CORAL RELOCATION METHODOLOGY

FIESTA JAMAICA LIMITED, HANOVER

JUNE 2006

Submitted by
C.L. ENVIRONMENTAL
Town House 21
Perkins Estate
1 Perkins Boulevard
Kingston 19

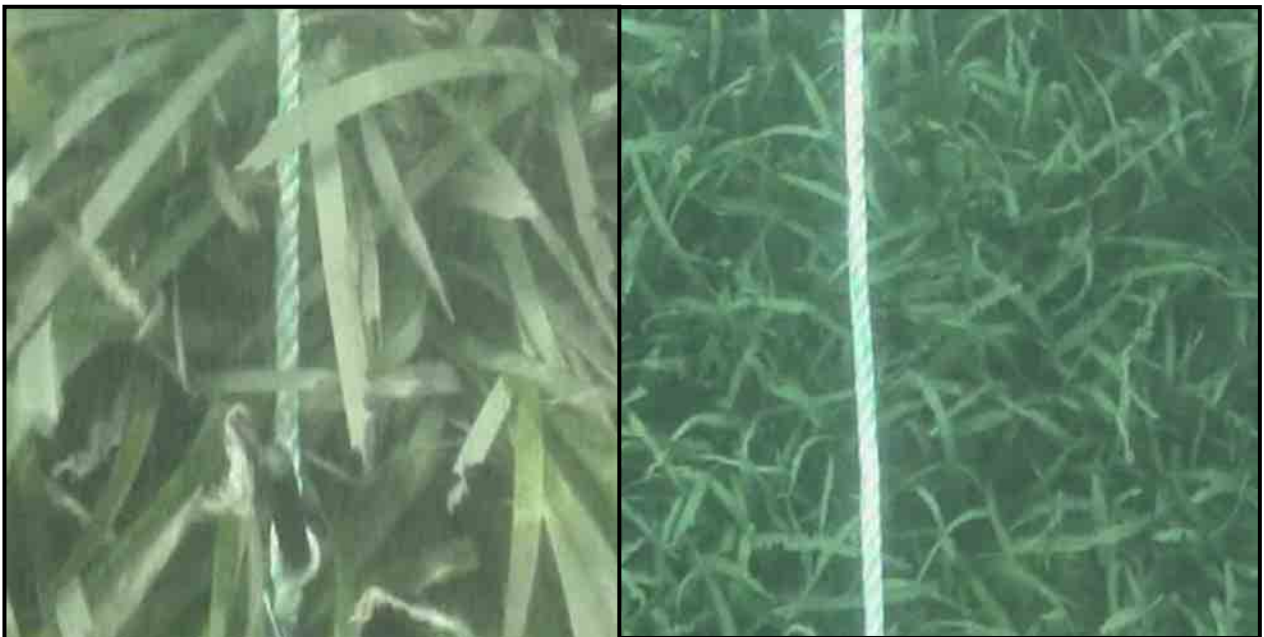
The seagrass beds were generally in good health with some of the blades showing signs of grazing. The beds located at the Southern Beach 1 (Plate 4) were generally healthier than those at Southern Beach 2 although some beds at this beach were healthy.

Plate 4 **Examples of seagrass beds located at the proposed Southern Beach 1**

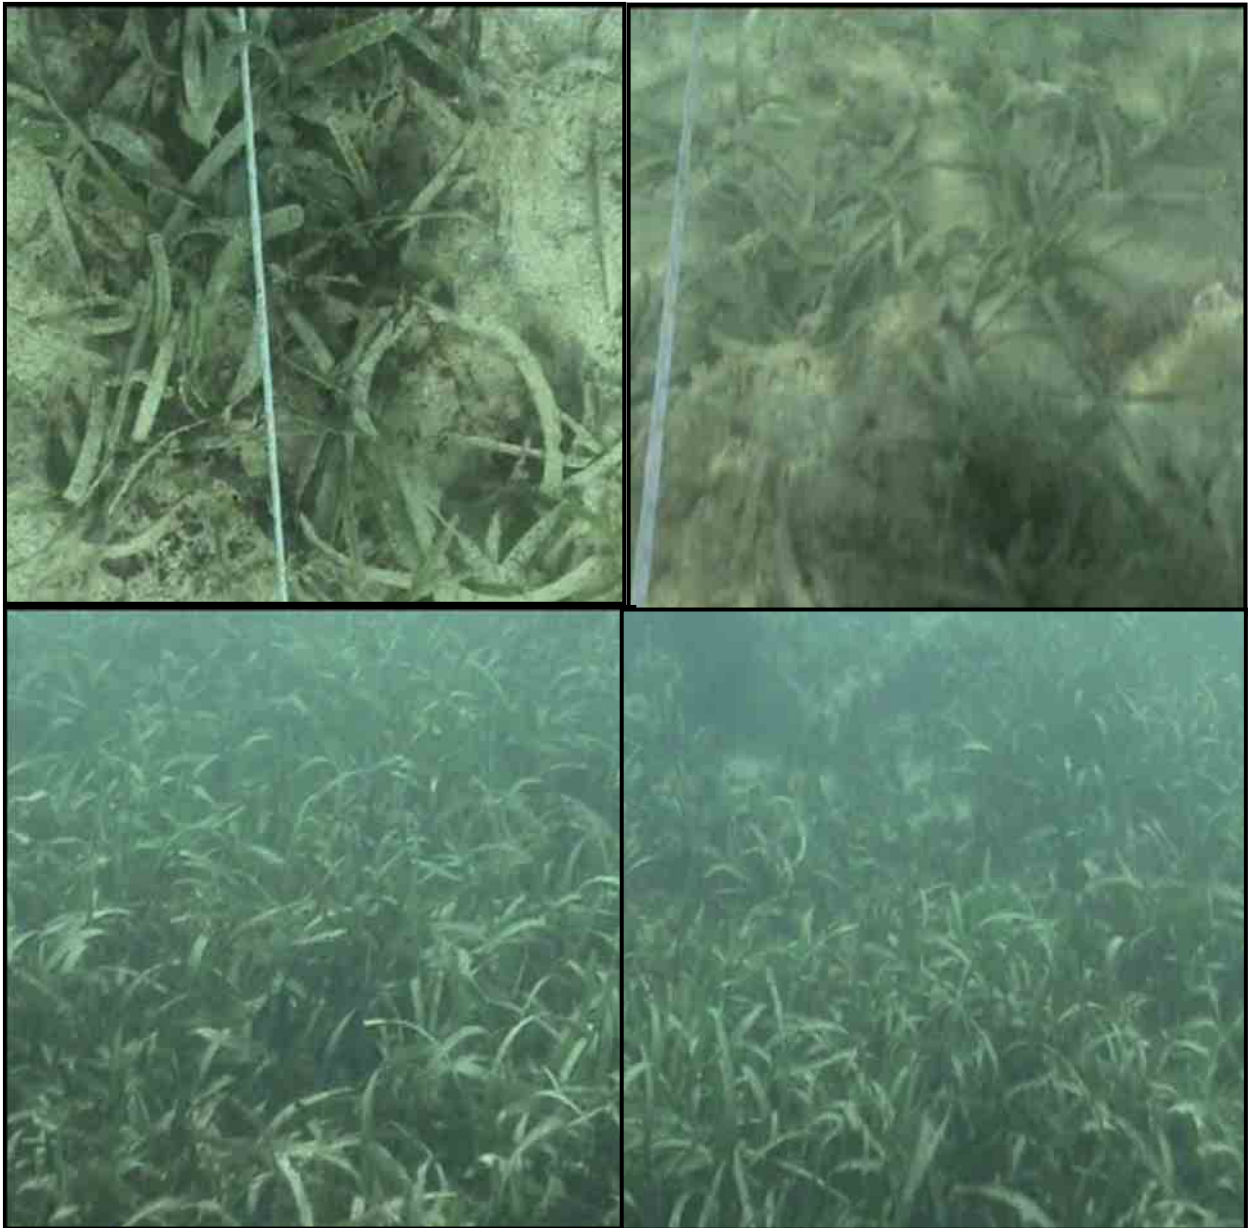
Plate 5 **Examples of seagrass beds located at the proposed Southern Beach 2**

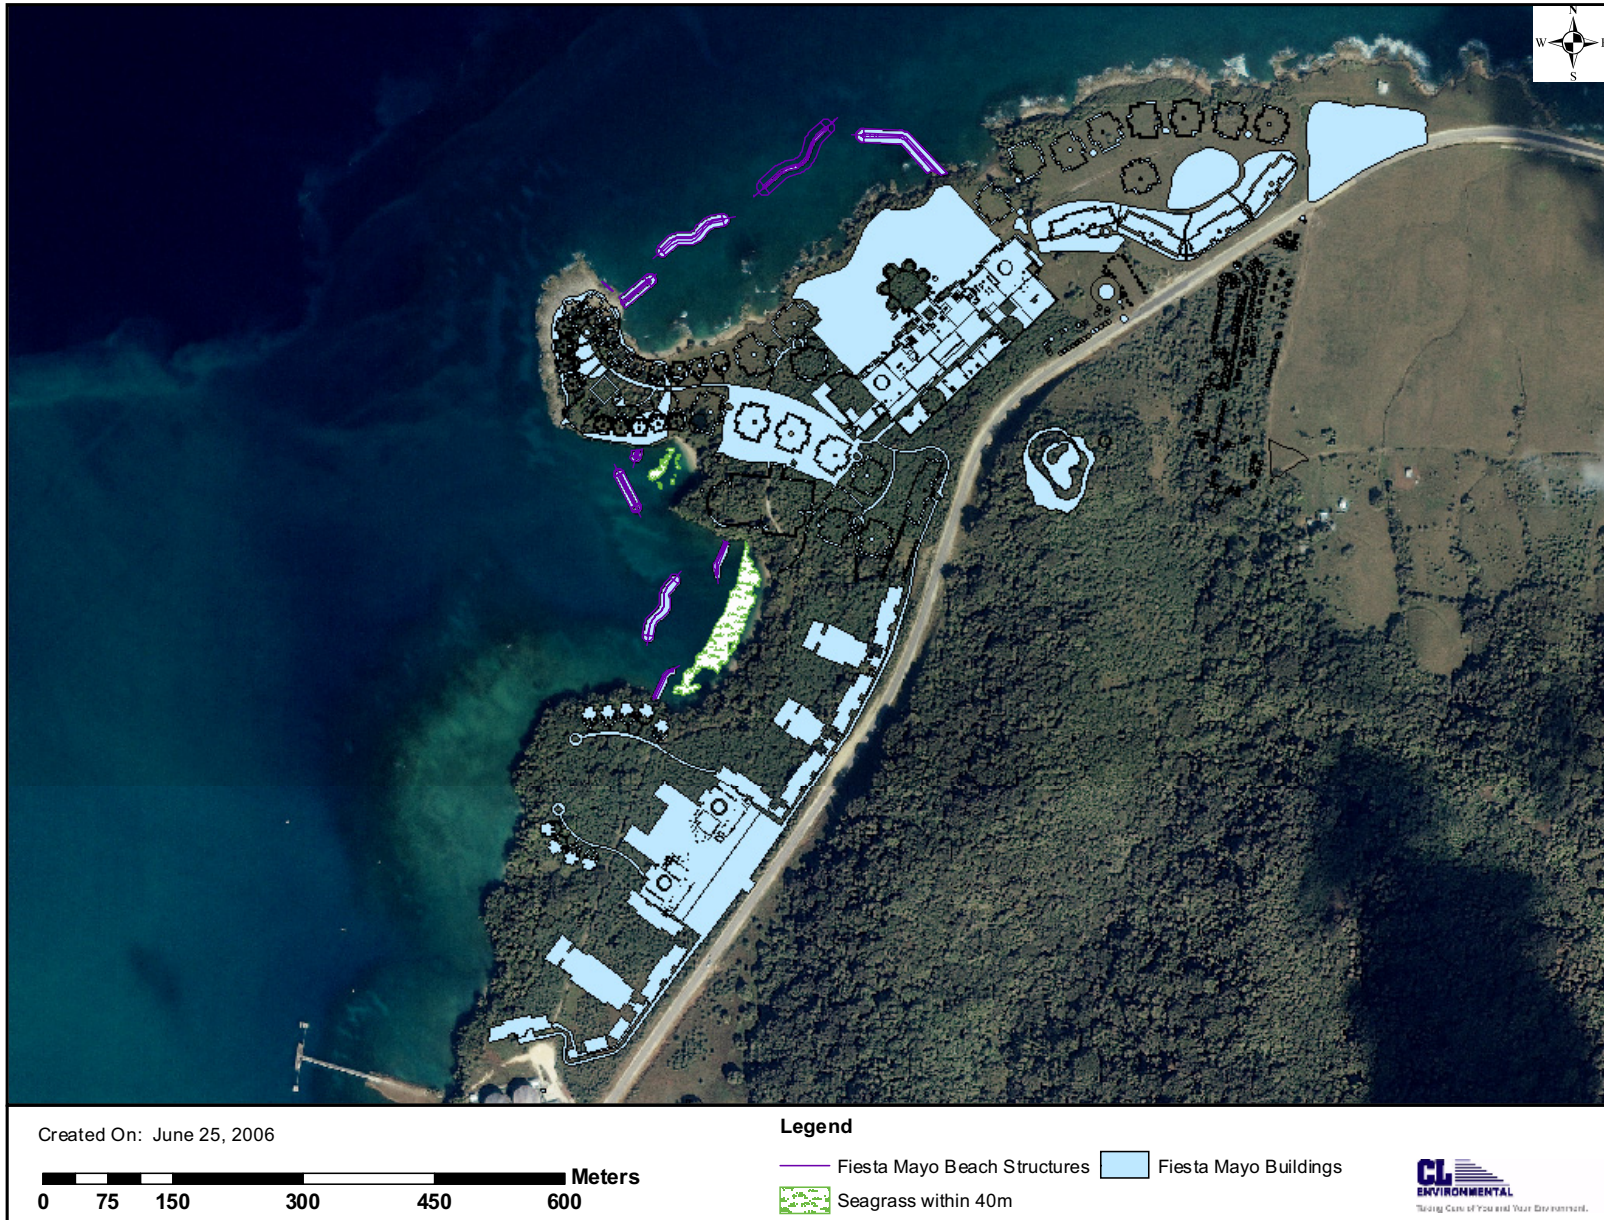
Figure 19 Diagram illustrating the Southern Beach 1 reduced to 40m seawards

This alternative involves reducing Southern Beach 1 seaward extent to a maximum of 40m. This measure would reduce the area of seagrass to be removed and replanted from Southern Beach 1 to approximately 4,021.81 m² (\approx 0.41 ha or \approx 1 acre) from approximately 8,069.89 m² and the total overall seagrass from approximately 8,449.84 m² to approximately 4,401.76 m² (Figure 19).
