PROPOSED EXTENSION OF RUNWAY AT NORMAN MANLEY INTERNATIONAL AIRPORT

A RAPID ECOLOGICAL ASSESSMENT

Airports Authority of Jamaica
Norman Manley International Airport
Palisadoes
Kingston

Environmental Solutions Ltd.
20 West Kings House Road
Kingston 10

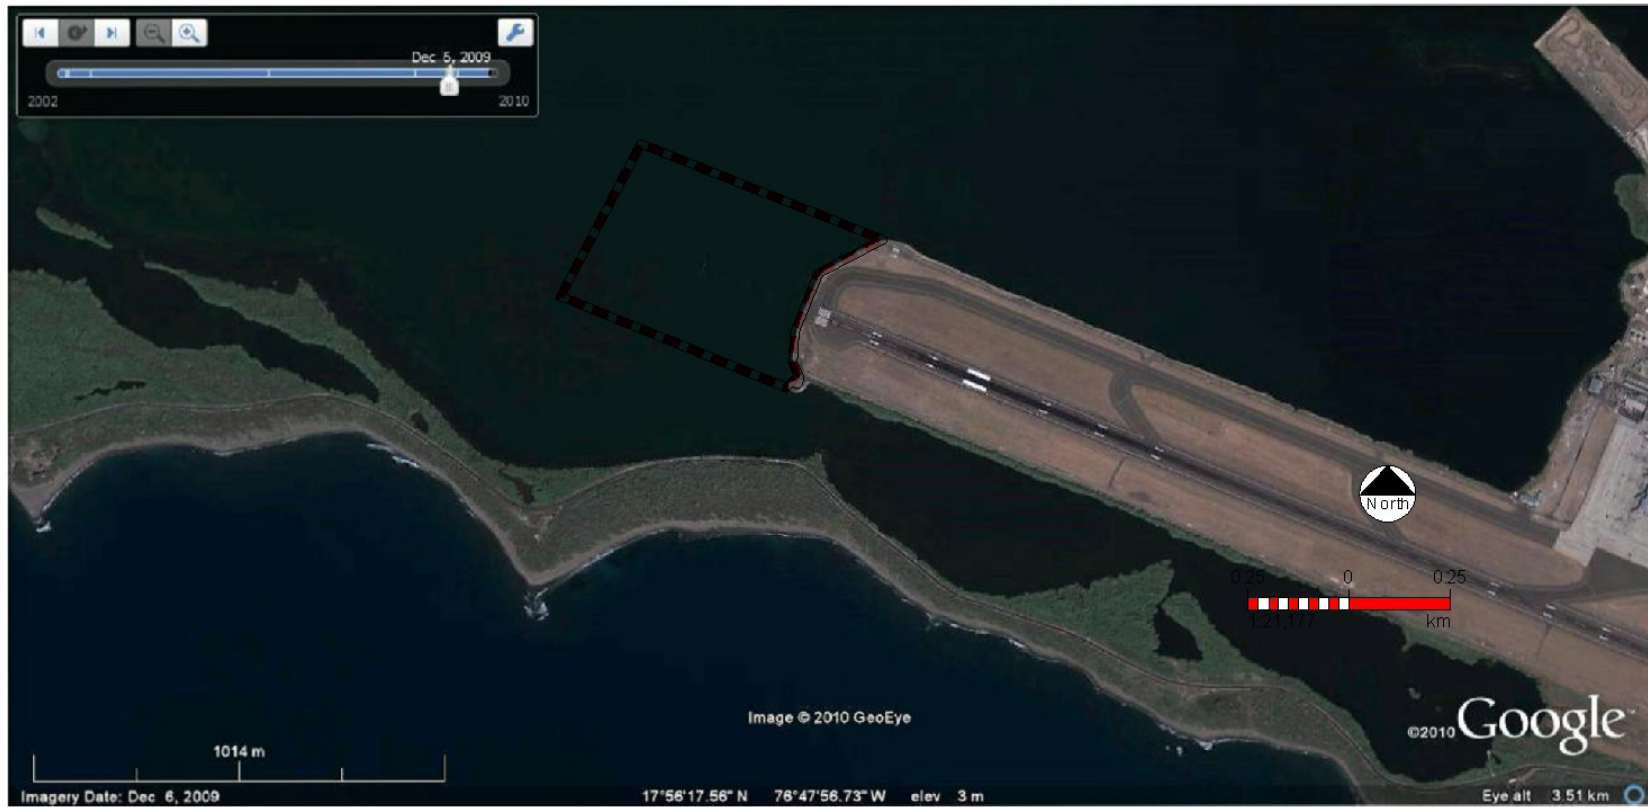
Figure 1 – Study Area Norman Manley International Airport (Box Highlighted in Red).

Environmental Solutions Ltd. received a request for Proposal from the Airports Authority of Jamaica (AAJ) for a Rapid Ecological Assessment (REA) of an area of seafloor immediately adjoining the western end of the Norman Manley International Airport runway in Kingston (see Figure 1). The REA is required to satisfy permitting requirements for the National Environment and Planning Agency for the extension of the airport runway by up to 500 meters, using land-filling methods.

A detailed census of flora and fauna components existing within the areas peripheral to the study area was not done. However, a technical reference entitled The Biodiversity of Jamaican Mangrove Areas -Volume 7⁹ (see Appendix 3) was used as a reference for the observation and identification of the following species observed during boat-based surveys conducted immediately adjoining the study area, within the confines of the area defined on Figure 1 above:

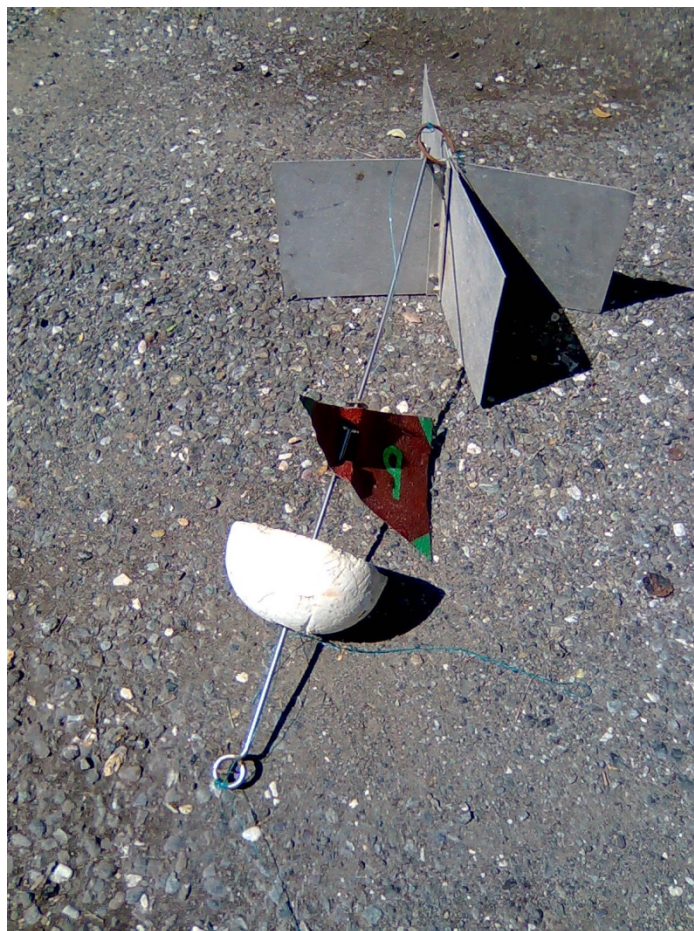
Figure 3: Shallow Water Drogue used for Current Tracking at NMIA

The first evaluation method was the collection of two sets of sea current measurements, which were obtained on the 13th of October, 2010 using a shallow water drogue (see Figure 3) deployed at two specific locations within the study area.

Both drogues were set up to measure shallow water currents (less than 1m depth). Each drogue deployment was commenced from a fishing canoe, which was used as a support platform for the field surveys conducted.

The drogue was allowed to drift for 15 minute periods⁵ at the end of which, the drogue was carefully approached by boat (so as not to disturb its movement with wake wash) and a position and time taken with a Global Positioning System. The positions and times of position taking were then plotted onto Google Earth imagery so that a spatial understanding of their movement could be obtained.

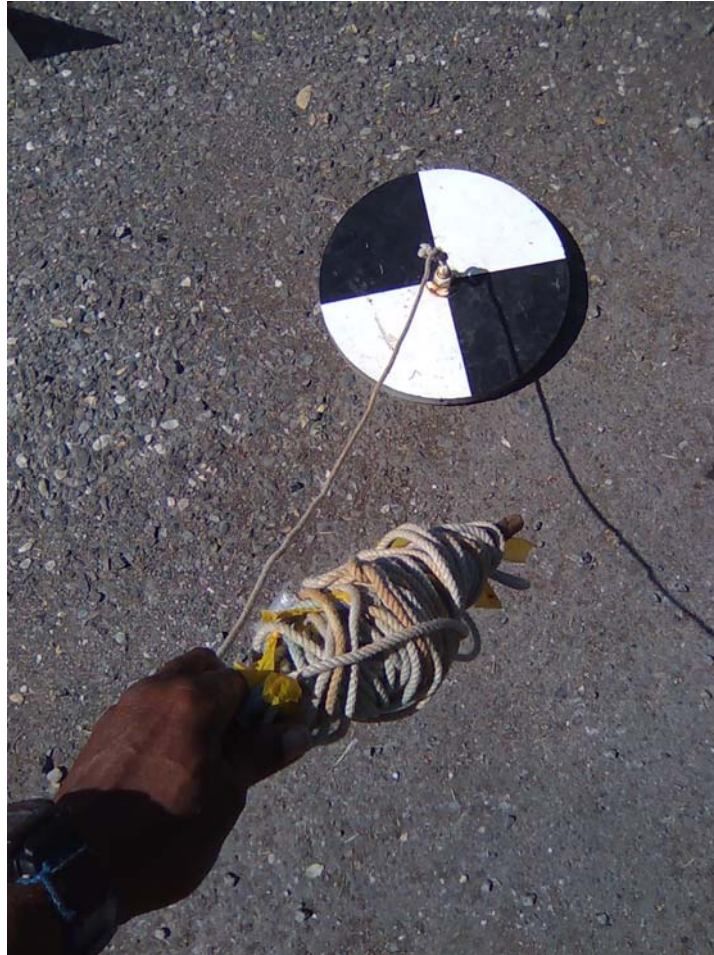
Figure 4: Secchi Disk used for Water Turbidity Measurements at NMIA

In addition, water clarity data was obtained through the use of a Secchi Disk (see Figure 4) at all seafloor assessment locations.

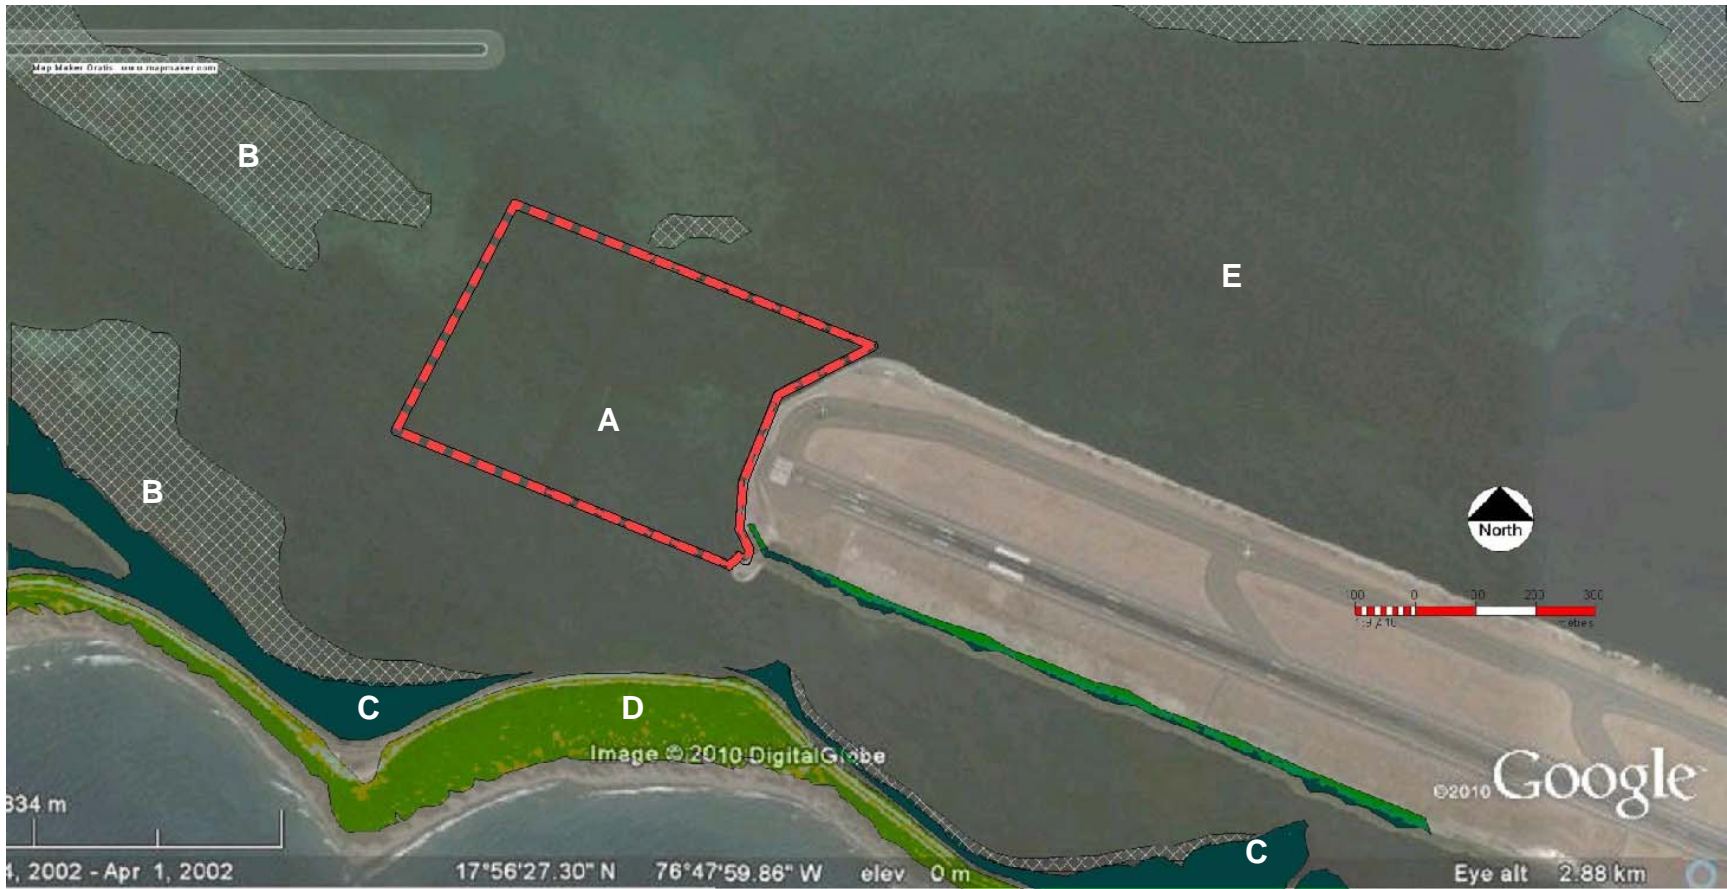
Figure 5: Google Earth Diagram of the NMIA Runway and Adjoining Areas Showing Sessile Marine and Terrestrial Lifeforms Present. A: Study Area, B: Seagrass Beds (*Thalassia* sp.) C: Mixed Mangrove Wetland Vegetation D: Sand Dune Vegetation E: Seafloor Sediments with Undetermined Biota.

Figure 5 below describes in general terms the types of marine and terrestrial sessile lifeforms existing within and peripheral to the development site, as interpreted from aerial images.

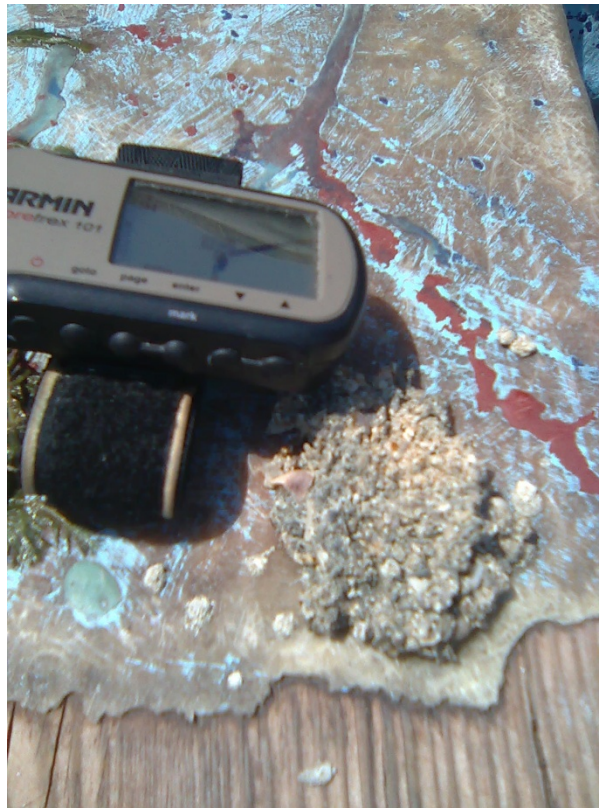
Figure 8A Black Sand Sample Obtained from Seafloor within Study Area

Diving inspections conducted within the study area revealed that the majority of the substrates observed were black sand typical of that seen on the dunes and beach areas on the southern side of the Palisadoes area, while the southern sections of the study area were dominated by thick layers of organic mud greater than 30 cm in depth, which most likely overlaid black sand sediments (see Figure 7). Mixed into the black sand sediments were abundant fragments of bivalve shells, which gave the initial appearance of white sands to the inspecting diver until a closer inspection was made (see Figures 8A-B).

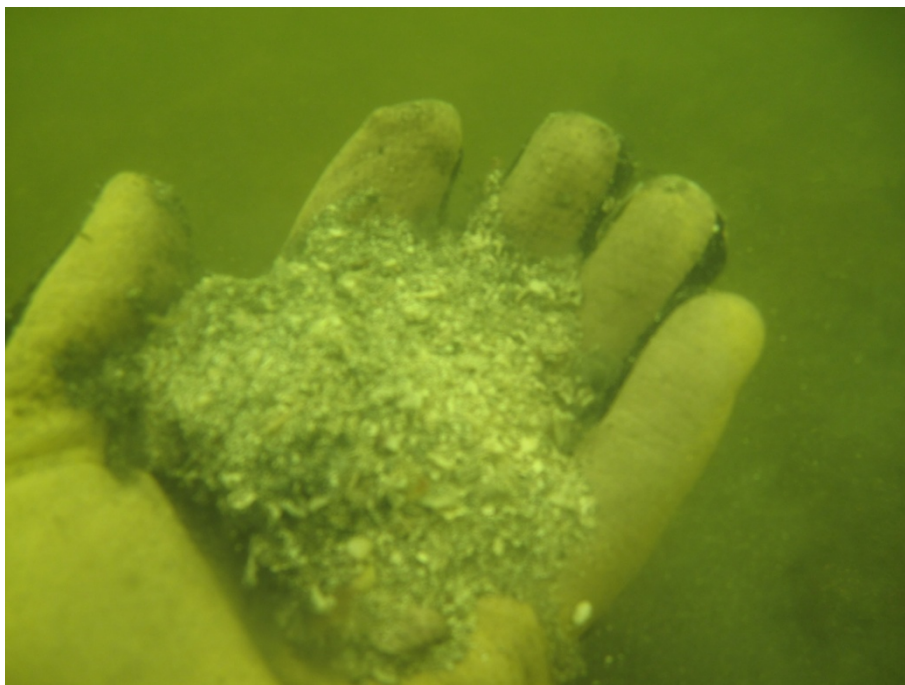
Figure 8B: Black Sand Seafloor Substrate with Bivalve Fragments, As Observed In Situ at the Study Area

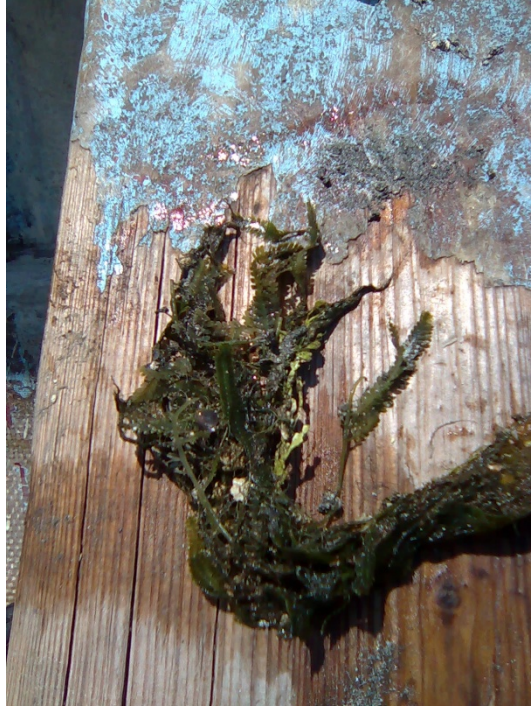
Figure 9B: Sample of *Caulerpa mexicana* recovered from the Seafloor Within the Study Area

None of the typical attached benthic lifeform features of importance, namely, corals and seagrass, were observed within the study area. The seafloor was largely devoid of any attached benthic lifeforms, with the exception of the northeastern section of the project area, which had 25-100% coverage of macro-algae, as measured within the 1m² PVC quadrats deployed for sampling. Figures 9A-C illustrate the algae observed in situ and after being sampled, while Figure 9D shows an approximate area of seafloor within the study area that was covered with macroalgae.

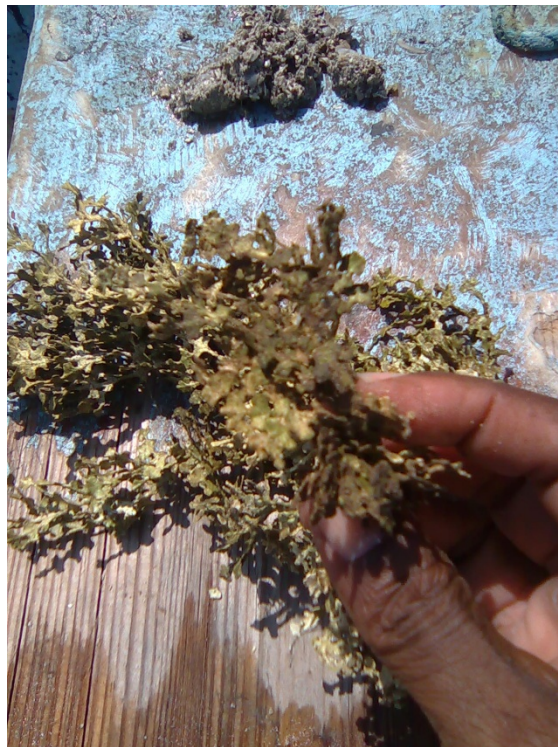
Figure 9C: Sample of *Halimeda sp* recovered from the Seafloor within the Study Area

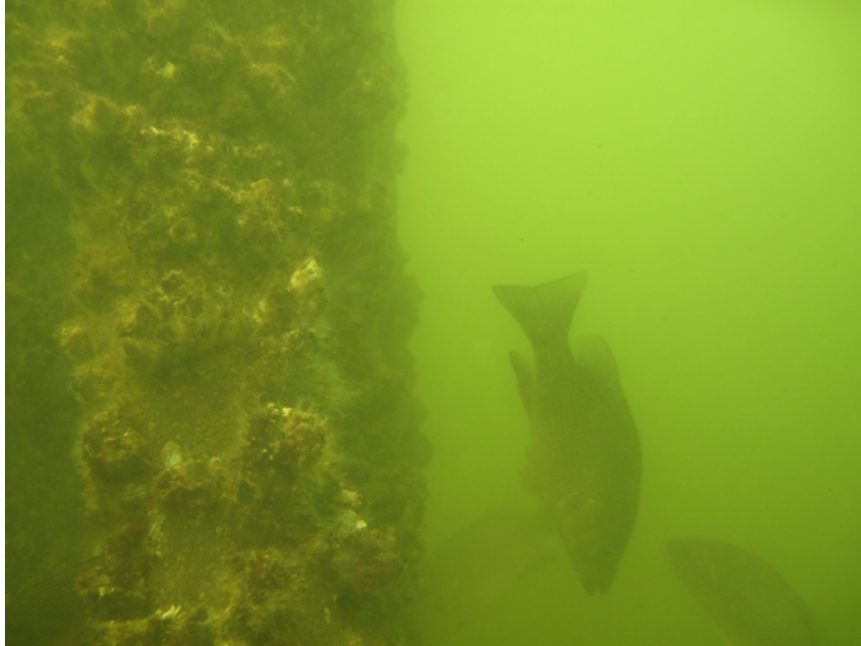
Figure 11A: Example of Mangrove Snapper School Observed Around Supports for Approach Lights

1. Mangrove (Black) Snapper (*Lutjanus griseus*)
2. Four-Eye Butterfly Fish (*Chaetodon capistratus*)

Examples are illustrated on Figures 11A-B below:

The Mangrove Snapper was the more abundant of the two fish types observed, with schools of up to 8 individuals being observed swimming around each of the supports examined.

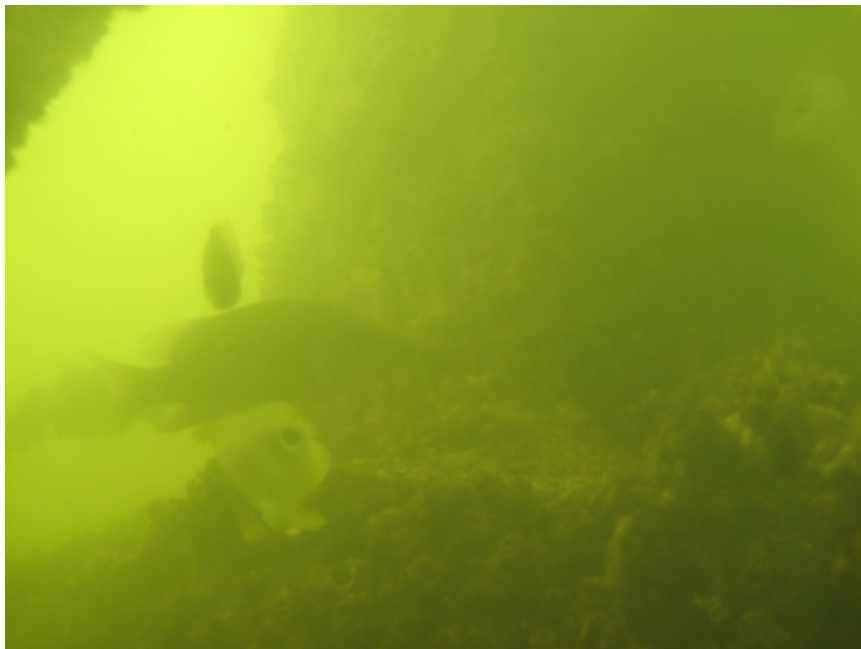
Figure 11B: Example of Solitary Four-eye Butterfly Fish Observed around Supports for Approach Lights

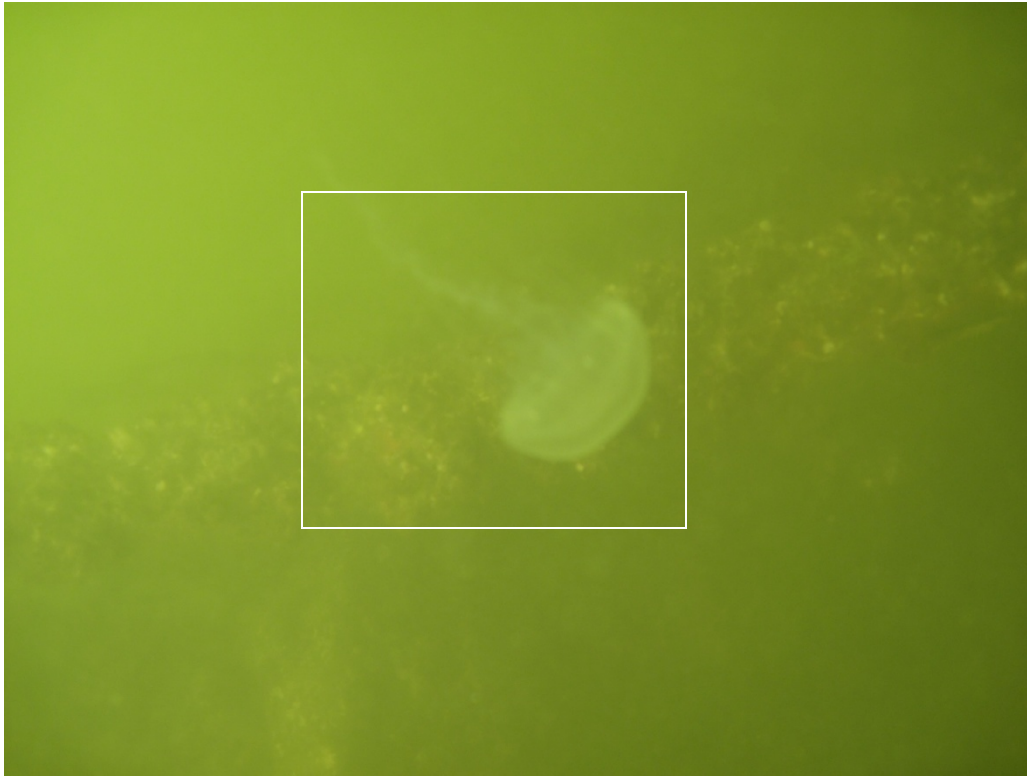
Figure 11C: Image of Dactylometra sp. Seen Amongst the Approach Light Supports within the Study Area.

Other than fish, the only other pelagic lifeform observed within the study area were jellyfish, specifically *Dactylometra* sp, which were seen in abundance near to the approach light supports within the study area (see Figure 11C).

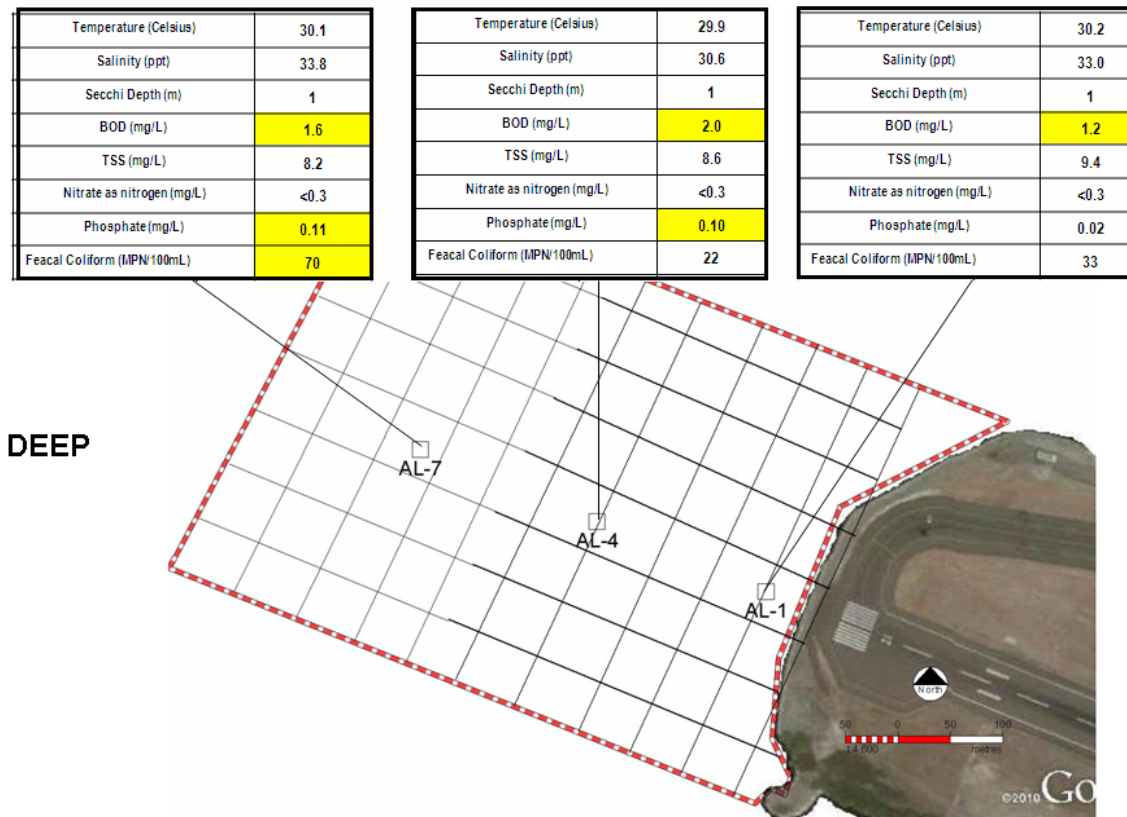
Figure 12B Water Quality Data for Bottom Samples Taken Within Study Area (Yellow = Non-compliance with NEPA Marine Standards)

All BOD samples were marginally in excess of the NEPA Marine Water Quality standards, with the exception of the nearshore surface sample point. Particularly high Faecal Coliform counts were obtained for two of three of the surface sample locations, with one marginally high result being observed for one deep sample.
