**PROPOSED EXTENSION OF RUNWAY AT
NORMAN MANLEY INTERNATIONAL AIRPORT**

**ADDENDUM
TO
RAPID ECOLOGICAL ASSESSMENT
NOVEMBER 2010**

ADDENDUM – PART 1
CIVIL ENGINEERING DETAILS

**PROPOSED 500m EXTENSION TO NMIA RUNWAY
ADDENDUM TO REA REPORT SUBMITTED TO NEPA IN FEBRUARY 2011**

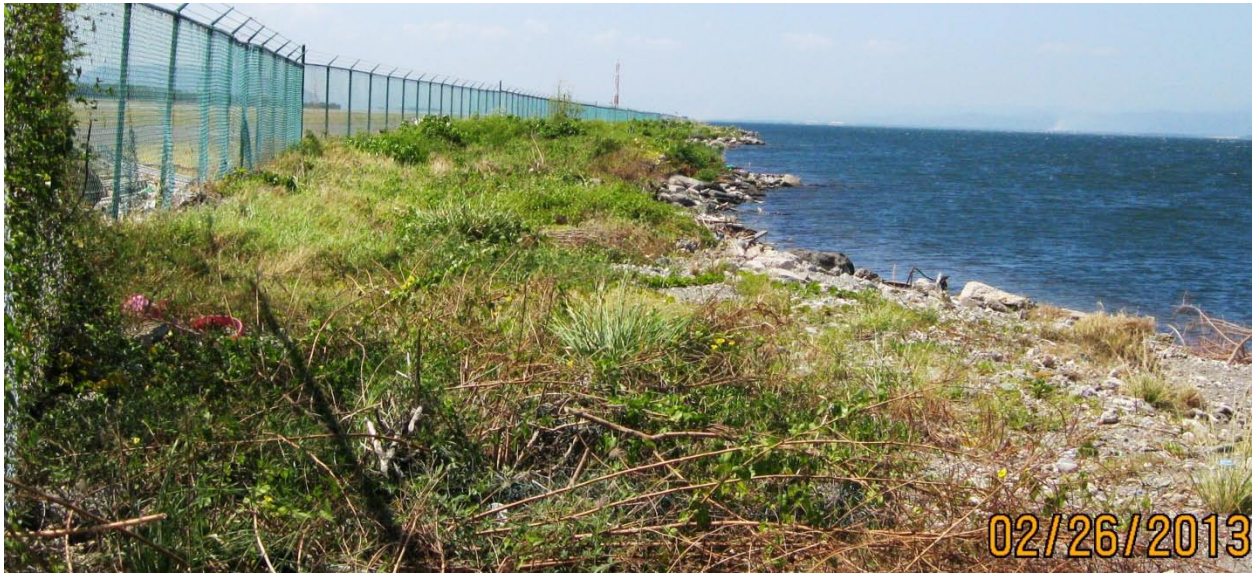
Fig. 3 Photo looking westwards along the north edge of the existing runway. This portion of the runway is to be widened by 15m, Reclamation area B in the above Fig.2

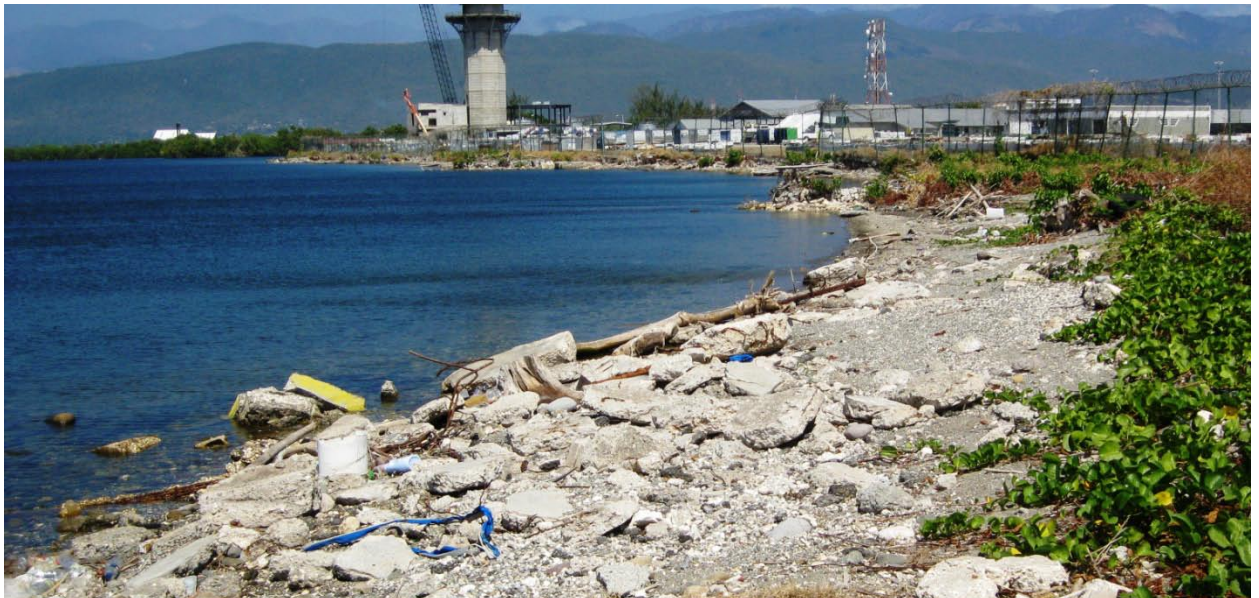
Fig. 4 Photo looking northwards along the western boundary of the NMIA compound. Reclamation area C in the above Fig.2

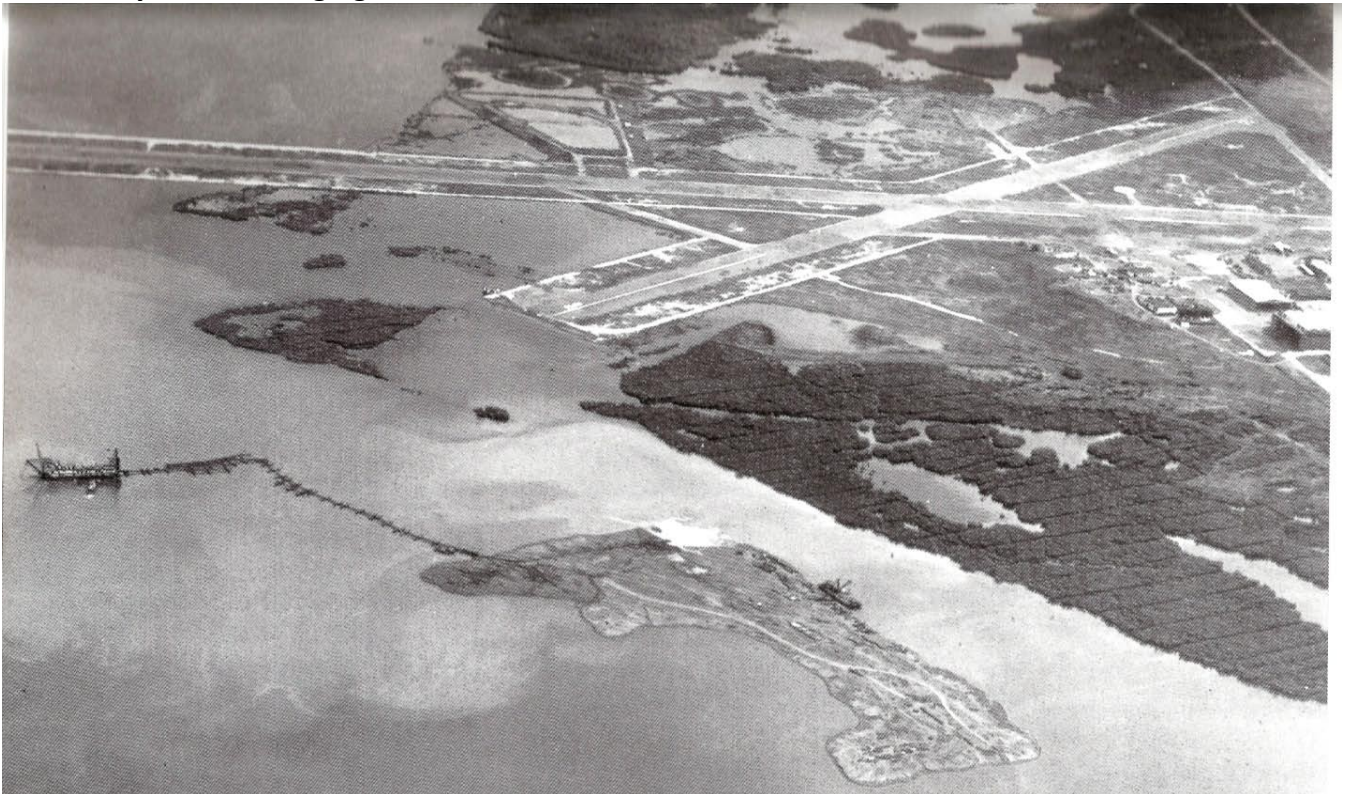
Fig 8 above is a 1955 aerial photo showing a cutter suction dredger (CSD) operating in the Palisadoes wetlands at the start of construction of Palisadoes Airport, which later developed into becoming the present Norman Manly International Airport, NMIA. Over eight million cubic yds of seabed material was dredged to create the 310 acres of new land, using this flat bottom, shallow draught CSD and the “pump ashore “ method of reclamation.

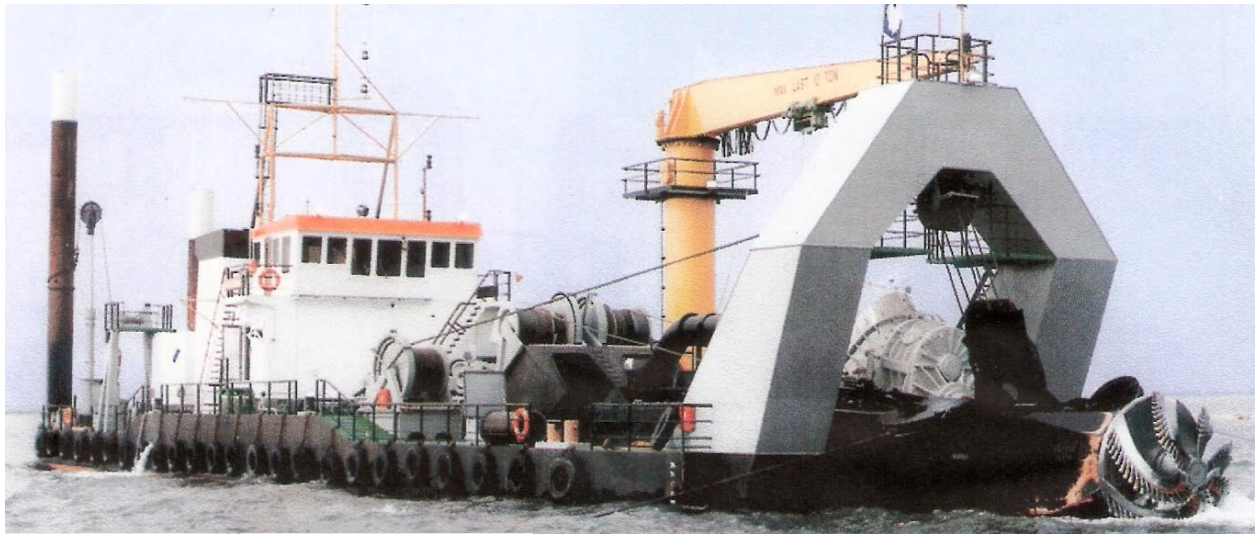
Year of construction	1984
Classification	B.V. I 3/3 E Deep Sea
Tonnage	702 GRT
Length overall	66.00 m
Length pontoon	53.40 m
Breadth	12.50 m
Moulded depth	4.50 m
Normal draught	2.40 m
Suction pipe diameter	0.70 m
Discharge pipe diameter	0.70 m
Maximum dredging depth	20.00 m
Minimum dredging depth	4.00 m
Anchoring system	Spud carriage

Fig.9 Photo of CSD *Mercurius*
 Typical pontoon shallow draught CSD. Most likely this will be the type of machine that will be used for carrying out pump ashore reclamation for the proposed 500m extension of NMIA runway.

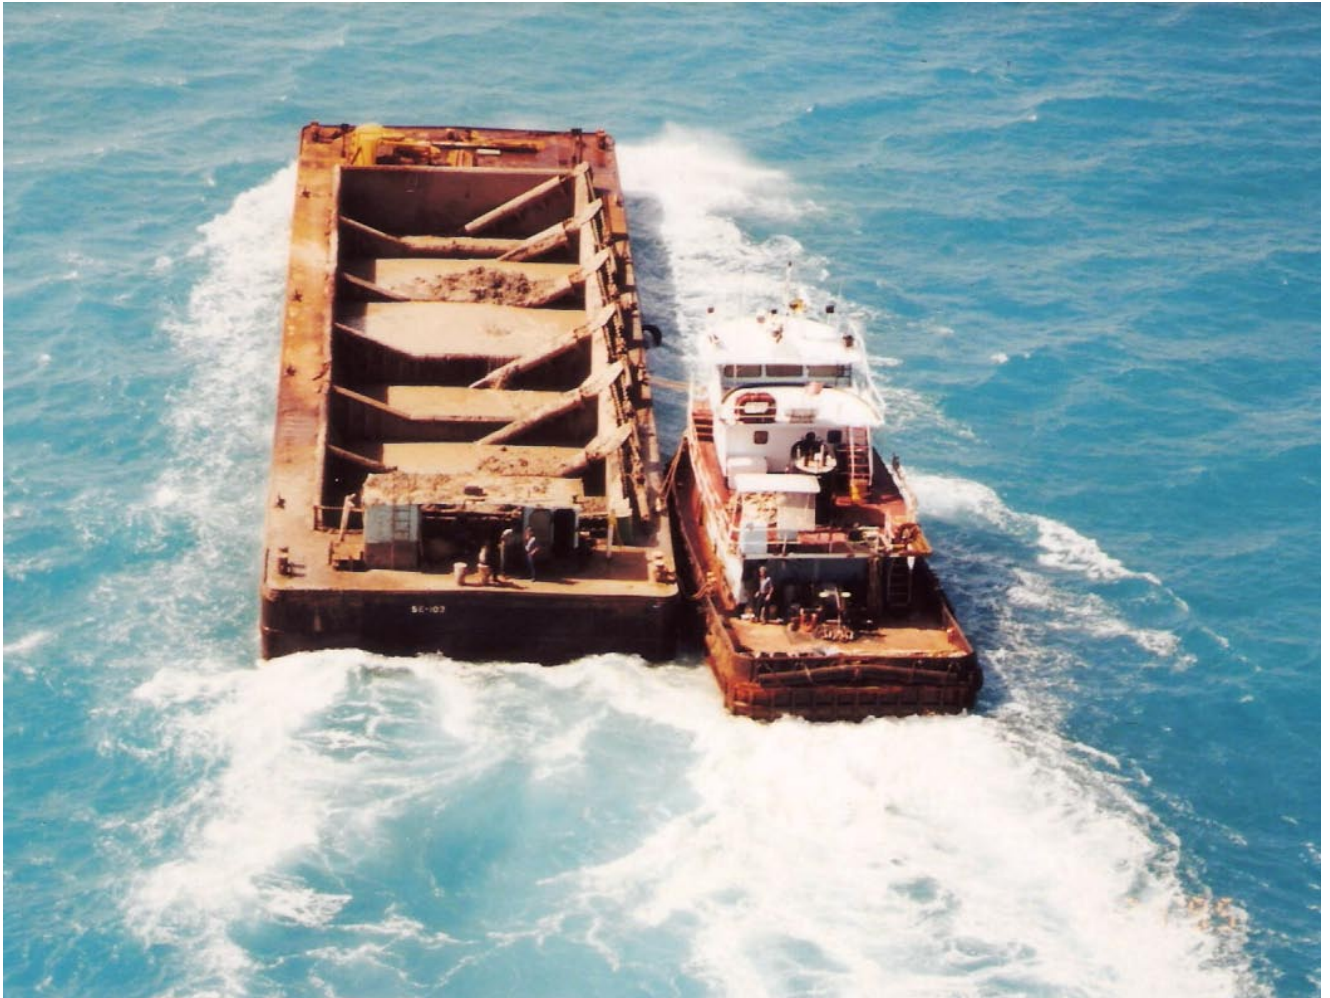
Fig. 11 Photo of a split hull barge being towed away from a dredge site carrying dredged material to be disposed of at a remote dump site. Any Contractor engaged for carrying out this proposed NMIA RESA project will very likely come with equipment such as that shown in the above photo to deal with any off-site disposal situations that might arise.

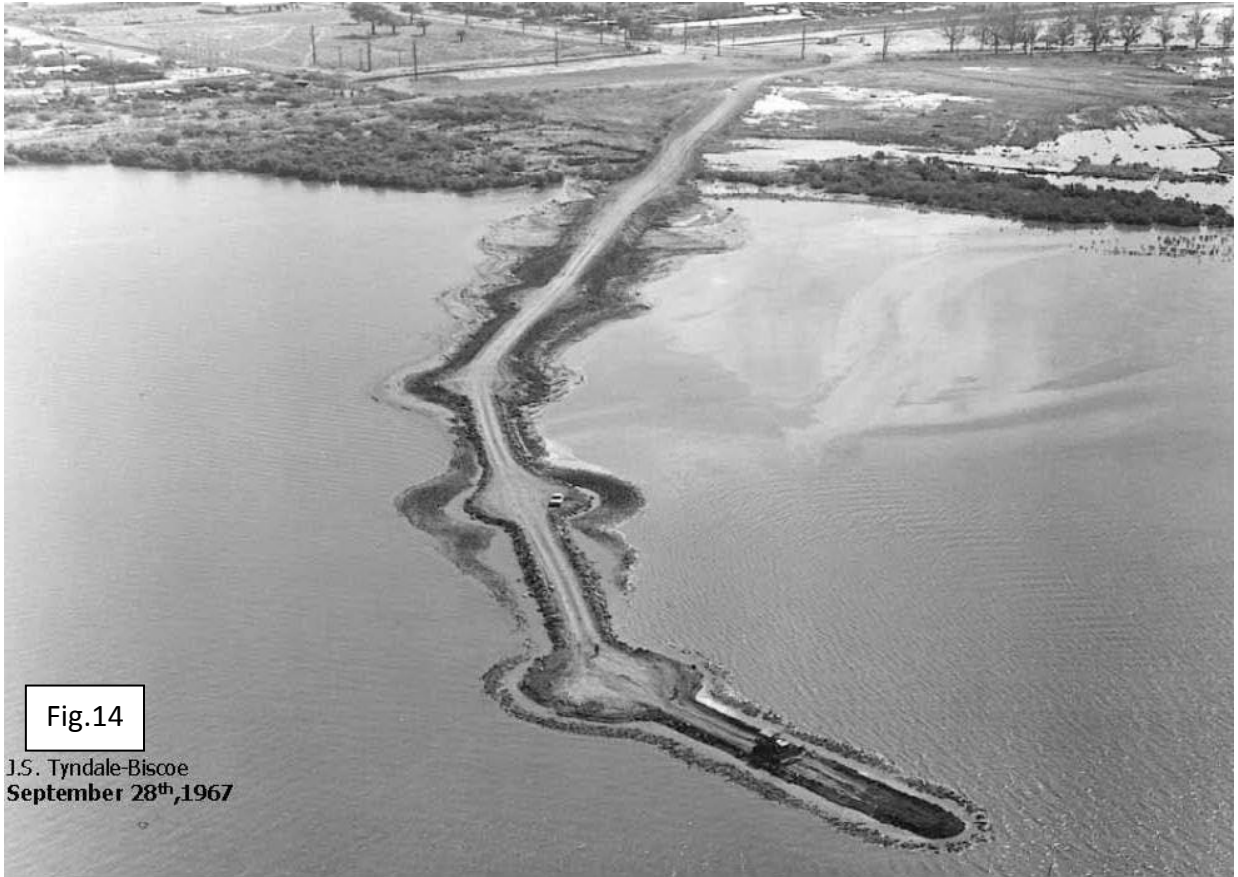
Fig. 14 Containment bunding being constructed in 1967 at Newport West by dry filling with river shingle

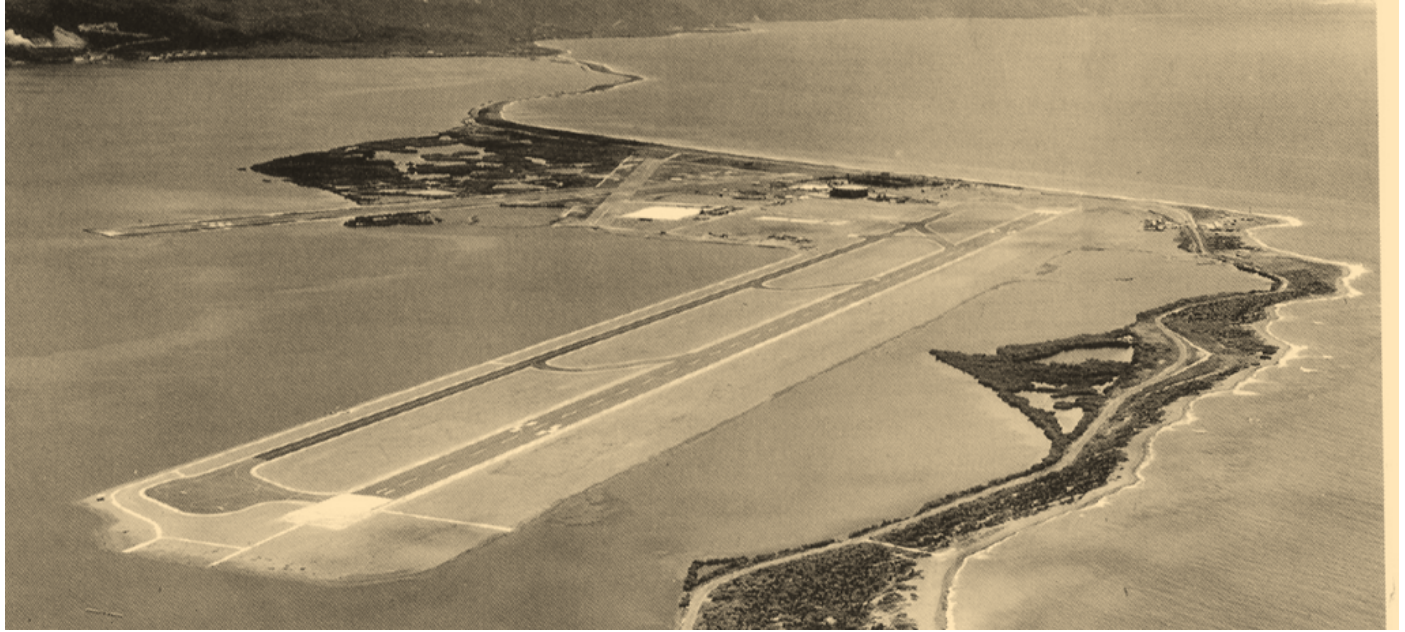
Fig.17 Aerial photo showing the newly completed (August 1959) 1.4 mile long Palisadoes Airport runway

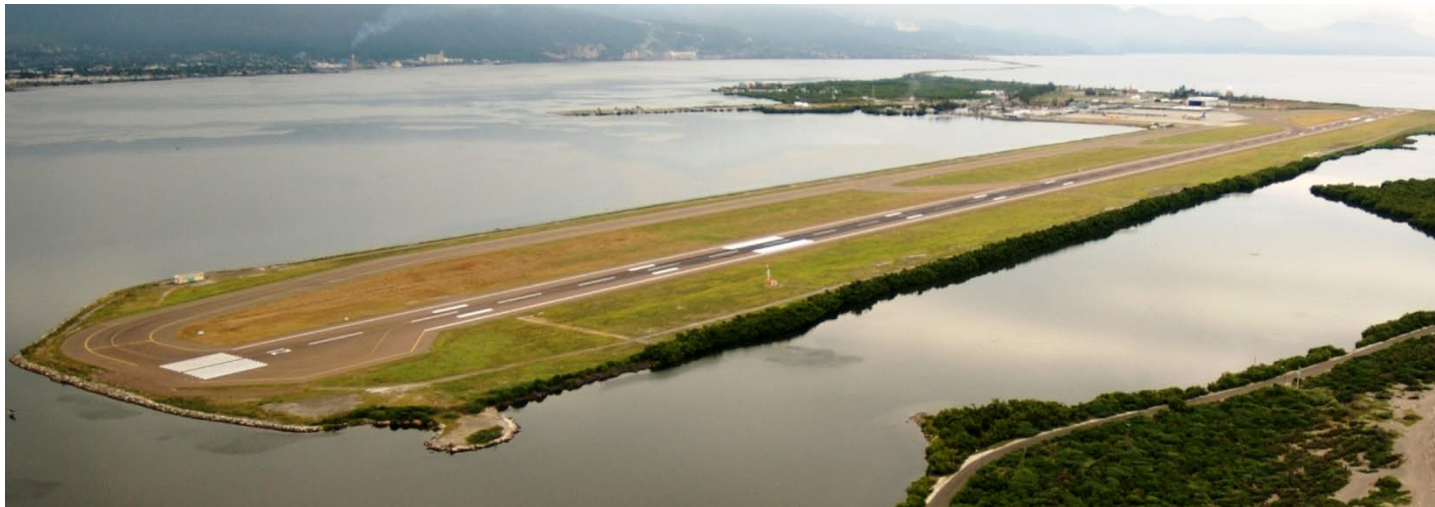
Fig.18 Recent aerial photo showing flourishing growth of mangroves along the south edge of the runway.

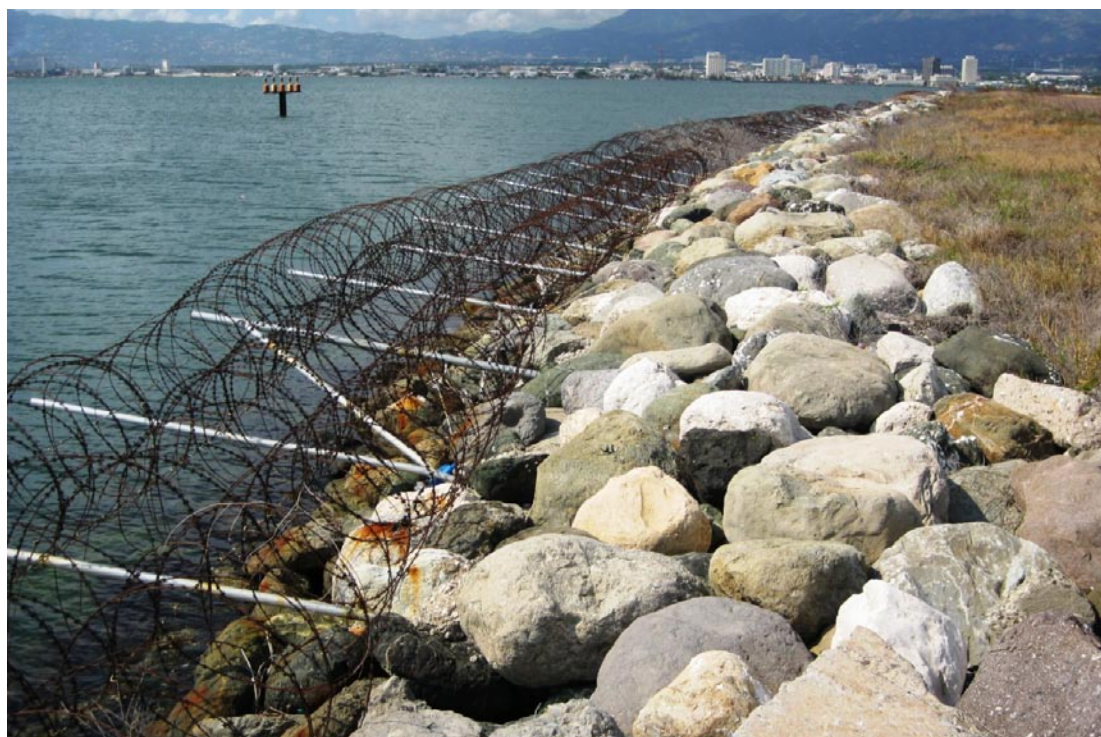
Fig.20 Photo looking north along the tip of the runway showing existing slope protection

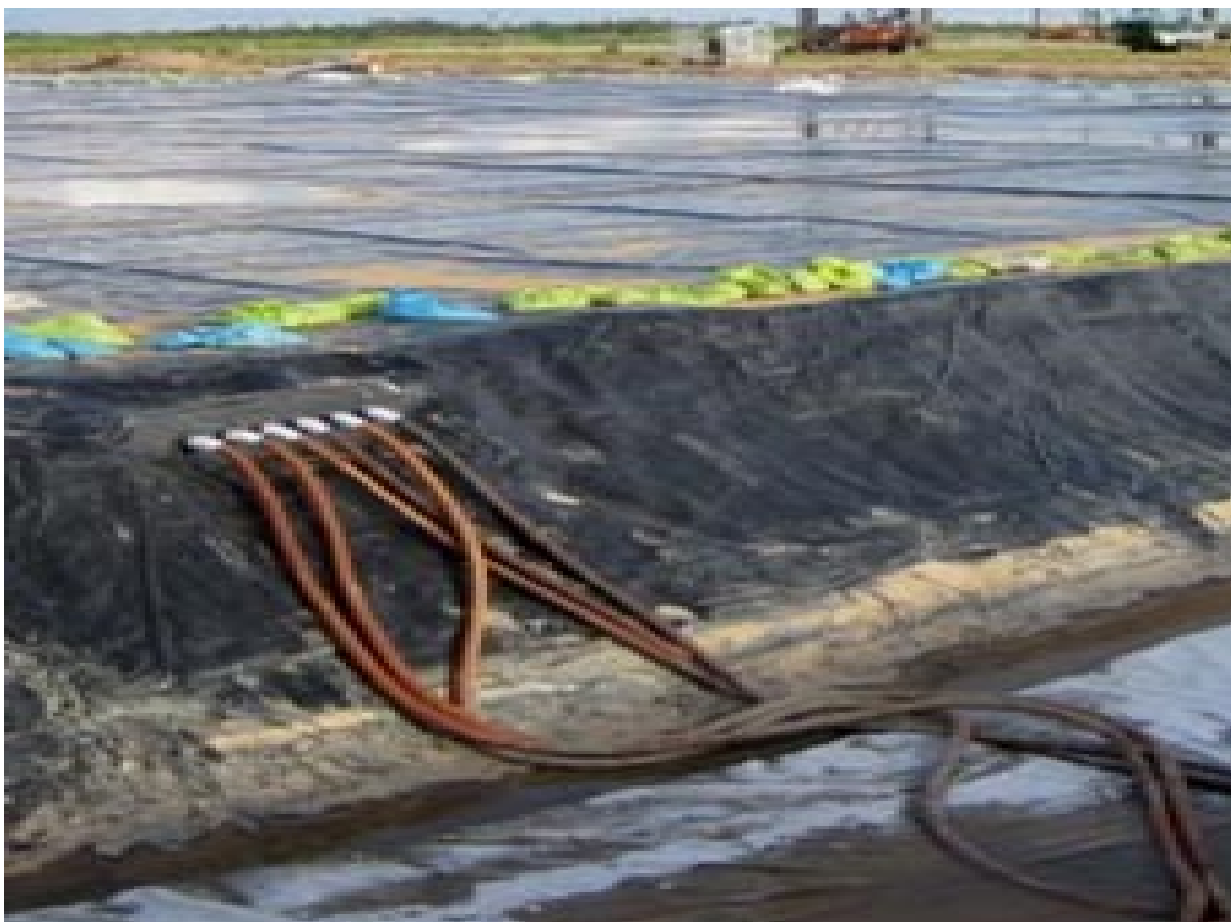
Fig.21 The surcharge method of compacting newly placed granular reclamation fill

The surcharge method is the least likely to be adopted for this NMIA runway project, because it would require extra fill material to be placed high upon top of the formation level for the runway extension, and left in place over a period of time for actual compaction of the newly placed fill to take place. The height of the surcharge above the existing runway level would likely be deemed unacceptably hazardous for aircraft operations to be ongoing at the airport, while the surcharge was in place.

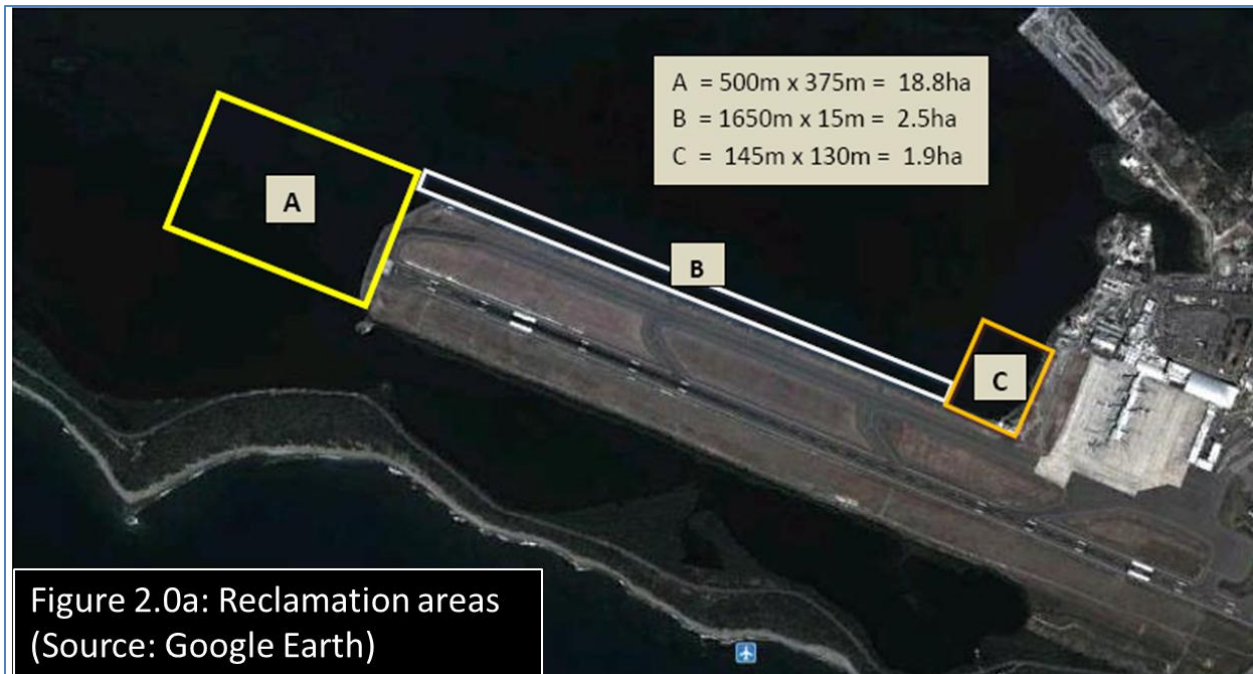
Figure 2.0a: Project site showing areas to be reclaimed. A - This will be the main area for extension of the runway platform; B - This widening of the existing runway platform will allow for better separation between the centerlines of the runway and the taxiway, which presently is somewhat inadequate; C - This reclamation is needed to provide additional land space for aircraft parking and for relocation and upgrading of the airports fire rescue facilities including boathouse. Space will also be provided here for construction of a new electrical substation.

- 1) Reclamation works as follows (Figure 2.0 below):
 - Area A - 500 m x 375 m (for runway extension)
 - Area B - 1650 m x 15 m (for widening existing runway)
 - Area C - 145 m x 130 m (for aircraft parking & fire rescue station)
- 2) Slope protection for edges of reclaimed areas.
- 3) Compaction of all of the reclaimed areas.
- 4) Construction of new runway and taxiway pavements.
- 5) Relocation of:
 - Landing approach lights in the sea.
 - Fire Rescue facilities, including boathouse.
 - Electricity substation presently located at tip of runway.
- 6) Construction of new electricity substation near to relocated Fire Rescue
- 7) Modifications to existing aircraft navigation aids
- 8) Extension of:
 - Runway and taxiway markings and lights
 - Runway fencing

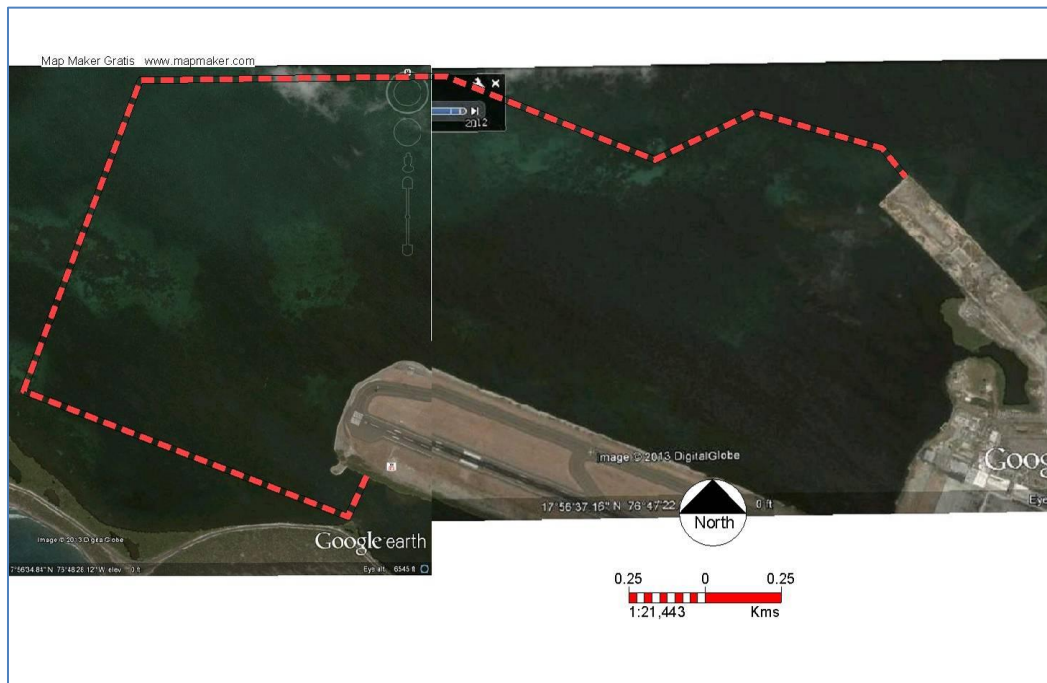
Figure 4.1: Mosaic of 2002 Google Earth images of the study area used for initial assessments

The 2002 Google Earth images were the most suited for interpretation and mapping as they show the most detailed illustration of the seafloor conditions compared to the other image dates in the Google Earth archives. Though these images are 11 years dated, they were useful in providing a basis for the understanding of how benthic organisms might be distributed over the study area (Figure 4.1).

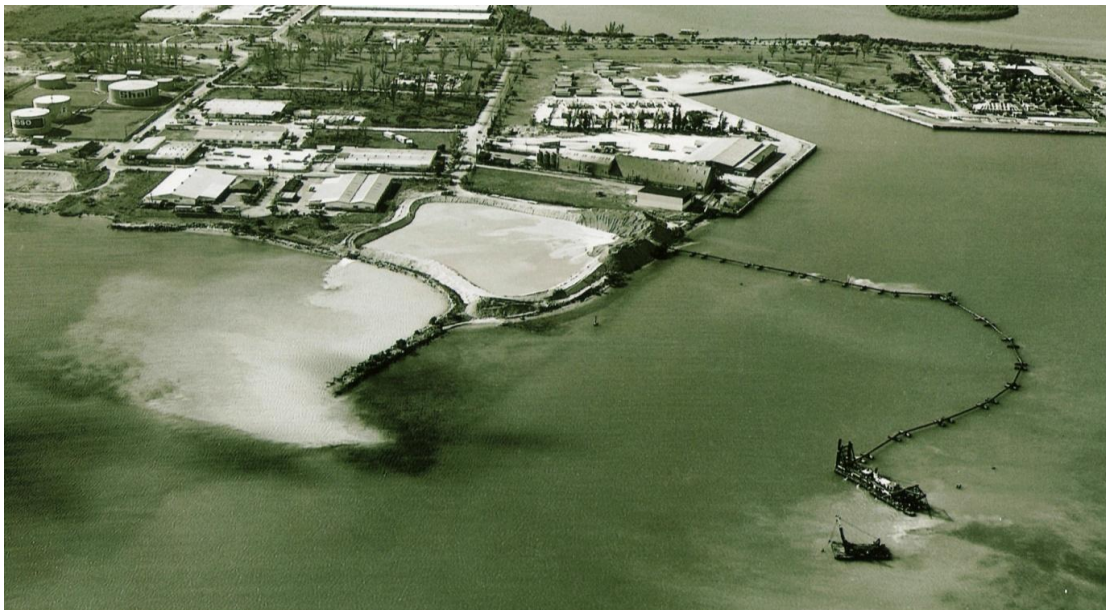
Figure 6.1.2c: Sediment plume from spoil slurry water discharge from spoil disposal area at Montego Freeport Montego Bay during dredging in 1991

is not done to ensure that settling of suspended solids occurs, a plume of sediment could be discharged from the bunded area (see example illustrated on Figure 6.1.2c below).

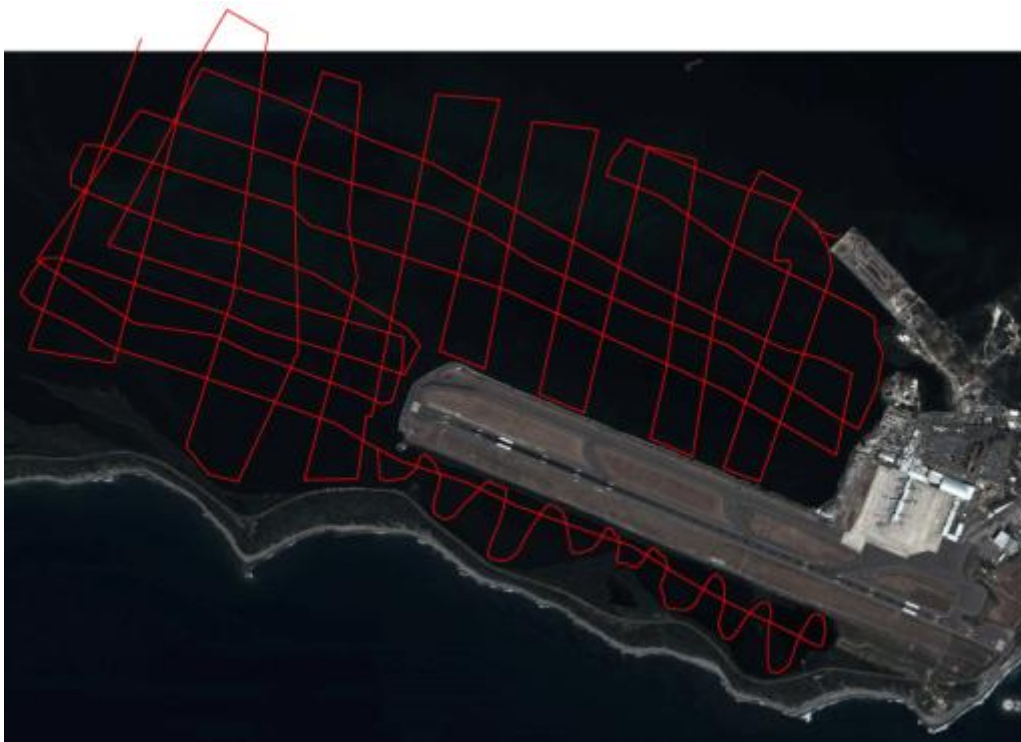
Figure 1 Surveyed bathymetric tracklines

As stated in the inception report, a bathymetric survey was carried out on March 7th and 8th (2013) with the actual tracklines shown in Figure 1. Figure 2 shows the results of the survey as shaded contour lines. What stands out is the more detailed outline of the dredge borrow zone just north of the NMIA runway. This detailed survey has been combined with the spot depths of the British Admiralty charts contained in MapSource. These data were used in the hydrodynamic model.
