NEGRIL CABINS HOTEL EXPANSION BLOODY BAY, JAMAICA

ENVIRONMENTAL IMPACT ASSESSMENT

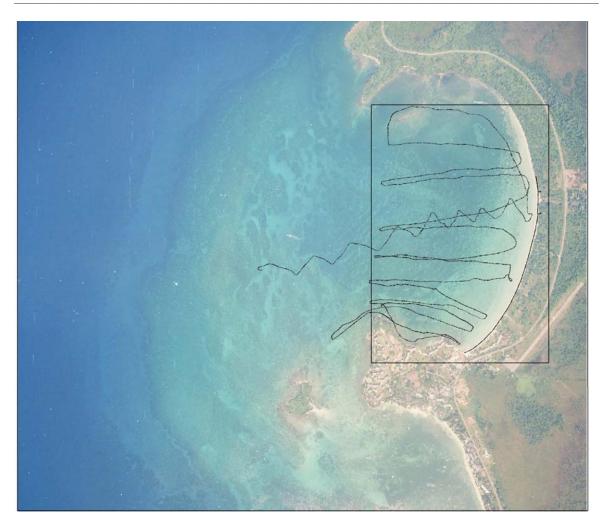
Figure 1.3 Locations of water depth recordings (2003).

A bathymetric survey was conducted on May 29th, 2003 within Bloody Bay to define the nearshore topography. Data was collected using an AutoHelm ST160 depth sounder and a Magellan Pro-Mark X ten-channel GPS receiver. Both instruments logged data points to their internal memories at approximately 1-second intervals. The survey took approximately 2 ³/₄ hours, collecting almost 5000 positions and corresponding depths. Back in the office, the two data sets were merged to create an ASCII file with X, Y and Z coordinates. A digital elevation model was then constructed using this database. Figure 1.3 shows the locations where water depths were recorded.

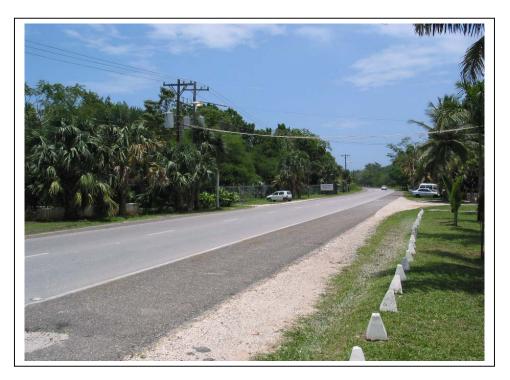
Plate 1.

The proposed development site is located at Bloody Bay on the sandbar separating the sea from the Great Morass of Negril; i.e. opposite the existing Negril Cabins Hotel, along the Norman Manley Boulevard between Long Bay (to the south) and Orange Bay (to the north) (Plate 1). The proposed site is a green-field site which is presently used to allow access to the beach for guests staying at Negril Cabins (Plate 2). RIU's Phase I hotel is located on the lot adjacent to, and south of, the proposed development site while the adjacent lot to the north is undeveloped.
