ENVIRONMENTAL IMPACT STATEMENT

Proposed Quarrying and Mineral
Processing at Halberstadt Quarry, St.
Andrew, Jamaica

Date: **October 2013**

Prepared by: **CL ENVIRONMENTAL CO. LTD.**

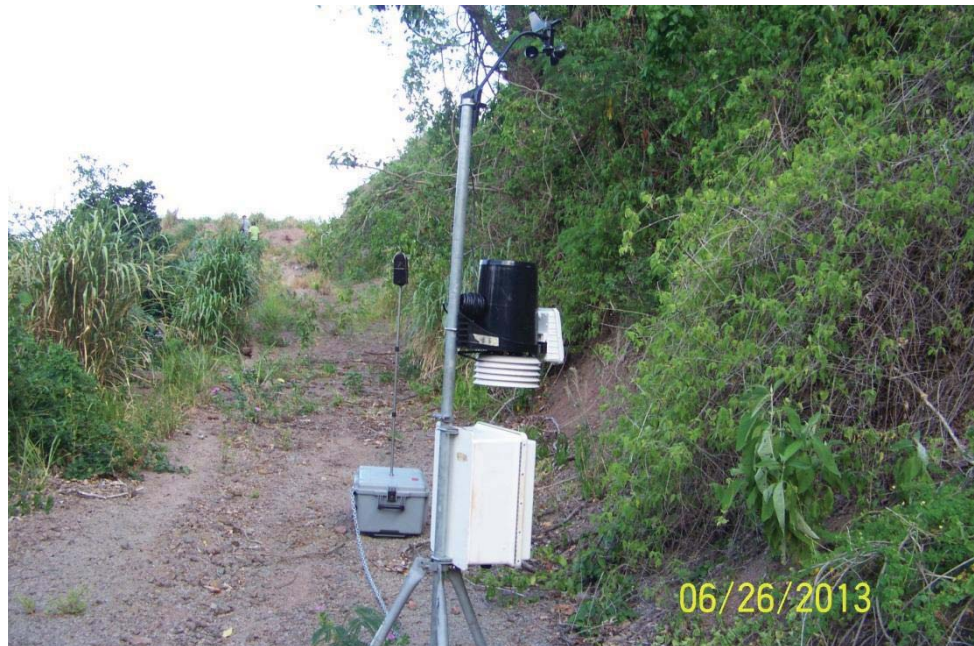
Plate 6.1 Photo showing weather station setup at proposed quarry site

Temperature, relative humidity, wind speed and direction, rainfall and barometric pressure were recorded at one (1) location at the boundary of the proposed quarry site (at noise station N3 / particulate station P3) from Wednesday June 26th – Sunday July 28th, 2013 by using a Davis Instruments wireless Vantage Pro2 weather system with a data logger and a complete system shelter erected on a tripod (Plate 6.1). Data were collected every fifteen minutes and stored on the data logger. This information was downloaded using the WeatherLink 5.9.2 software.

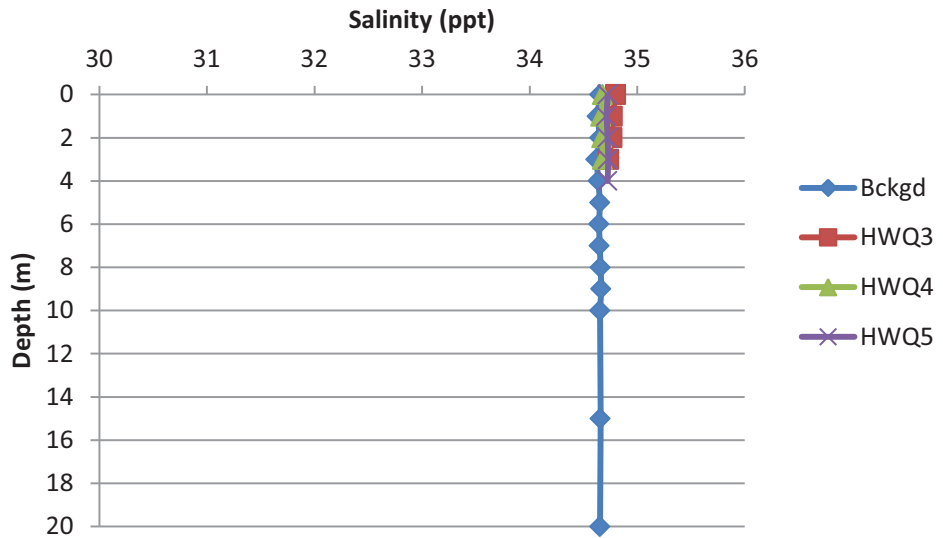
Figure 6.19 Salinity variation across the marine sampling stations

Average salinity values varied little across the stations ranging from 34.62 – 34.77ppt. The background station reported the lowest value and the highest value were observed at station HWQ3. When compared to depth, the values at each station showed little variation indicating a well-mixed layer to 20m within the area (Figure 6.19).

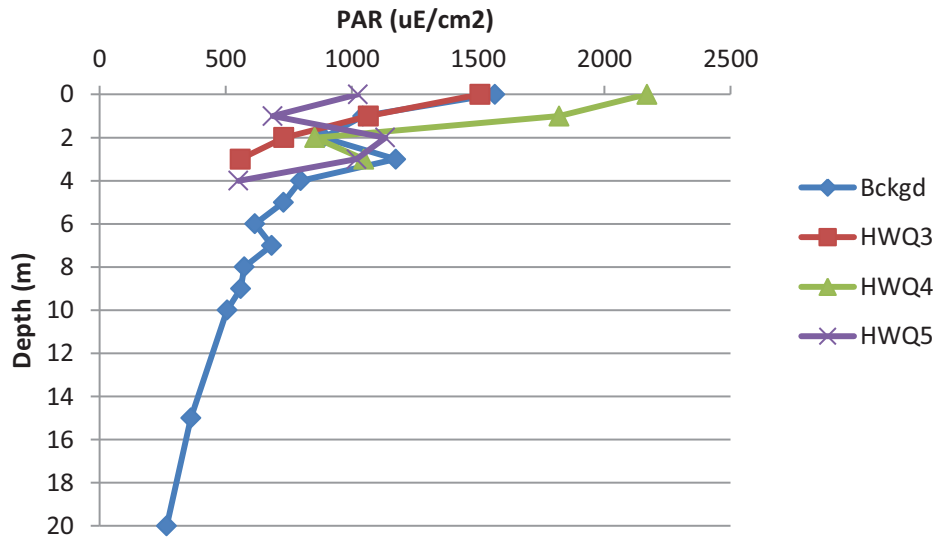
Figure 6.21 PAR variation across sampling stations

Average PAR varied greatly across stations ranging from 505.5 – 1507.5uE/m²/s. The highest PAR values were observed at station HWQ3, whereas the lowest value was reported at the background station. When compared to depth, the PAR values showed a general decrease at each station (Figure 6.21). The decrease in PAR is expected as less light is able to penetrate with increasing depth. Cloud cover, time of day, and the presence of organic and inorganic material also affect the amount of PAR available.

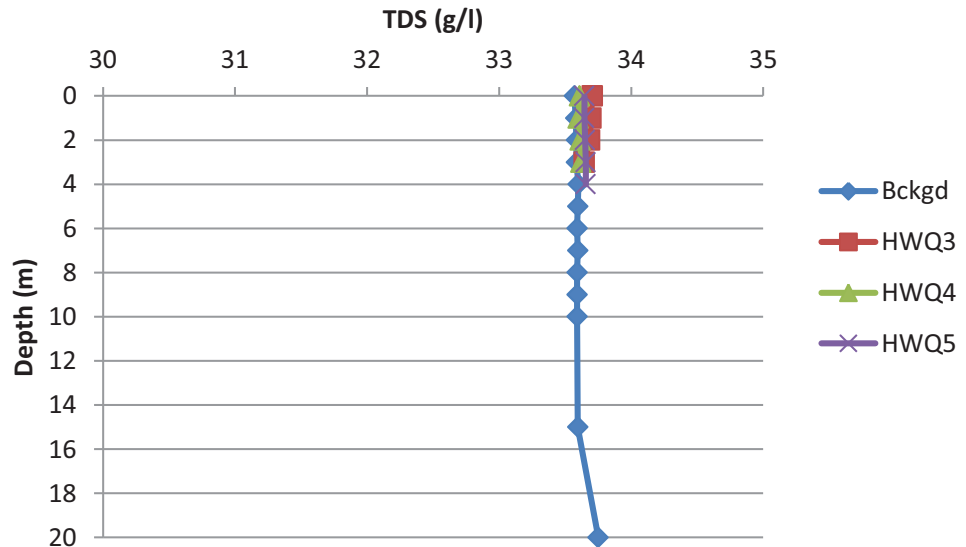
Figure 6.25 Average TDS variation across the marine sampling stations

Average TDS varied little across the stations ranging from 33.54 – 33.75g/l. Lowest TDS value was reported at station HWQ3 and the highest value was observed at the background station. When compared to depth at each station, the values showed little variation (Figure 6.25).

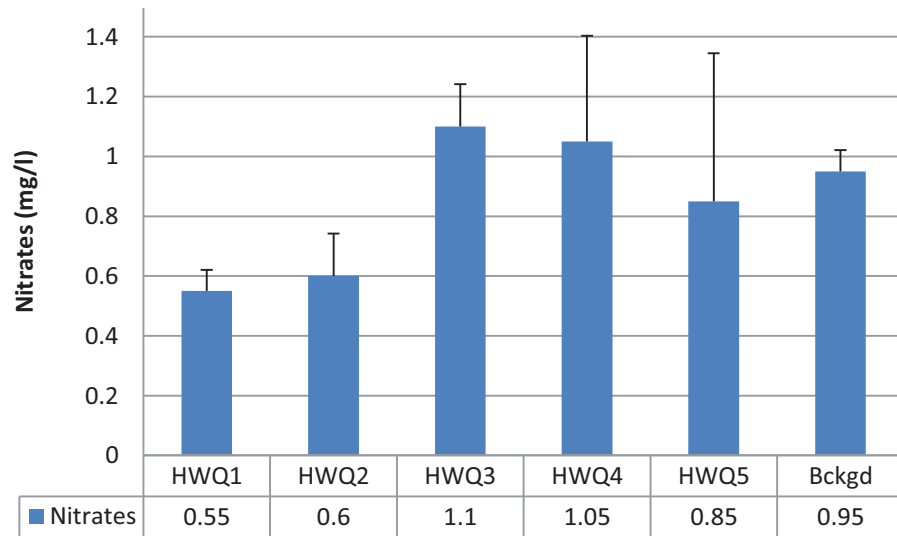
Figure 6.27 Nitrate variation across sampling stations with standard deviation

Average nitrate values varied little across the stations ranging from 0.55 – 1.1mg/l (Figure 6.27). The freshwater stations (HWQ1 and 2) had lower values when compared to the marine stations. This would indicate the input of nutrients from other sources into the marine environment. In comparison, a study by Webber *et al* (2003) in Kingston Harbour found a maximum nitrate concentration of 2.8mg/l. This could indicate the influx of nutrients from run off from the nearby rivers and gullies. All stations were above the Draft Jamaica National Ambient Water Quality Standard for Seawater for nitrates of 0.014mg/l.

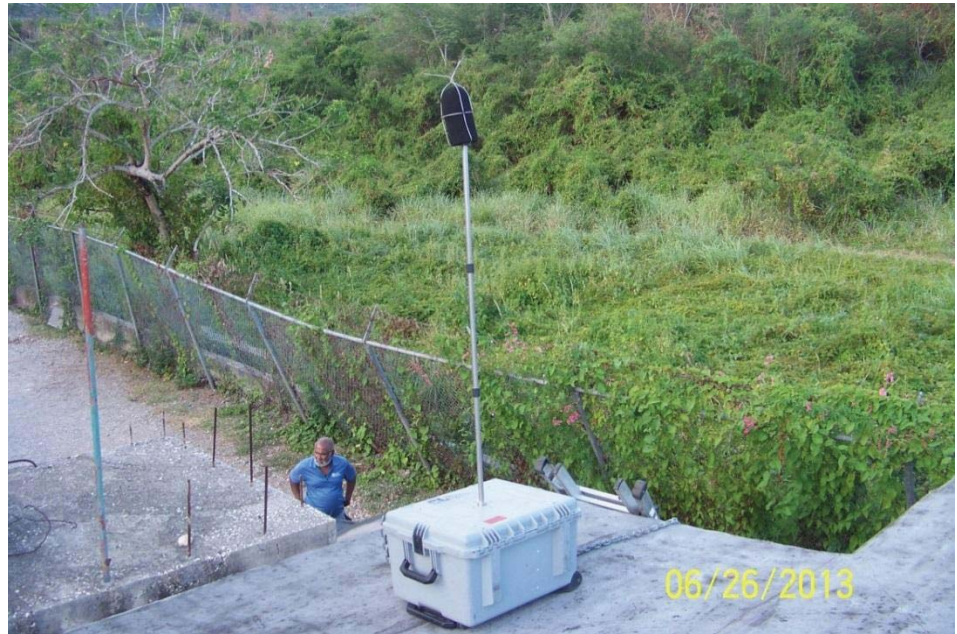
Plate 6.6 Photo showing noise meter at Station N7

A windscreen (sponge) was placed over the microphone to prevent measurement errors due to noise caused by wind blowing across the microphone. Plate 6.6 shows one of the noise monitoring outdoor kits.

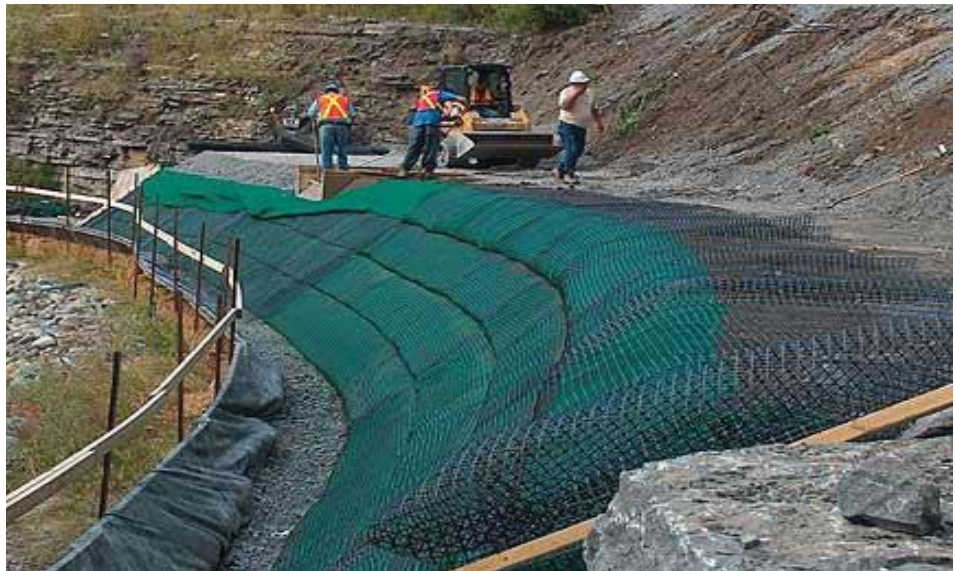
Plate 9.5 Geogrids being placed on face of slope
