Mount Rosser Rehabilitation Project

November 2006

OBJECTIVE

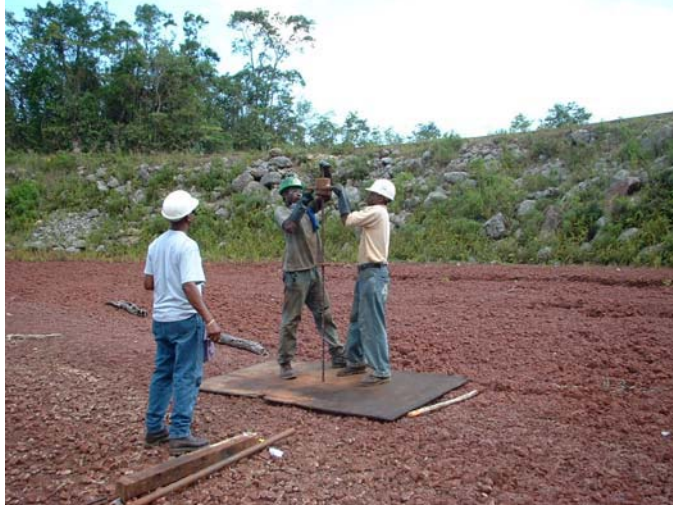
Figure 2: Investigation of the bauxite residue surface using probes

The results of the investigations of the bauxite residue indicate that, although the upper few metres is very soft, it becomes stiffer with depth.

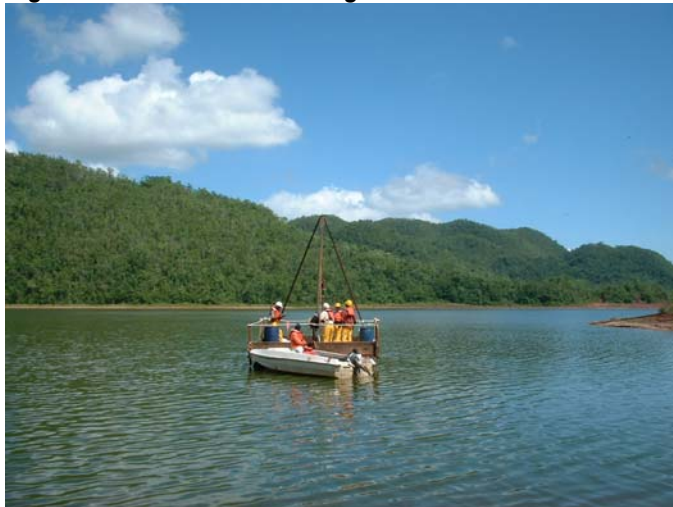
Figure 3: Over-water investigation

During the over-water portion of the ground investigation carried out in 2004, RPS undertook a bathymetric survey, to determine the extent and volume of water to be partially neutralised. The bathymetric survey measured the profile of the bottom of the lake and provided a plan showing the depth of water at all points. The survey comprised measuring the water depth and recording the position by Global Positioning Satellite (GPS). This information was inputted into a Geographical Information System and a bauxite residue (water depth) profile was modelled.

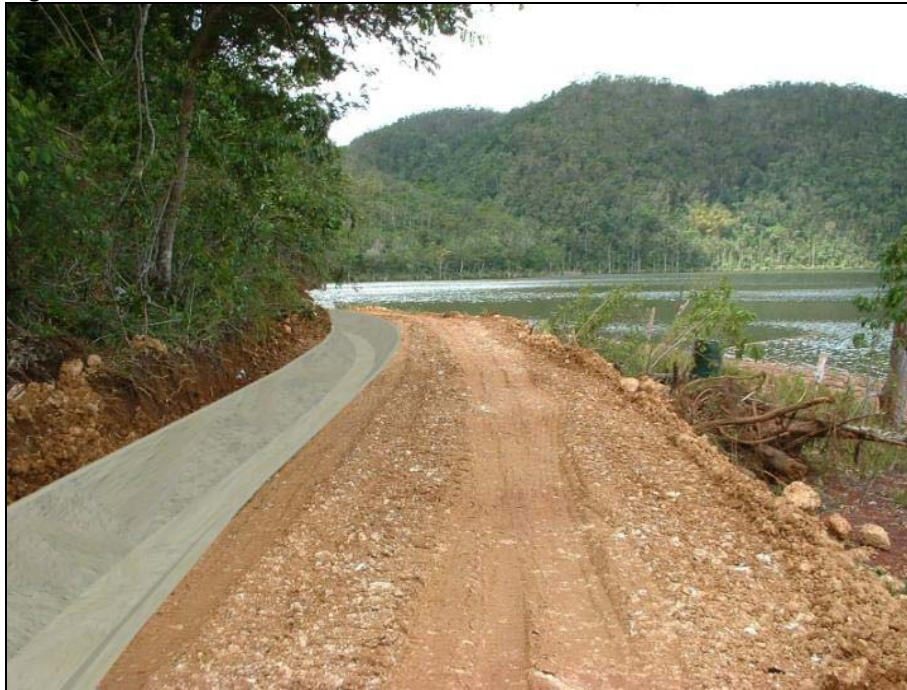
Figure 5: Illustration of the track and ditch

An access track will be continued along the western side up to the North Finger at which point it will cross the water via an embankment and continue up to the existing soakaway.

Ditches will be constructed on the slope side of the access track. Construction of the ditches was identified as crucial step towards removing the ponded water. In order to limit the volume of water requiring treatment, it is necessary to limit recharge of the ponded area. This can only be achieved by creating a cut-off between the ponded water and surrounding in-sloping lands using diversion ditches.

To avoid any risk of impacting the elevated highway, it is proposed to position the ditches at beach level. This approach would comprise the construction of an access track at beach level and placing an open ditch on the interface with the slope.

Field trials have indicated that any proposed trench cannot function effectively while unlined and as such a concrete lined channel will be laid along the slope side of the new access track. This approach has been adopted given the availability of local material and ease of ongoing maintenance. The catchment was modelled to enable suitable sizing of the concrete channel to deal with envisaged flows for a one in 20 year event.

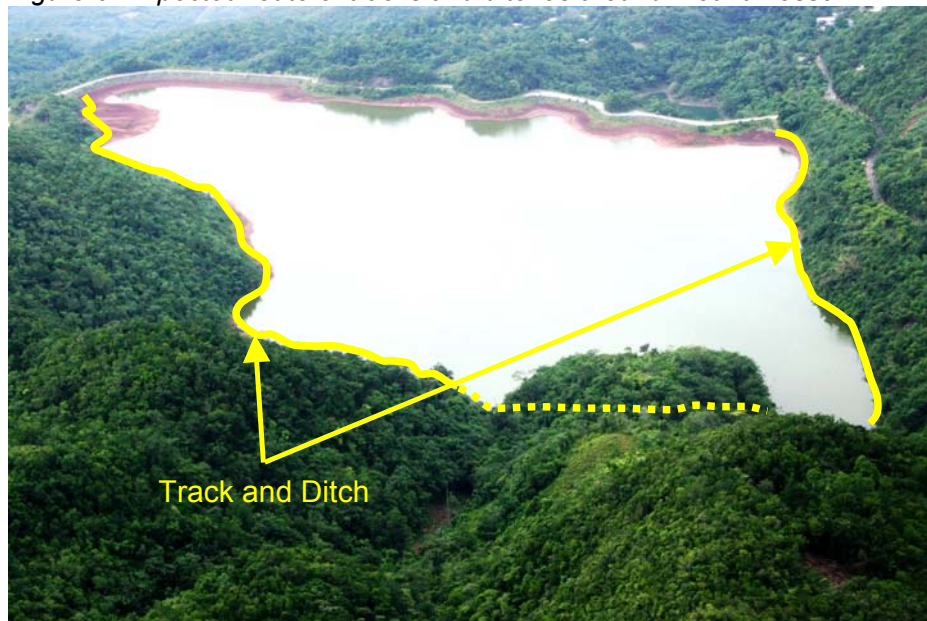
Figure 6: Expected route of tracks and ditches around Mount Rosser

The access track will then be continued around the North Finger headland before continuing along the northern beach heading east. This work will rely on the water levels within the ponded area being lowered to expose sufficient areas of bauxite residue beach to enable placement of material won from the adjacent limestone quarry. Figure 6 illustrates the route of this access track.

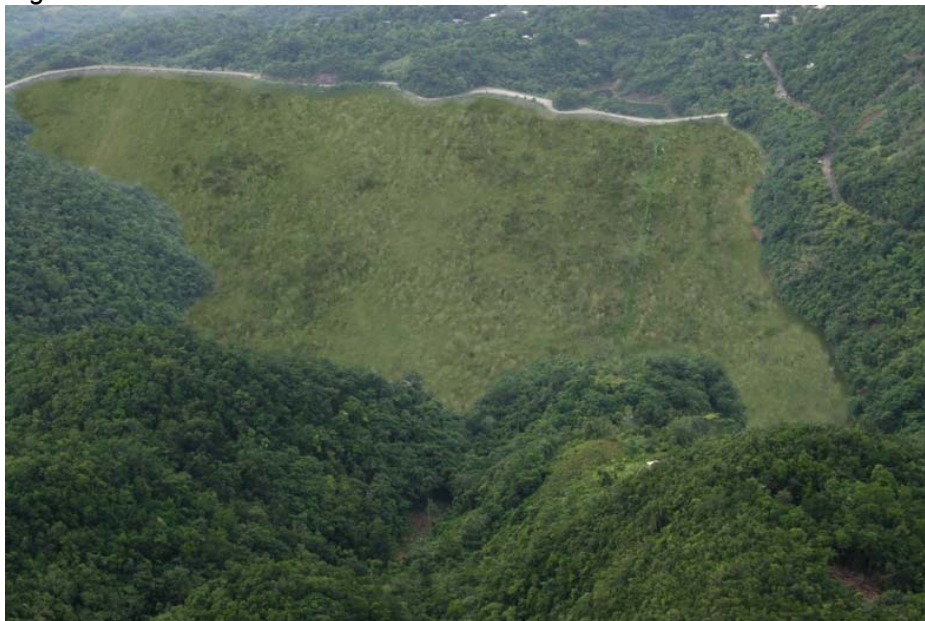
Figure 9: Illustration of rehabilitated area

In order to provide the final rehabilitated site, it is intended that the bauxite residue will be treated with gypsum as a way of reducing its cation exchange capacity and thereby improving its ability to sustain growth. The proposed process of converting the bauxite residue into a growing medium capable of sustaining vegetation has a major environmental benefit in that it returns the surface of the bauxite residue, over a period of time, to a soil type matrix capable of sustaining diverse vegetation and does not require the importation of scarce topsoil that can be more effectively used elsewhere.
