# Summary of Proposed Works

## - Gran Bahia Principe Expansion

This report serves as a project brief as part of the Beach Licence Application for the proposed beach works at the Gran Bahia Principe Jamaica. The purpose of this report is therefore to furnish the National Environment and Planning Agency (NEPA) with the necessary and relevant information regarding the proposed works.

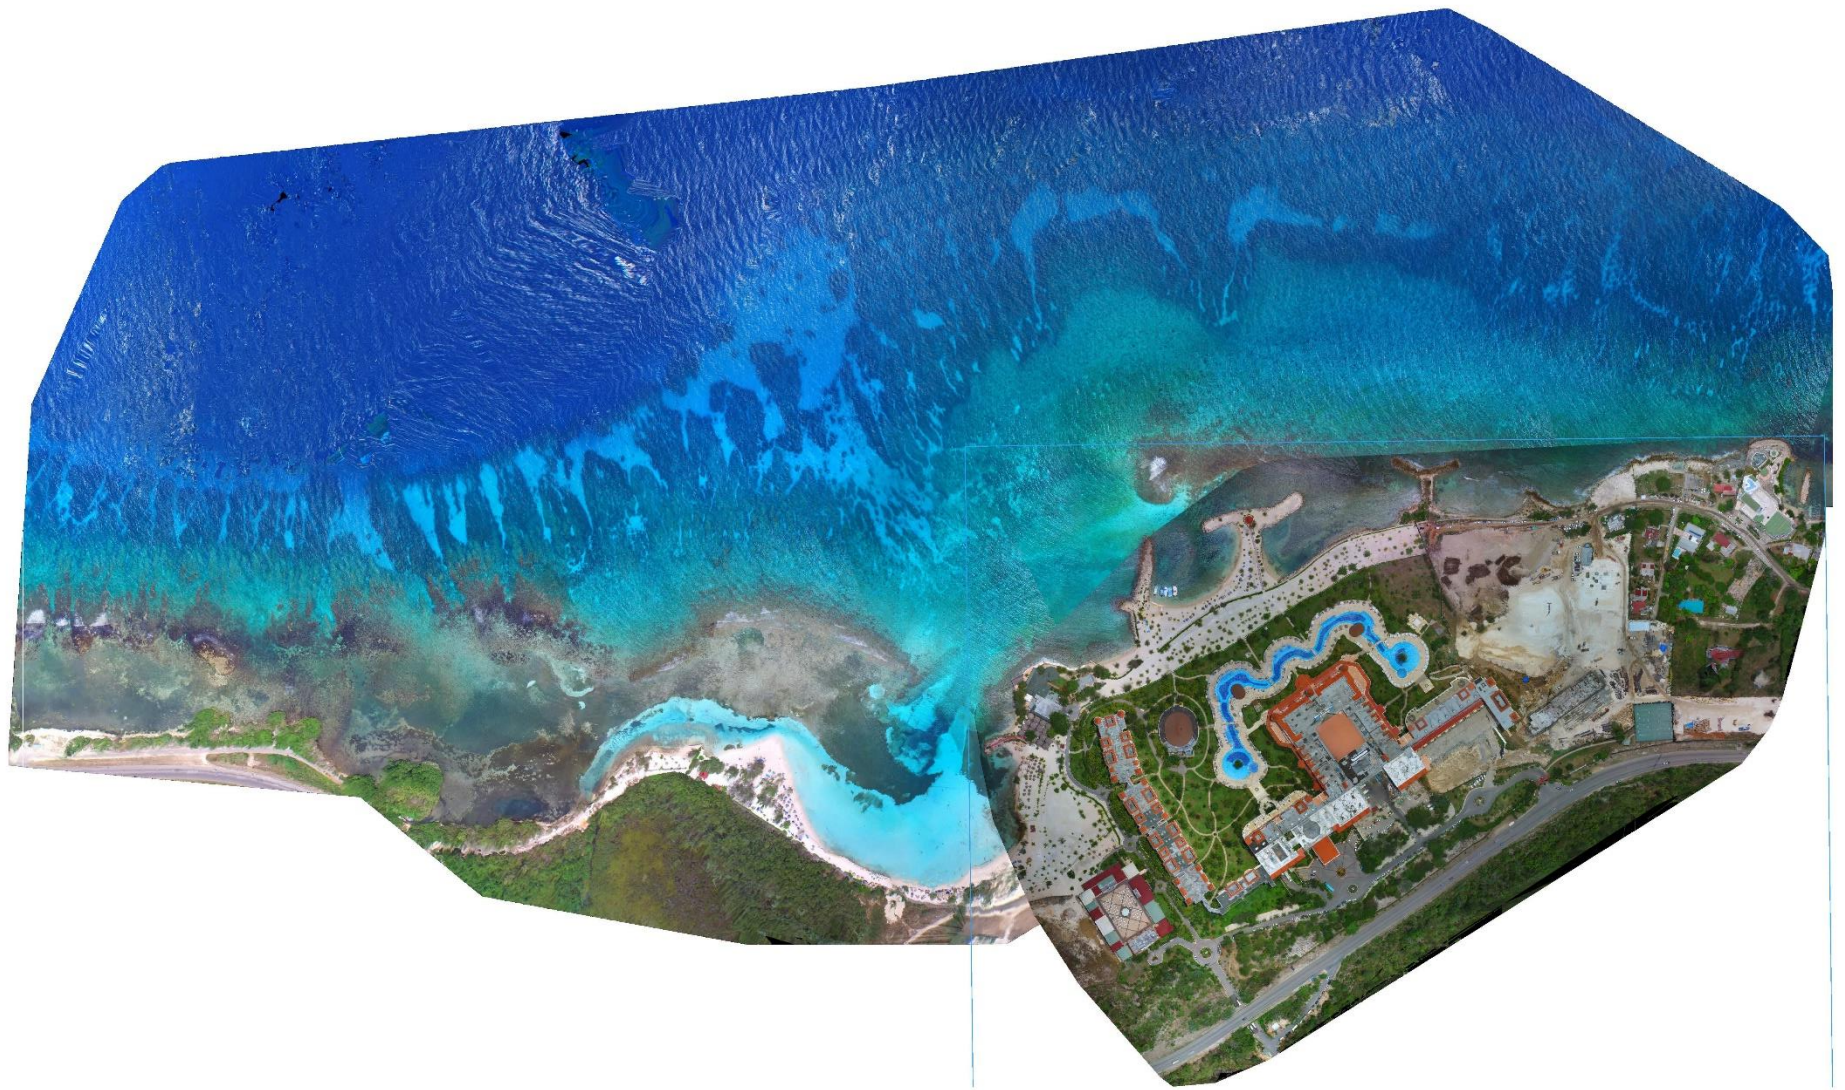
Figure 2.2 Aerial imagery captured in drone survey of project site

An aerial drone survey was also conducted at the project site. The purpose of this survey was to collect high resolution images of the nearshore area from which an estimate could be made as to the best possible alignment of structures as well as the location of offshore sand deposits that could be used in sand nourishment. An example of the aerial imagery is shown in Figure 2.2.

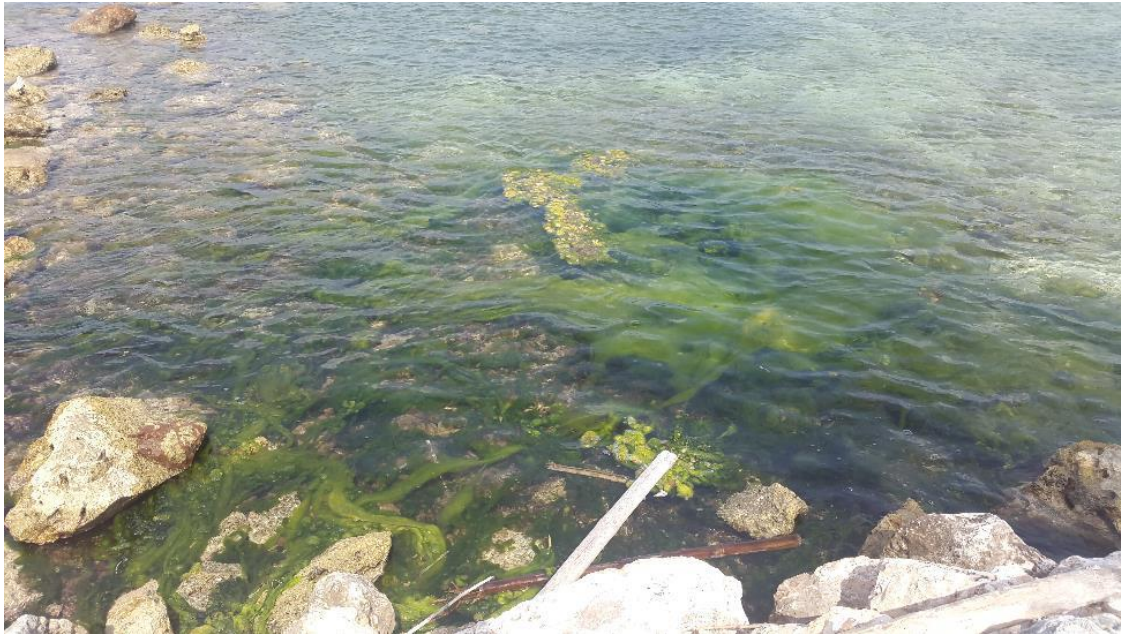
**Plate 2.1** Algal bloom in nearshore of project area

During the site visit to the Gran Bahia Principe on May 1<sup>st</sup> 2015 there were algal blooms occurring in the shallower areas of the proposed beach. These algae are shown in Plate 2.1 and Plate 2.2 below.

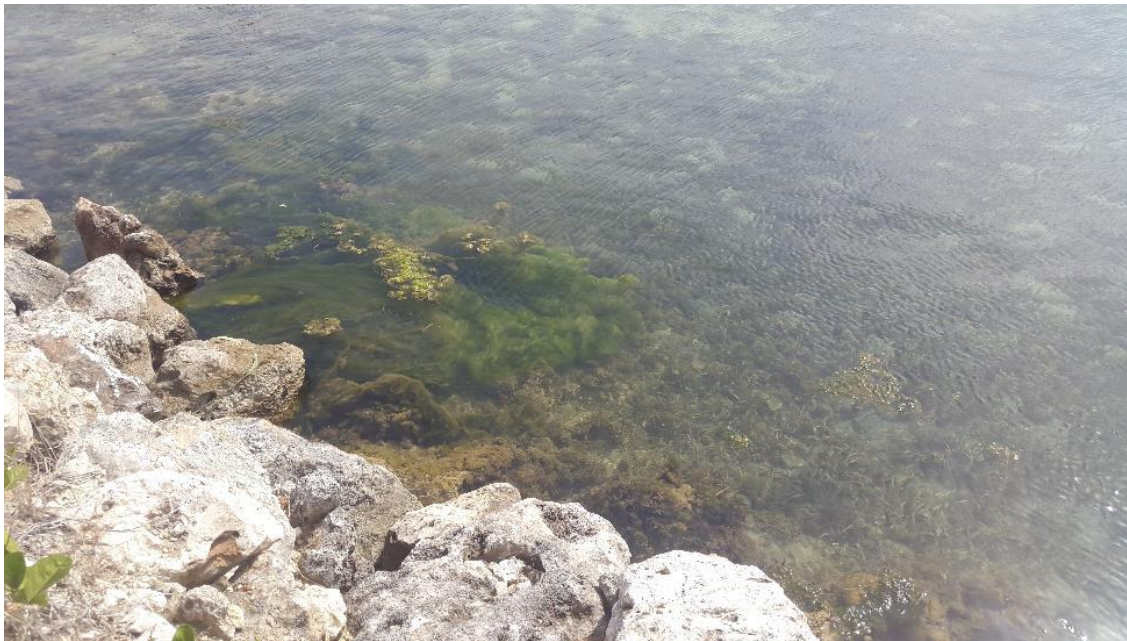
**Plate 2.2** Algae on rocks in the nearshore of project site

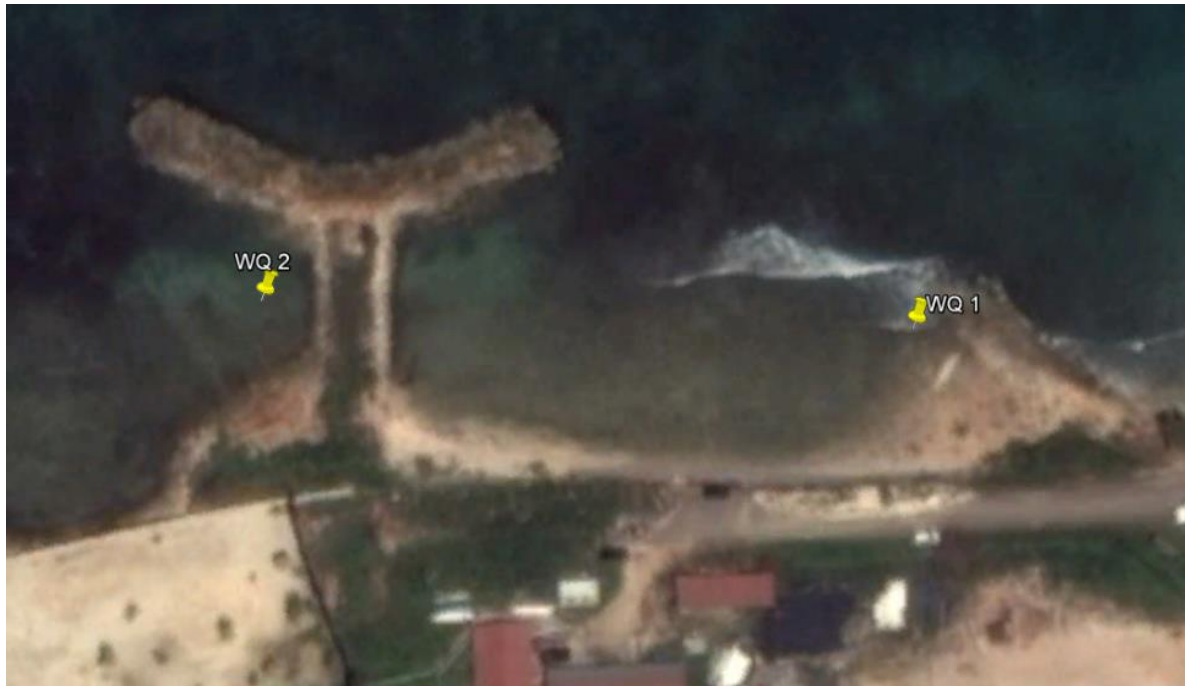
Figure 2.3 Location of water quality samples (WQ1 & WQ2) taken from the project area

These observations caused some concern regarding the water quality at the beaches. As a result of the concerns arising from the observations, two samples were collected for water quality testing, both in

the lee of the existing structures as shown in Figure 2.3. The results of the lab tests are shown in Table 2.1.

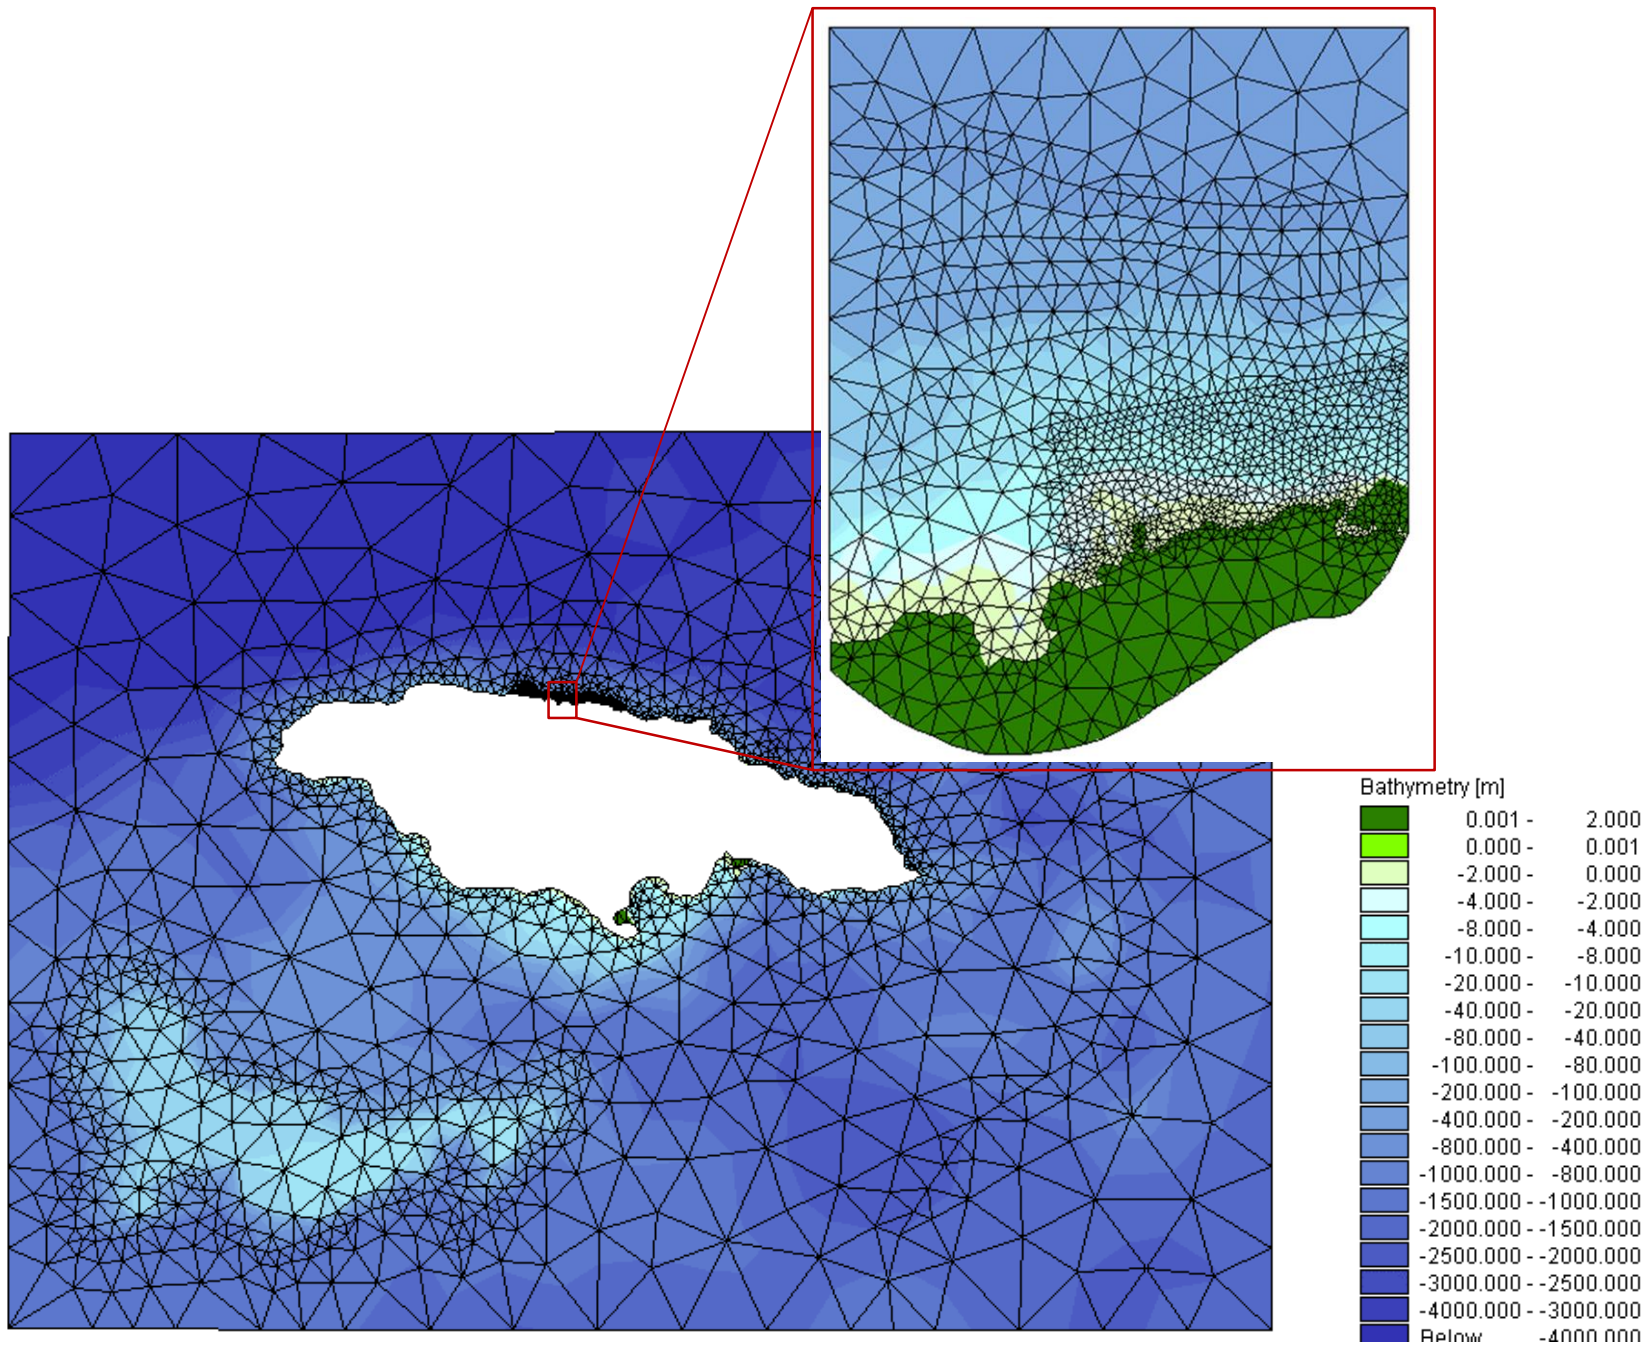
Figure 3.1 Nearshore bathymetry and flexible element mesh details used in MIKE 21 modelling

The results of the bathymetric survey as well as the shoreline profile results were all input and used in the model mesh development. Offshore depths were established through the incorporation of nautical chart data and other available map data, such as previous surveys of the site. The model domain encompassed the entire island of Jamaica, extending out to water depths of roughly 6000m, and extending more than 130km from the coastline. The MIKE 21 mesh used in the modelling exercises is shown in Figure 3.1. The figure shows the entire domain as well as a close-up of the Gran Bahia Principe project area.

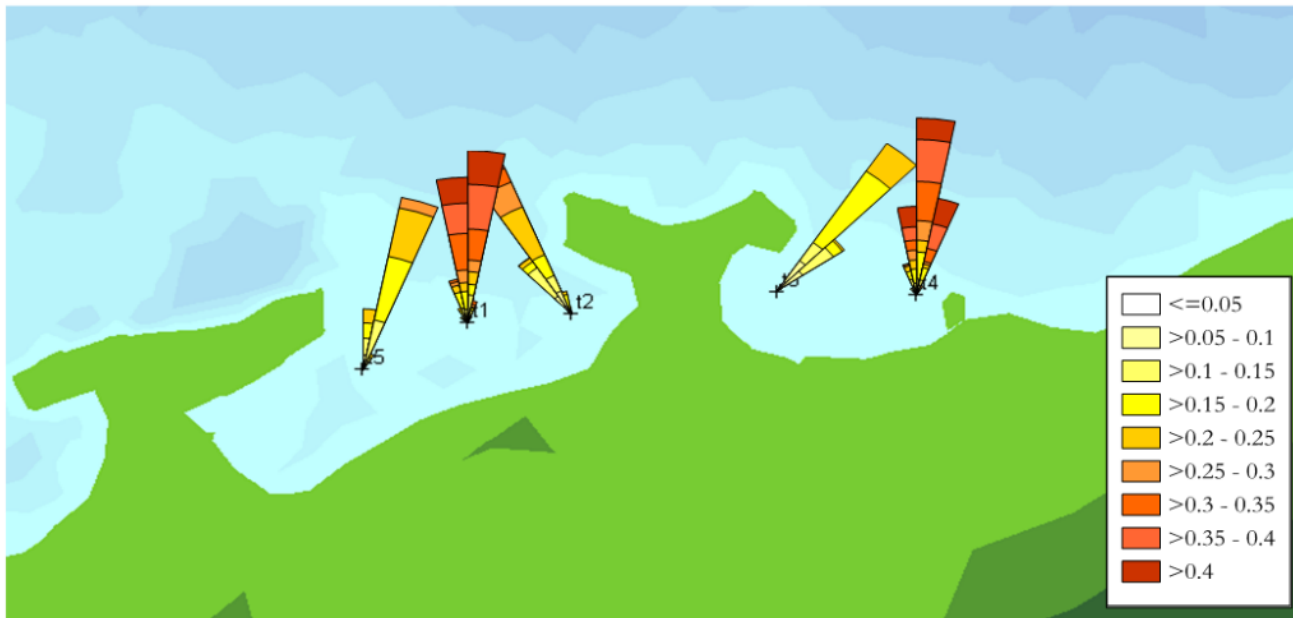
Figure 3.4 Wave Rose plots of typical conditions (binned operational waves) at the site

The resulting annual wave rose distributions at the location of the five selected nearshore nodes are shown in Figure 3.4. Results indicate that wave heights at the site are very low and typically do not exceed 0.4m throughout the year with occasional maximums up to 0.5m. Results further indicate that the predominant approach was from the north-north-east. The only exception was Profile 2, which is located in the shadow of the existing structure and thus is only exposed to those which wrap around the T-groyne and approach from the west.

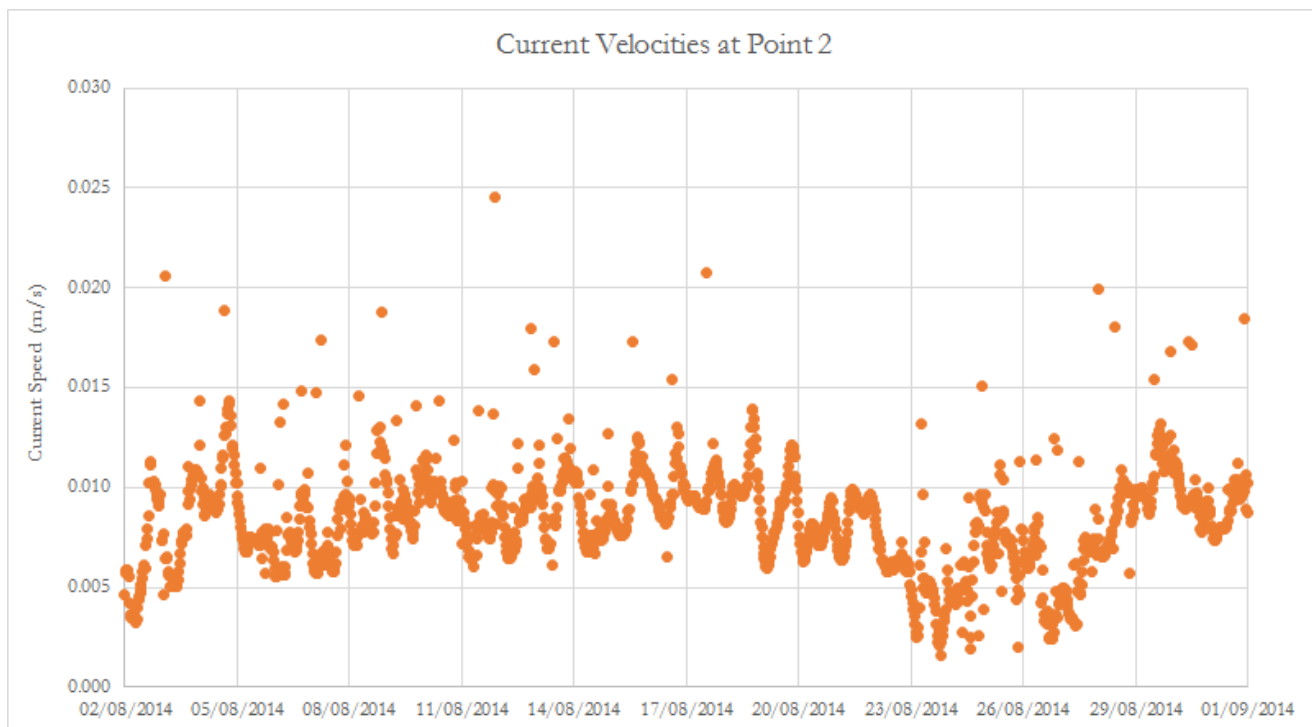
Figure 3.7 Values of Current Speeds at Point #2 throughout the month of August-2014

The hydrodynamic results revealed what was expected, that currents in the area are very low averaging 12mm/s (0.123m/s) across all four extraction points. Extraction Point #2 (see Figure 3.2 for reference) is in the approximate location of the water sample collected with parameter values just within the range of acceptable standards, and so was chosen for further analysis. The time series of depth-averaged currents throughout the month of August 2014 is shown below in Figure 3.7.

As shown, the values tend to oscillate in between 0.015 m/s and 0.005 m/s corresponding to tidal oscillations. Additionally the first three weeks of the month, which corresponds to the spring tide, tends to be higher than the remaining three weeks, which corresponds to neap tide. It should also be noted that there are some higher values that appear to fall outside of the pattern. These are likely corresponding to higher gusts of wind at these points.

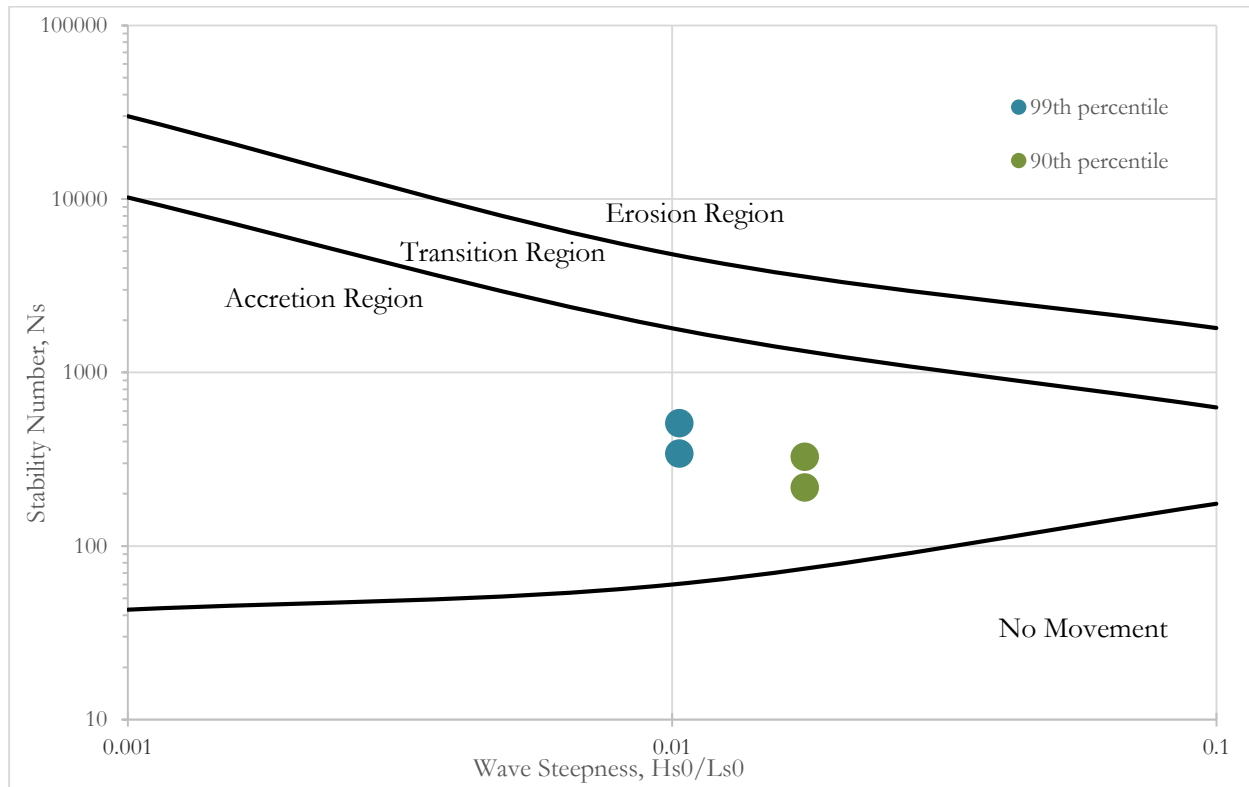
**Figure 4.6 Graph of Beach Stability regions developed by Ahrens and Hands. Position of proposed beach depicted by dots.**

When the values for wave steepness and stability number were plotted on the graph shown below, the position on the graph places the proposed Gran Bahia lagoon beach firmly within the *Accretion Region* of sediment movement regions as highlighted by the blue (99<sup>th</sup> percentile) and green (90<sup>th</sup> percentile) dots on the graph. It further shows that both grain sizes, (0.4mm and 0.6mm) are acceptable for the proposed nourishment.
