FORCES *of* NATURE

Local Scale Assessments
on Mangrove Ecosystems
Status and their Role

COASTAL RESILIENCE

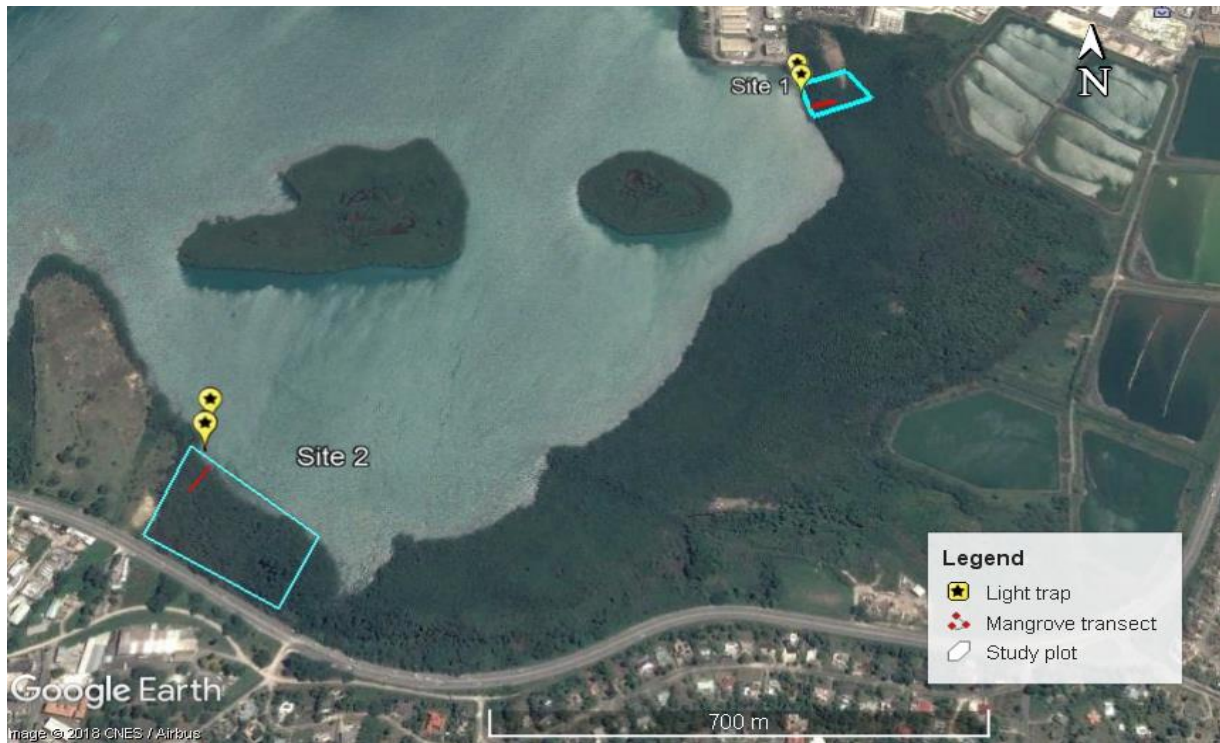
Figure 6: Bogue lagoon mangroves, St. James showing the sites sampled. (Google Earth, 2018).

(Figure 6). Of significance is the existence of waste-water stabilization ponds (east of Site 1) from which effluent discharges into the lagoon. The areas sampled had intact fringe forests and there was no evidence of either hurricane damage or timber harvesting.

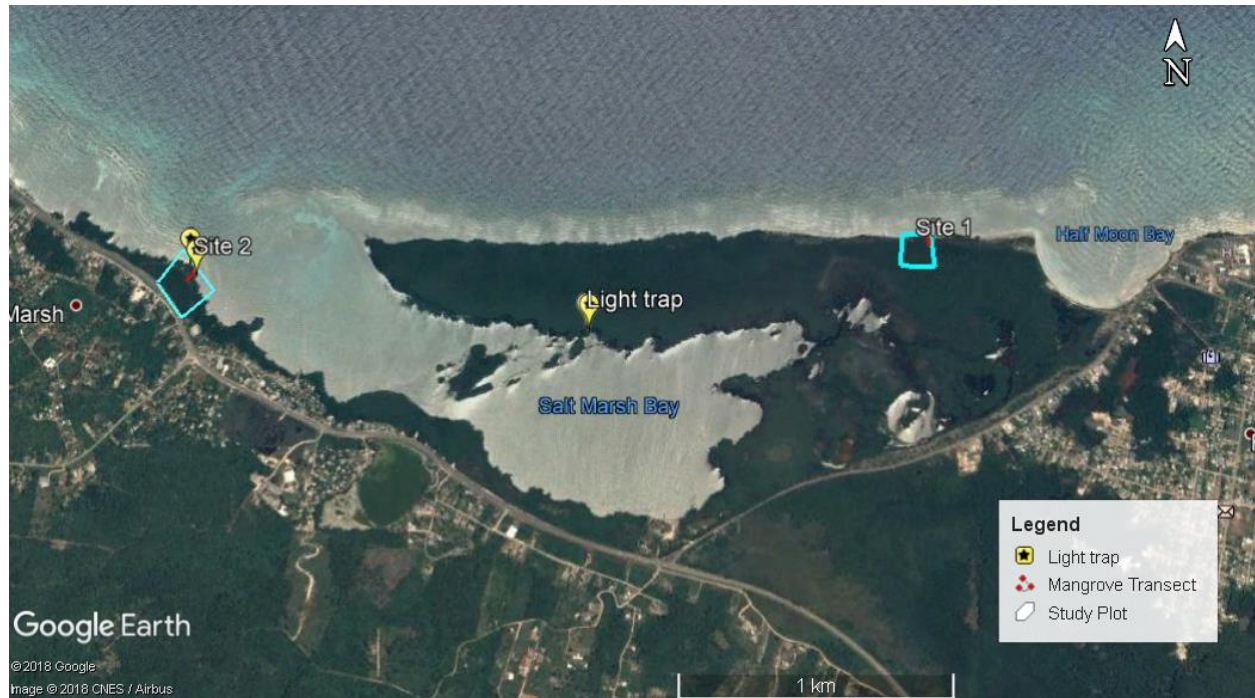
Figure 7: Salt Marsh mangroves, Trelawny. (Google Earth, 2018).

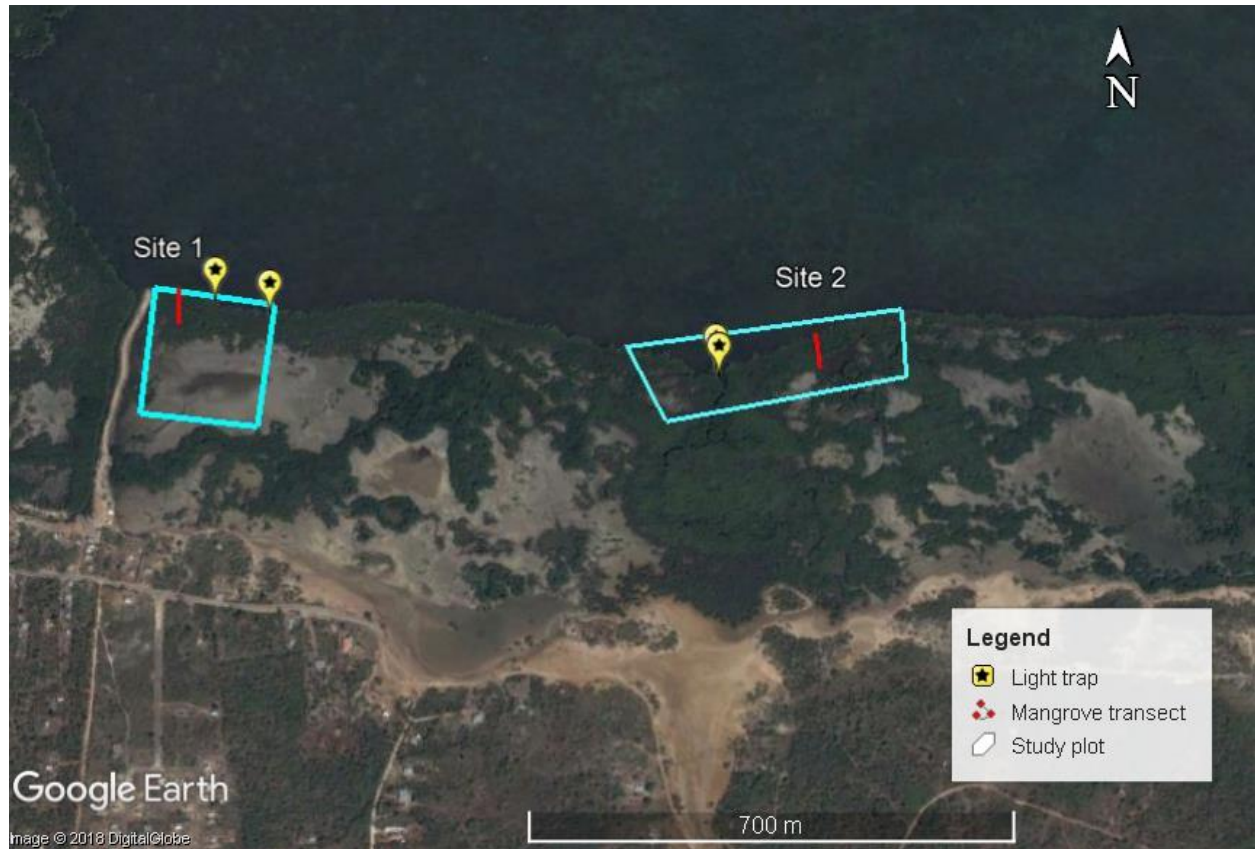
Figure 8: Portland Cottage mangroves, Portland Bight, Clarendon showing sites sampled. (Google Earth, 2018)

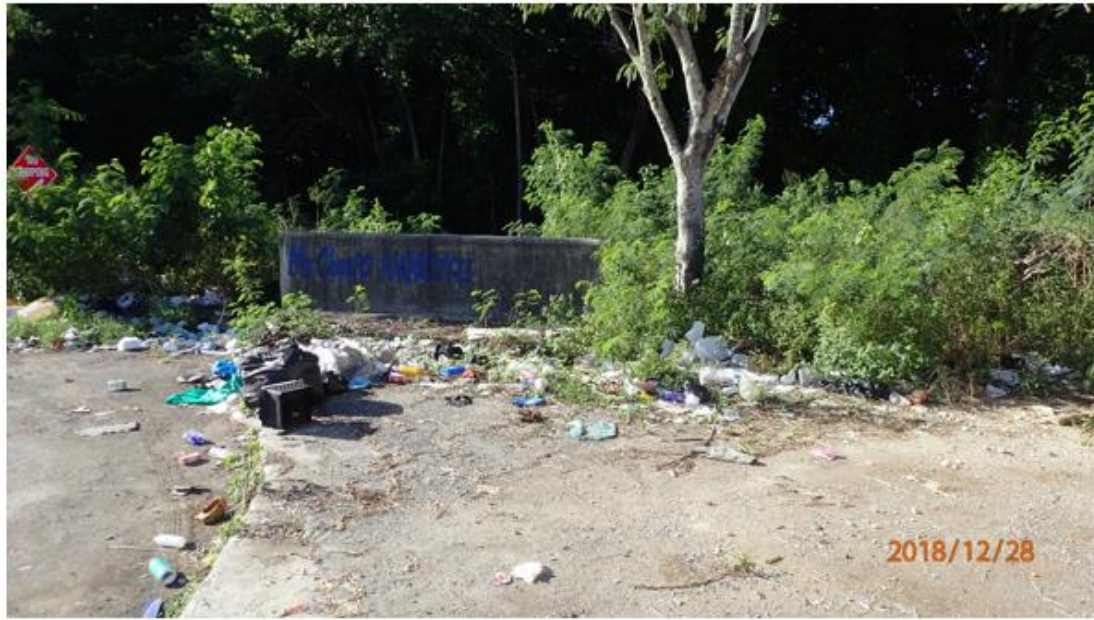
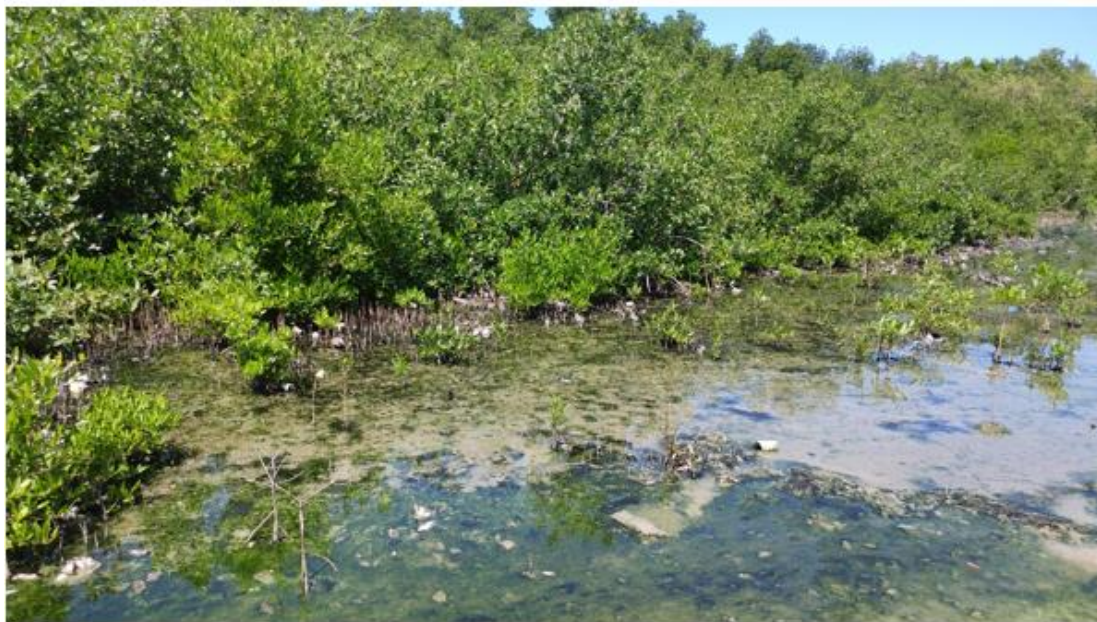
Figure 19: Garbage disposal (top) and effluent discharge (bottom) in mangrove forest (Source: Camilo Trench, 2018)

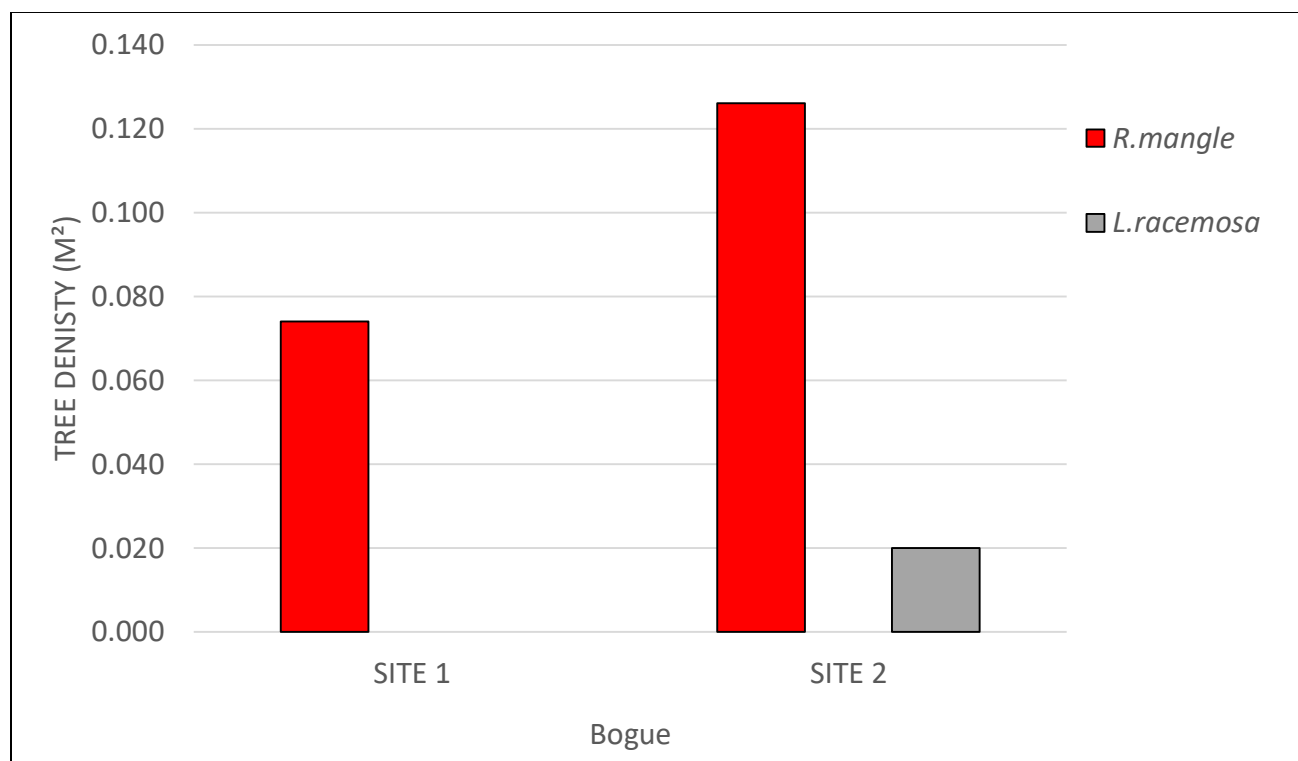
Figure 21: Overall tree densities for both sites at Bogue Lagoon.

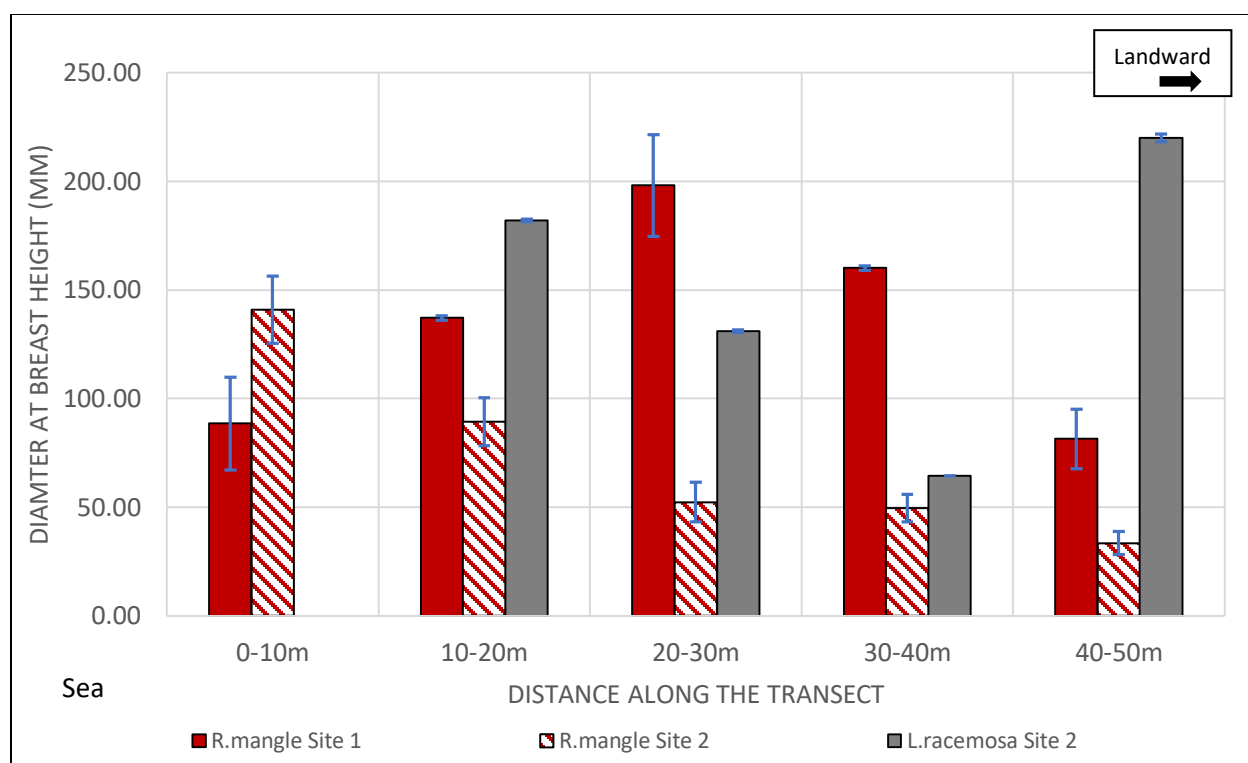
Figure 22: Mean Diameter at Breast Height (with SE) along the transects at Site 1 and 2, Bogue Lagoon

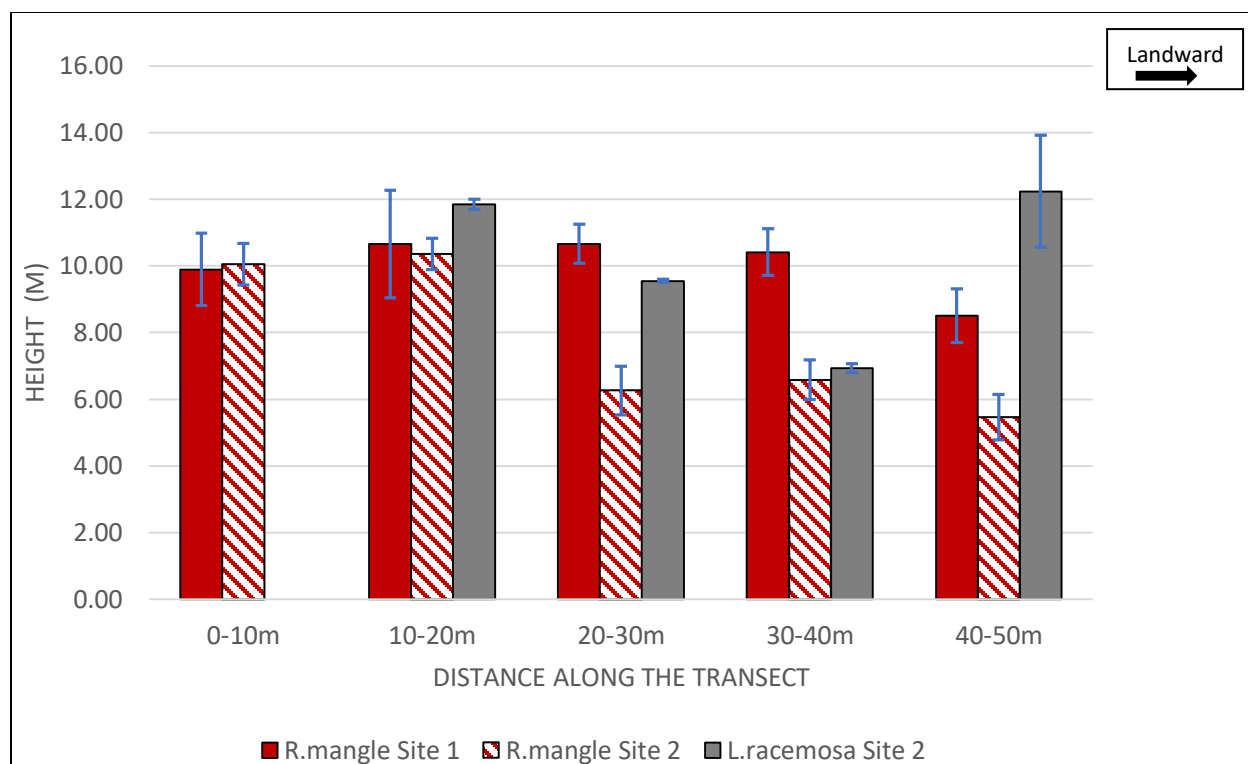
Figure 23: Mean Height (with SE) along the transects at Site 1 and 2, Bogue Lagoon.

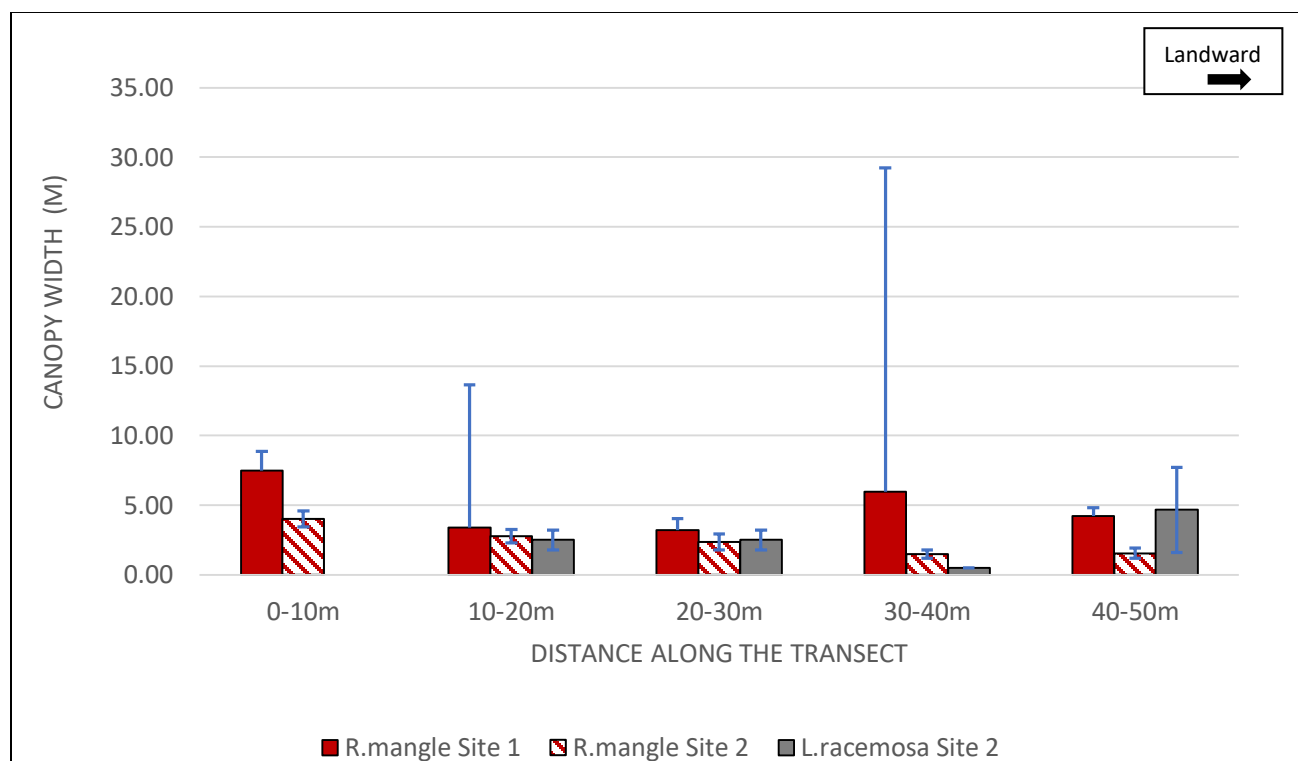
Figure 24: Mean Canopy width (with SE) along the transects at Site 1 and 2, Bogue Lagoon.

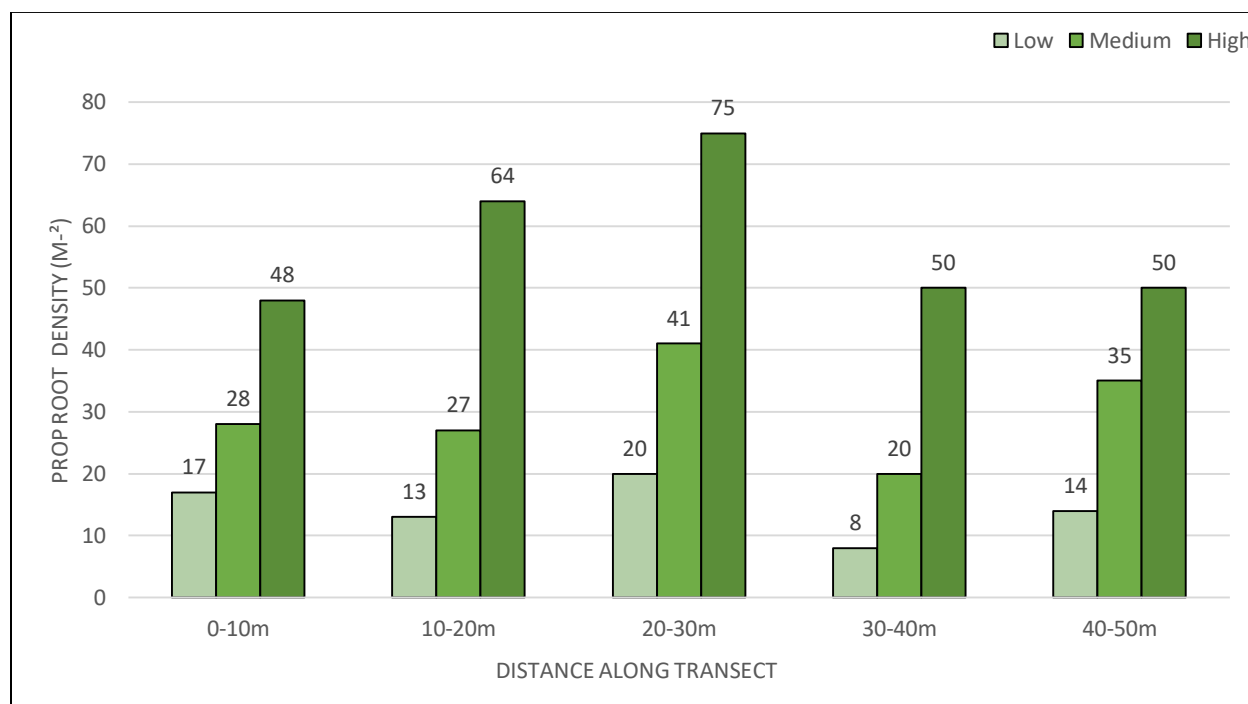
Figure 25: Prop root density along the transect at Site 1, Bogue Lagoon.

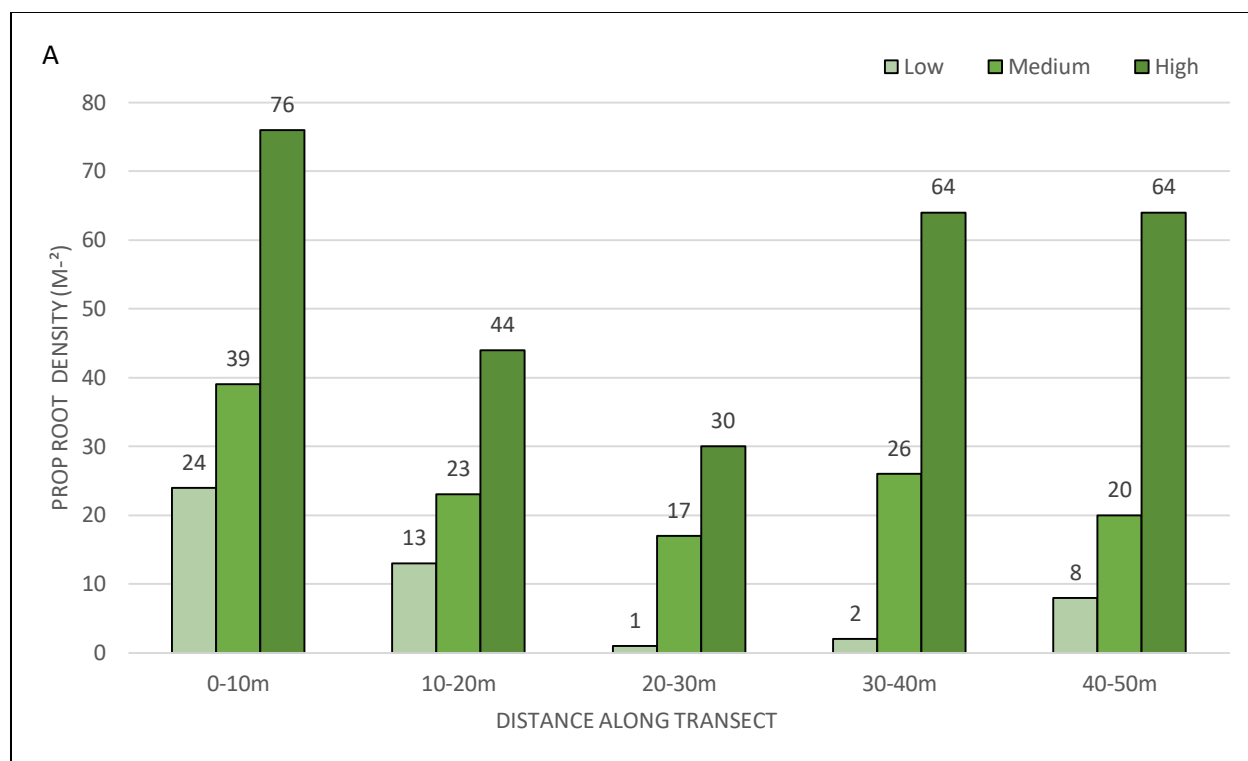
Figure 26: Prop root density along the transect at Site 2, Bogue Lagoon.

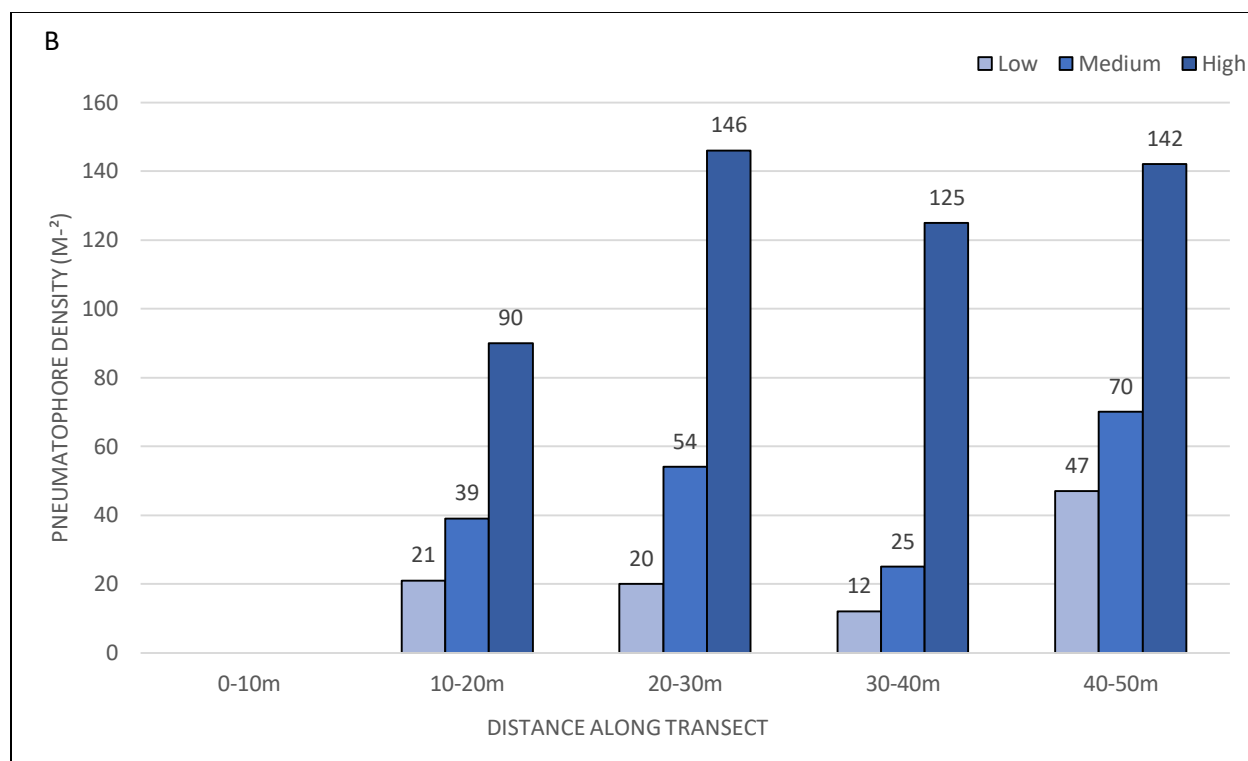
Figure 27: Pneumatophore density along the transect at Site 2, Bogue Lagoon.
