# **Assessment and Economic Valuation of Coastal Protection Services Provided by Mangroves in Jamaica**

**The University of the West Indies**

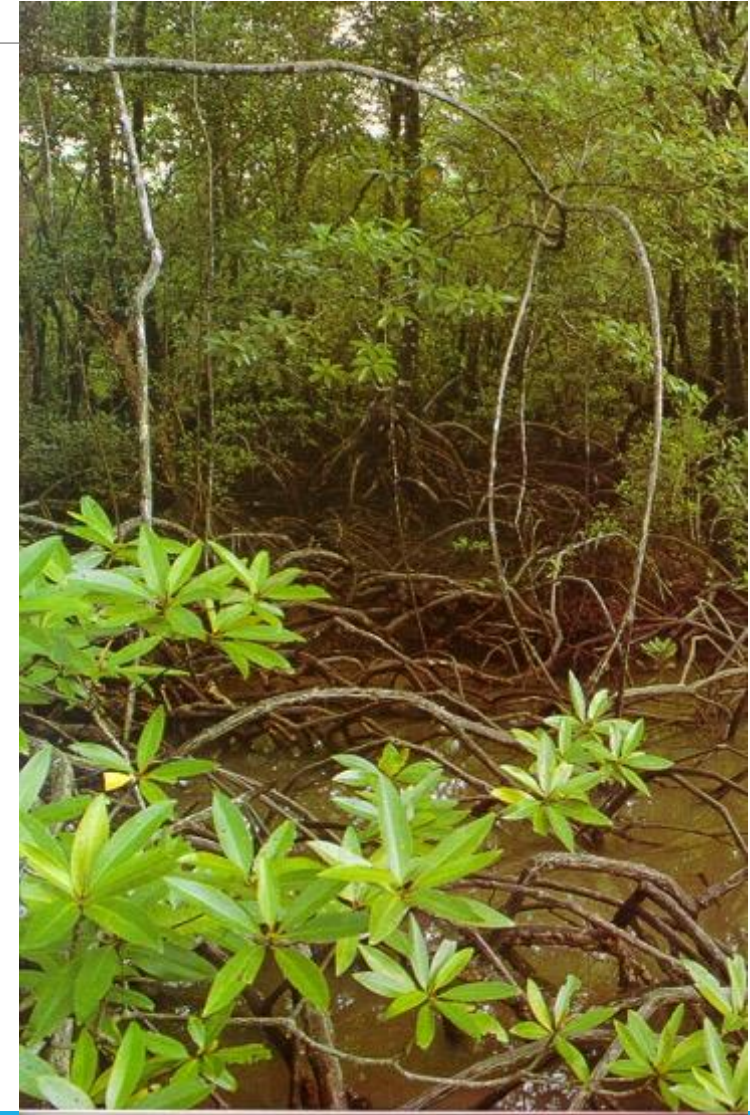
69 species; 4 species found in Jamaica *and Caribbean*:

*Rhizophora mangle* (Red)

*Avicennia germinans* (Black)

*Laguncularia racemosa* (White)

*Conocarpus erectus* (Button)

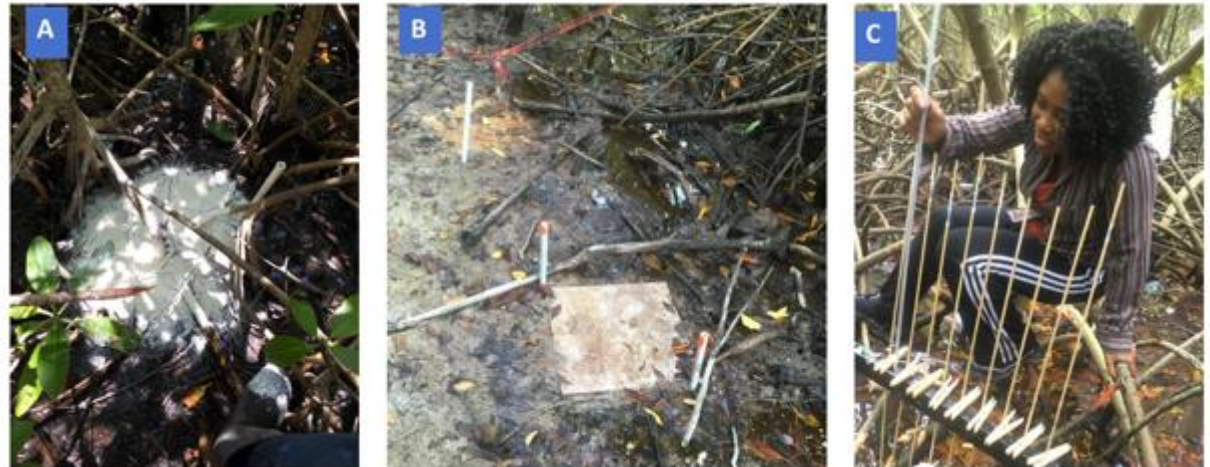
## Physical

- Flooding and coastal erosion
- Sediment sampling and assessment
- Surface accretion and soil surface elevation
- Wind data
- Bathymetry
- Soil –atmospheric carbon
- Water quality

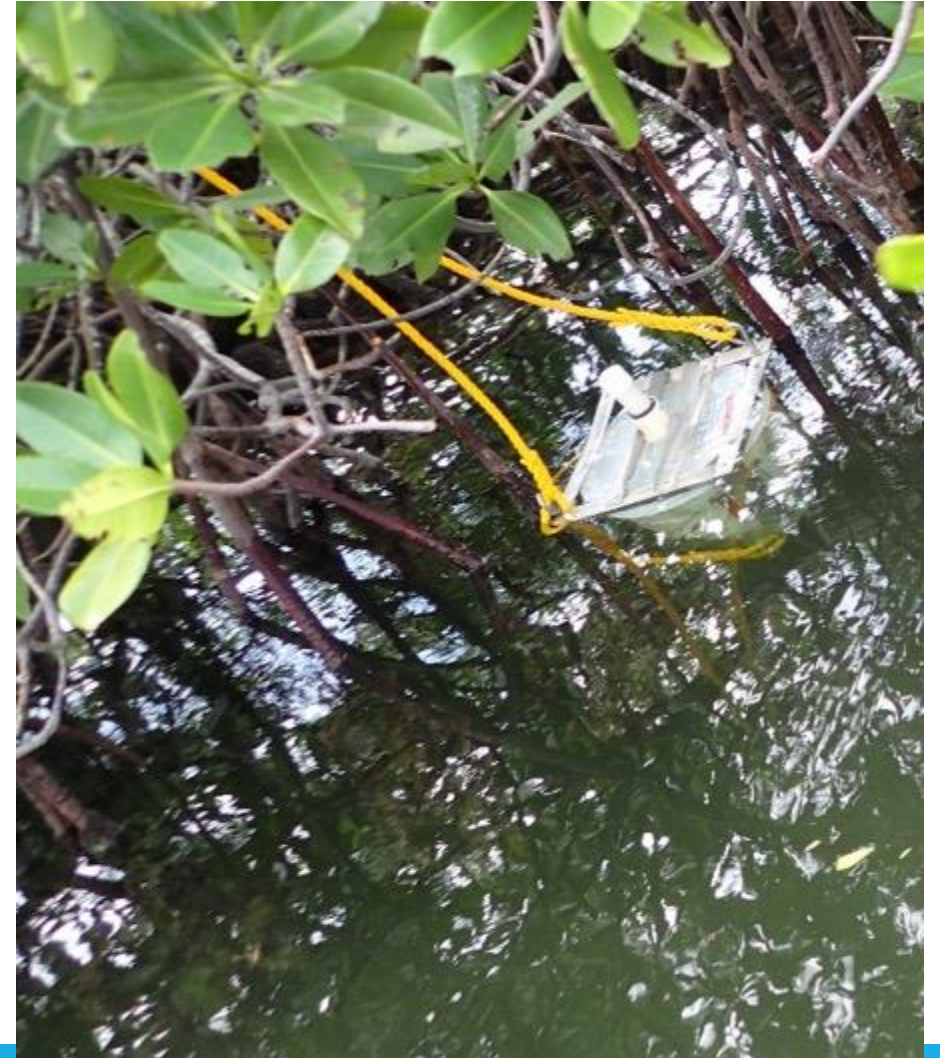
## Ecological

- Mangroves species composition, density & diversity
- Prop root/Aerial root network
- Mangrove trunk diameter
- Mangrove height and canopy width
- Ecosystem services

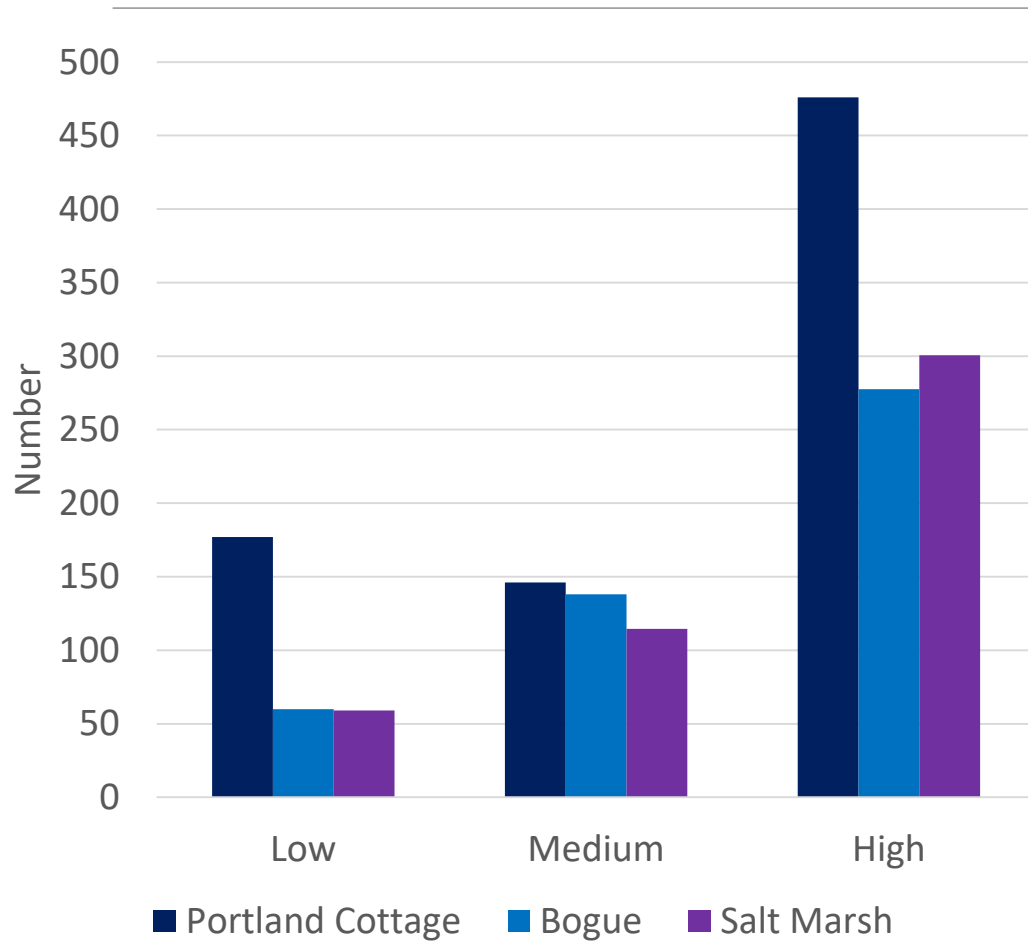
PROP ROOTS

# Results (Prop roots /aerial roots network)

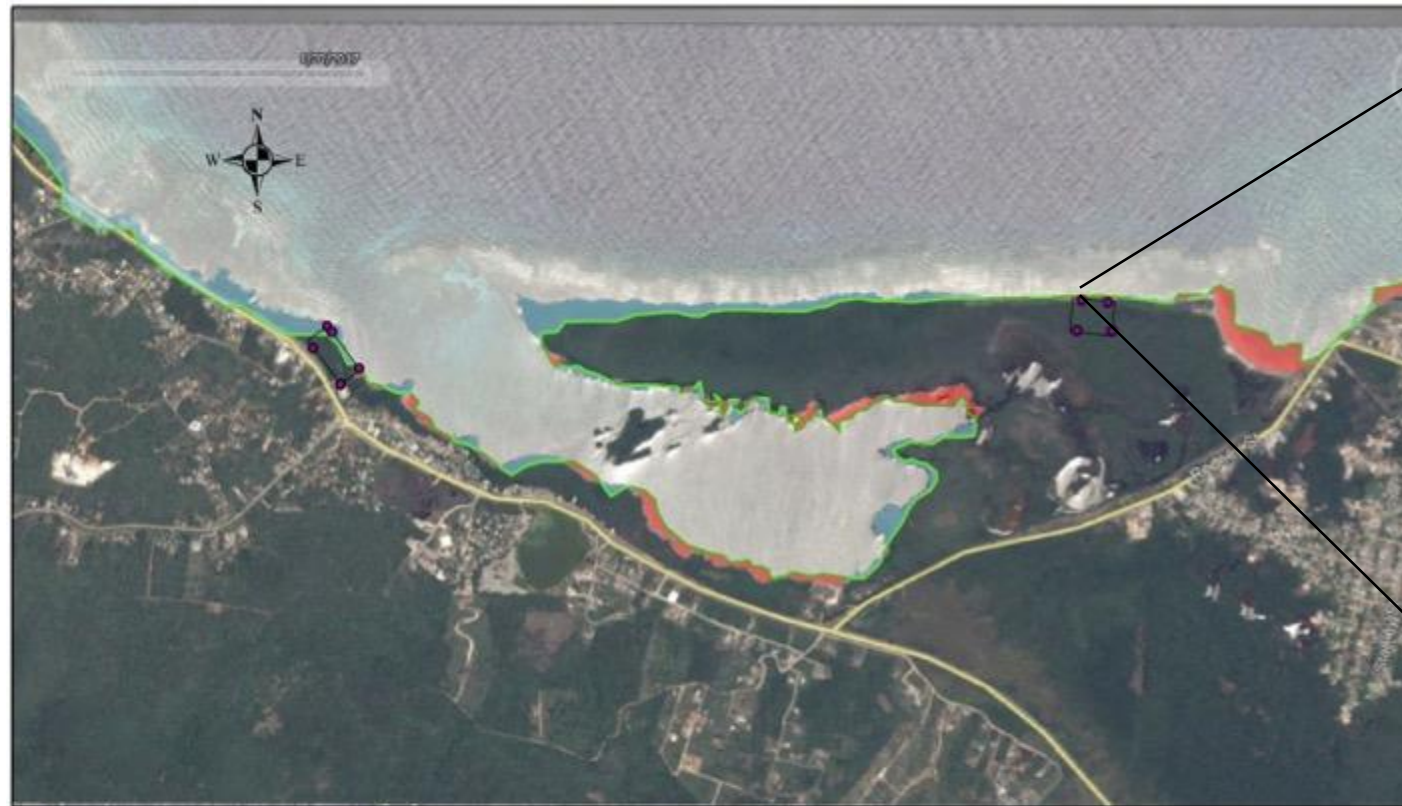
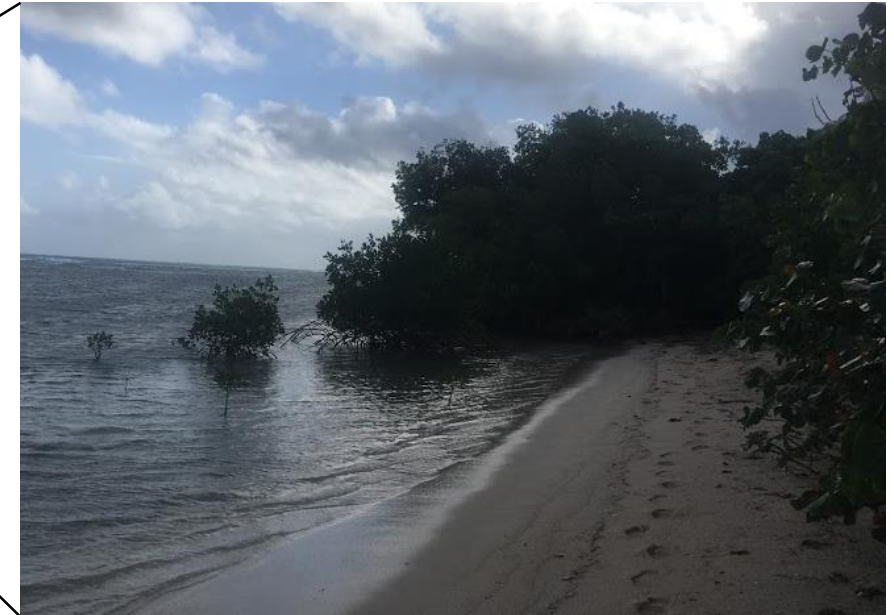
# Erosion & Accretion of Coastlines Sites at Trelawny (1966-2017)

Trees are moving seaward as the conditions permit which if sustained will build more land by stabilizing and trapping more sediments.

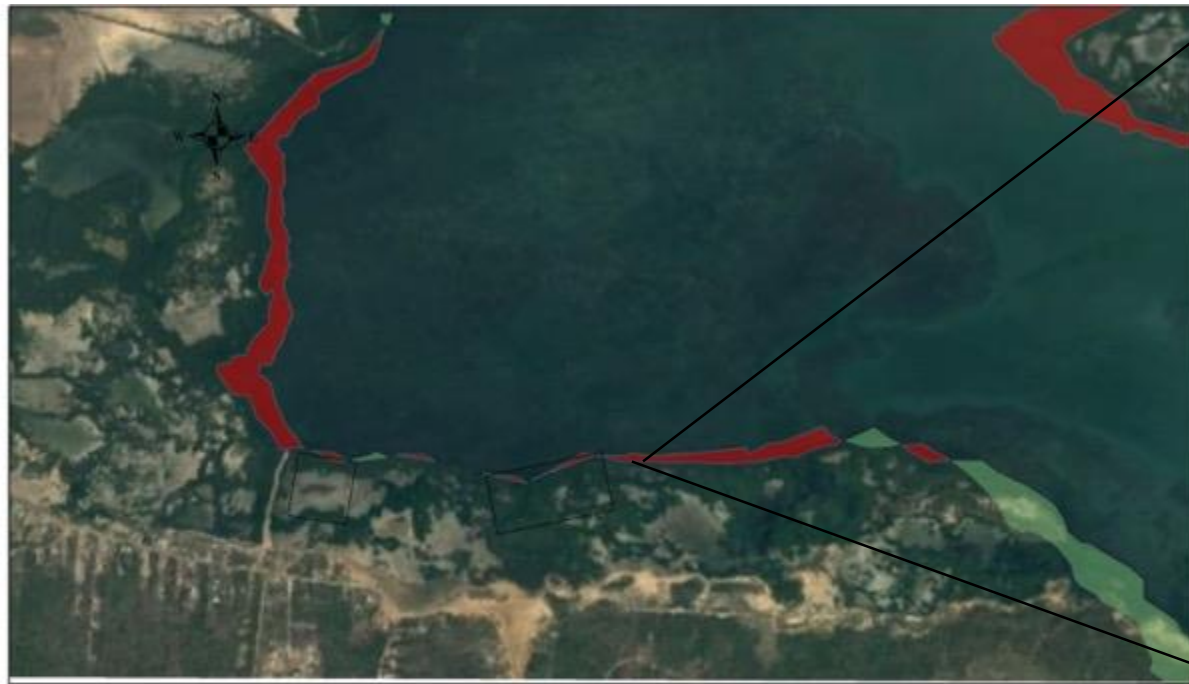
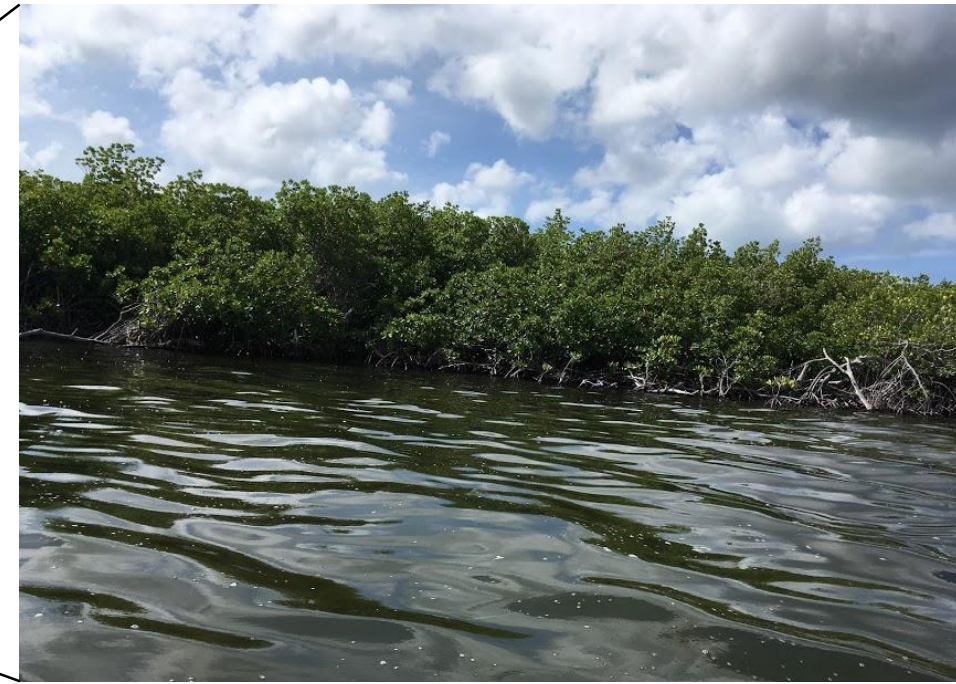
## Portland Cottage (1966-2017)

Dead trees on the edges potentially evidence of the retreat

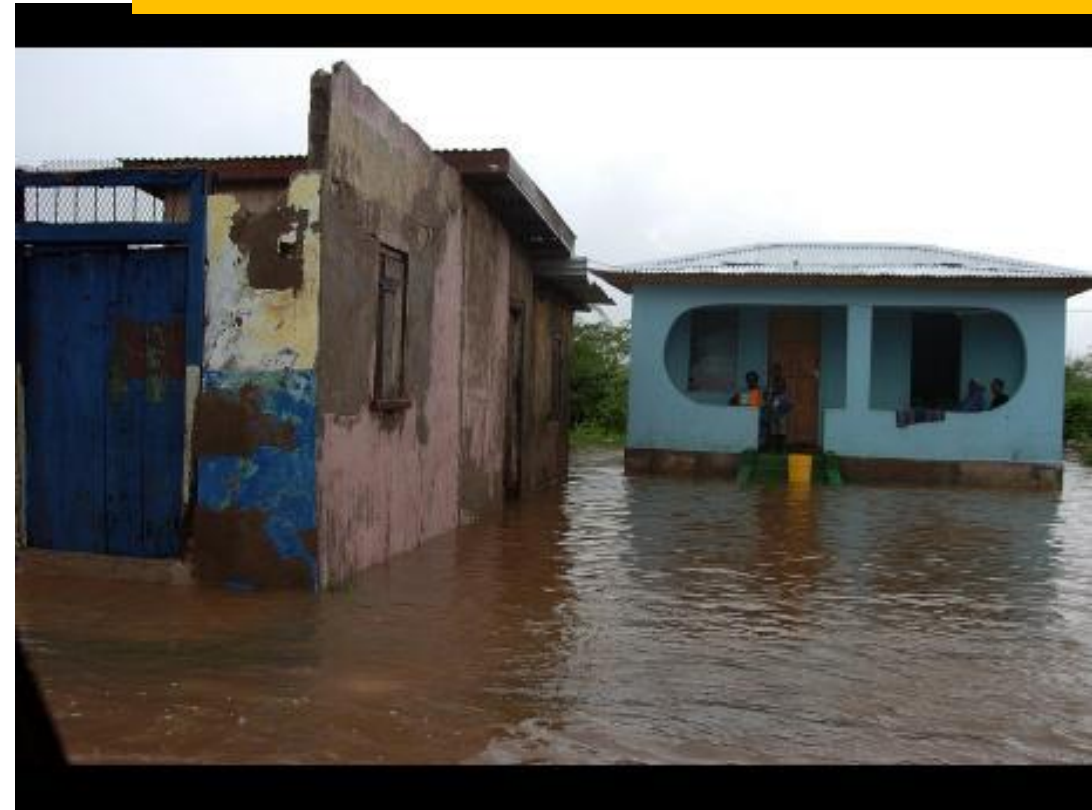
# Prediction of Flooding in Proximity to Infrastructure, Study Plots & Reported Flood Events

Jamaica Gleaner 2017, Portland  
Cottage house affected by flooding

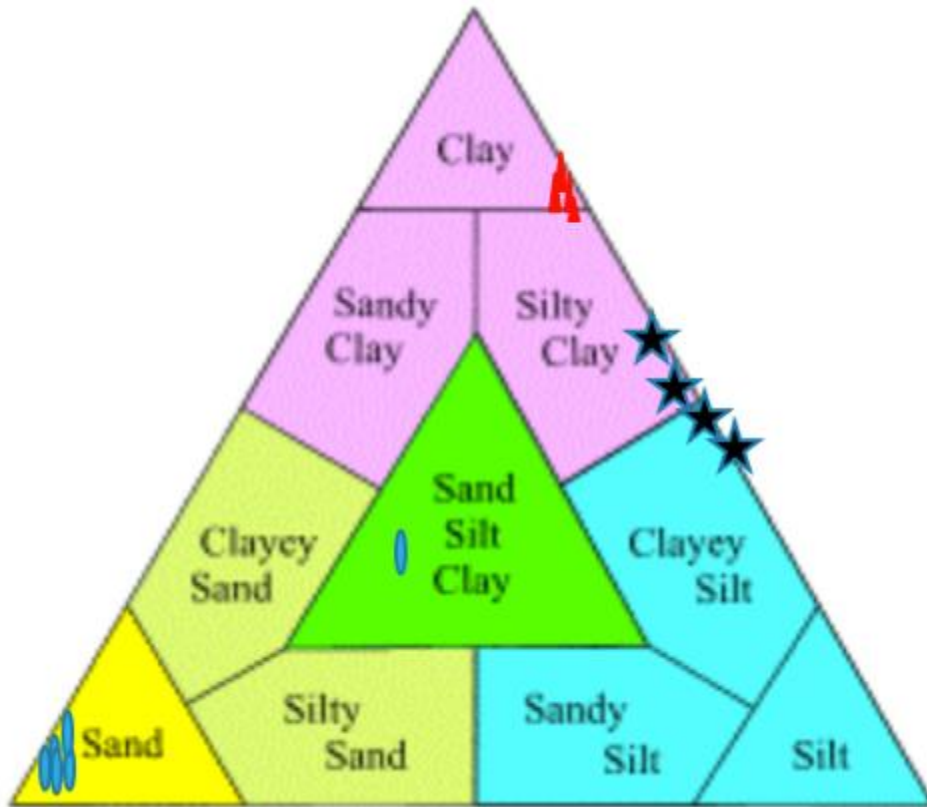
# Soil Characteristics-Grain Sizes

Salt Marsh  
& Rodney  
Street

Portland  
Cottage

Freeport  
& Bogue  
Rd

Roots & un-degraded  
leaves Composition in soil  
(% weight)  
5-25 %

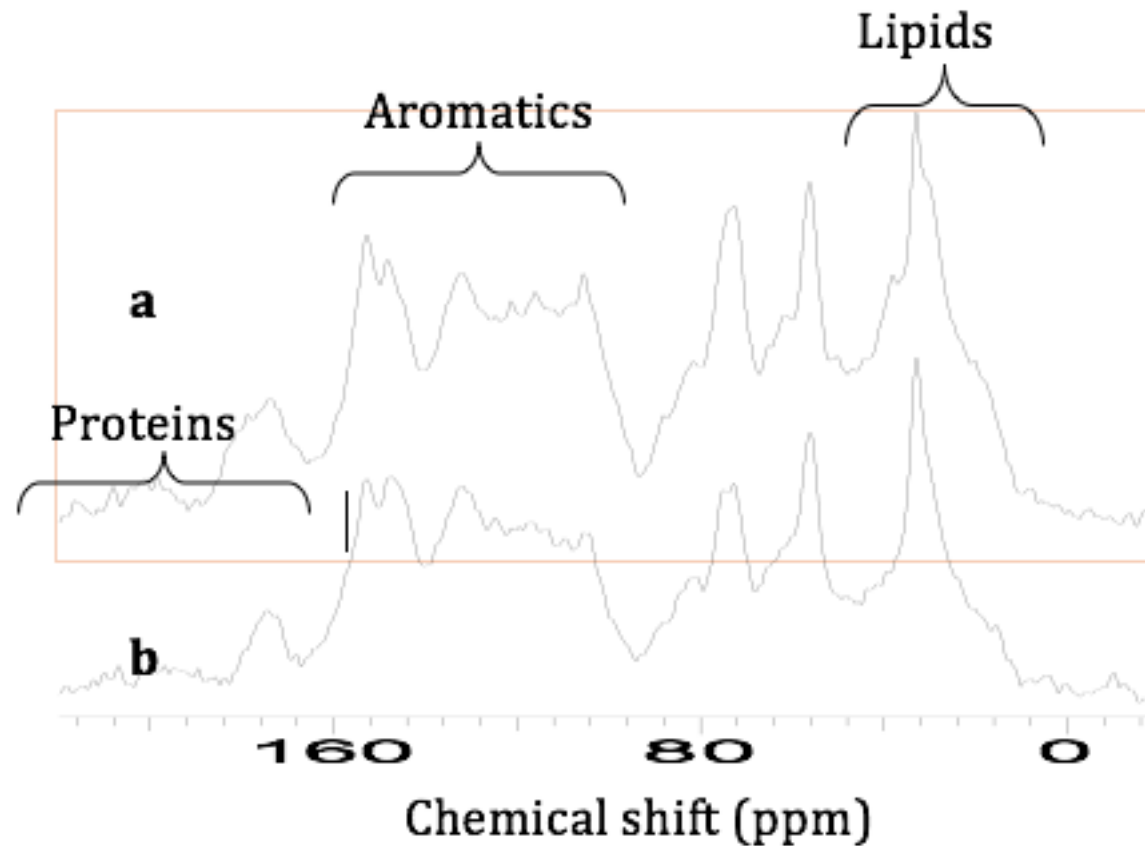
Macromolecular structure of soil organic matter from Portland Cottage localities (a) site 1 and (b) site 2. Samples dominated by aromatic components from vascular plants. Such organic structures are difficult to degrade.
