ALTERNATIVE ANALYSIS

2 ALTERNATIVE ANALYSIS

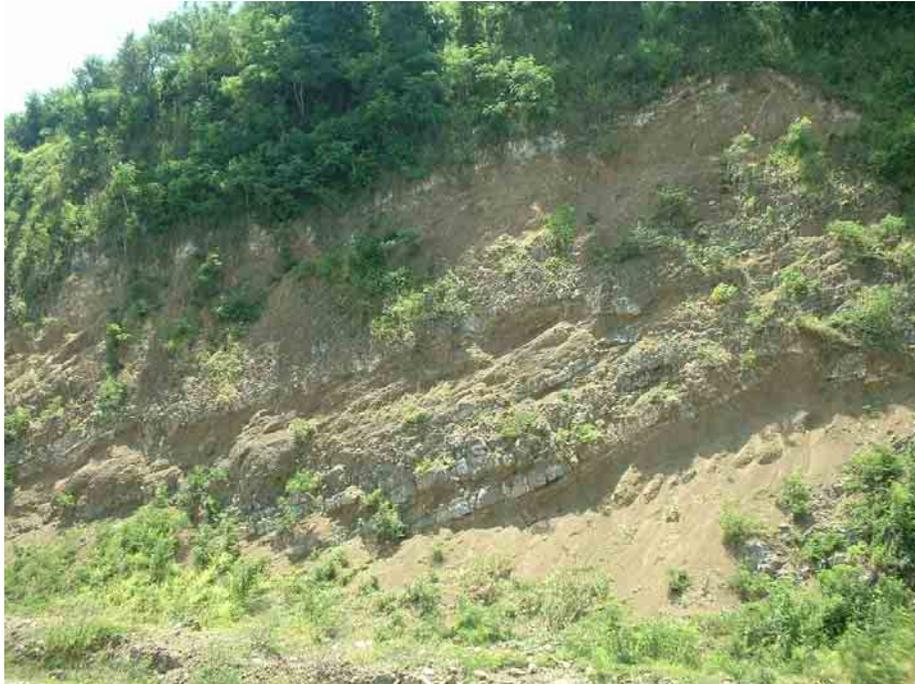
The proposed hotel site, located on the eastern side of the Lucea Harbour and along the harbour coastline, is underlain by a lithologically contrasting unit of arenaceous material (Kha) with sandstones, conglomerates and interbedded shales. This formation is a part of the Cretaceous age Hanover Shale Formation. The Hanover Shale Formation is an extensive outcrop of interbedded shales and sandstones stretching from Mosquito Cove in the east to Haughton Court just west of Lucea. The road cut along the Elgin Town-Lucea main road to the east of the site shows the rock types with differential weathering as the softer shales weather out leaving the more resistant sandstones (see Plate 3-1 and Plate 3-2).

PLATE 3-1: GEOLOGICAL FORMATIONS ALONG HIGHWAY

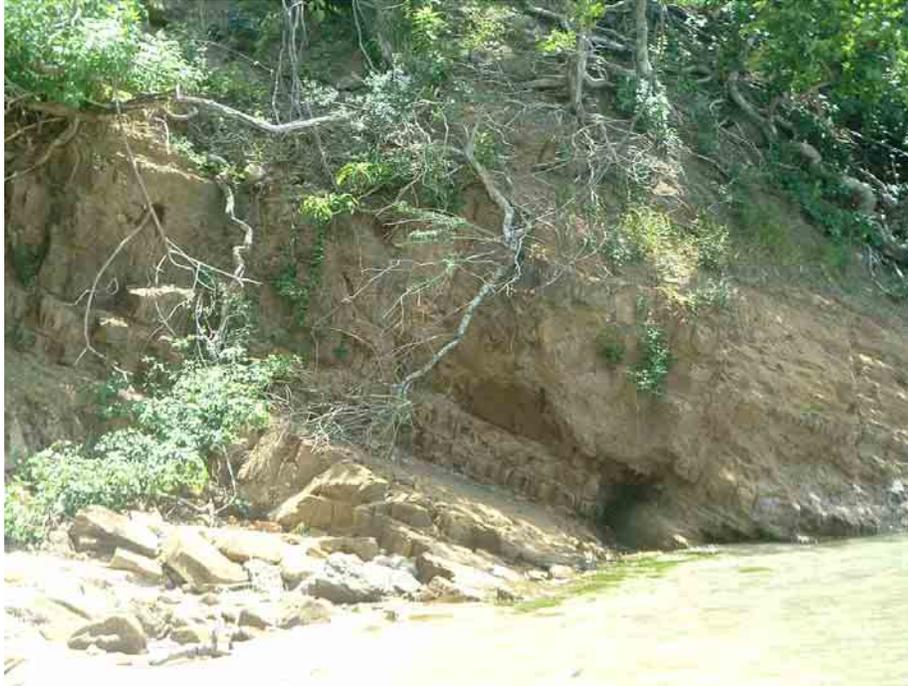
PLATE 3-2: GEOLOGICAL FORMATIONS NEAR BEACH
