**ENVIRONMENTAL IMPACT
ASSESSMENT OF**

**THE FAIRY HILL DEVELOPMENT
PHASE 2**

October 2006

**TECHNOLOGICAL AND ENVIRONMENTAL MANAGEMENT
NETWORK LTD.**

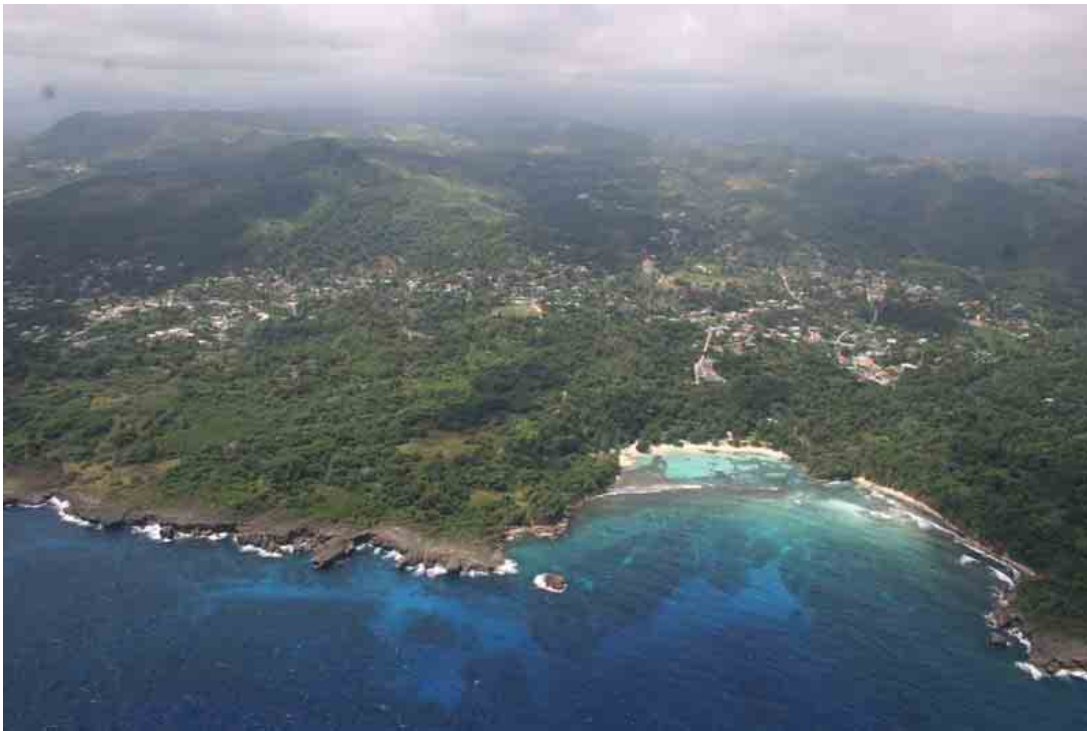
Photo 1: Aerial survey documents the current state of the area to provide a general overview of the terrain, vegetation and marine features of the site

An aerial survey of the proposed development site and surrounding areas was conducted on May 8th, 2006. Photographs were taken from an altitude of approximately 1,500 feet and documented

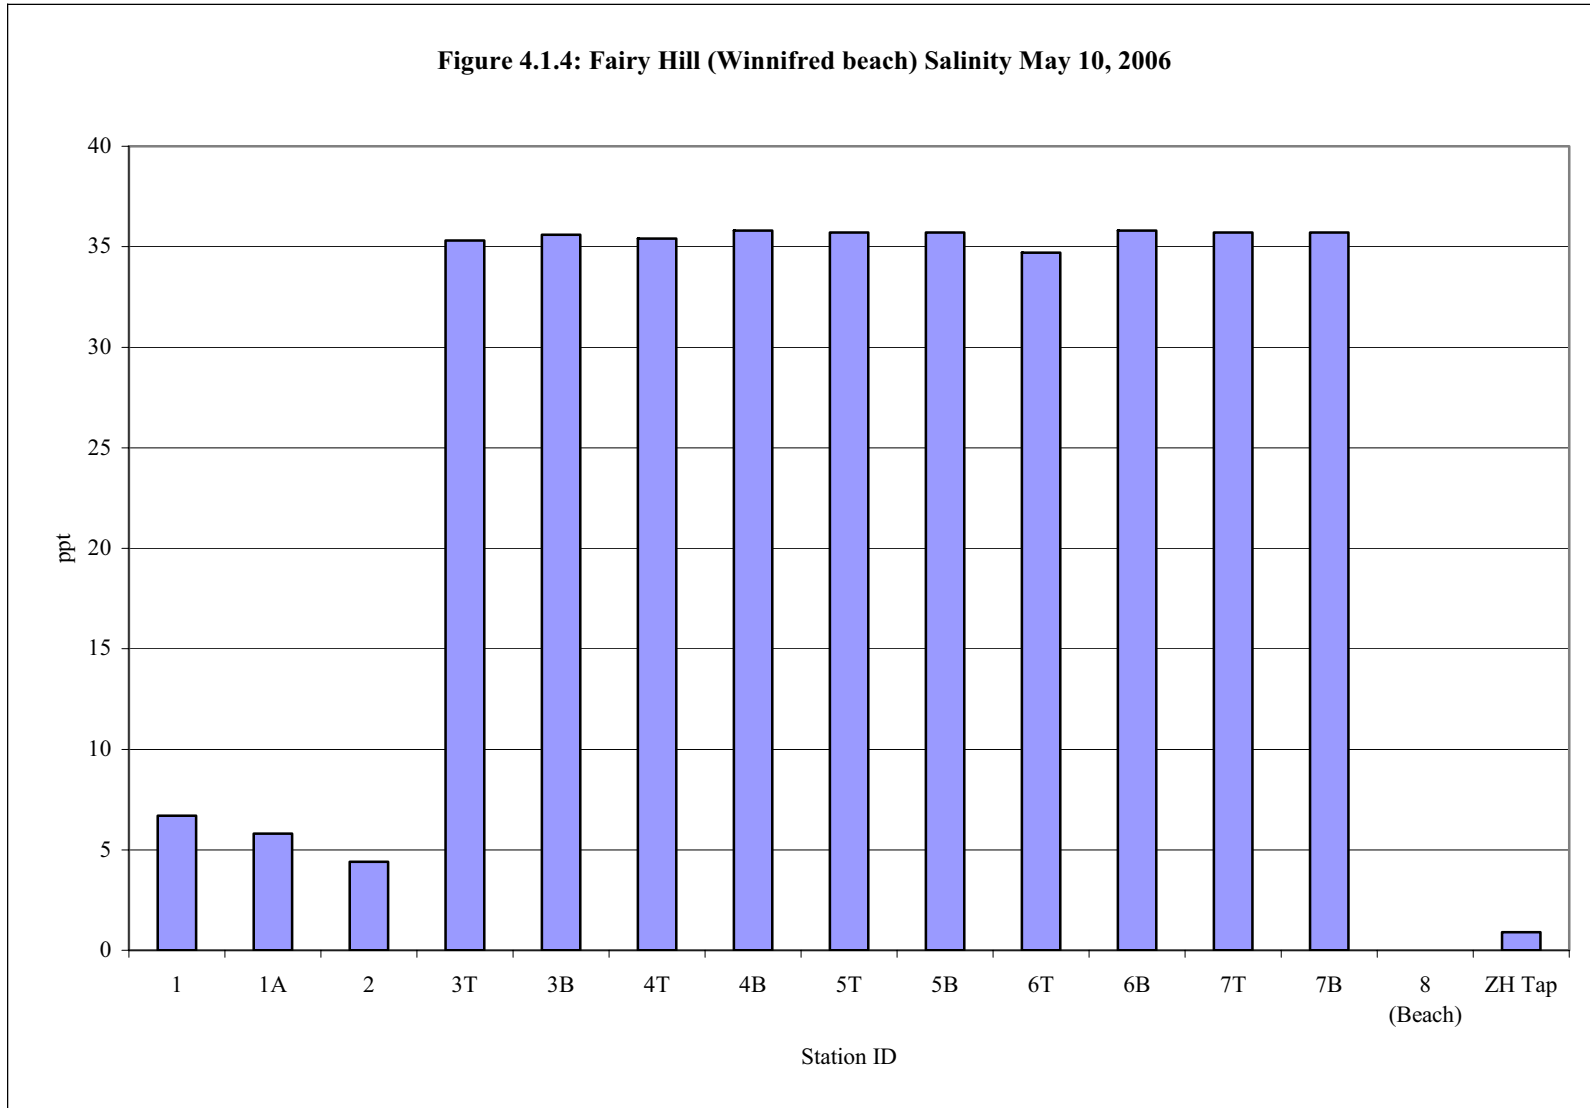
Figure 4.1.4: Fairy Hill (Winnifred beach) Salinity May 10, 2006

Salinity was generally slightly lower at the top or identical at the top and the bottom. The springs had salinity of 7.7ppt (Station 1) and 4.4ppt (Station 2). The Zion Hill domestic sample (ZH Well) had a salinity of 0.9ppt.

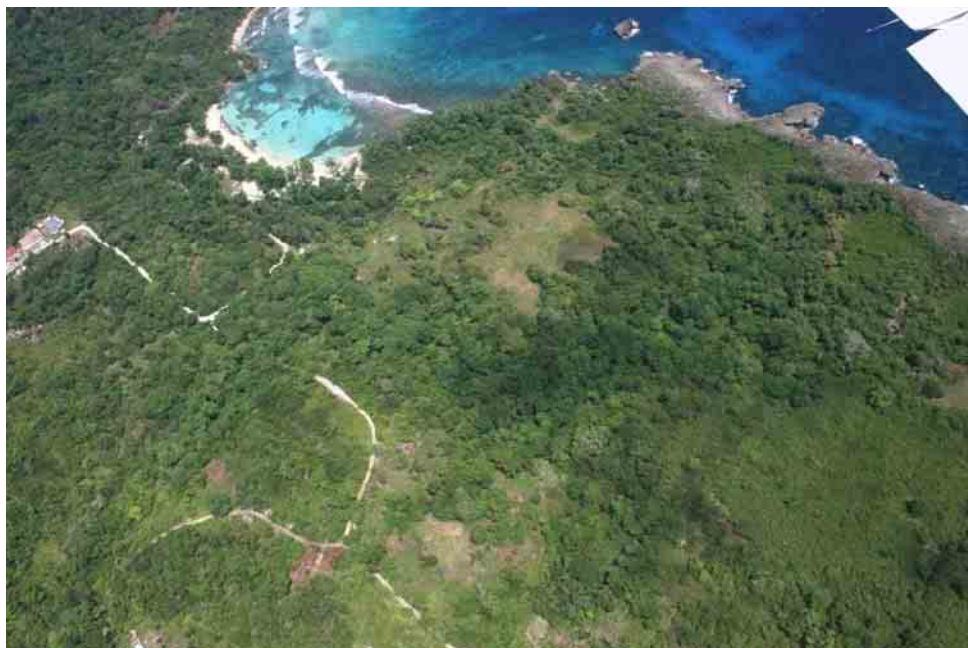
Photo 2: Aerial photo of proposed development site – view from the south east

The aerial photos (Photos 2, 3) of the proposed development site show a densely forested terrain, with thick shrubs near the rocky bluff, and open areas that were previously cleared presumably for pastures or agricultural uses. The area can best be described as a disturbed woodland area, of fairly low elevation reaching a maximum height of 70m above sea level. A number of well worn paths weave through the study site. Rubbish (burned cars and building debris) was found strewn around the area as were a number of fire pits. A stone ruin, presumably an old agricultural estate, is located on the ridge immediately above the east side of the bay, near the site designated for the wetland conservation area. Parish records should be consulted to determine the possible historical or heritage importance of the ruin.

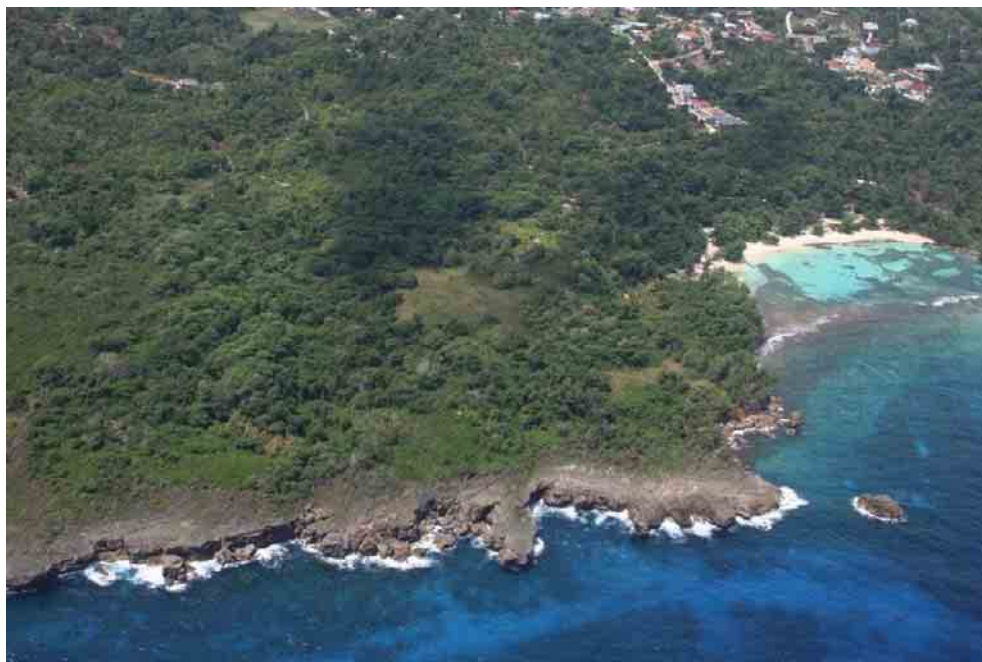
Photo 3: Aerial photo of the proposed development site – view from the north east

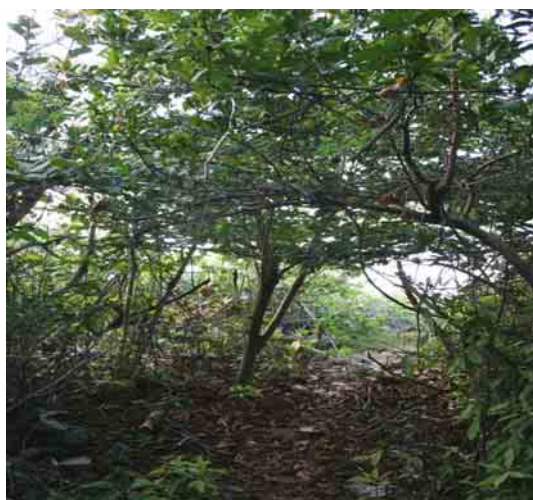
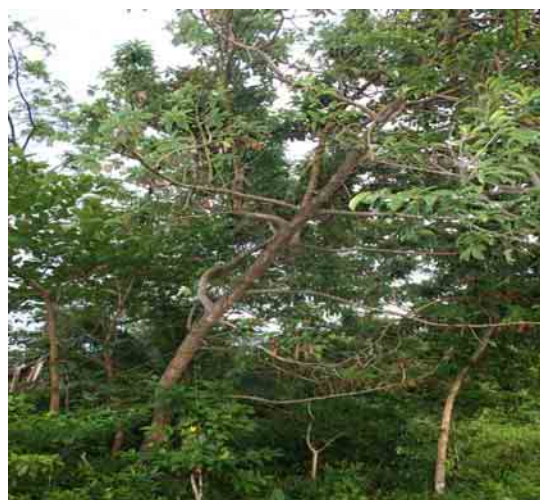
Photos 4 a, b: Forested area in development site

The floral species identified in the area are typical of a wet limestone forest. The forest is composed of numerous large trees, many exceeding 0.3m diameter and 15m in height e.g. Trumpet trees. The forest floor is soil covered in a thick layer of moist leaf litter. Cleared areas are overgrown with short grasses. The canopy is closed throughout the forest creating a shaded interior providing an ideal habitat for various birds heard in the area (Photos 4 a, b). The under canopy layer is open towards the periphery where the forest gives way to dense shrubs.

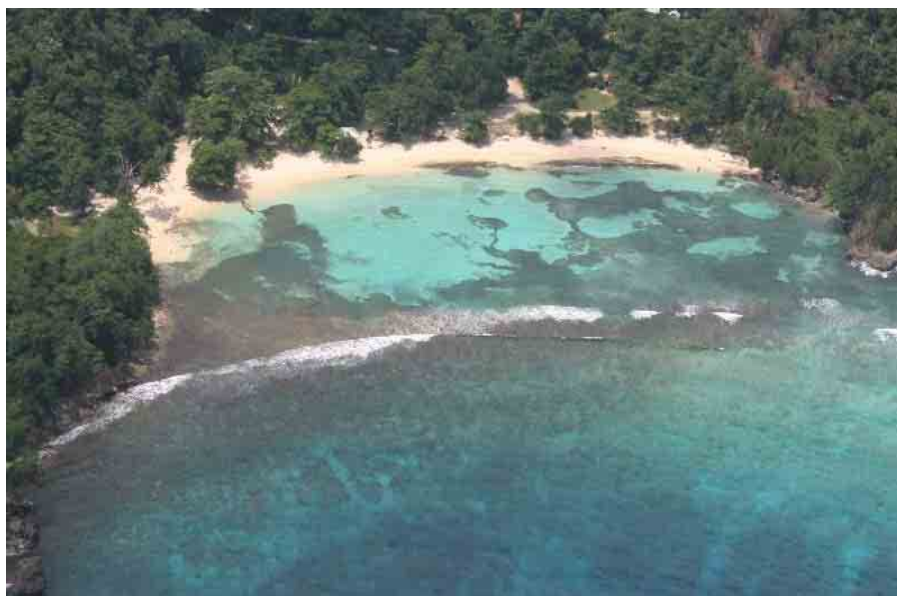
Winnifred Beach (Fairy Hill Bay) is a sheltered cove 1.6 sq km in area, with a small stream (as well as a shoreline point of freshwater seepage) on the east side of the bay. The bay is sheltered by a modest submerged reef crest formed primarily by a ridge of dense fire coral on the east side and mounds of coral colonies on the west side of the bay. A small, shallow, natural channel on the western side of this protective ridge provides boat access to and from the beach (Photo 5).

Photo 5: Reef crest protecting beach

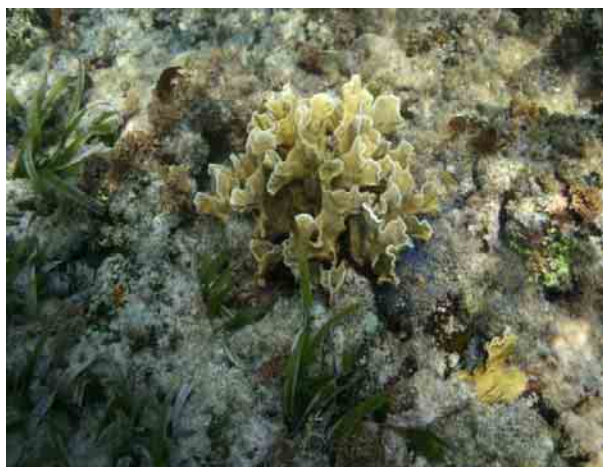
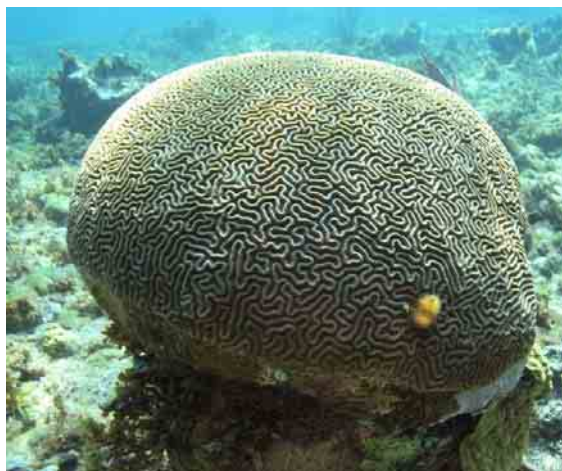
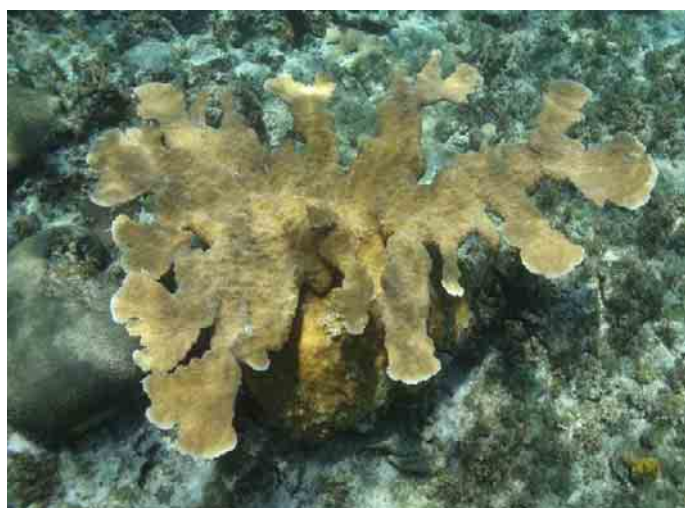
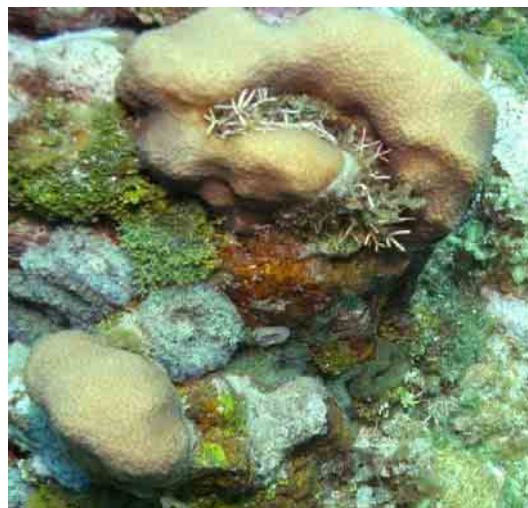
Photo 6 a, b, c, d: Coral species observed on the ridge and on coral patches in the lagoon

Coral species observed on the ridge and on coral patches in the lagoon included Fire Coral (*Millepora* spp.), Smooth Brain Coral (*Diploria strigosa*), Elkhorn Coral (*Acropora palmata*, both mature and recruits) as well as Boulder and Smooth Star Coral (*Montastraea annularis* and *Siderastrea siderea*) (Photo 6 a, b, c, d). Corals were of small to medium size, with an average diameter of 20-30 cm.

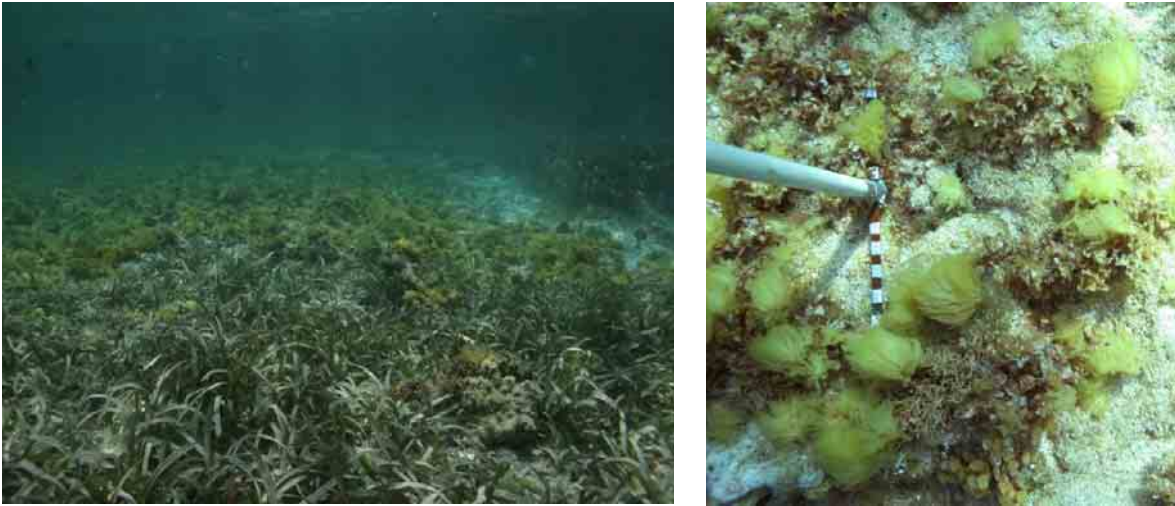
The algal community on the reef crest includes *Sargassum* sp., *Galaxaura* with other species such as *Schizothrix* sp. occasionally spotted on coral rubble with *Penicillus* sp. and *Avrainvillea* sp. on the sandy substrate in the lagoon. The shallow sandy lagoon (~1-1.5m) contains dense Turtlegrass (*Thalassia testudium*) beds extending to the reef crest. Shoot densities averaged 806 shoots per m². The substrate on east side of the lagoon where the stream flows into the bay is overgrown with a pale green filamentous turf (possibly *Lyngbya semiplena*) (Photo 8 a, b) which is indicative of localized eutrophication.

Photo 8 a, b: Evidence of possible eutrophication in the lagoon near the stream

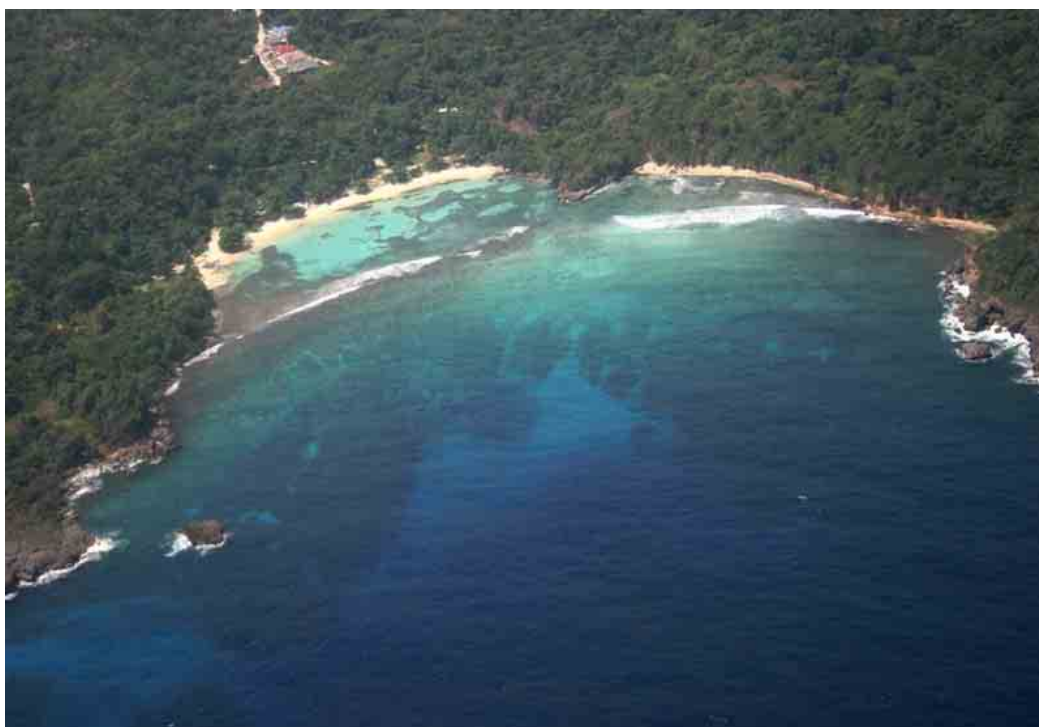
The gently sloping substrate on the seaward side of reef crest was primarily barren hard pavement interspersed with mounds of coral and urchins, giving way to the typical spur and groove reef formation common to Jamaican north coast reefs. The main reef buttress (see Photo 9) outside of the bay supported a healthy community of benthic fauna including scleractinian corals, sponges and gorgonians (Fig. 4.2.1).

Photo 9: Seaward of reef crest - barren hard pavement interspersed with mounds of coral and urchins. Main spurs support scleractinian corals, sponges, gorgonians & abundant algae

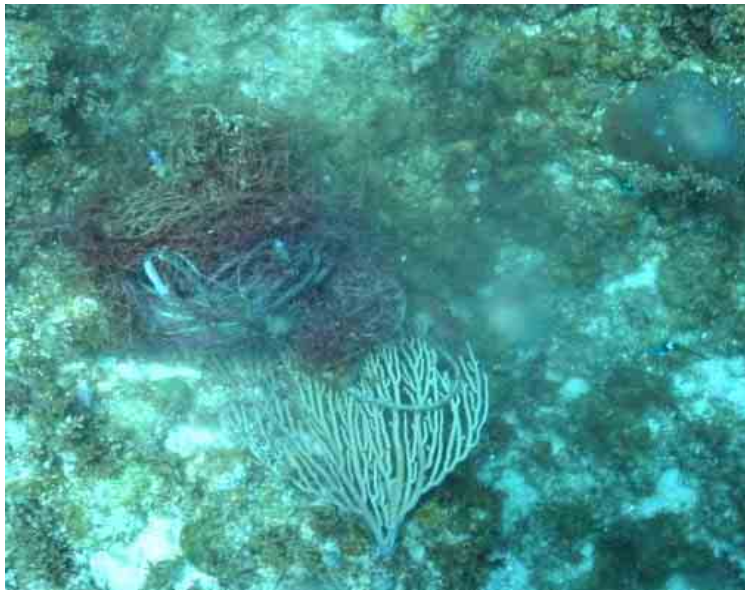
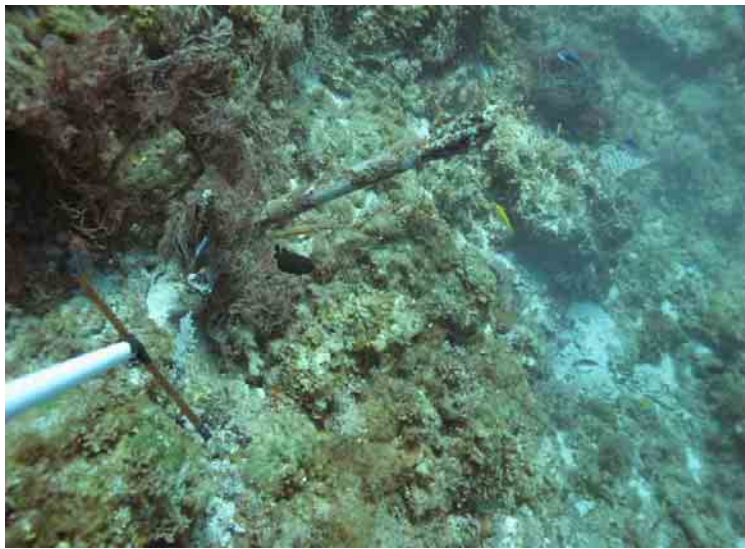
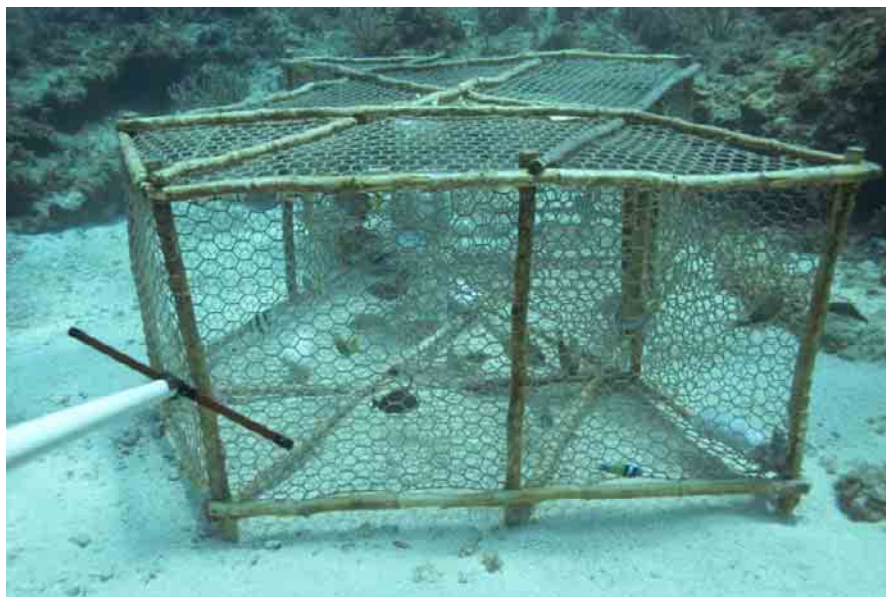
The results of the fish census indicated similar numbers of species (28) to those observed on previous visits to the area (Table 4.2.3). The size of fishes seen however was smaller than those previously noted. Few mature, commercially important fishes (grunts, parrot fish, goatfish, and groupers) were observed. The reef was considered to be heavily over-fished. Discarded fish nets, anchors and fish traps were observed in the area (see Photo 10 a, b, c).

Photos 10 a, b, c: Debris found on the reef: discarded fishing nets, anchor and fish traps

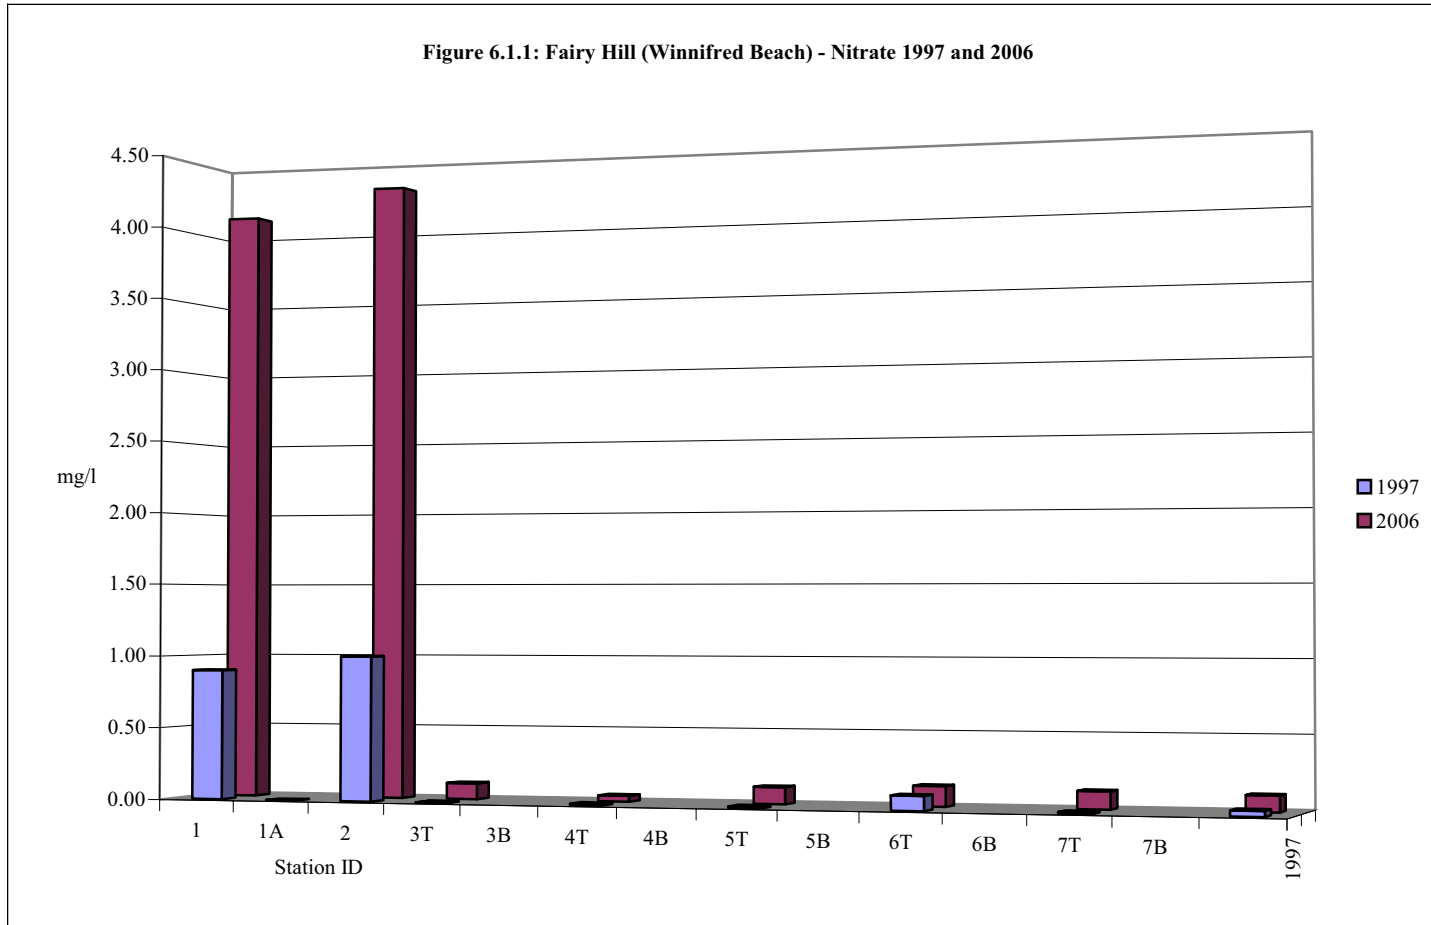
Figure 6.1.1: Fairy Hill (Winnifred Beach) - Nitrate 1997 and 2006

noted in the spring strongly suggests that the source for these elevated Nitrate levels is up gradient groundwater. This, along with the increased faecal coliform in the brackish pool suggests an increase in impact from sewage and/or other mammalian waste on water quality since the 1997 assessment.

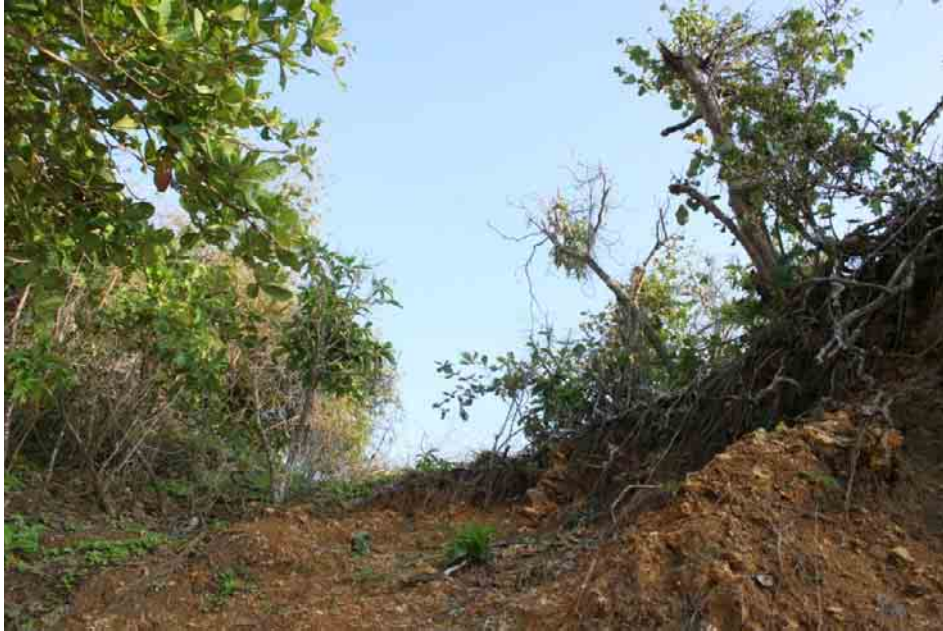
Small scale illegal sand-mining from the beach has been reported in the area. On the west side of the beach, there are exposed hard surface areas in the swash zone of the beach which have presumably been exposed because of the removal of sand from this section of

the beach. The extent of erosion due to sand mining versus natural movement of sand onto or along the beach is unknown and requires additional field work to quantify. Other signs of erosion appear on the seaward promontories on either side of the bay presumably caused by wave action.

Photo 11: Erosion observed on the eastern promontory of the bay

The proposed development plan calls for controlling of access points to the area and restricting car access to the beach during and after the completion of the development. These measures would restrict if not eliminate illegal sand mining and mitigate degradation of the beach area caused by such activities.

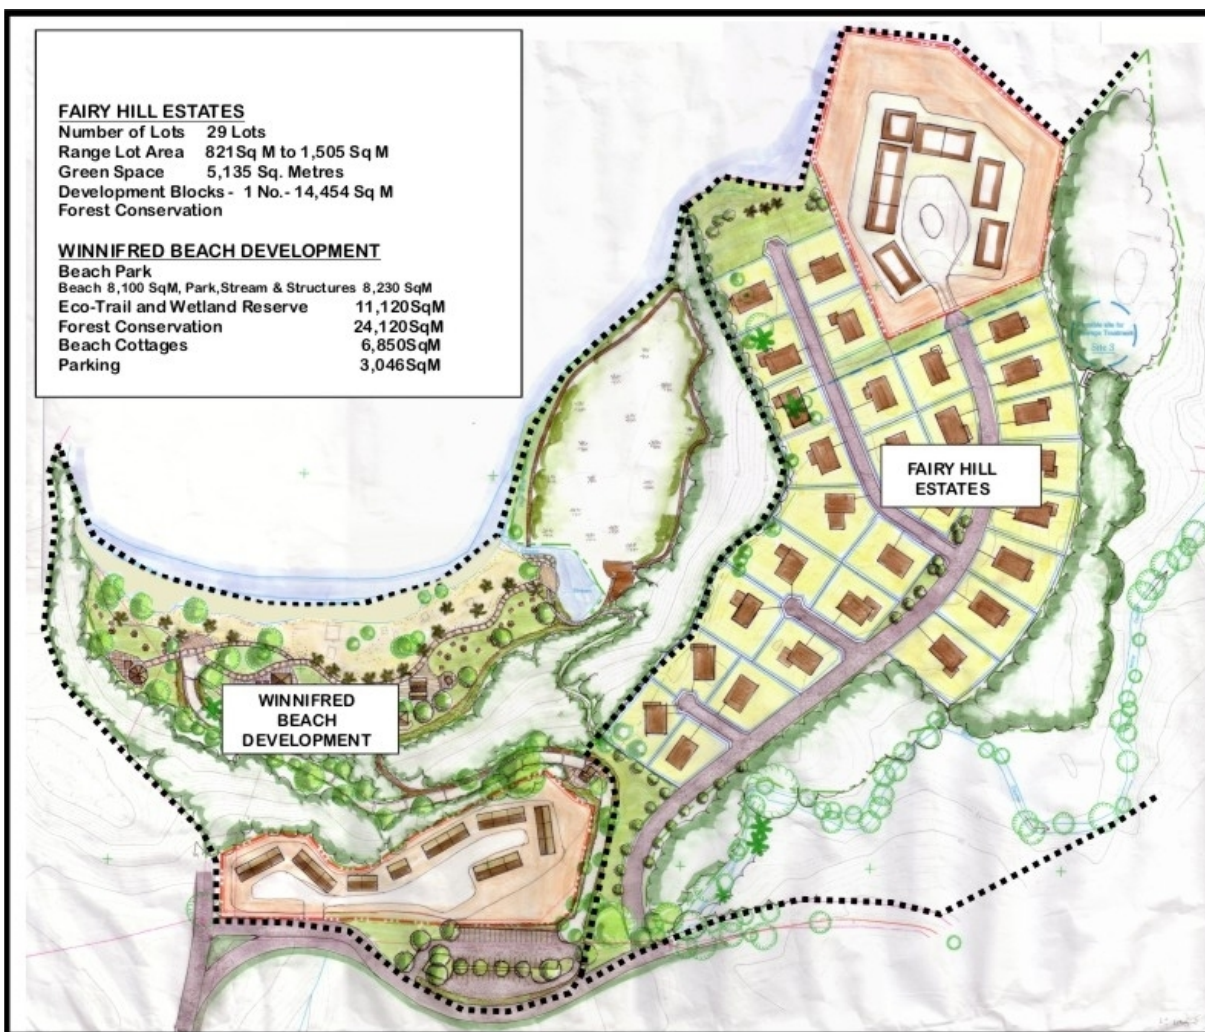
| <p>FAIRY HILL DEVELOPMENT FAIRY HILL, PORTLAND</p> | <p>MASTER PLAN FAIRY HILL ESTATES & BEACH DEVELOPMENT</p> | <p>URBAN DEVELOPMENT CORPORATION SEPTEMBER 2004</p> |

The proposed development site is located in the town of Fairy Hill, on the ridge located immediately East of Winnifred Beach and includes the immediate beach area and adjacent foreshore. The area assessed in this study corresponds to the area indicated on the Fairy Hill Development Phase 2 - Master Plan supplied by the UDC, outlining the boundaries of the proposed development site and the specific areas of concern.

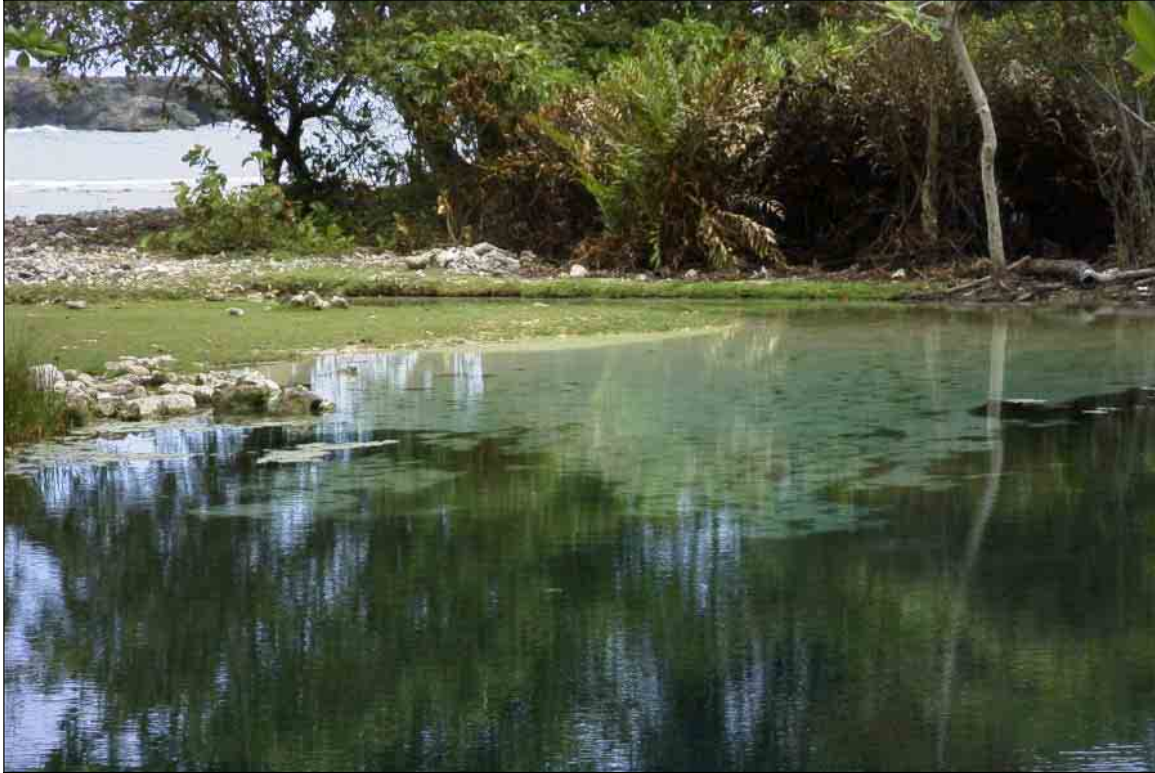
Photo 6.1 - Coastal freshwater spring with head waters in the foreground and its discharge stream leading to the sea in the foreground (May 12, 2006)

The field reconnaissance identified two freshwater springs and several dry natural drainage gullies. The largest of the spring is located at the southern end of the small wetland near the beach (see Figure 3, Appendix 6). It forms a small wading pond approximately 1.4m (4.5ft) deep and 4.5m (15ft) across which then discharges by way of a small rivulet to the sea in the north. The measured surface velocity of the discharge stream was approximately 11 cm/s (0.4 ft/s).

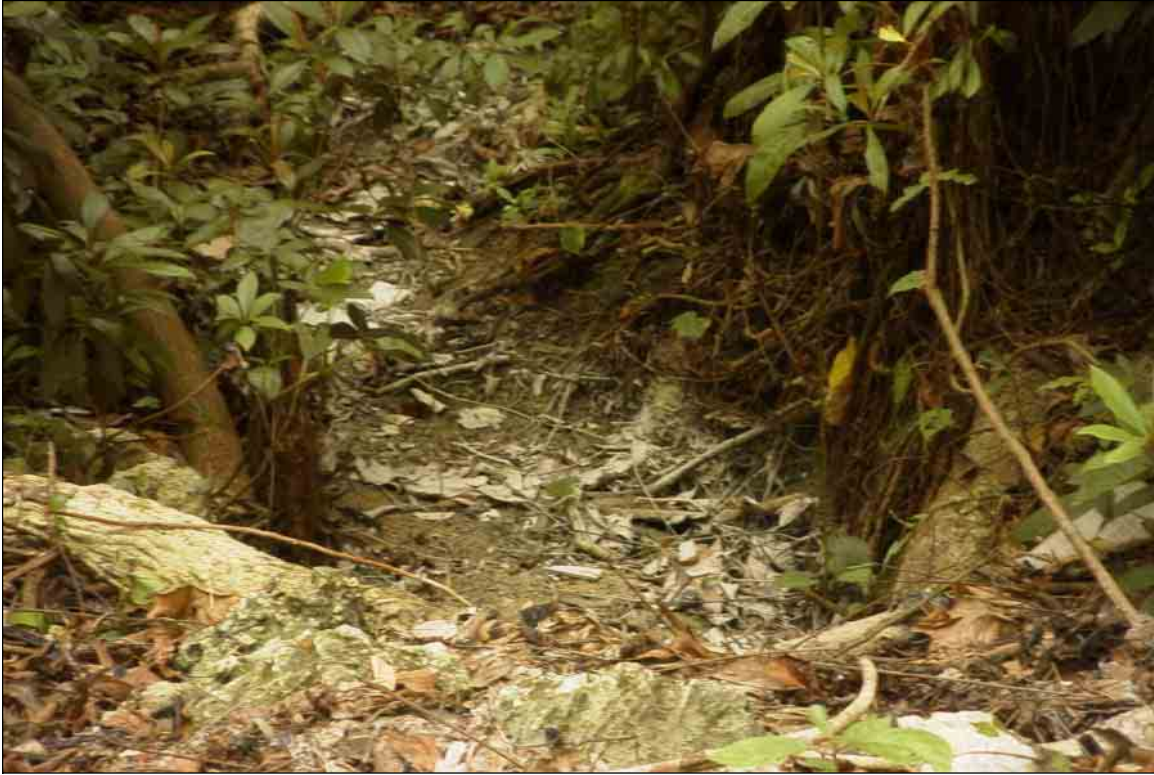
Photo 6.2 - Natural Gully showing evidence of hydraulic scouring (May 12, 2006)

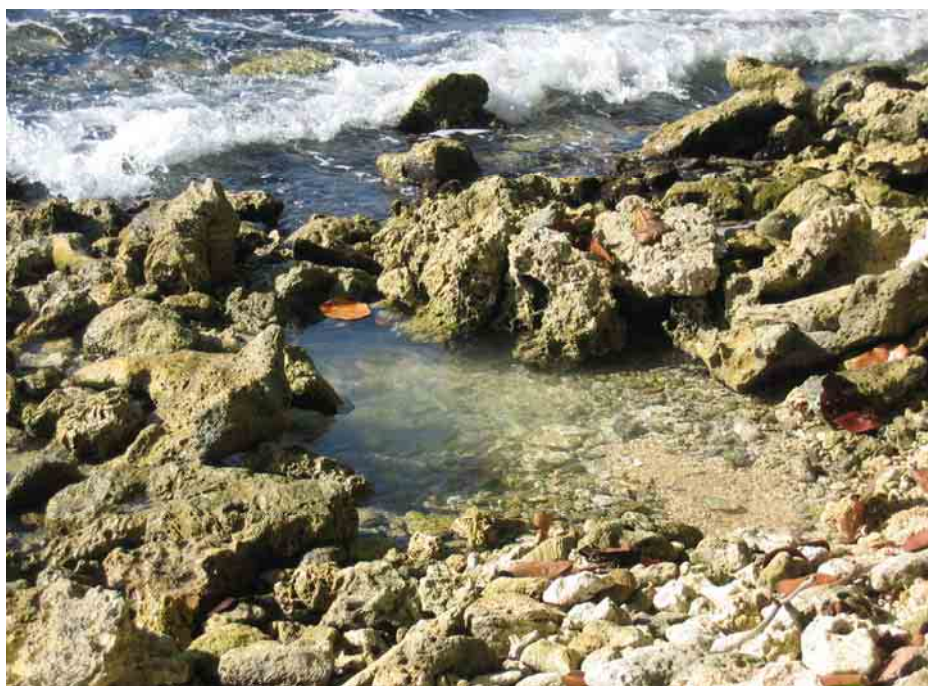
Photo 7.2-Smaller spring, emerging along rocky shoreline.

At the time of sampling water in the bay off Winnifred Beach was clear and appeared free of any notable floating matter or turbidity. The springs were also free of any obvious floating or suspended matter. The larger spring (Station 1), which opened on the beach (Appendix 7 - Photo 1), was flowing freely to the sea. The other spring further to the east was also active emerging along the rocky shoreline (Appendix 7 - Photo 2). Solid waste heaps showing evidence of previous burning were observed (Appendix 7 - Photo 3).

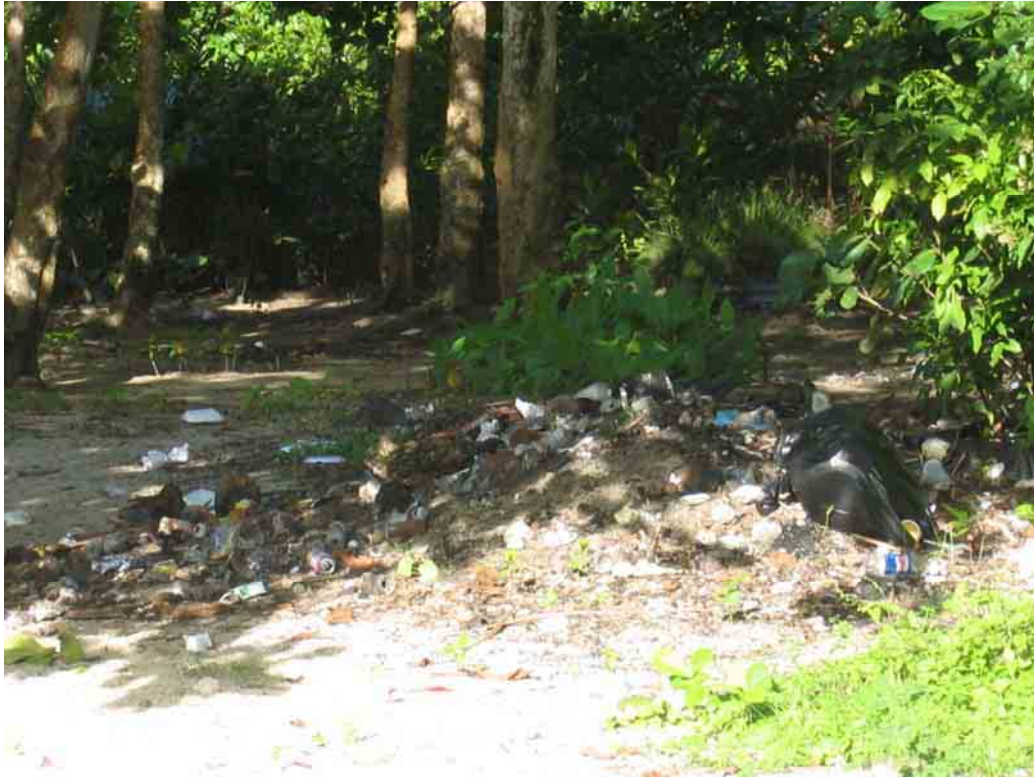
Photo 7.3-Solid waste heaps on beach.

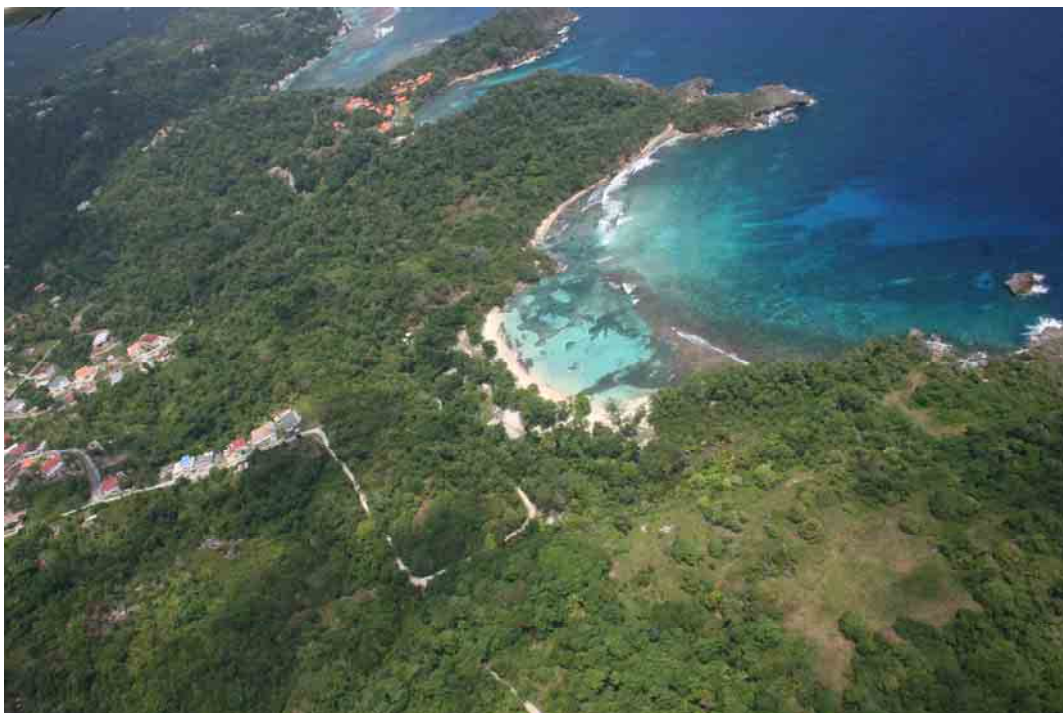
Photo 7.4-Aerial photographs of proposed site showing forested terrain.

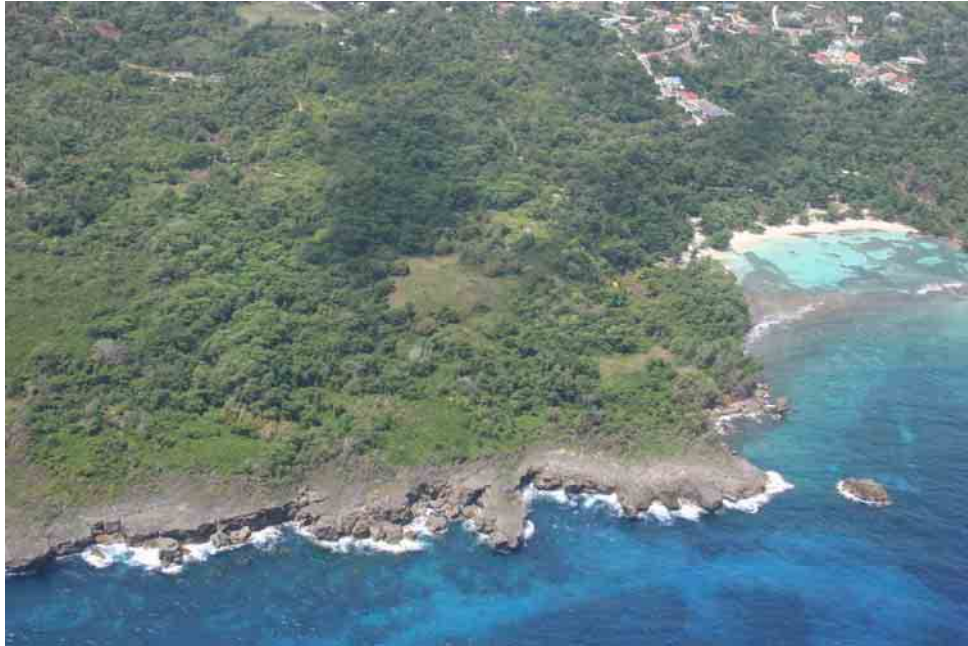
Photo 7.5-Aerial photographs of proposed site showing forested terrain.

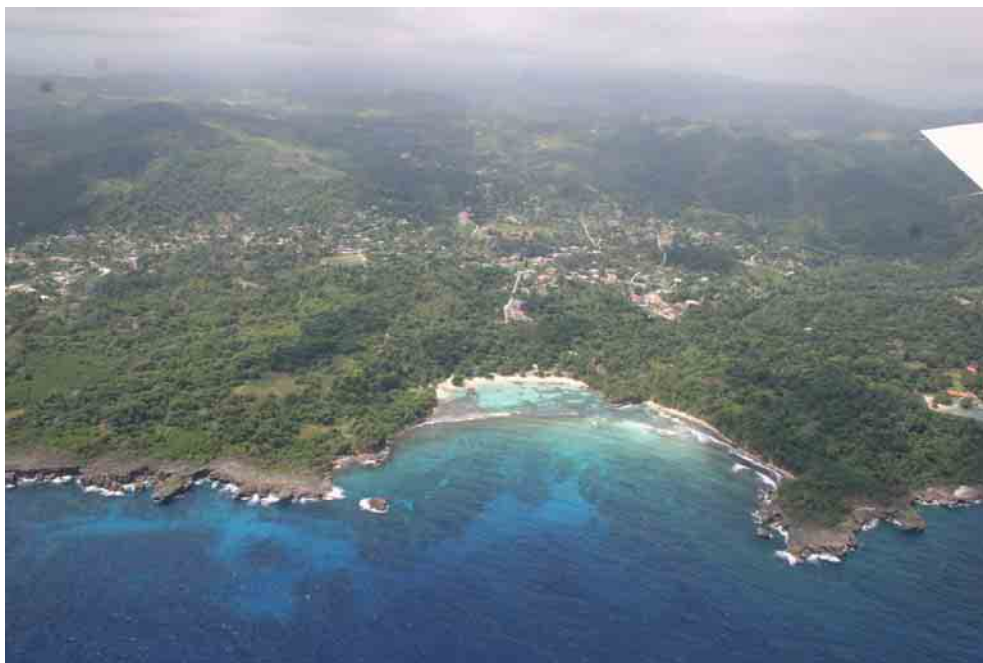
Photo 7.6-Aerial photographs of proposed site showing forested terrain.
