# ENVIRONMENTAL IMPACT ASSESSMENT

## BAHIA PRINCIPE HOTEL RESORT DEVELOPMENT

### PEAR TREE BOTTOM ST. ANN, JAMAICA

**Environmental Solutions Ltd.**  
20 West Kings House Road  
Kingston 10  
Jamaica

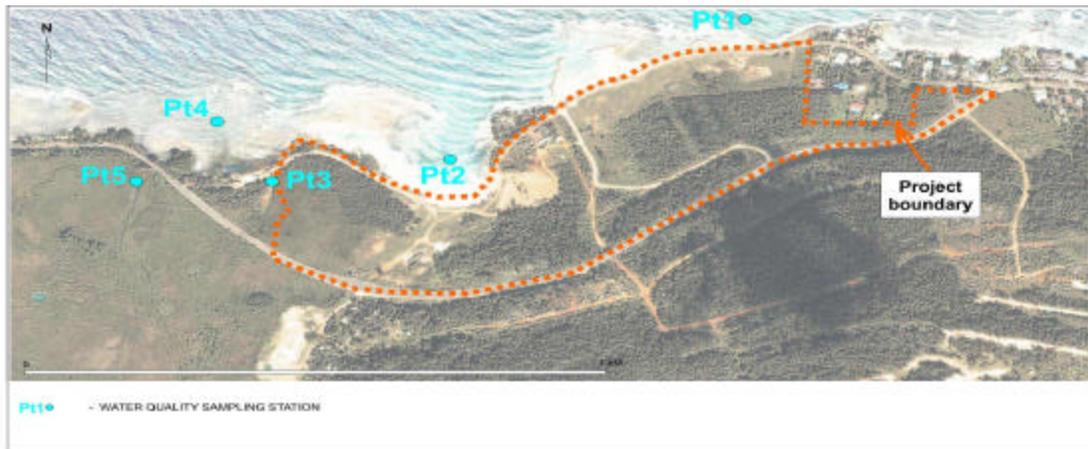
**Figure 1.2 Map showing location of water quality sampling stations**

Water quality analyses were made of samples taken on 19 January 2005 at selected stations to assess baseline water quality conditions of the surface water systems. The five sampling stations were selected based on their location relative to the discharge points of major water streams, and to their risk of contamination. The station locations are shown at Figure 1.2 and described in Table 1.4.1.

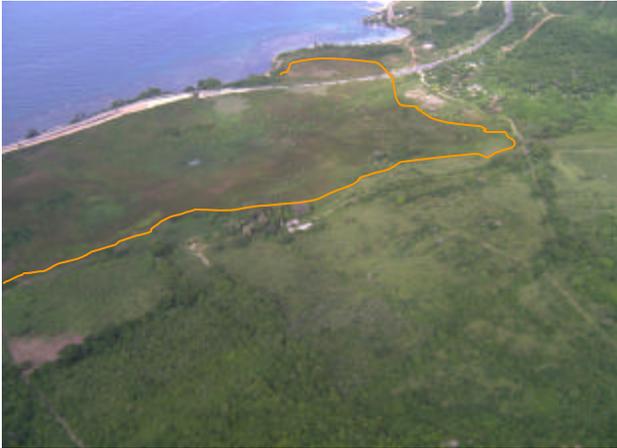
**Plate 3.7.1.1 Aerial view of wetland (outlined in orange) at Pear Tree Bottom.**

A 65 ha (160 ac) freshwater marsh lies immediately to the south and west of the site (Plate 3.7.1.1). It is a basin type, which has developed around a complex of streams arising from ground water upwelling (blue holes – see Plate 3.4.1) and springs. It is separated from the sea by a sand/beach barrier and the wetland connects to the sea by a few streams of which the Pear Tree River is the most significant (Plate 3.7.1.2).

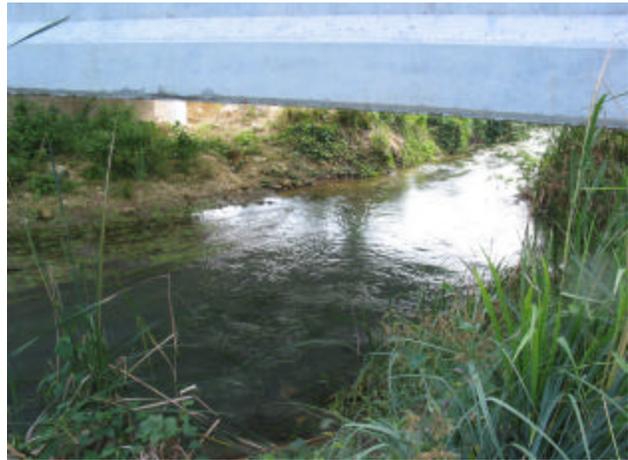
**Plate 3.7.1.2 Pear Tree River below new highway bridge.**

The new highway traverses the marsh and culverts have been placed under that road to allow existing stream flows. An estimated 25 –30 mgd of water flows to the sea. A small portion of the wetland (2.5 ha / 6 ac) lies north of the highway (Plate 3.7.1.3) and adjacent to the western end of the resort.

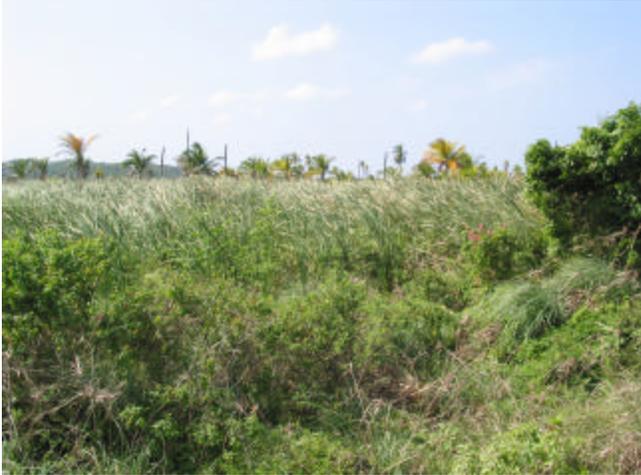
**Plate 3.7.1.5 Wetland occluded with bulrushes.**

Bacon et al (1991) report that some thirty species of plants have been identified from the Pear Tree wetland (Table 3.7.1) These include submerged aquatic plants, rooted emergent herbaceous plants, trees and shrubs associated with the beach barrier, cultivated species, and adventive weed plants. Recent observations confirm that the species composition of plants has not changed over the past decade but that the wetland is now almost completely occluded by bulrushes (*Typha domingensis*) as depicted in Plate 3.7.1.5.

This has restricted water flow, caused spreading of inundated area and diminished the functional value of the wetland in terms of open water habitat (e.g. water fowl).

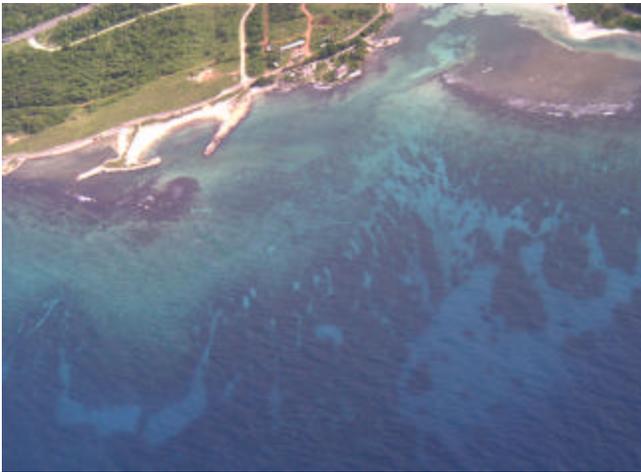
**Plate 3.8.1 Oblique aerial view of Pear Tree Bottom.**

The ecology of the marine nearshore is predominantly that of the fringing coral reef and the shallow backreef lagoon. This section relies much on the descriptions of these habitats presented in Harvey (1993) but there has been verbal confirmation that the current status of the reef is not much changed. The disposition and profile of the reef is shown in Figures 3.8.1 and 3.8.2 respectively. Plate 3.8.1 provides a good aerial perspective of a portion the fringing reef in front of the site.

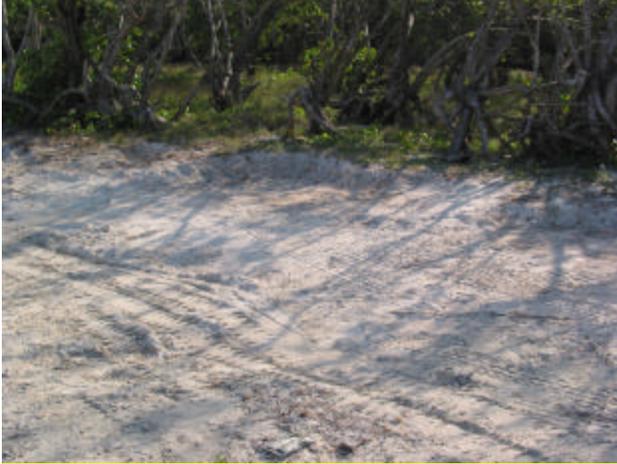
**Plate 3.8.3.1 Sand stealing from beach at Pear Tree Bay.**

The sandy shore of Pear Tree Bay (see Plate 3.6.1.4) is inhabited by the burrowing bivalve mollusk, *Donax sp.*, as well as other burrowing invertebrates. Ghost crabs, *Ocypode quadrata*, are common on the beach. Further inland are scattered land crab (*Cardiosoma guanhum*) holes in the mangrove scrub. Illegal sand mining has been reported from Pear Tree Bay in the past. Evidence of further sand removal was observed (Plate 3.8.3.1) during a site visit on 2 February 2005.
