Flooding at Moneague

Basil Fernandez
Managing Director

Water Resources Authority

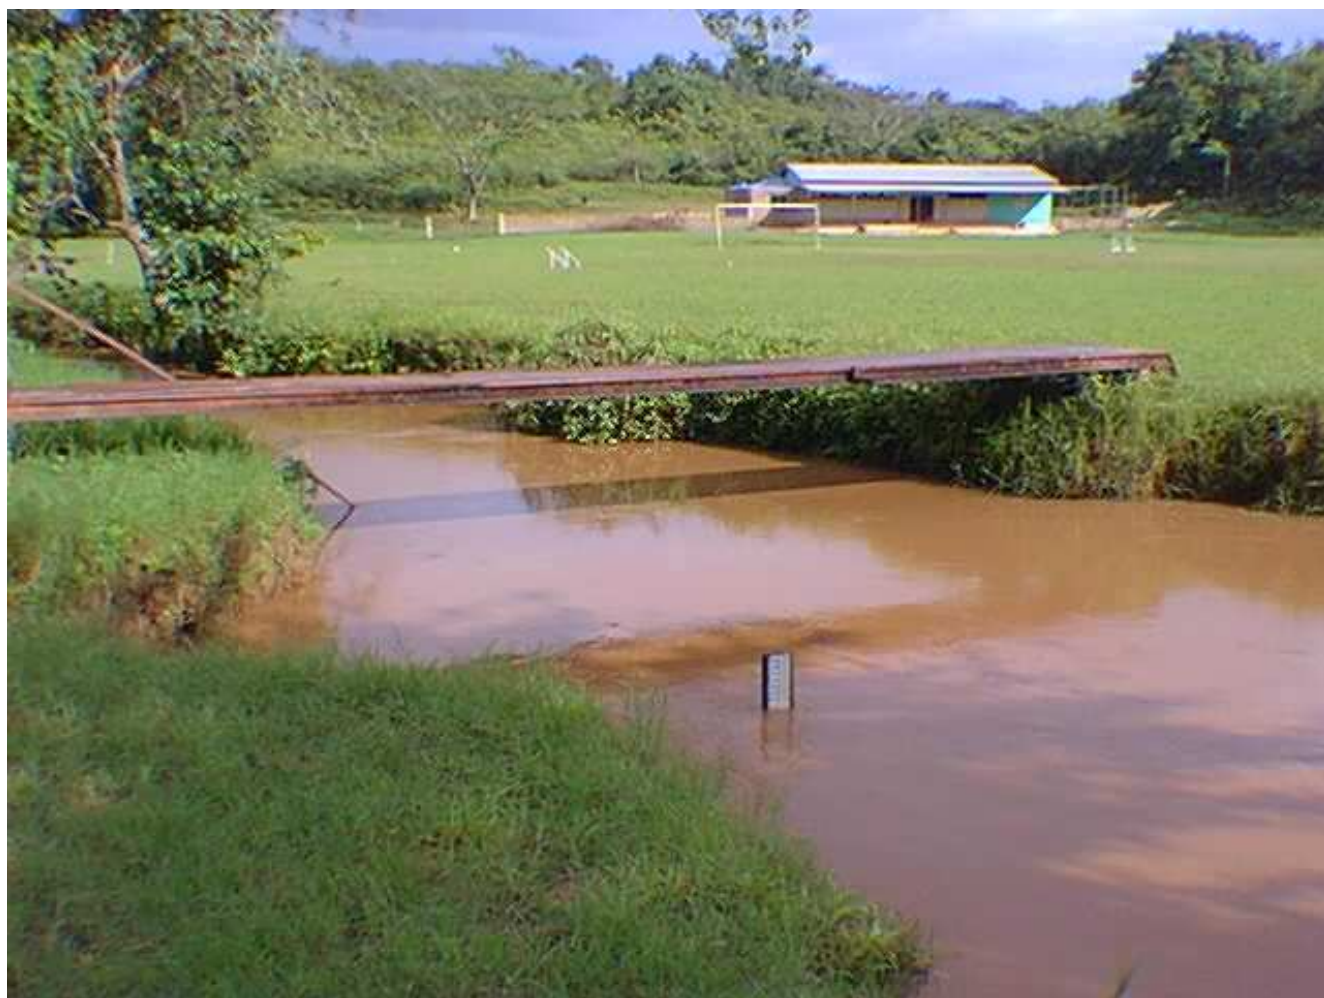
Sinkhole map

- Volcanics – runoff from - which is recharge to the Limestone Formation
- Basin underlain by White Limestone Formation
- Features; faults, fractures and sinkholes
- Water ponded by low permeable formation to the north.

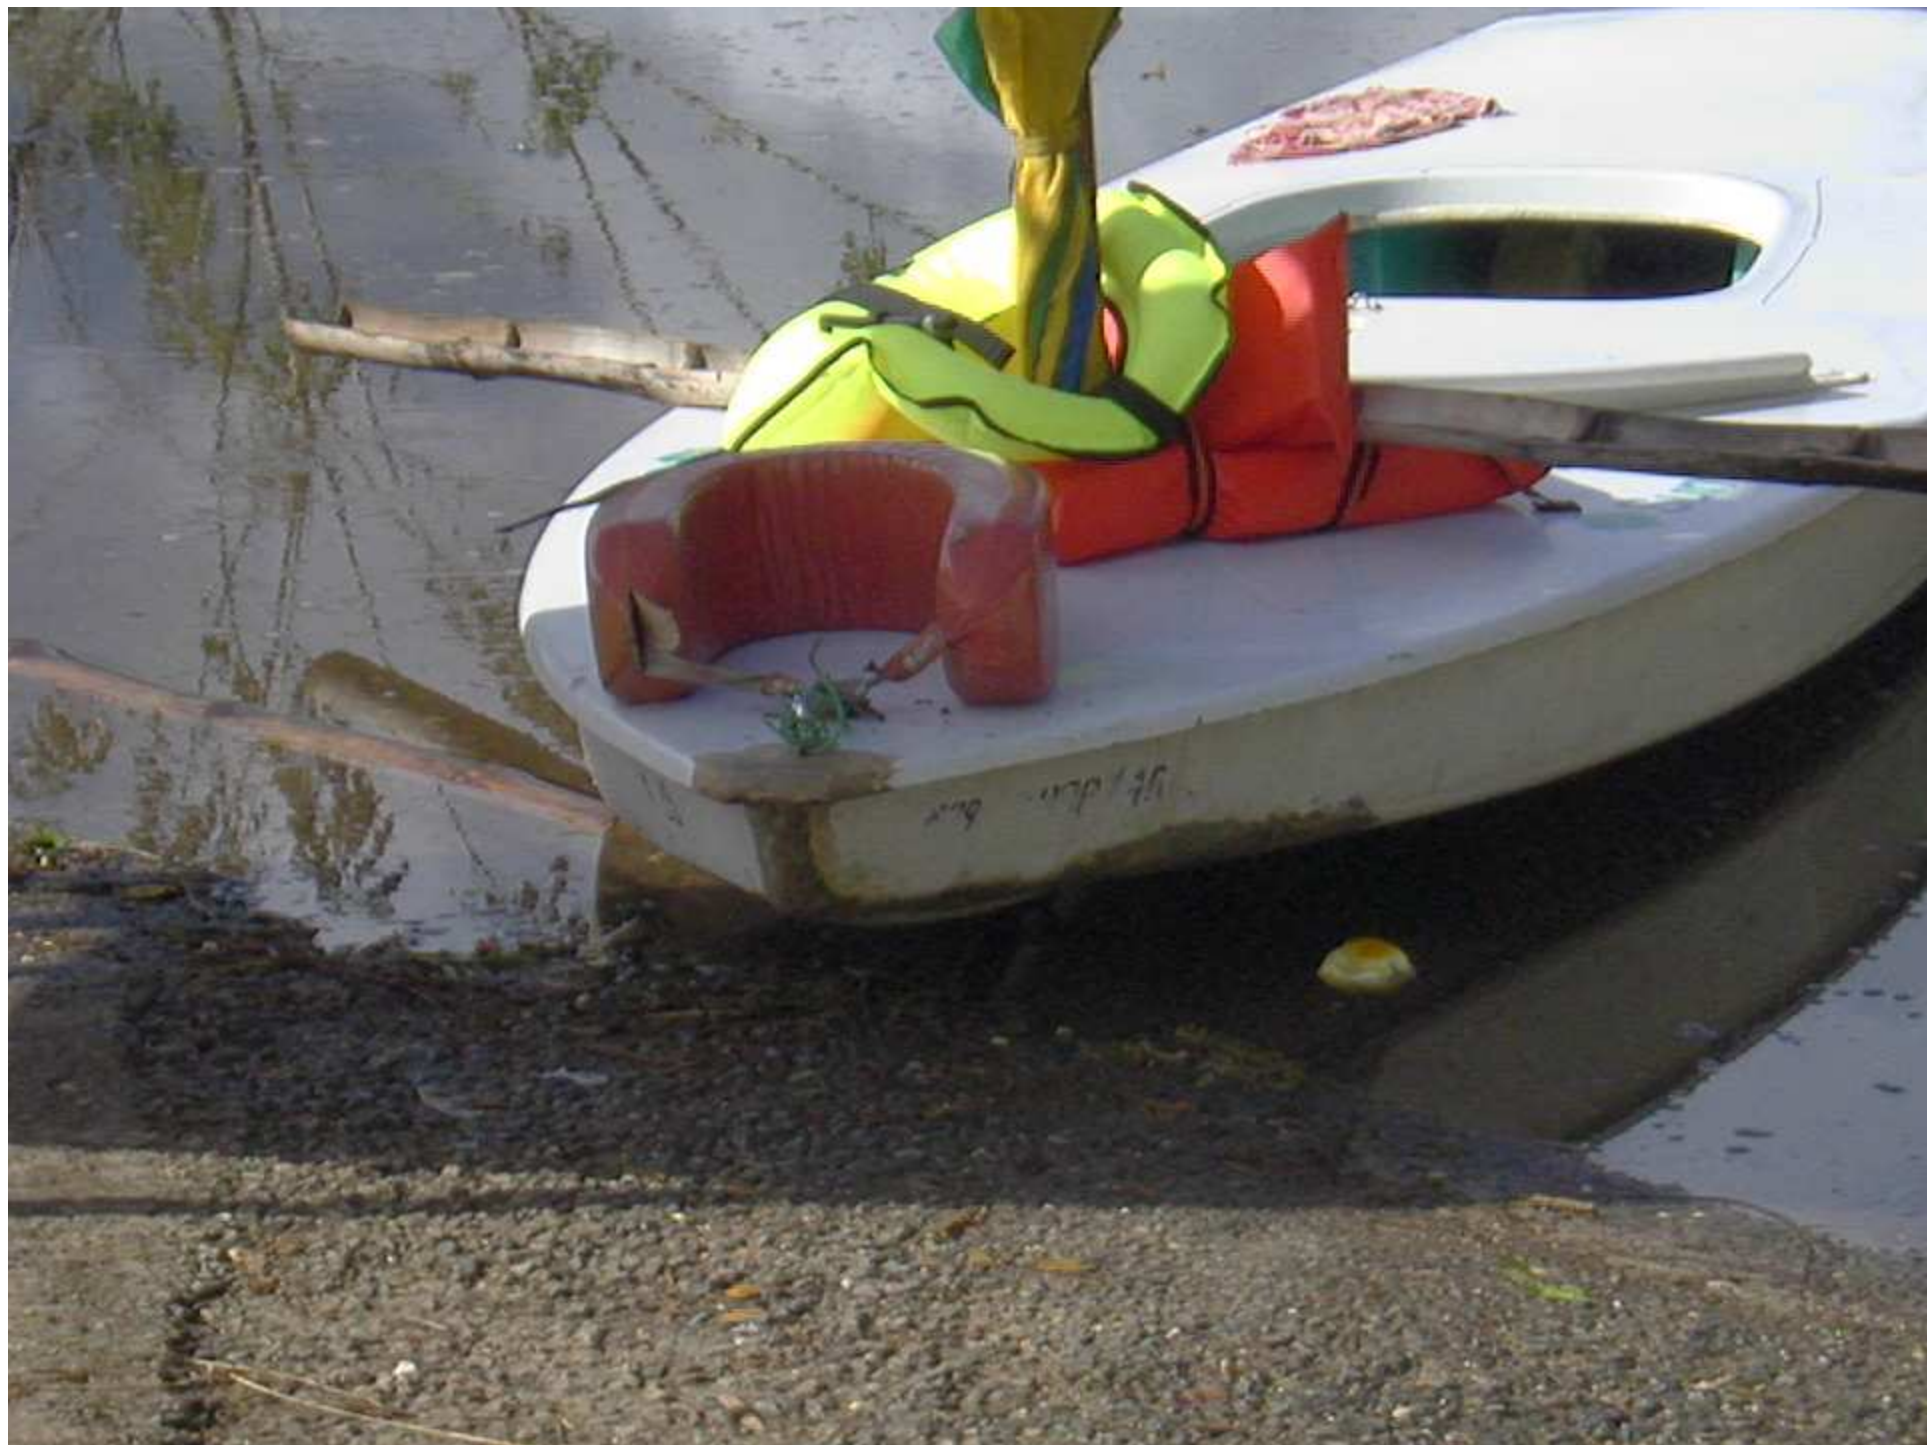
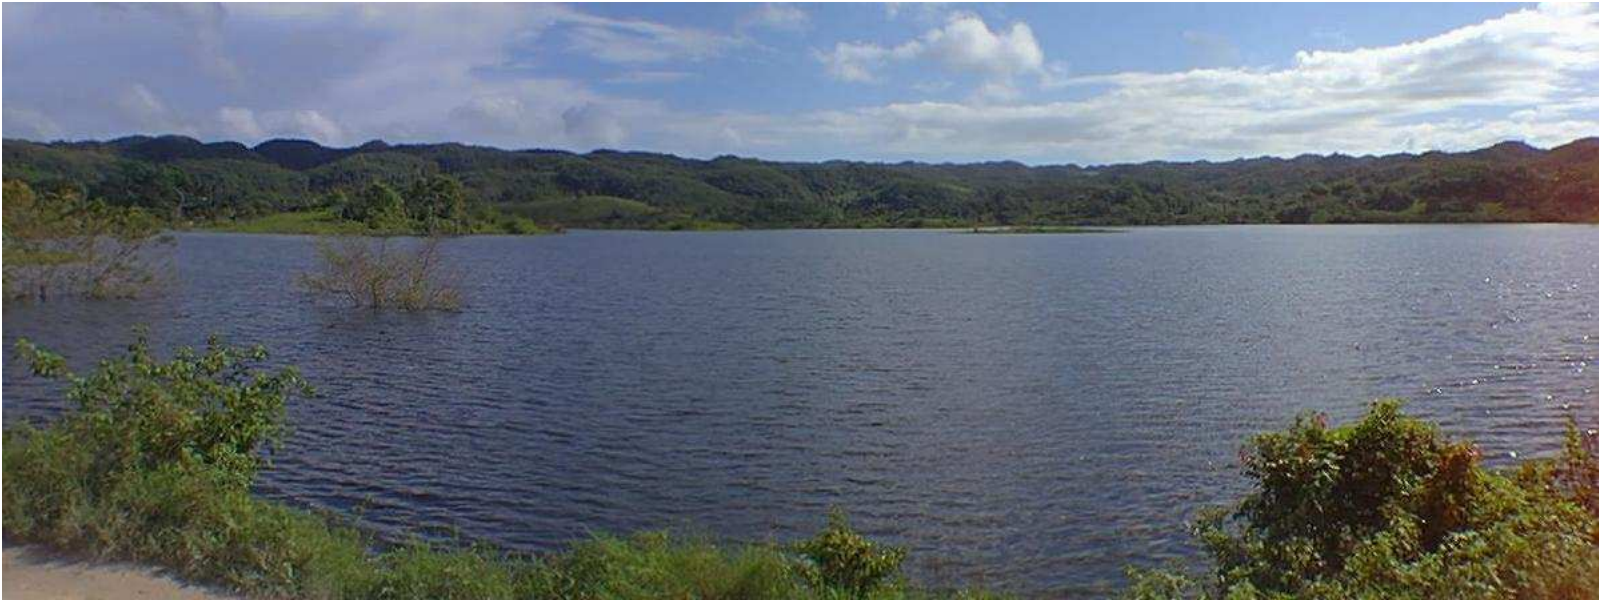
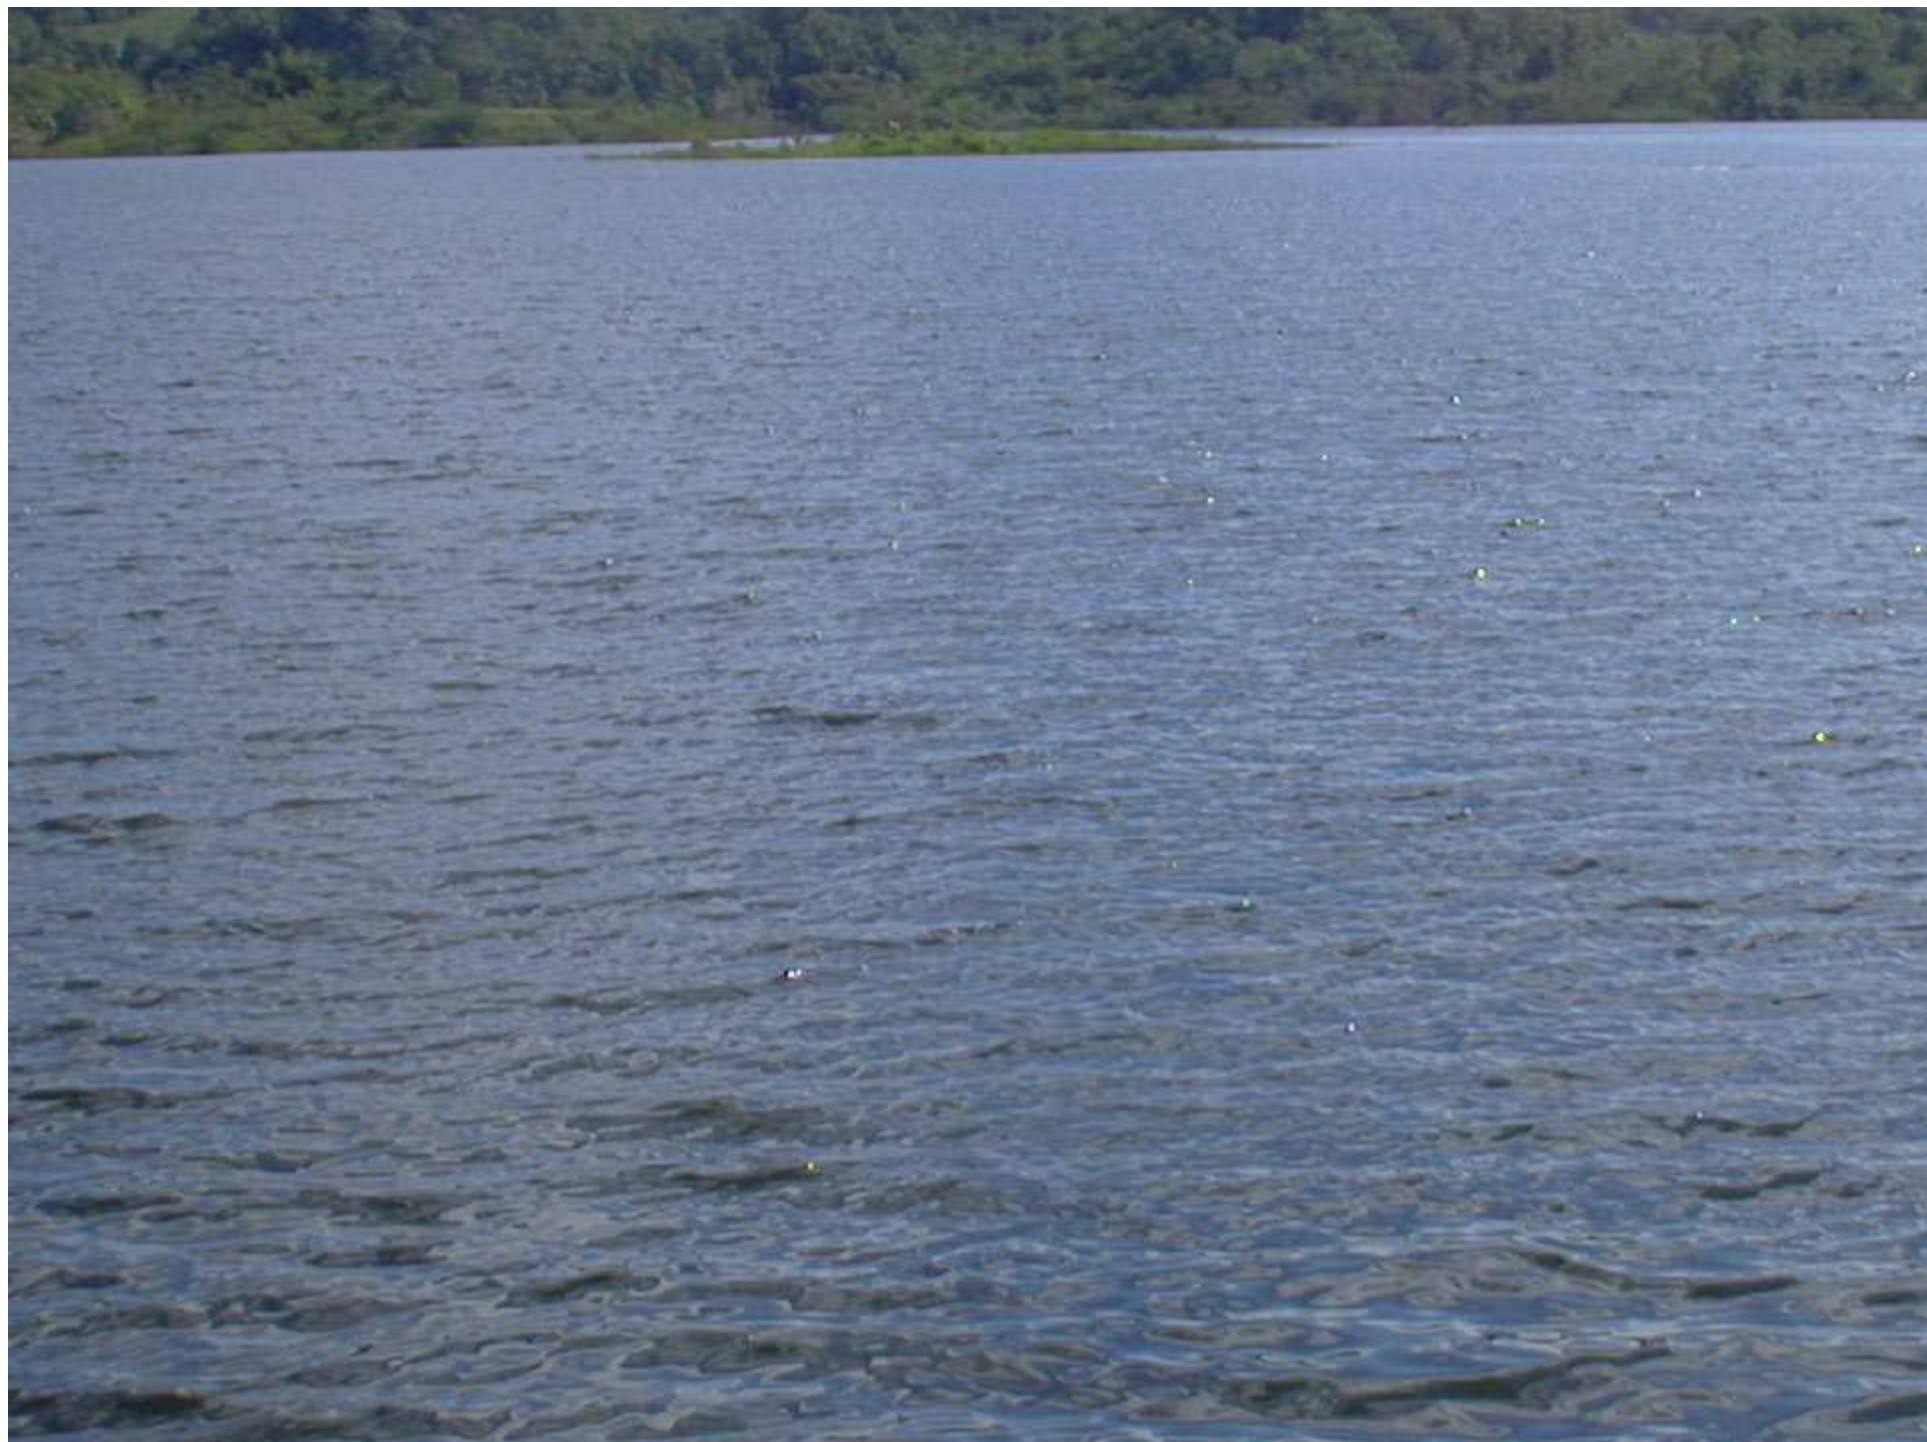
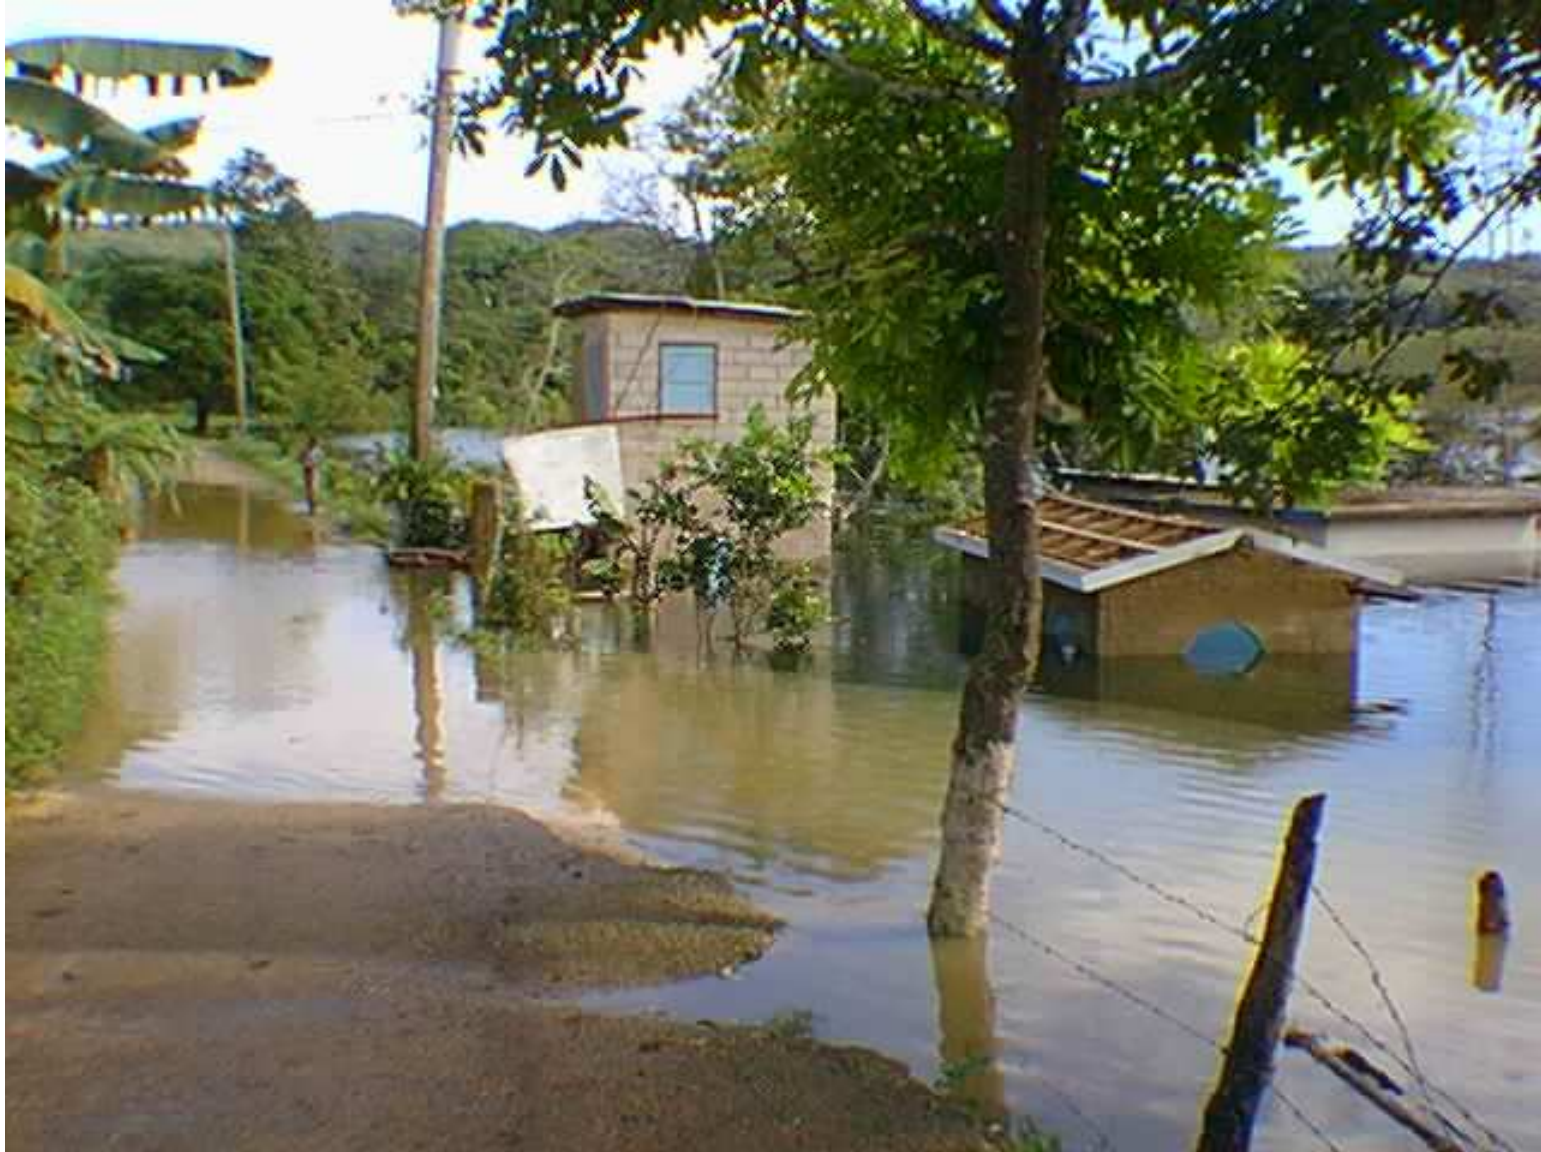
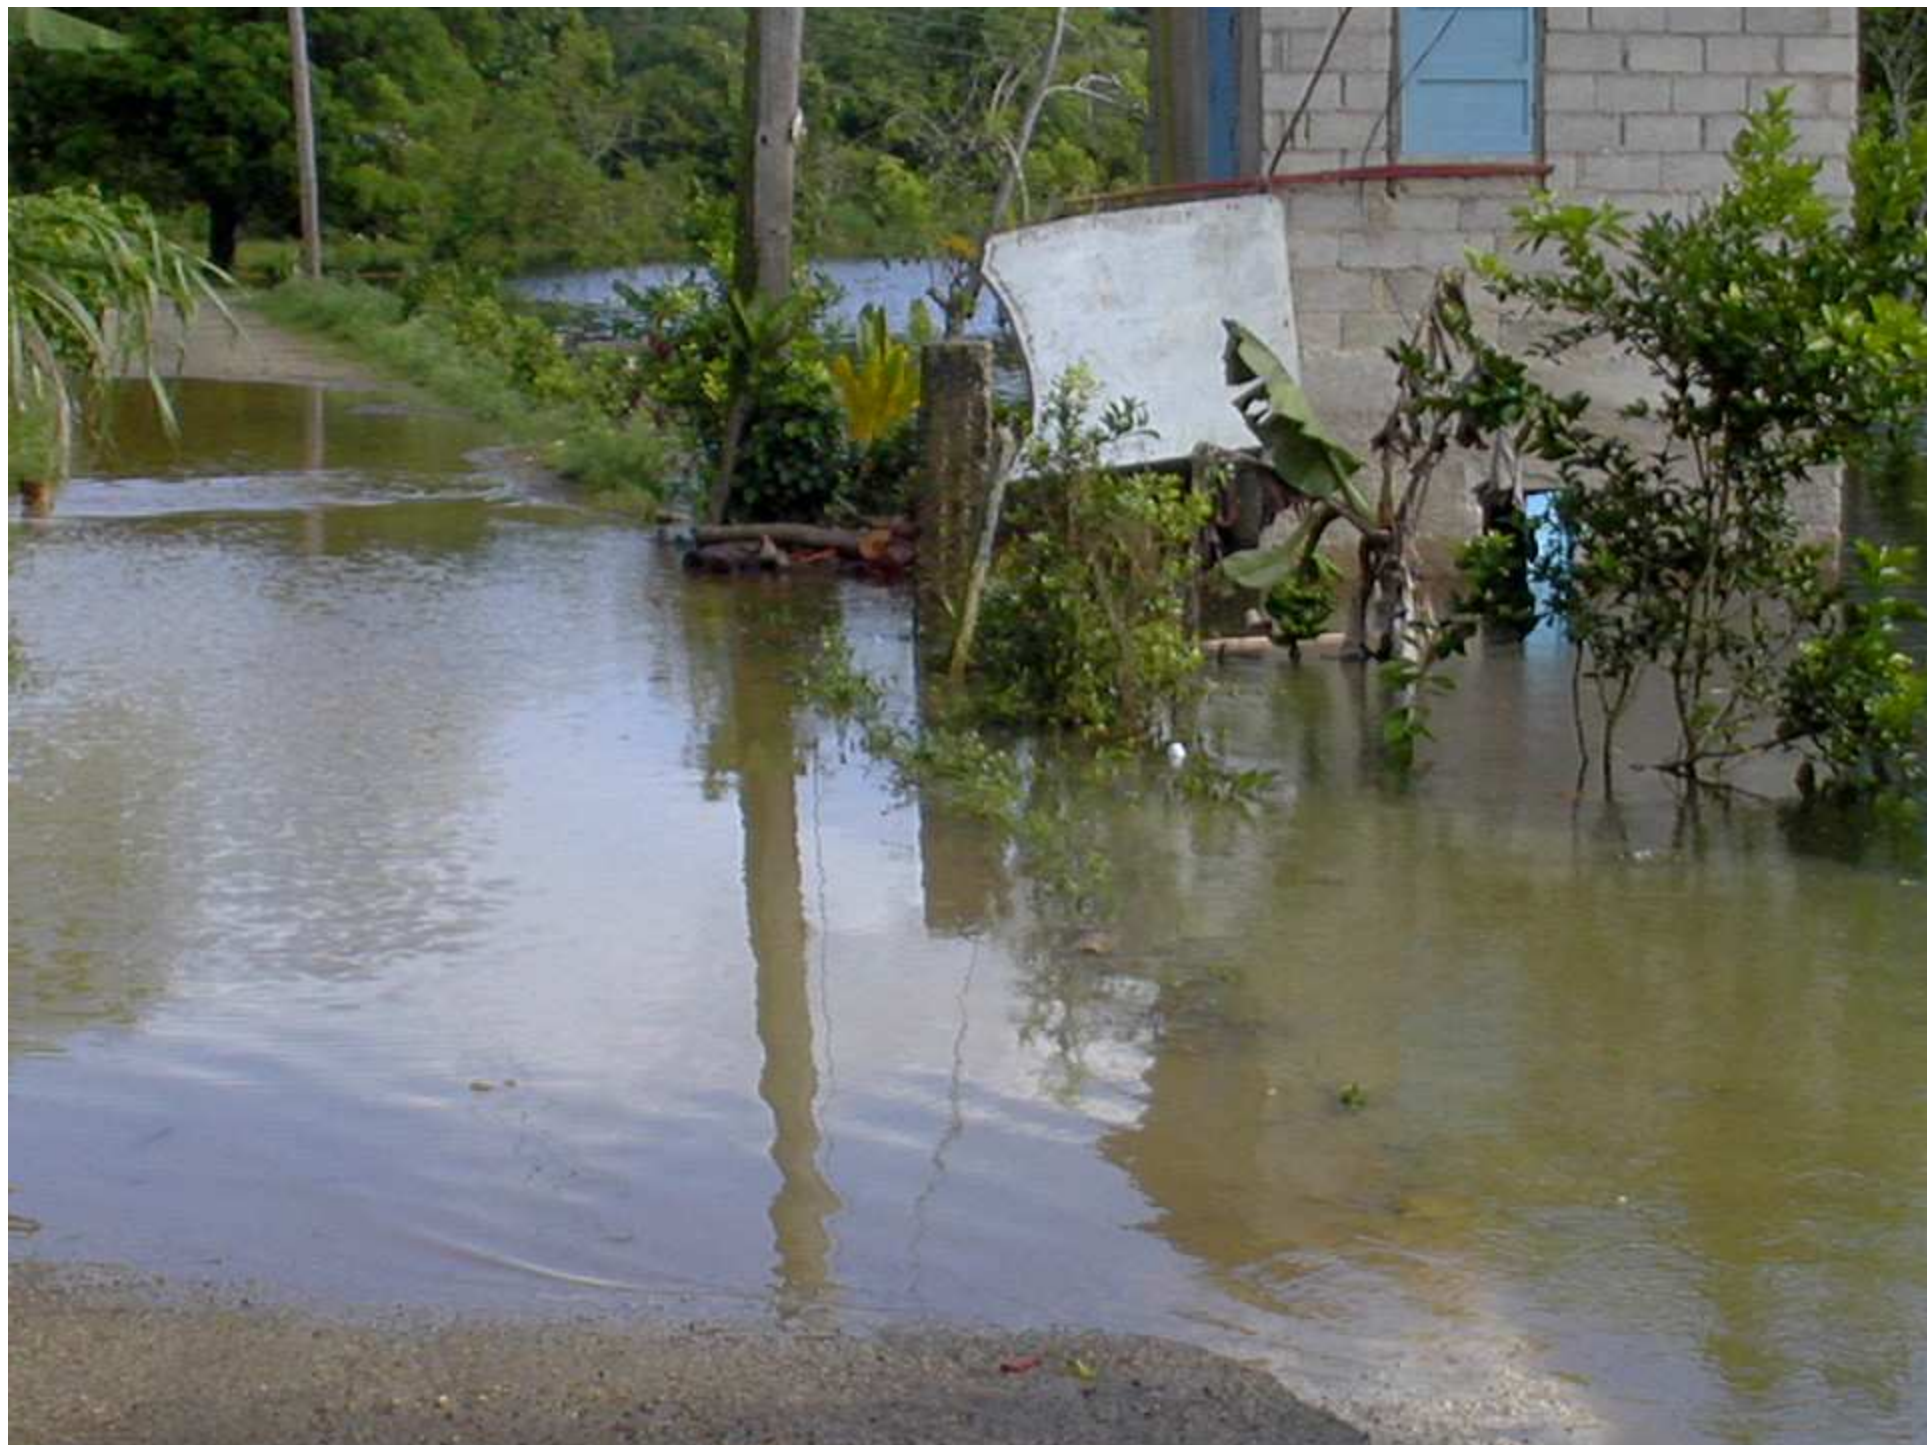
Tadmore (Clapham) Lake

- Area covered 491468 sq. m (121 acres)
- 2 houses inundated
- Goshen road threatened
- Road in Village inundated
- Mining Pits open-risk to life
- Lives severely affected
- High social cost
