Environmental Impact Statement (EIS)

**Alignment Changes at
K101 +440 – K101 +695
(St. Benedict's Church),
K102 +690 – K103 + 020
(Cane River),**

Southern Coastal Highway Improvement Project

Harbour View to Yallahs Bridge

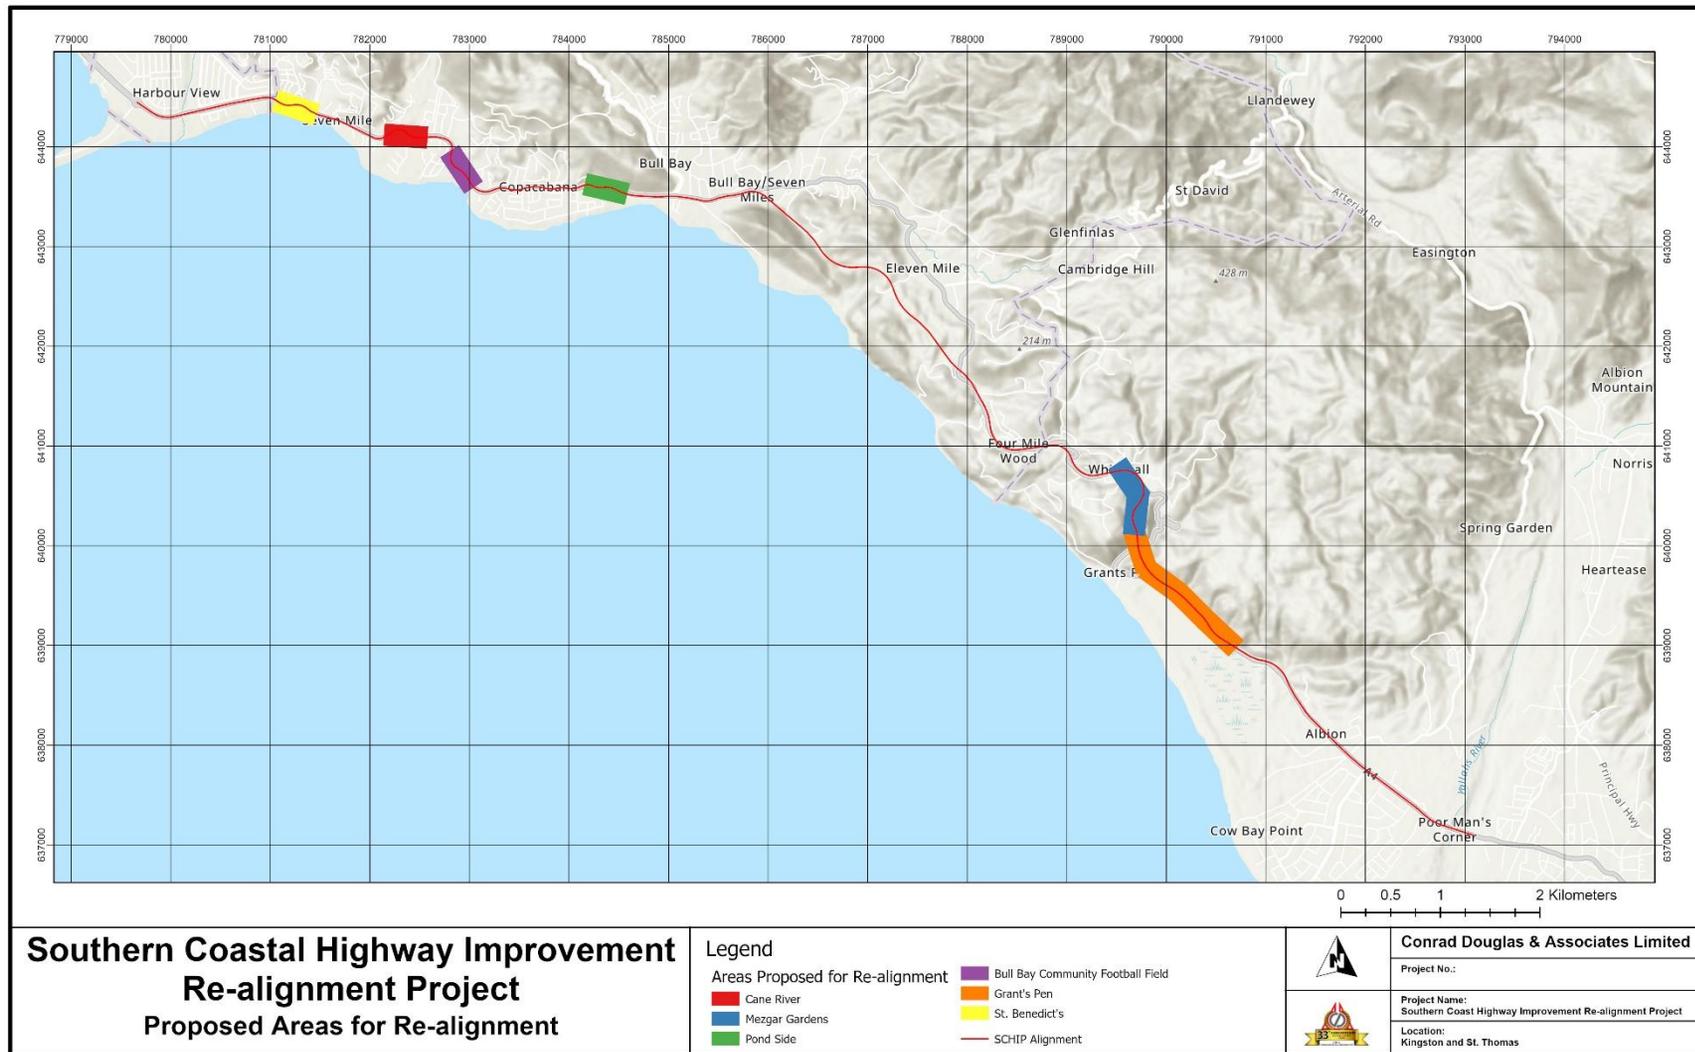
Figure 2-1. Southern Coastal Highway Improvement Project – Phase 1 with Areas for Alignment Adjustment Highlighted

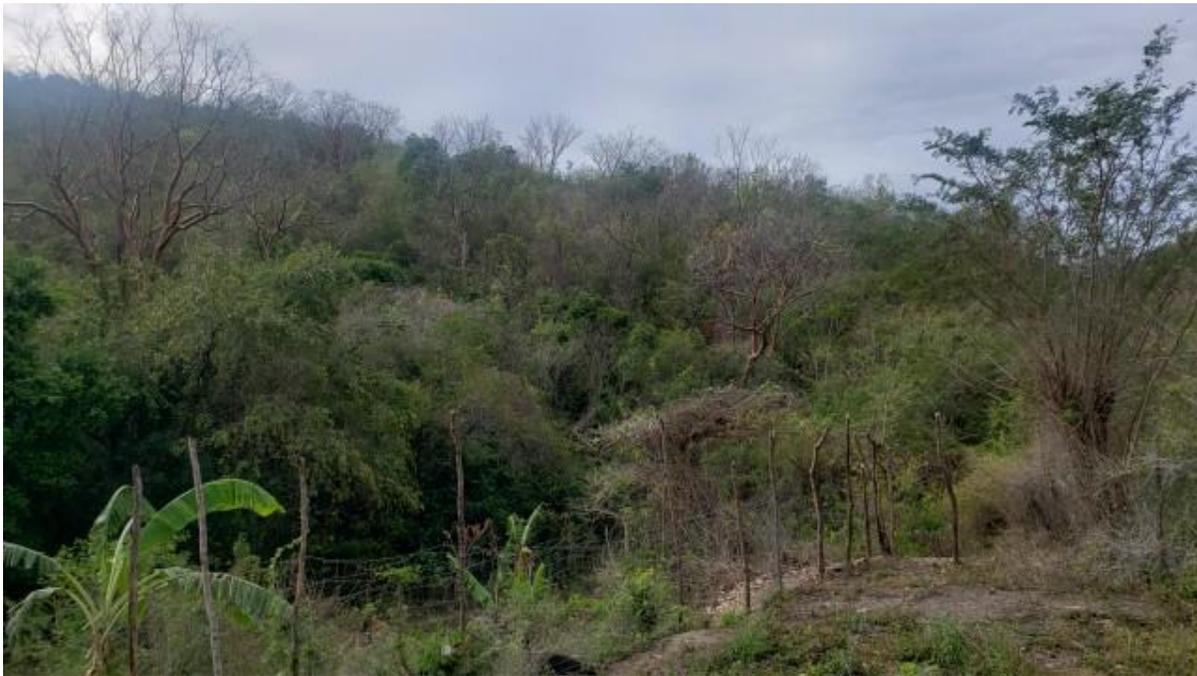
Figure 5-1: Typical Vegetation Type – Dry Limestone Scrub Forest

The main objective study was to identify the presence of any rare, endemic, protected or endangered species or any species with special conservation needs. The vegetation type was categorised as dry limestone scrub forest exhibiting different levels of disturbance. In the area there are limestone outcrops and little soil.

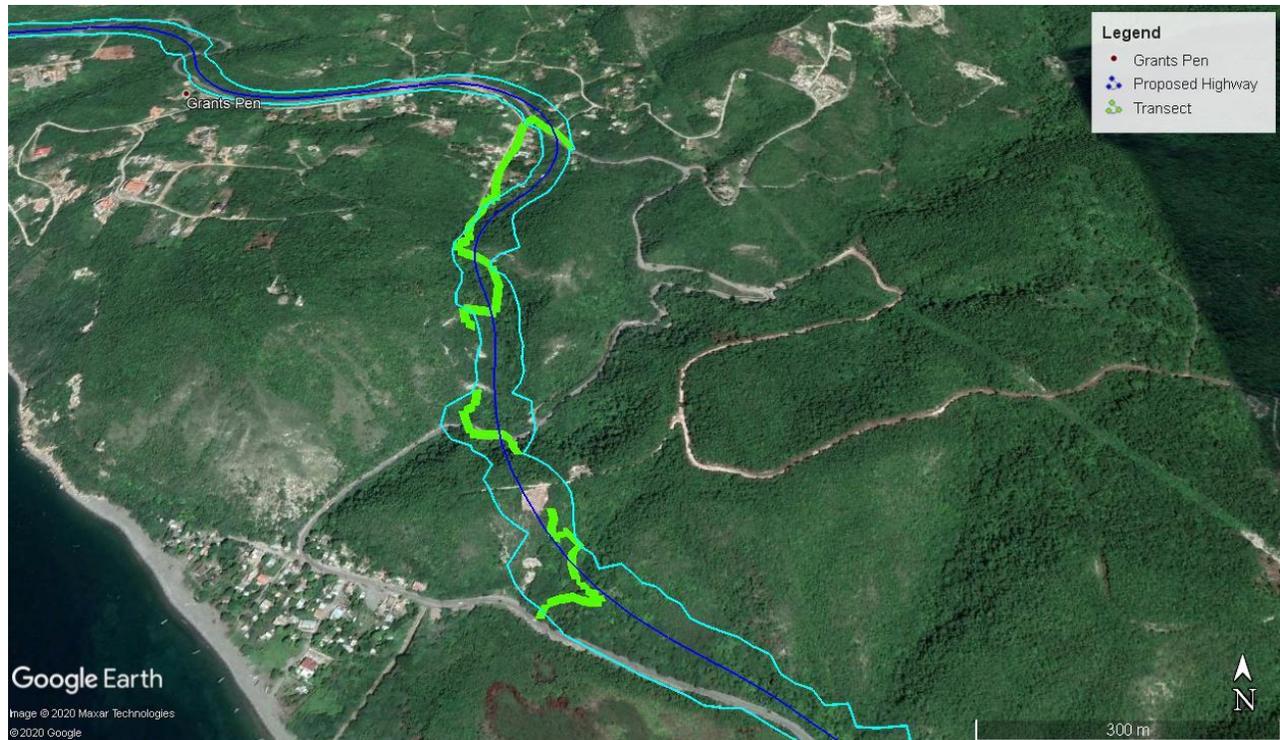
Figure 5-2: The transects used to compile the fauna and flora list

The fauna and flora assessments were conducted along the transects which were located in or close to the path of the proposed Highway (Figure 5-2).

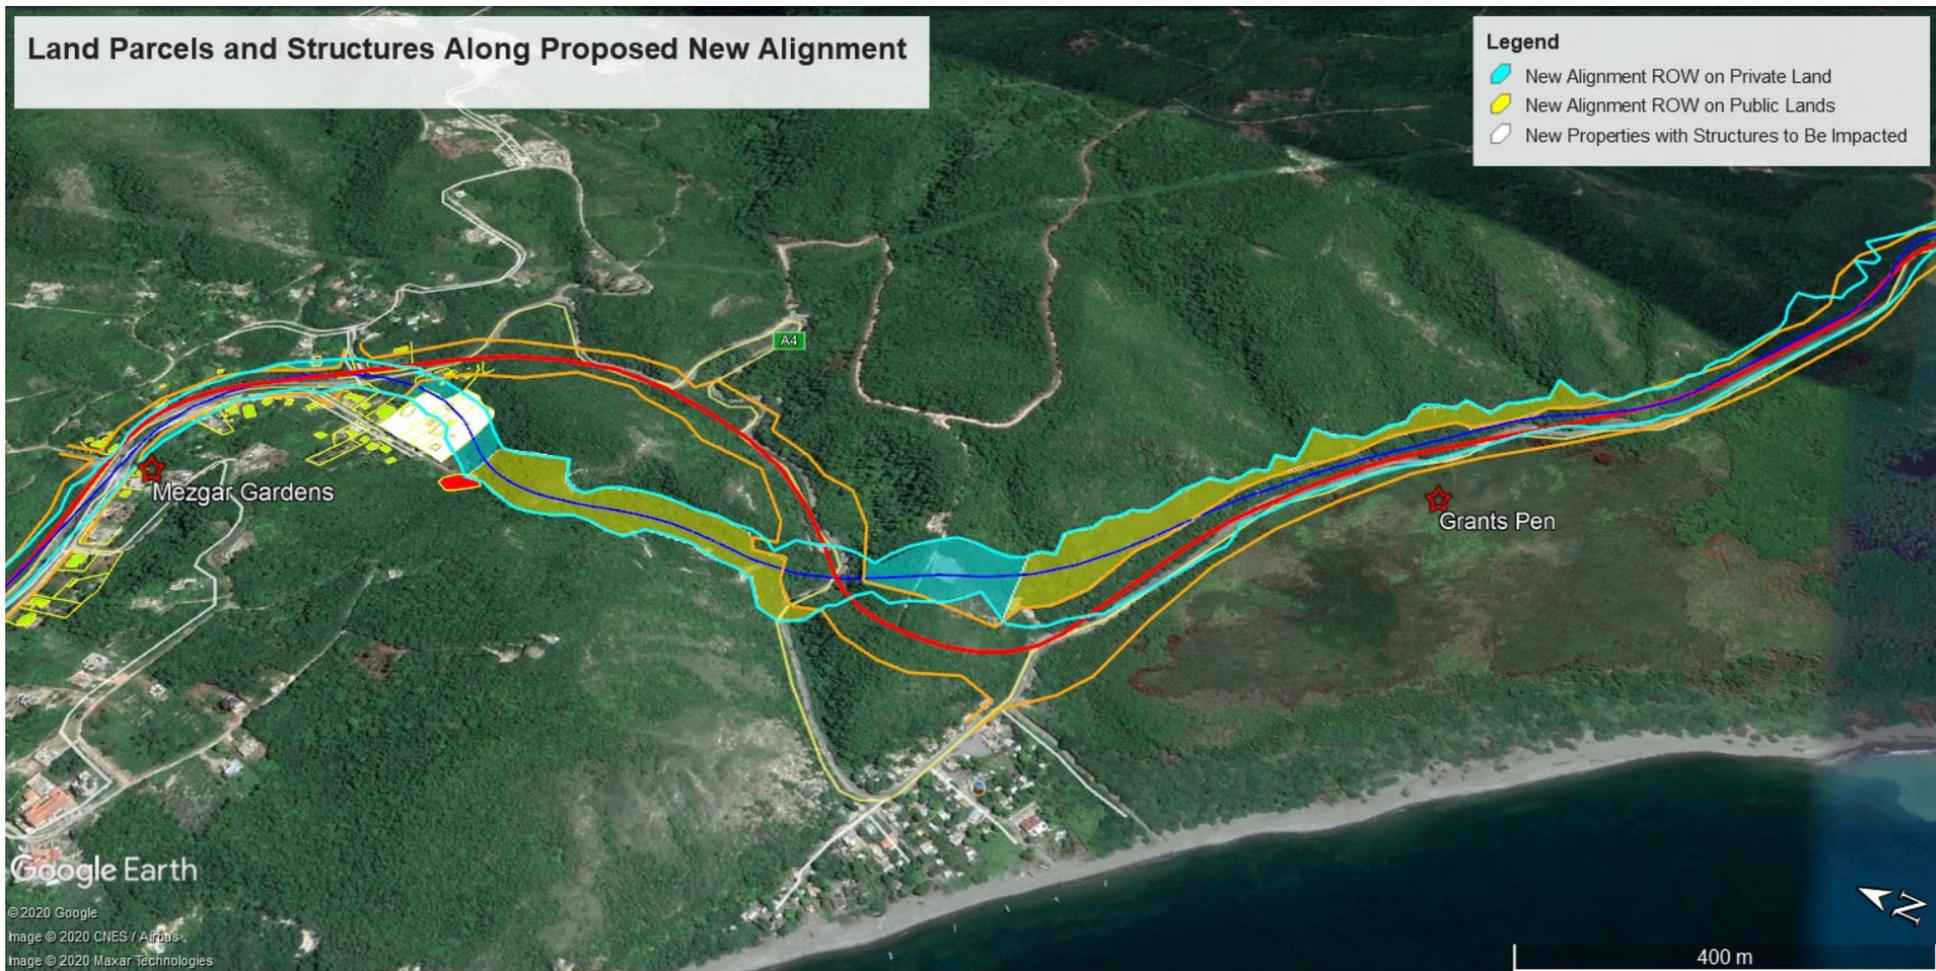
Figure 6-1: Proposed New Alignment in Mezgar Grants Pen Area with structures in the Alignment highlighted

Figure 6-1 below shows the proposed new alignments as well as the conceptual/preliminary alignment between Mezgar Gardens and the Yallahs River Bridge. The new alignment is hashed in yellow and blue where it departs from the old alignment. Four (4) new parcels of land with structures on them will be impacted by the proposed new alignment. These would not have been impacted by the conceptual/preliminary alignment. There are nine (9) structures in the Mezgar – Grants Pen area that will be impacted by the road alignment (4 would have been impacted by the conceptual alignment). Therefore, five of these structures proposed to be impacted were not envisaged in the conceptual/preliminary alignment. Another thirteen (13) structures in the Albion area will also be impacted (11 of these would have been impacted by the conceptual alignment) while 5 that were impacted on the conceptual/preliminary alignment will not be impacted. The detailed impact and alignment adjustments are presented in the zoomed images in Figure 6-2 below.

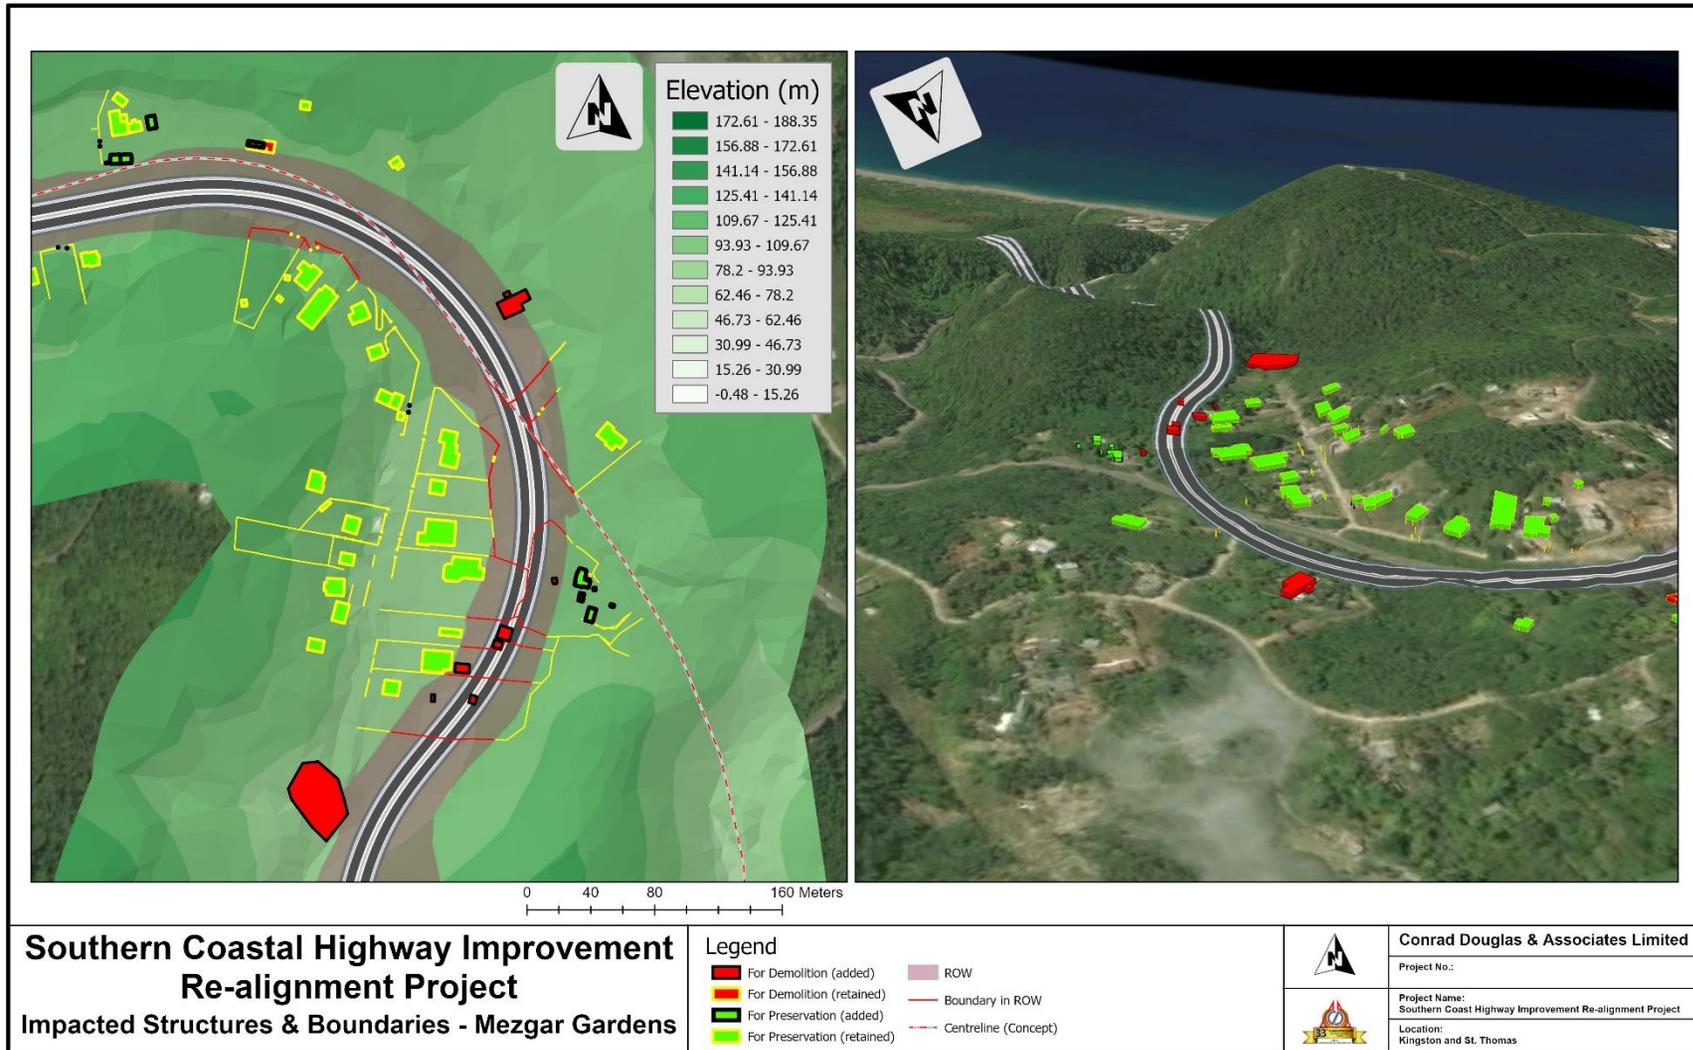
Figure 6-2: Detail of Alignment Adjustment on Structures in Mezgar Gardens Housing Scheme

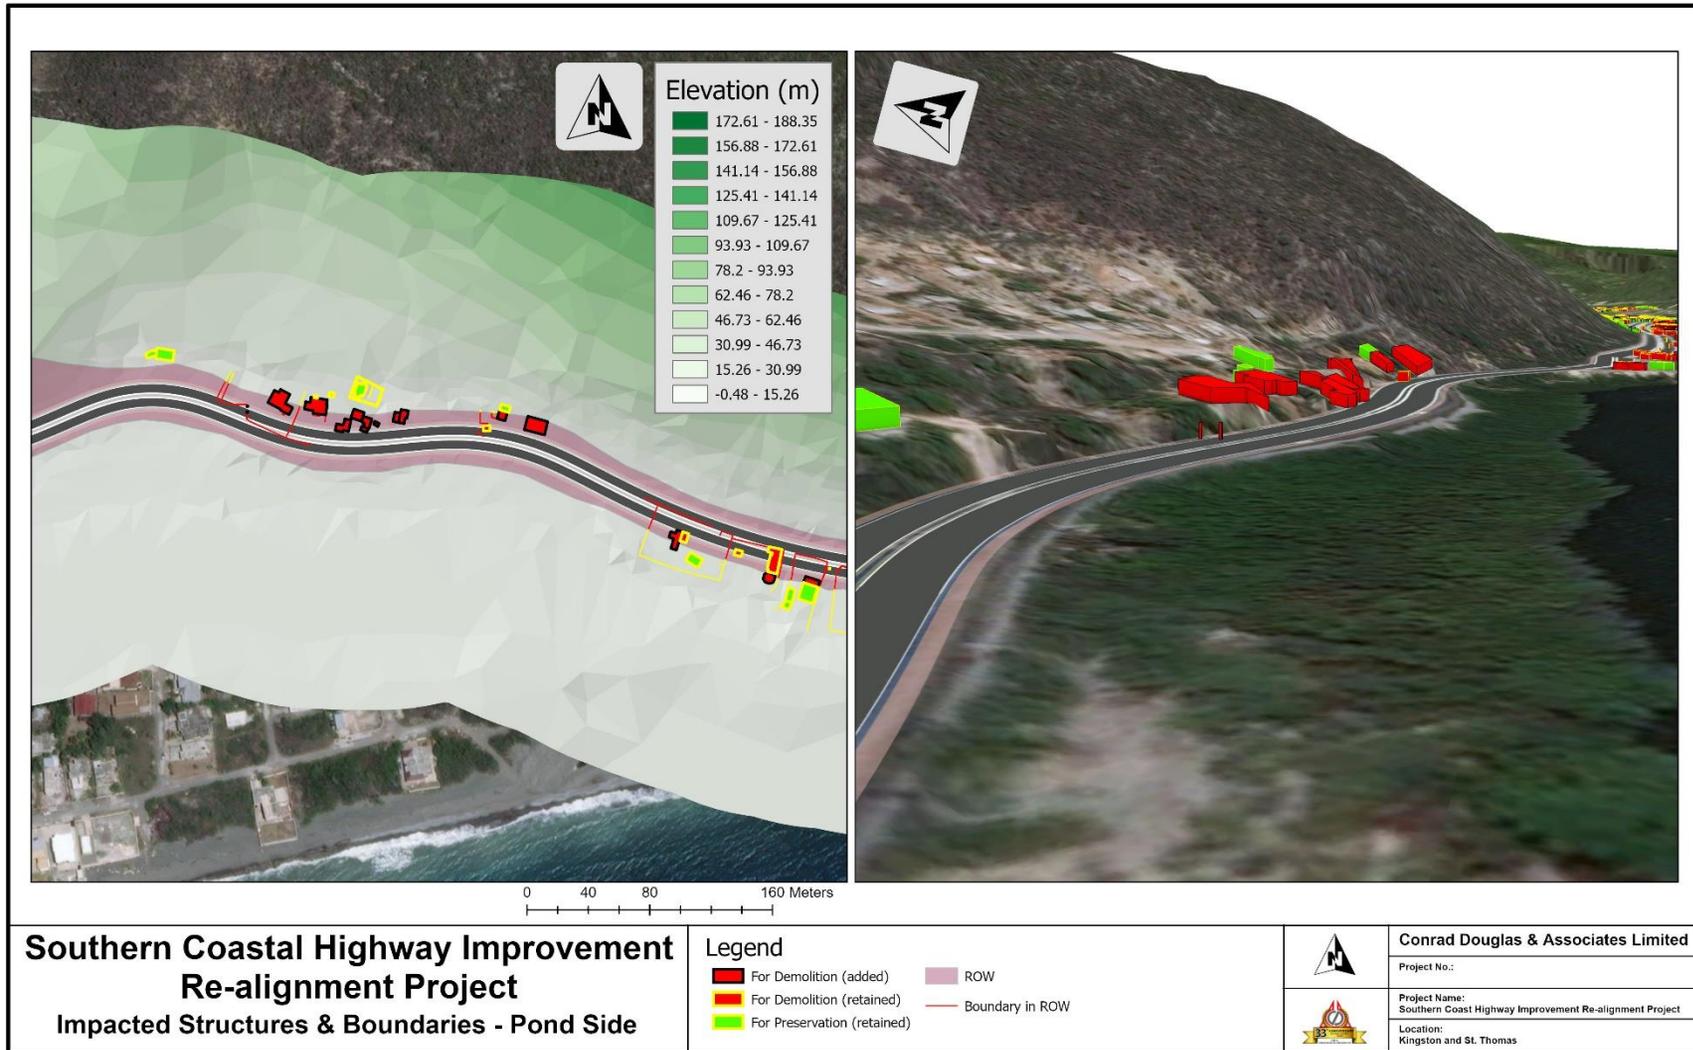
Figure 6-3. Detail of Alignment Adjustment on Structures in the Pond Side Area of Bull Bay

In Pondsides nine (9) new structures will be impacted. The detailed impact and alignment adjustments are presented in the zoomed images in Figure 6-3 below.

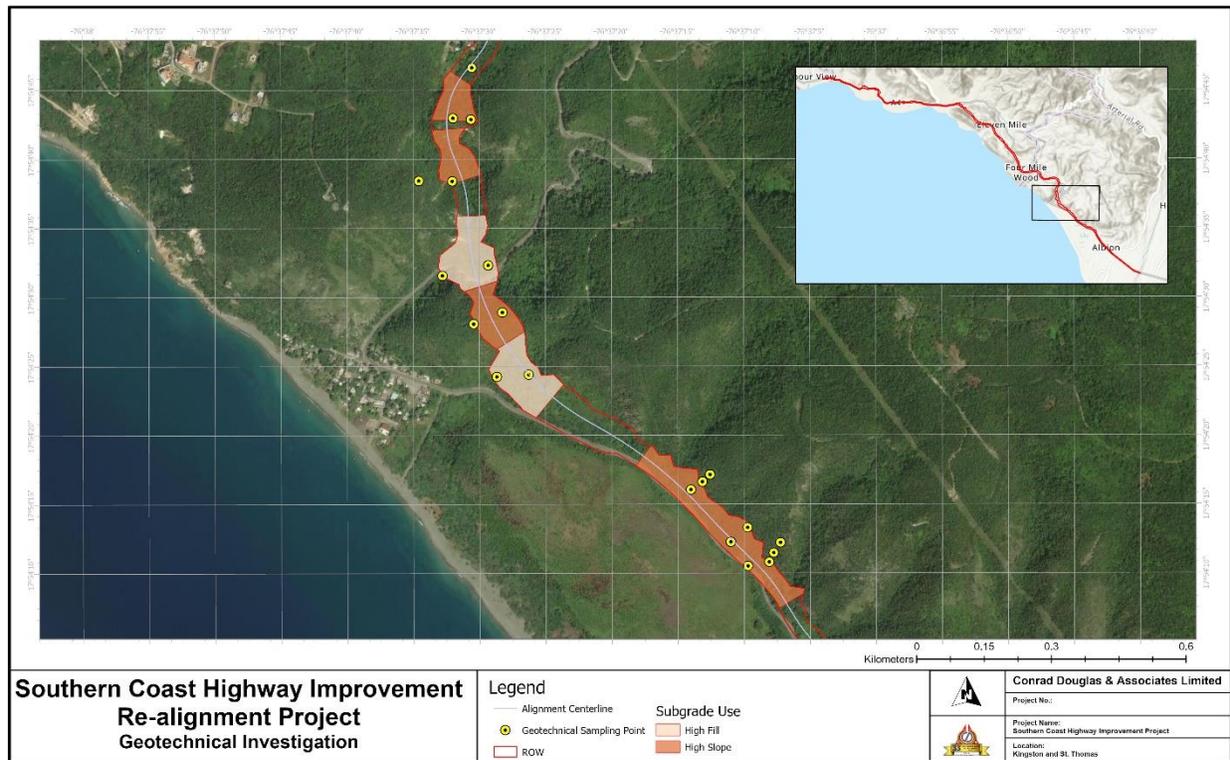
Figure 7-1: Section through Mezgar Gardens and Grants Pen covered by Geotechnical Investigation

China Harbor Engineering Company (CHEC) carried out an extensive geotechnical investigation along the alignment route through Mezgar Gardens and Grants Pen from **K112 +440 to K113 +920**. This is shown in Figure 7-1 below.

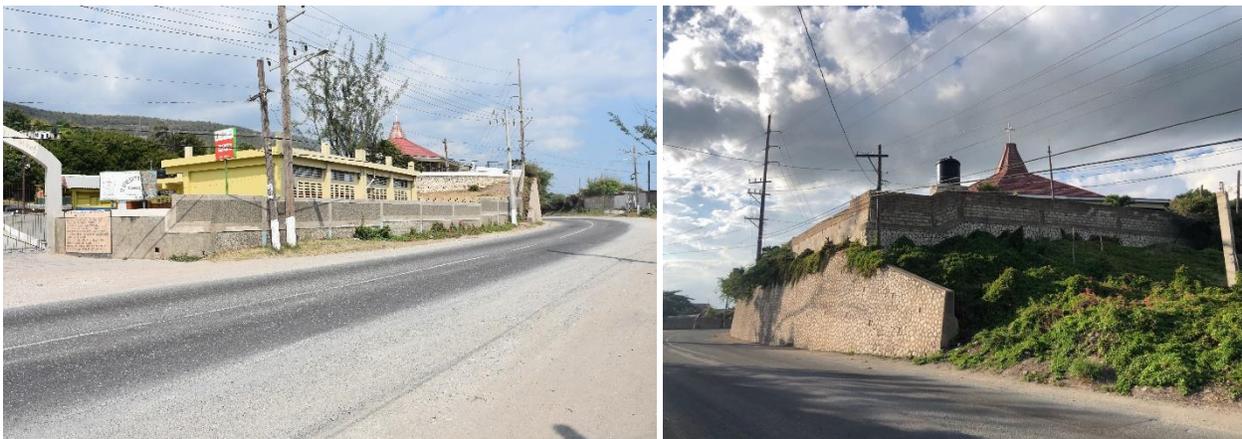
Figure 8-1: Eastbound (Left) and Westbound (Right) Perspectives of St. Benedict's Church and Primary School in Harbour View

The EIA compares the noise modelling results for the proposed noise wall design at St. Benedict's Church and Primary School in Harbour view (see Figure 8-1 below) against the recommended limit of 45 dBA for Silence Zones as defined in the **Jamaica Noise National Standards (JNNS)**. However, it should be noted that the JNNS explicitly indicates that the standards do not include the mechanical noise from motor vehicles. Therefore, the JNNS Silence Zone standard of 45dBA is most appropriately interpreted as the level that must be achieved by non-motor vehicular, non-mechanical emission sources when they impact a Silence Zone. As such, as far as the JNNS is concerned, there is no national standard for noise impact from motor vehicle mechanical noise within a Silence Zone.

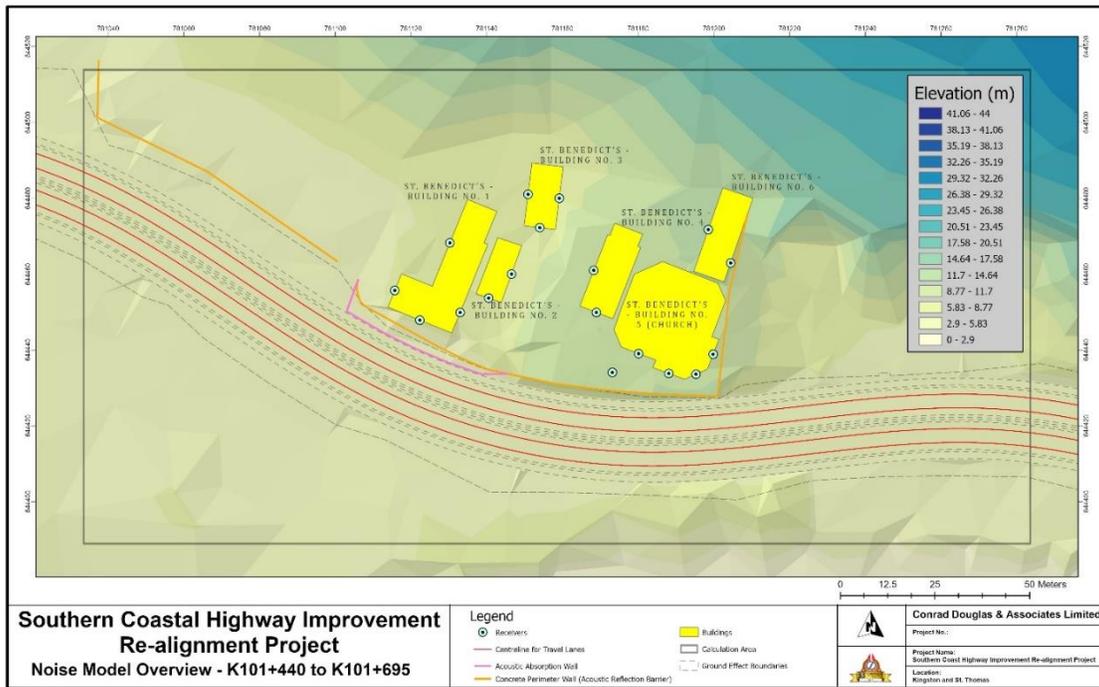
Figure 8-2: Overview of Model Inputs Inclusive of Elevation and Receivers

A total of eighteen (18) receivers were modelled to closely represent the impact of traffic noise emissions on buildings of interest. All receptors were placed on the façade of buildings or along faces where noise reflection may cause significant impact owing to other surrounding structures and the immediate terrain. The location of these receiver are listed below and shown in Figure 8-2 above.

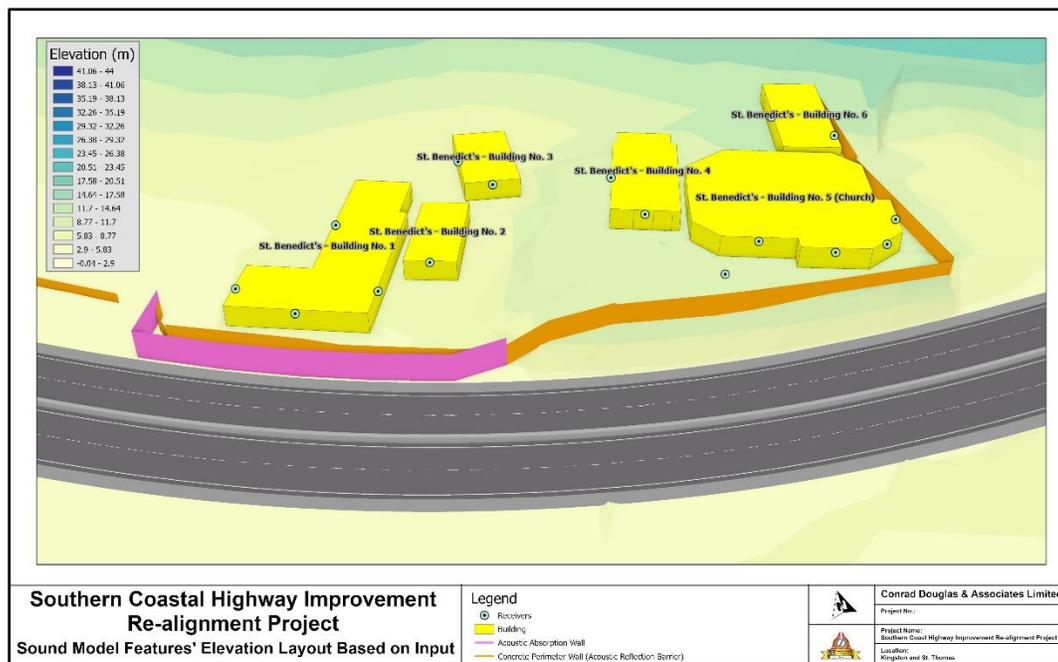
Figure 8-3: Confirmation of Elevation Layout (Overall Model Domain)

The perimeter walls for the property were observed as dense concrete blocks. Therefore, they were modelled as hard concrete noise barriers each with a Reflection Loss (as defined by SoundPLAN) of 1 dB. The elevation profiles for the perimeter wall are listed in the table below and depicted in Figure 8-4 and Figure 8-3 above.

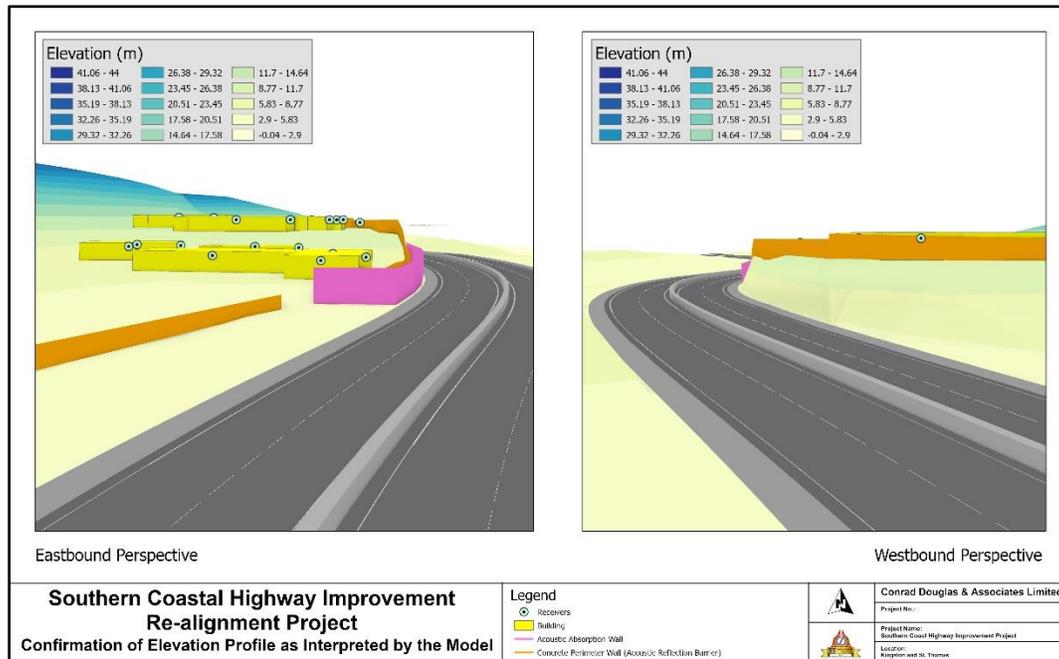
Figure 8-4: Confirmation of Elevation Layout (Eastbound and Westbound Perspectives)

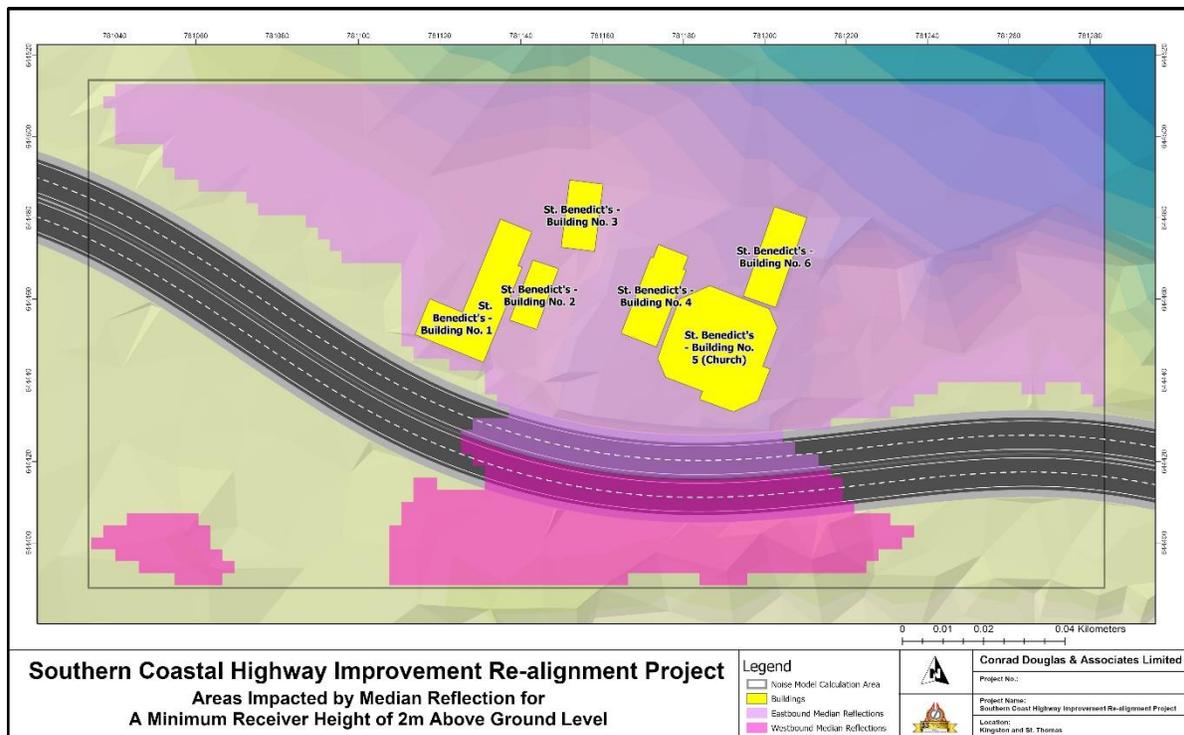
Figure 8-5: Areas Impacted by Median Reflection within the Calculation Area for a Minimum Receiver Height of 2m Above Ground Level

A map showing the regions impacted by the predicted median reflections of both eastbound and westbound traffic, for a minimum receiver height of 2m above ground level, are shown in Figure 8-5 below. This is based on criteria proposed for the Image Roadway Technique, with considerations for terrain and alignment features.

It should be noted that only median reflections caused by **eastbound traffic** were considered for this assessment since the impact receptor(s) of interest are located on that side of the alignment. Therefore, all noise and noise contour maps depicted in this report only account for the same. All other areas ignore the impact of median reflections caused by westbound traffic.

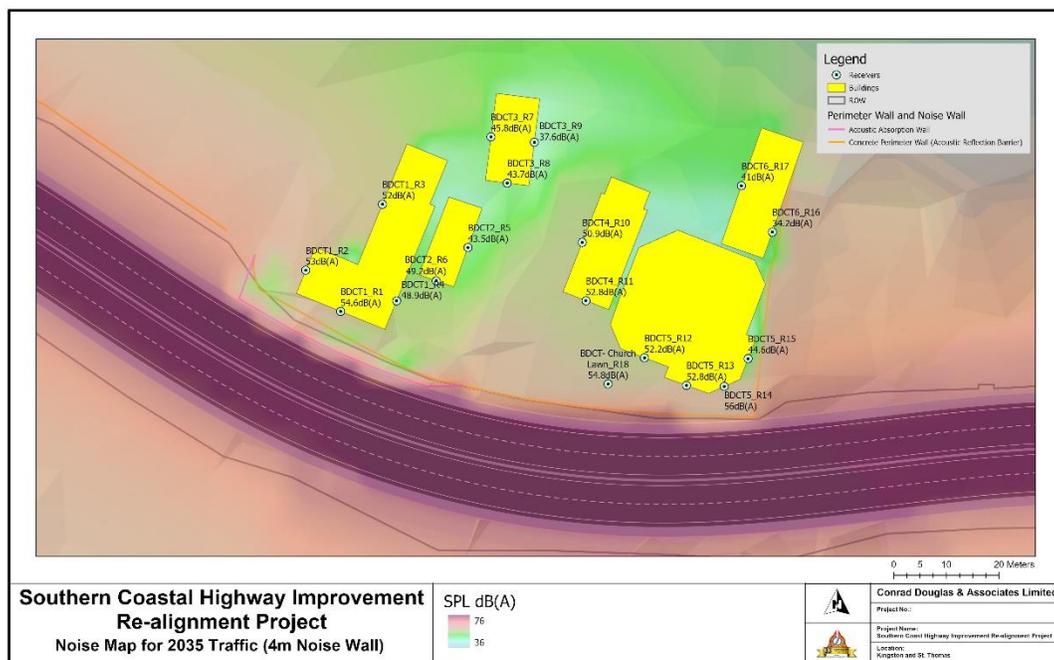
Figure 8-6: Noise Impact of 2035 Traffic on Receivers with the Proposed Noise Wall

- The FHWA Noise Abatement Criterion of 67dBA is met at all eighteen (18) receptors assessed without the application of noise abatement measures
- Predicted sound levels at two (2) of the eighteen (18) receivers approach the 67dBA FHWA criterion.
- Adequate attenuation was achieved with noise reductions of 7.3 and 5.8 dBA by using a absorption wall 4m high and 55m long with a reflection loss of 4dB (as defined by SoundPLAN).

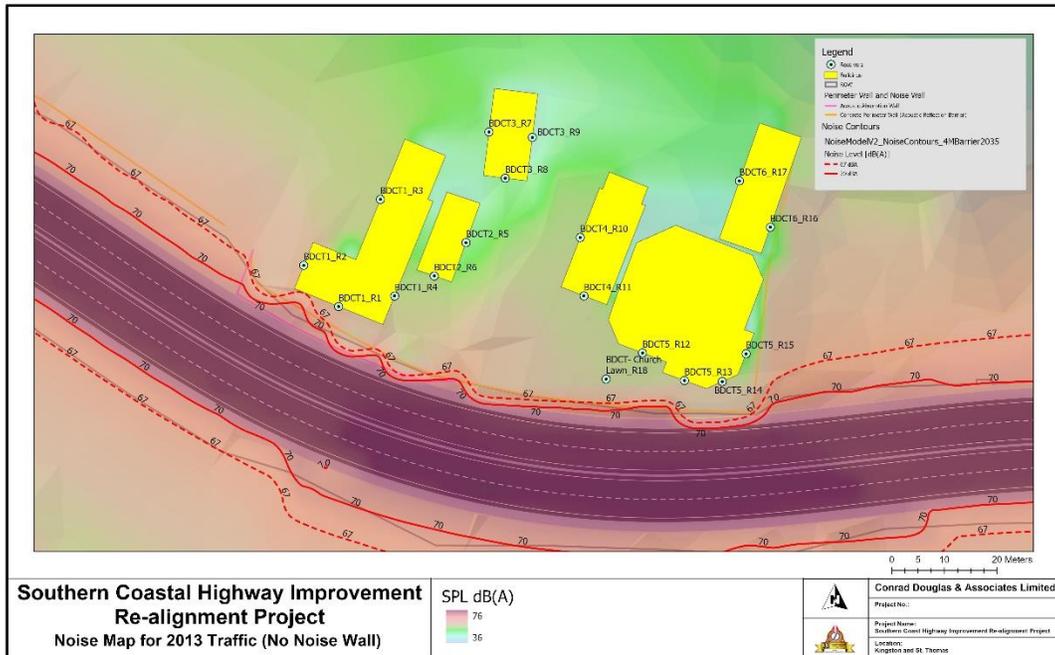
Figure 8-9: Noise Map with Permit and FHWA Criteria Limit Noise Contours for 2013 Traffic with No Noise Wall

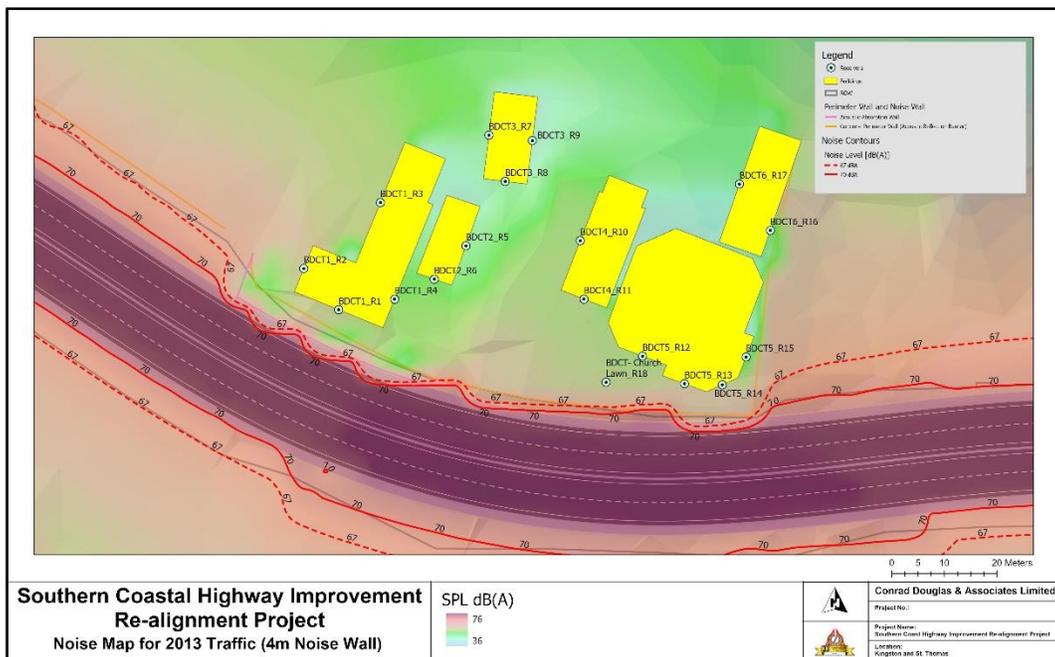
Figure 8-10: Noise Map with Permit and FHWA Criteria Limit Noise Contours for 2013 Traffic with 4m Noise Wall

A noise abatement wall was modelled 0.3 m from the Utility Corridor of the proposed alignment south east of Building No's 1, 2 and 3. The purpose of the wall is to provide adequate and effective noise attenuation in keeping with the FHWA recommendation of 5-10dBA for receivers approaching the FHWA criterion of 67dBA.
