# ENVIRONMENTAL IMPACT ASSESSMENT

## FOR THE PROPOSED DEVELOPMENT OF A HOTEL RESORT AT, CORAL SPRINGS TRELAWNY, JAMAICA

October 2016

**ENVIROPLANNERS LTD.**

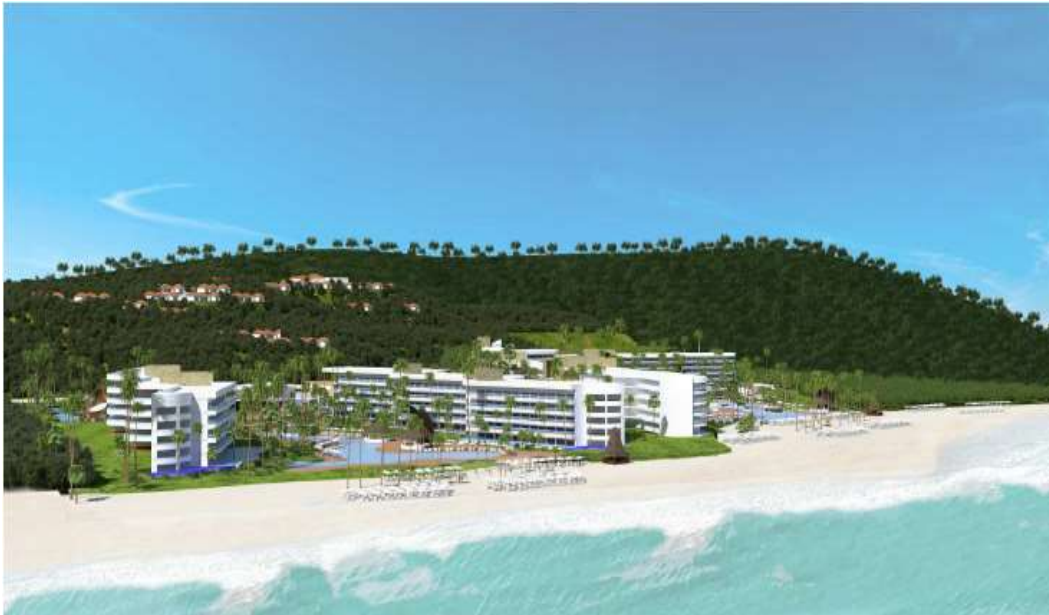
*Figure 2.1.1: Proposed Concept Design*

The proposed concept design is represented in the three Dimensional Rendering, Figure 2.1.1. The development Phasing Plan, Landscape Plan and preliminary designs are presented in the Project Description.

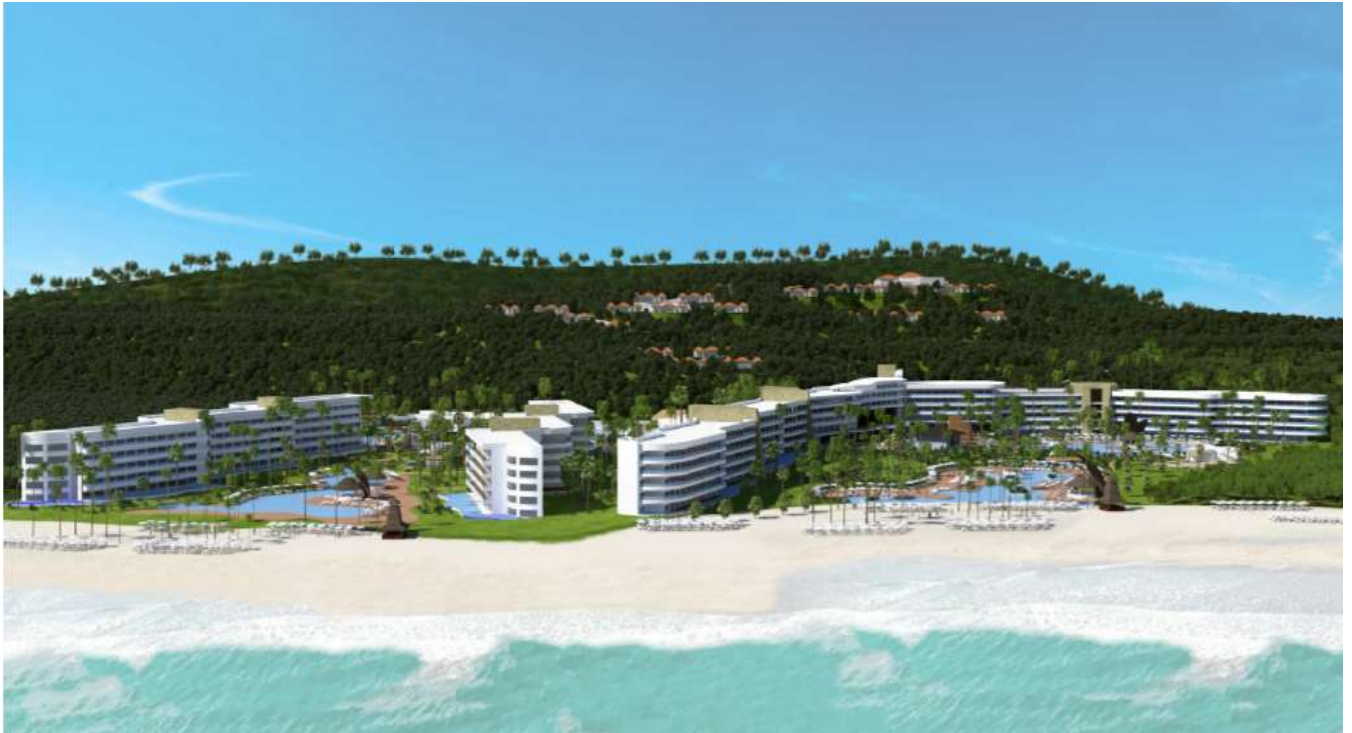
*Figure 4.3.5: A 3-dimensional architectural view of the proposed Coral Spring Hotel, phases 1, 2 and 3*

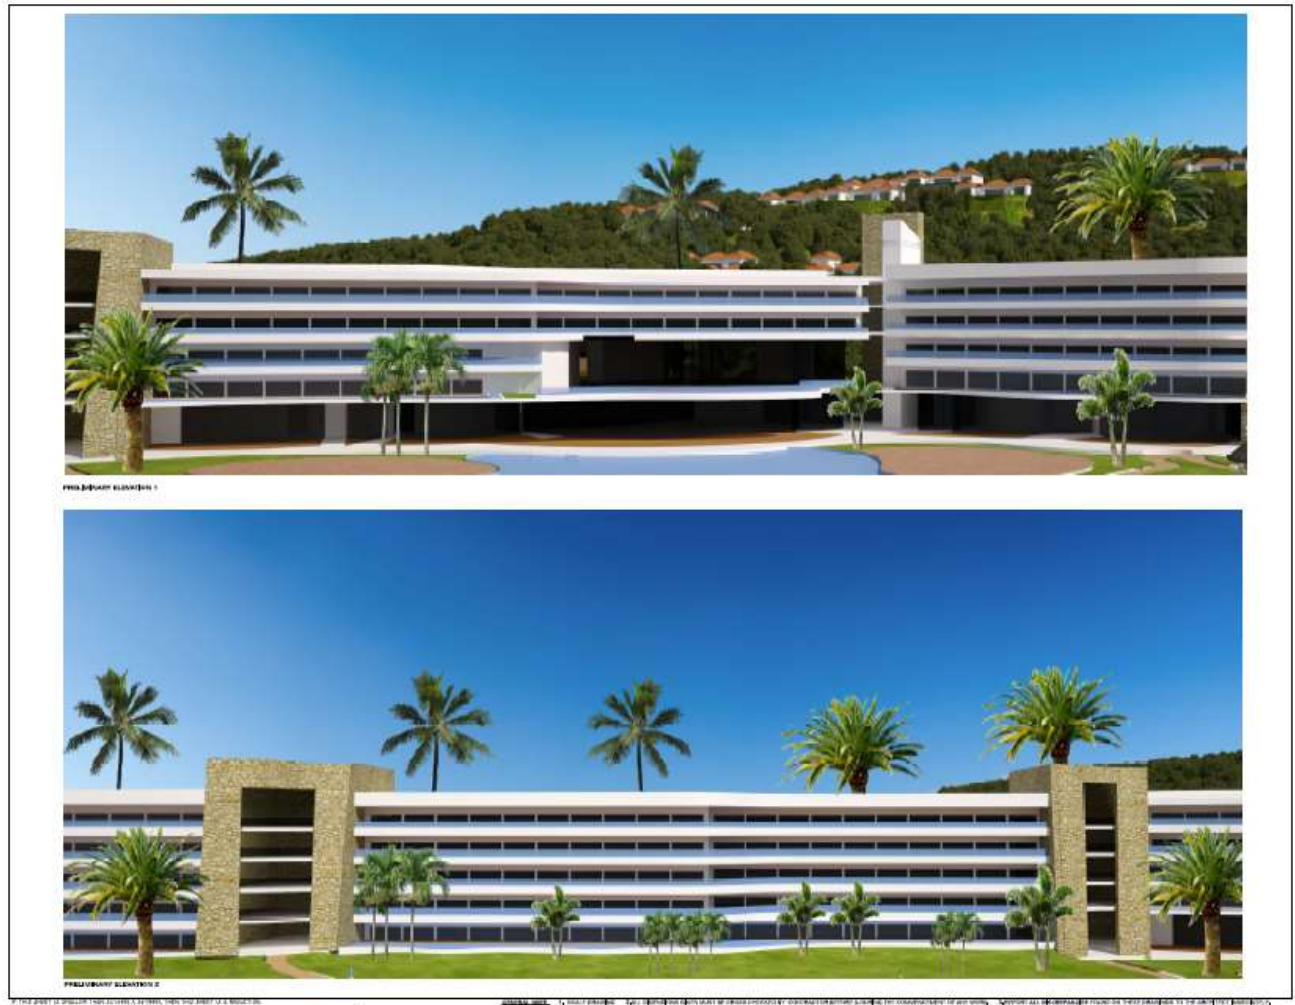
Figure 4.3.6: A 3-dimensional architectural view of the proposed Coral Spring Hotel - elevations

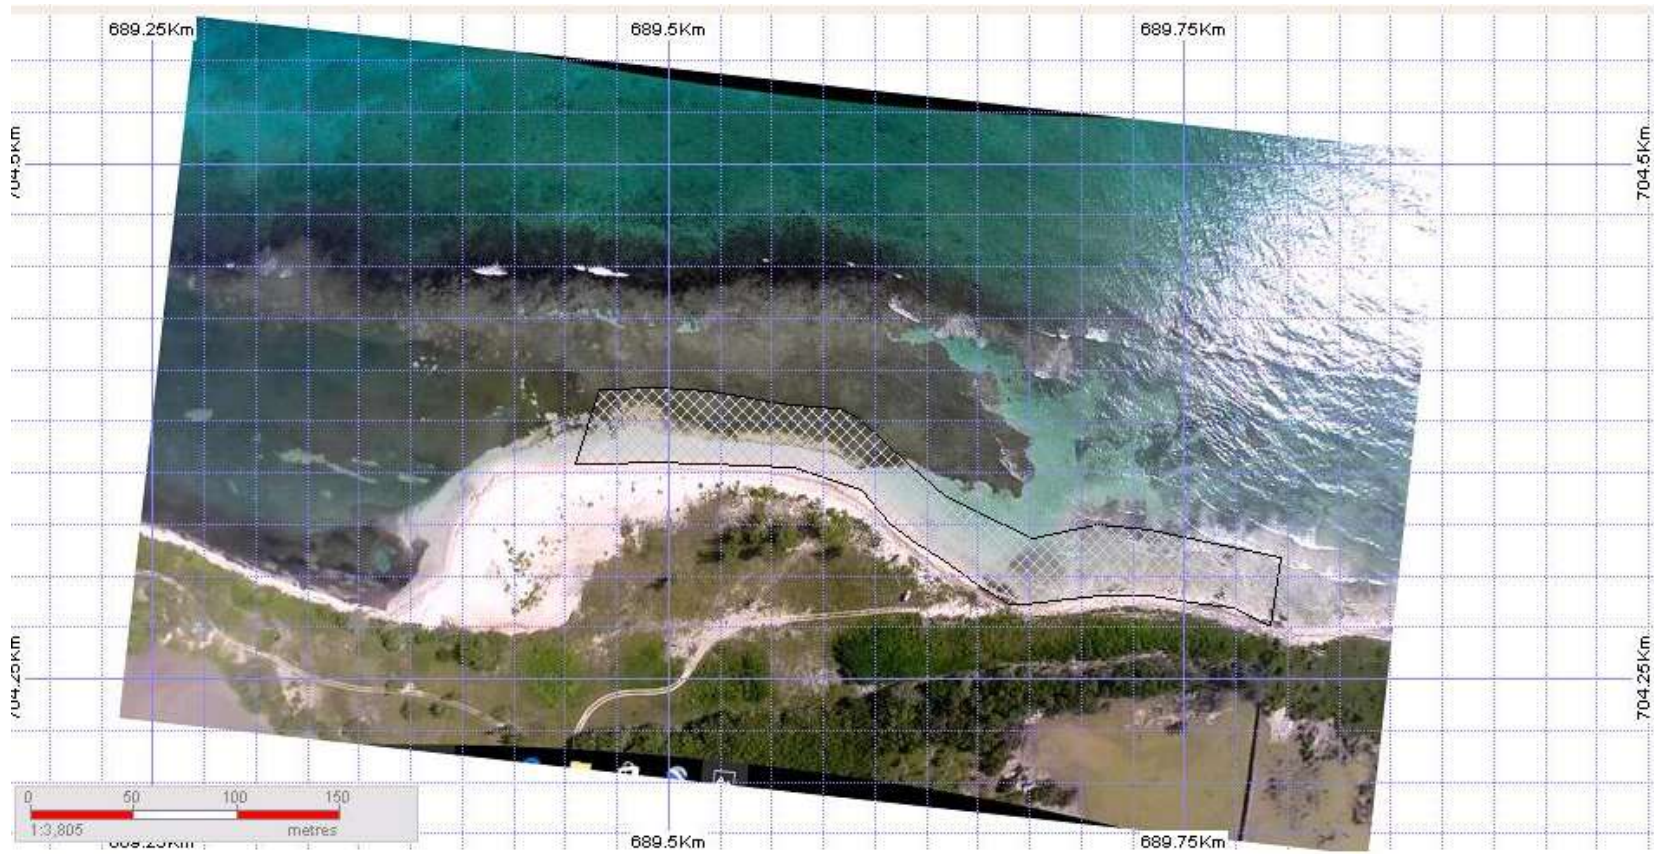
Figure 4.4.1: Proposed location for wading area

The current depths in approximately half of the proposed wading area (0.54 hectares) are less than 0.5 meters. Dredging will therefore be required to achieve the required depths. It is estimated that approximately 4,300 cubic meters of material will have to be removed from the proposed wading area in order to achieve the required wading depth. It is also estimated that approximately 0.23 hectares of seagrass resources will be impacted by proposed dredging activities, if mitigations are not implemented (Figure 4.4.2).

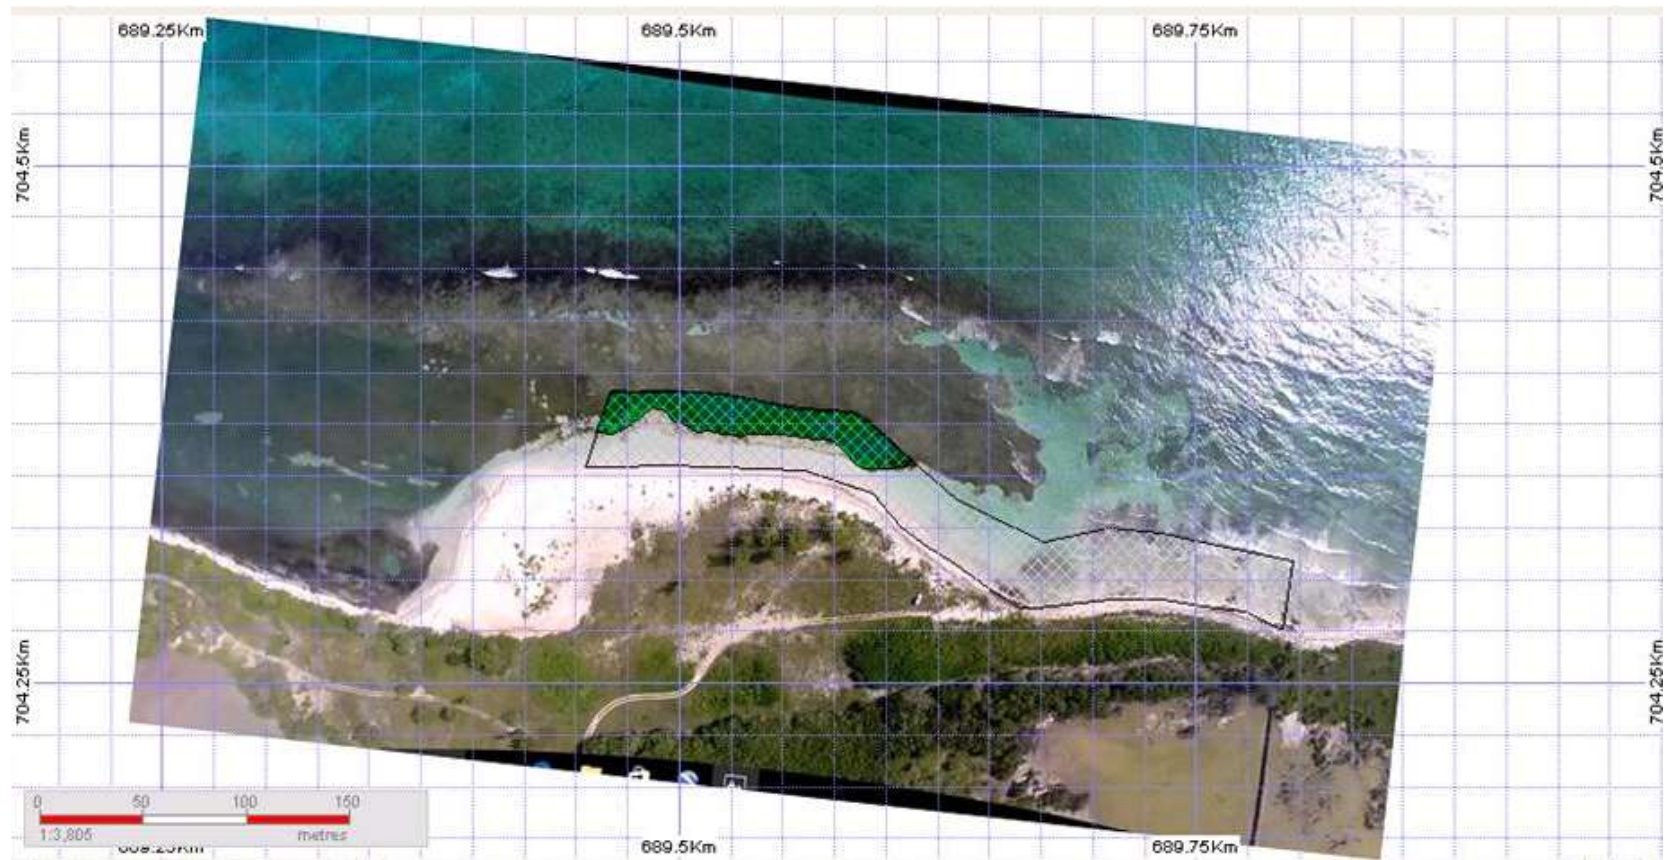
*Figure 4.4.2: Area of Seagrass within Proposed Wading Area that will require Mitigation (green hatched area).*

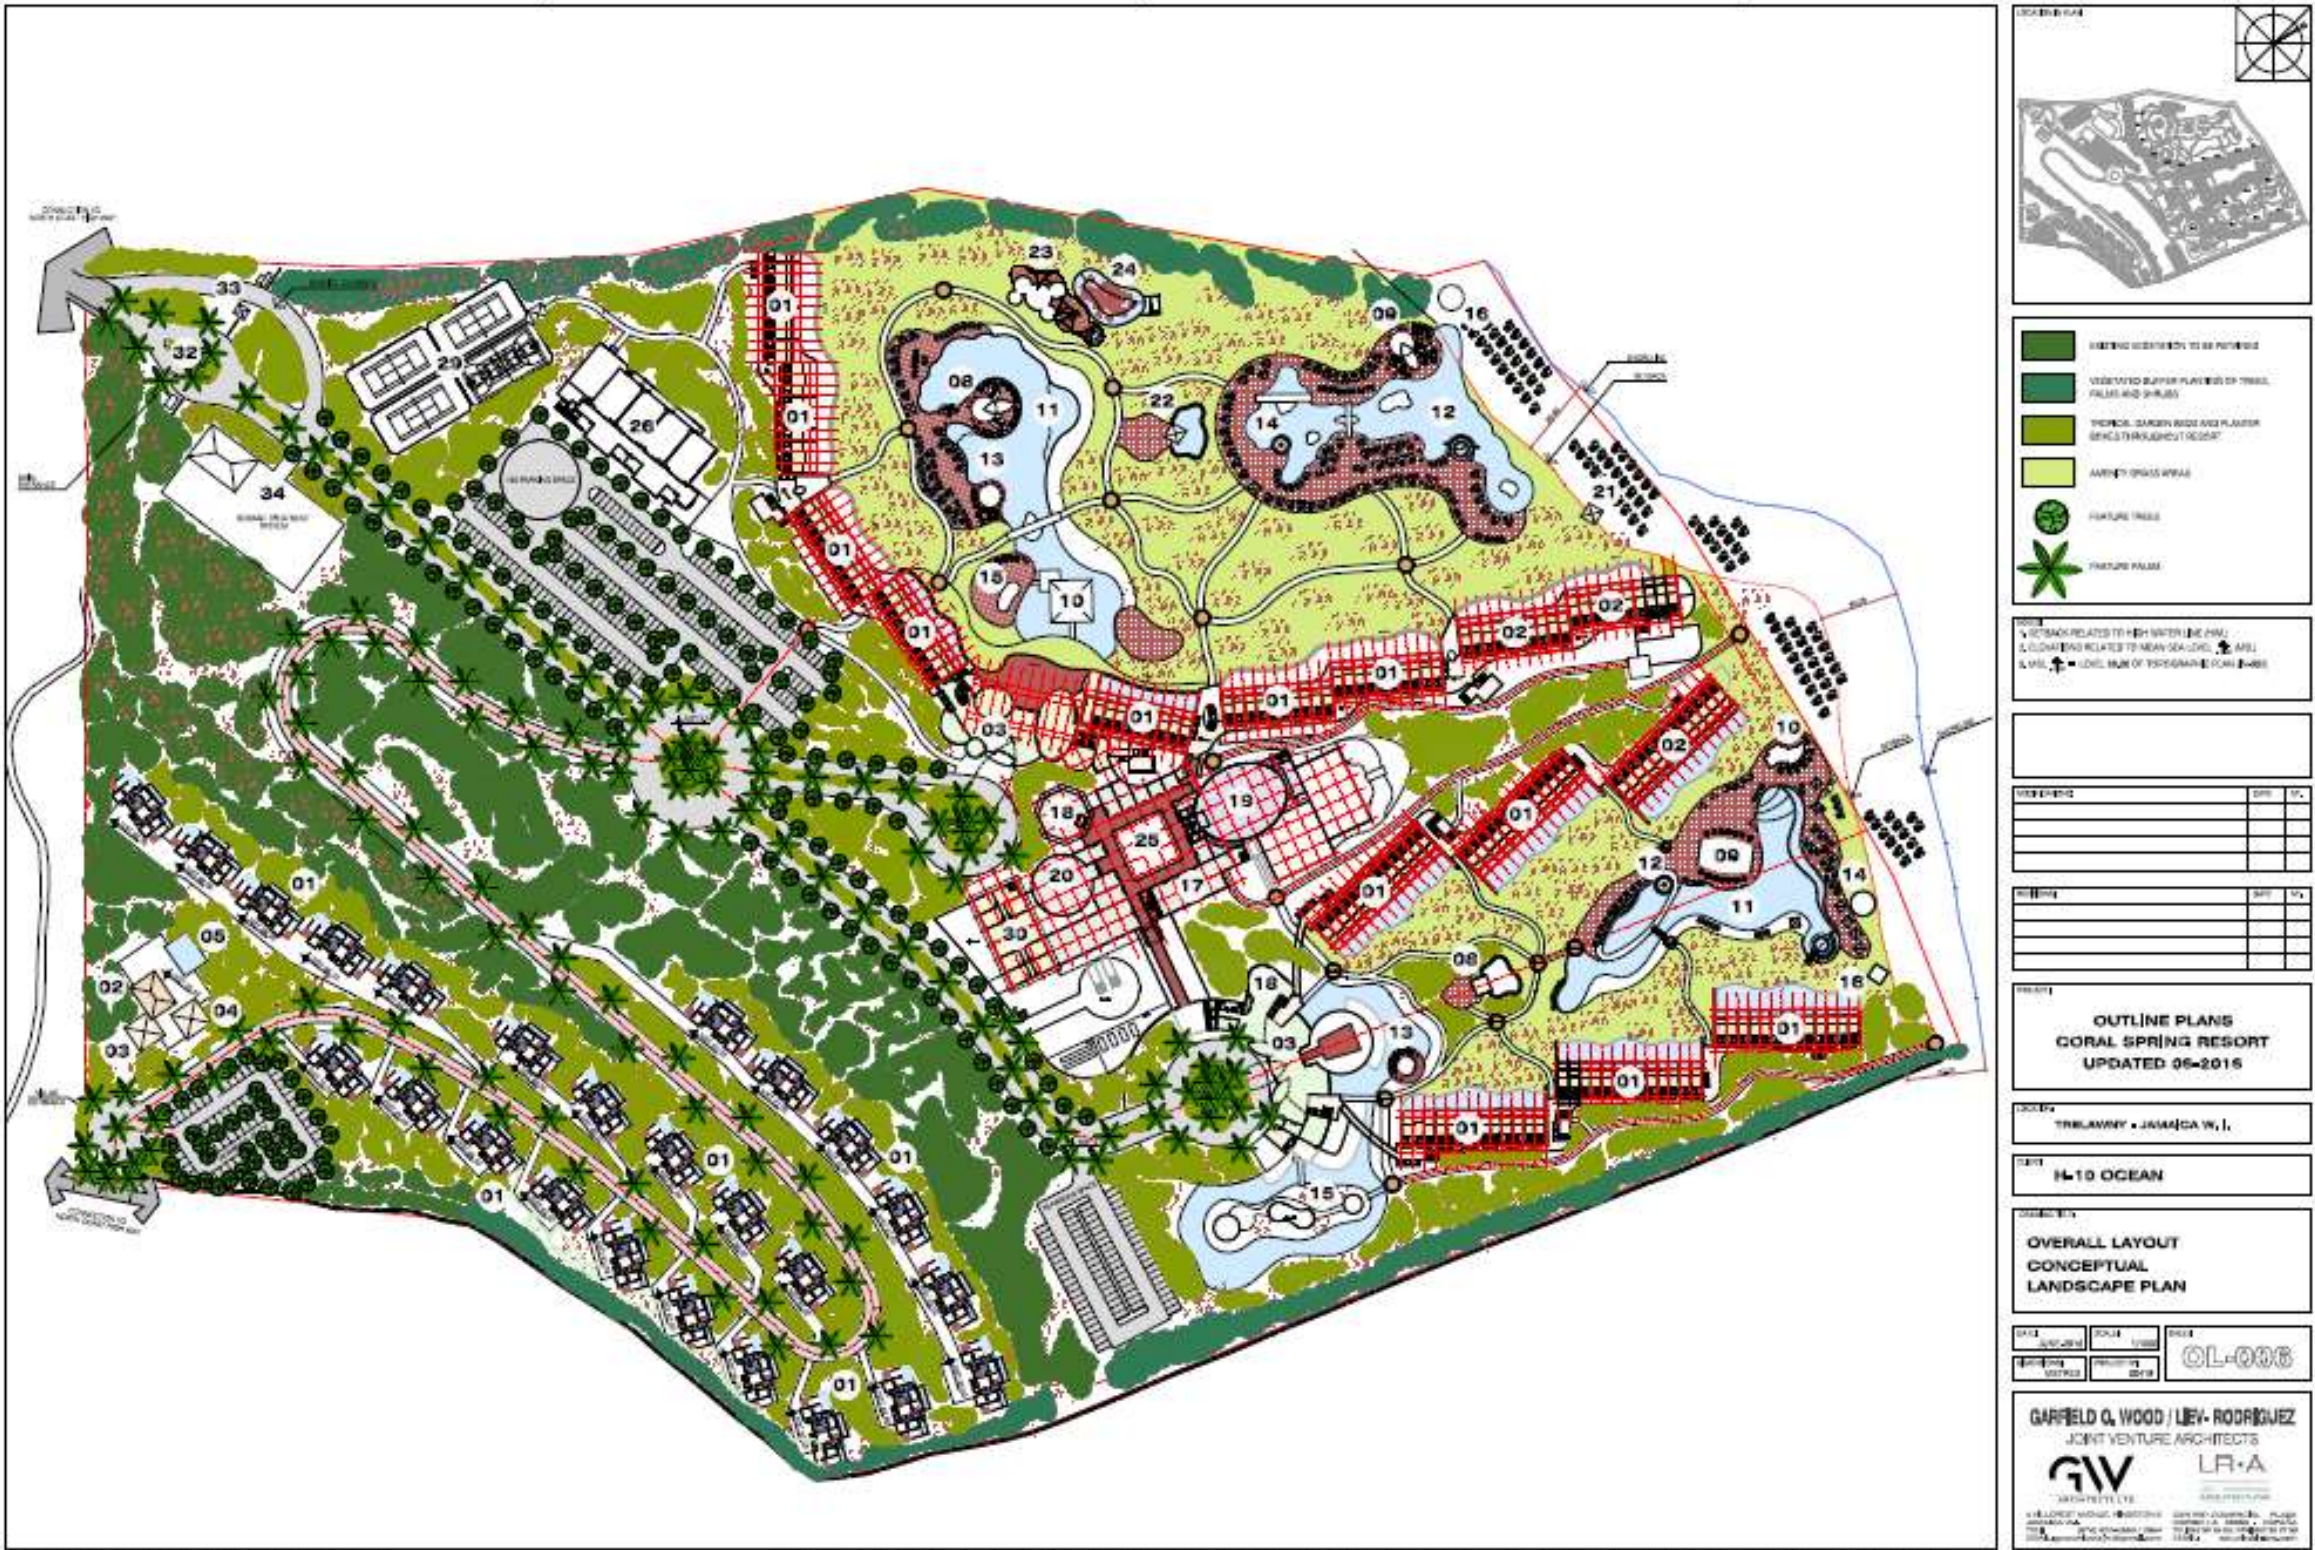
Figure 1.1.2: Landscape Layout

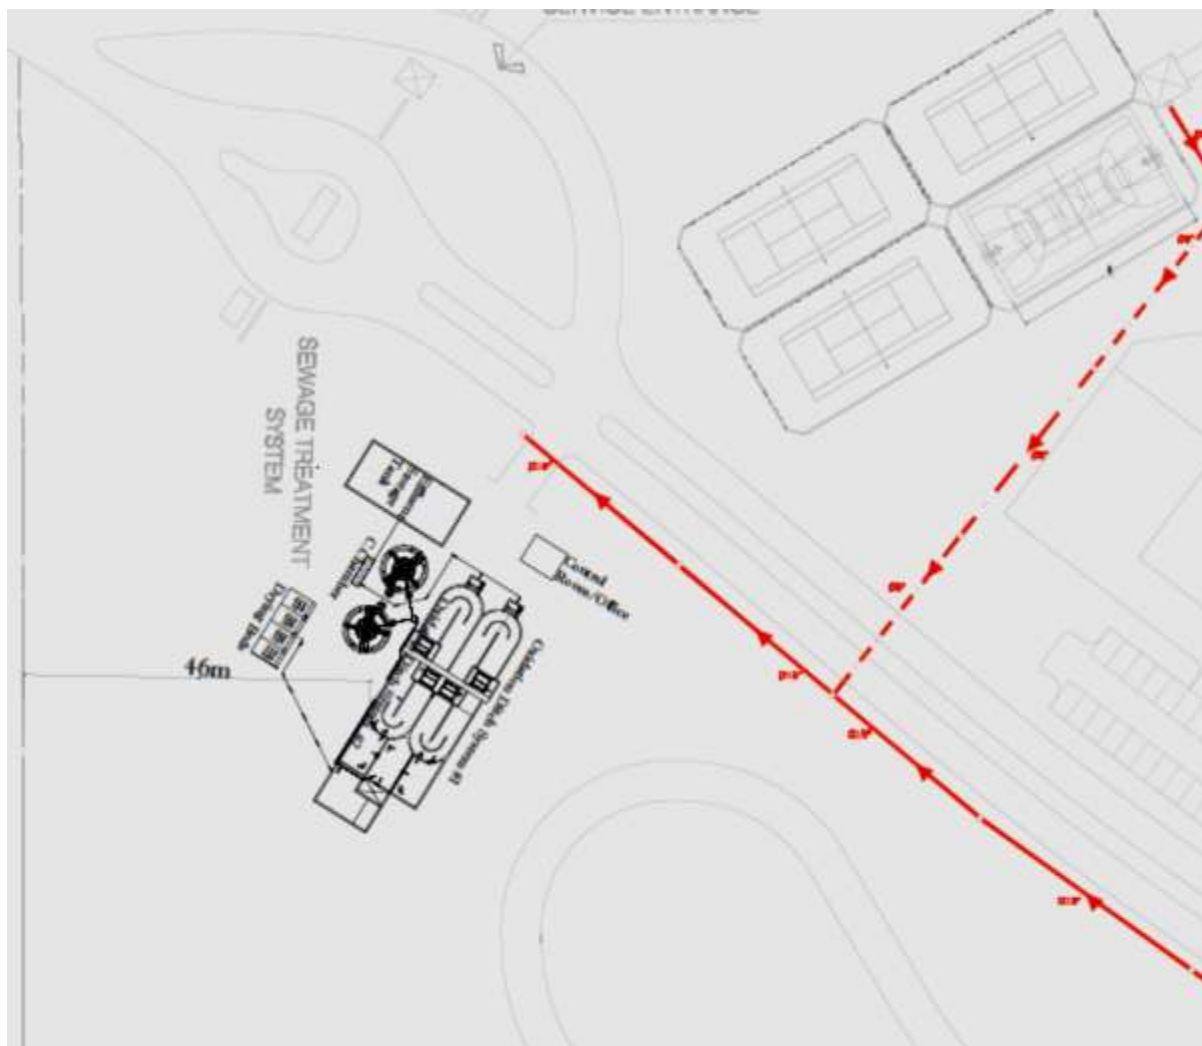
Figure 1.1.4: Schematic illustrating the proposed Site Layout of STP with setback

Category	Number of unit	Number of bedrooms	Litres/ room/ day	Sewage (m <sup>3</sup> / day)
Villas	37	5	1000	185
Junior Suites	753	1	1000	753
Master Suites	47	1	1000	47
<b>Total</b>	<b>837 units</b>			<b>985 m<sup>3</sup> / day</b> <b>+22% contingency (~216 m<sup>3</sup> / day)</b> <b>= 1200 m<sup>3</sup> / day</b>

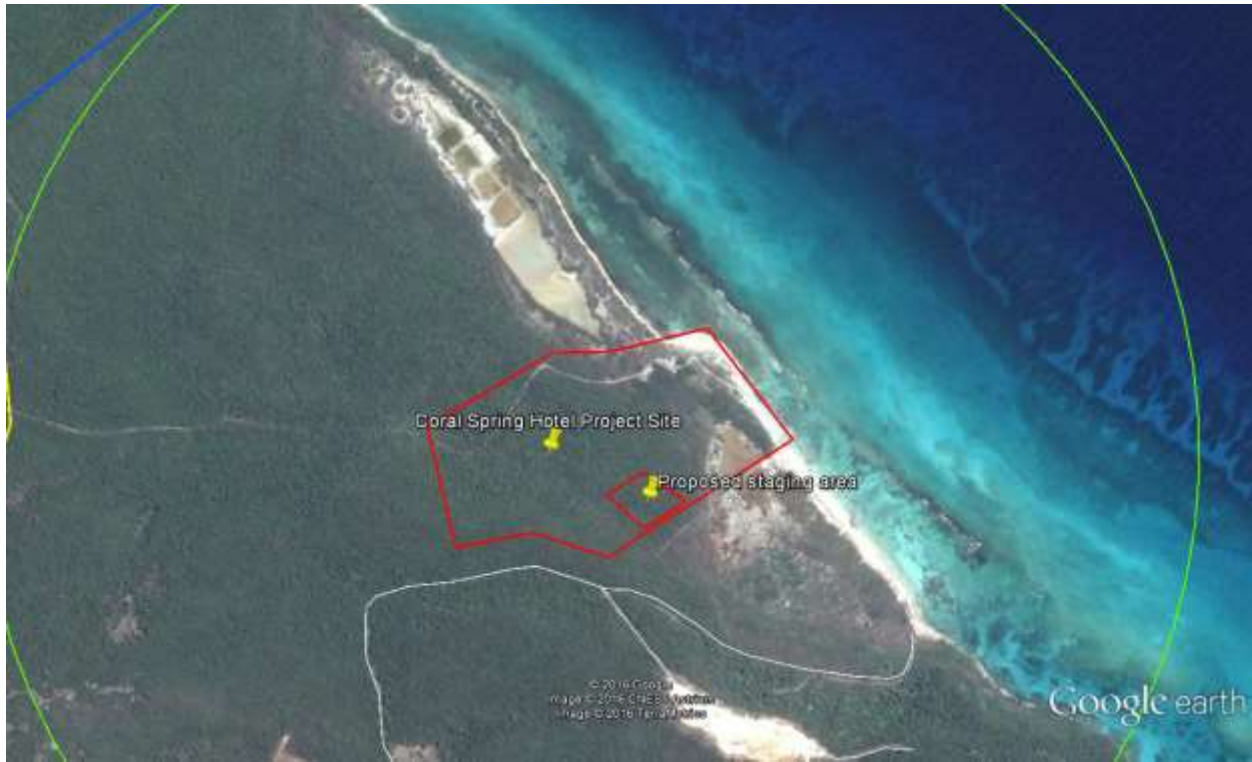
*Figure 1.1.6: Figure showing Proposed staging site for Heavy Equipment storage and office locations, area eventually to become parking space*

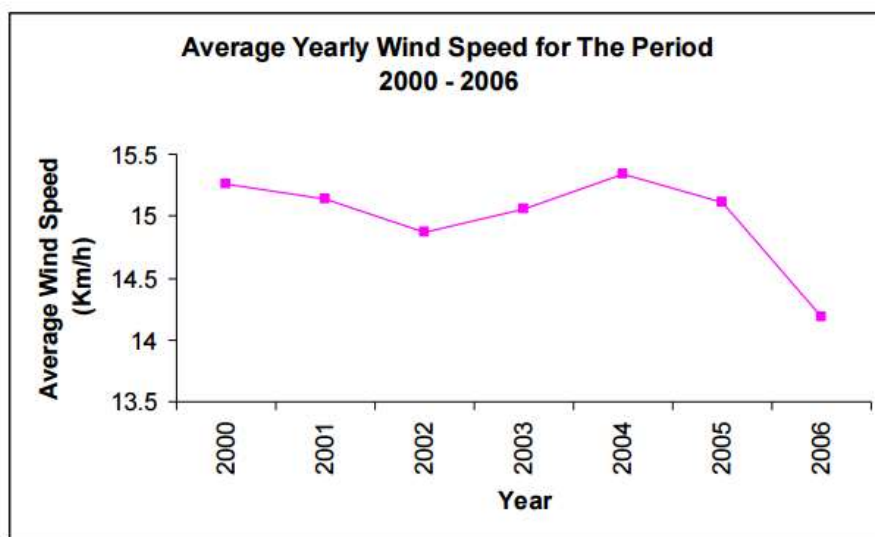
Figure 5.1.5: Average yearly wind speeds at Sangster's International Airport, Montego Bay<sup>4</sup>

Specific wind data was not available for the project area. The closest available data that could be considered reliable was from the Sangster International Airport in Montego Bay which is approximately 40 km (24 miles) to the west of the project area (Figure 5.1.5).

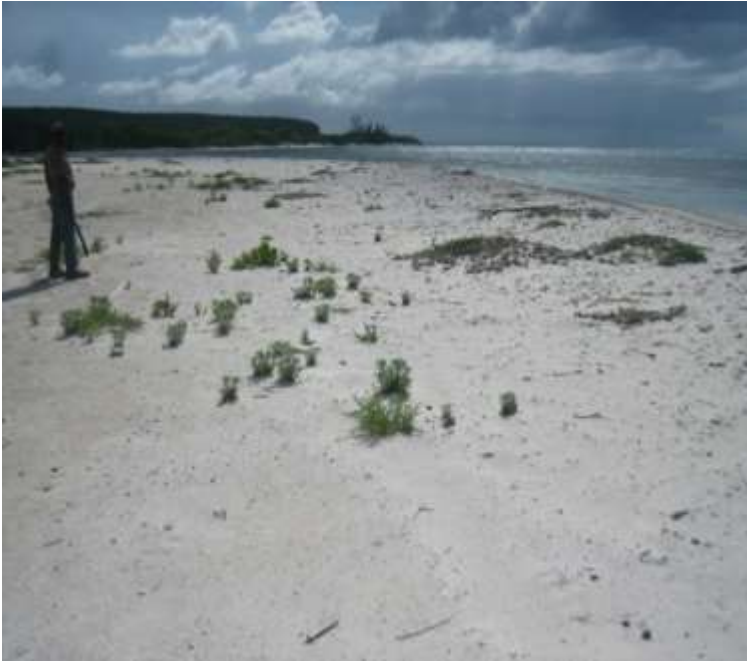
*Plate 5.1.1: White carbonate sand on the central and eastern section of property near the coastline.*

is limited to approximately 8m-15m from the shoreline. Beyond this point, the sandy area is mainly covered by brown and grayish brown sand with copious amount of broken pieces of limestone rock and shell fragments (Plate 5.1.2). Further inland, towards the south the site grades into a hilly, upland area consisting of moderate to steep slopes with abundant limestone boulders and cobblestone on the surface of the sloping ground.

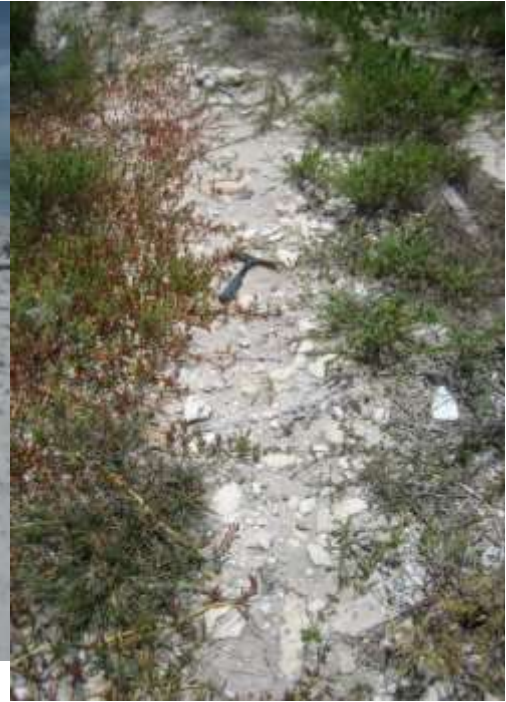
*Plate 5.1.2: Broken pieces of limestone and shell fragments embedded in greyish brown sand material*

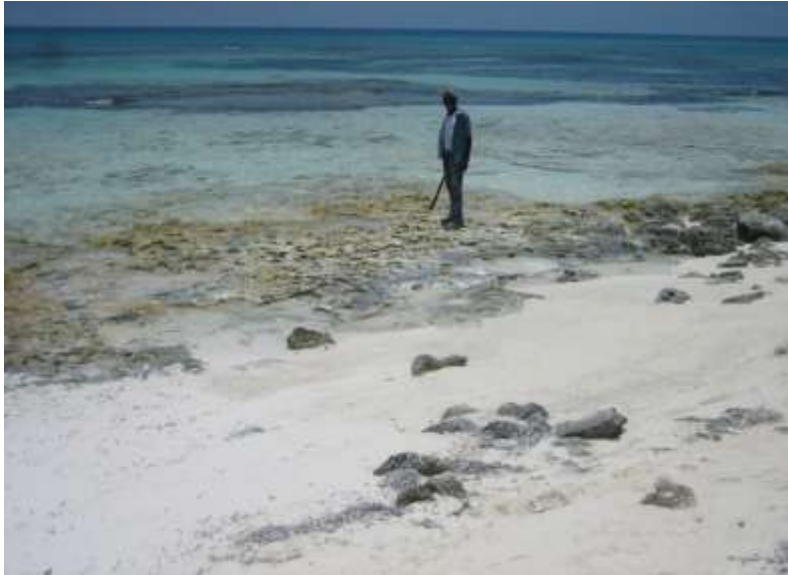
*Plate 5.1.3: Partially submerged rock on eastern boundary of shoreline on project site*

Within the near-shore marine area, partially submerged limestone flat rock extends for approximately 40m into the sea on the eastern side of the northern coastline. Further out to sea are the submerged coral reefs which are aligned parallel/sub-parallel to the coastline.

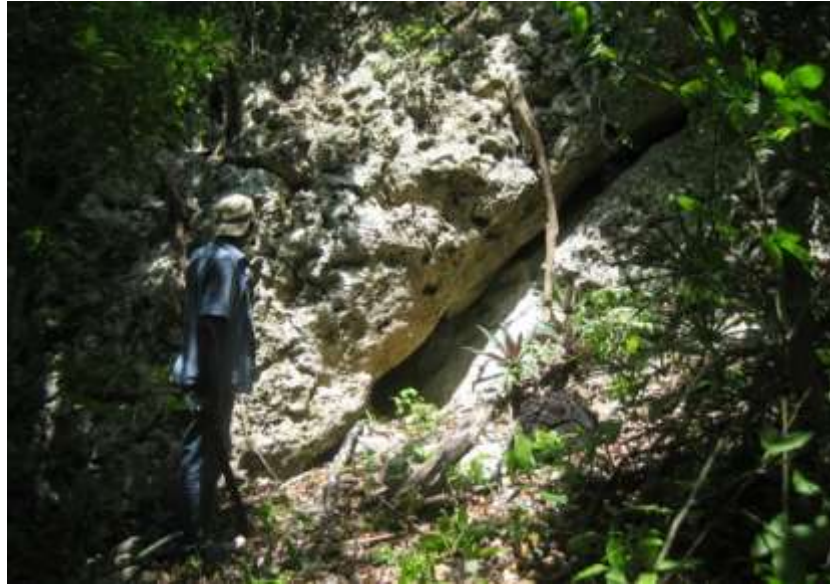
*Plate 5.1.4: Outcrop of Coastal Limestone near the south western boundary of the site with large open fracture.*

At the site, the ground surface in the hilly area within the older Coastal Limestone is dominated by large and medium size boulders and partly detached limestone on bedrock. On the south western side of the property, massive outcrops (bedrock) were identified but were infrequent (Plate 5.1.4 and Plate 5.1.5).

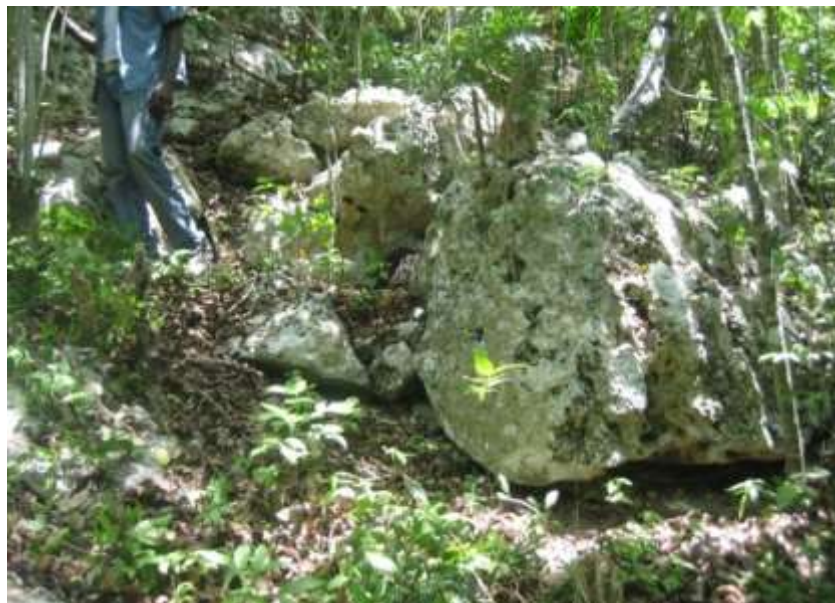
*Plate 5.1.5: Detached rock dominate the hillside in the Coastal Limestone*

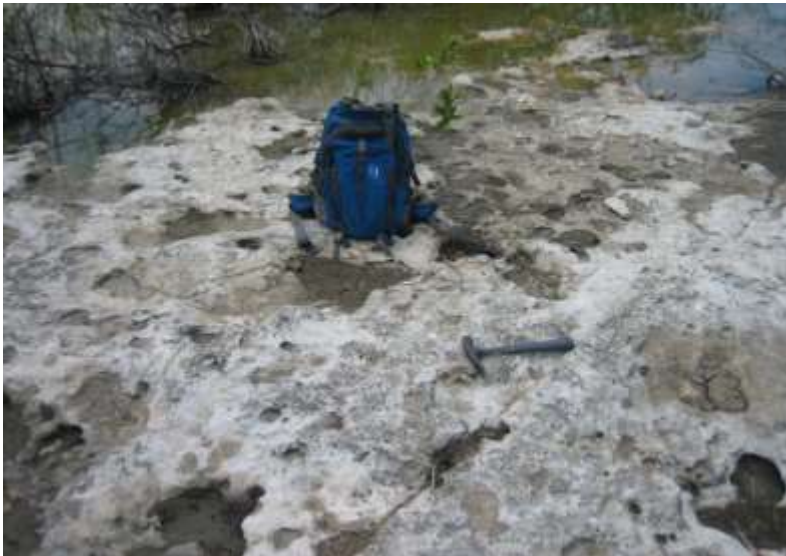
*Plate 5.1.6: Falmouth Formation as raised reef platform on the site*

The Falmouth Formation is to be found on the northern half of the proposed site and forms the flat, low-lying limestone platform (Plate 5.1.6). The pond on the eastern boundary and the Salt Pond to the west of the site are located in the Falmouth Formation.

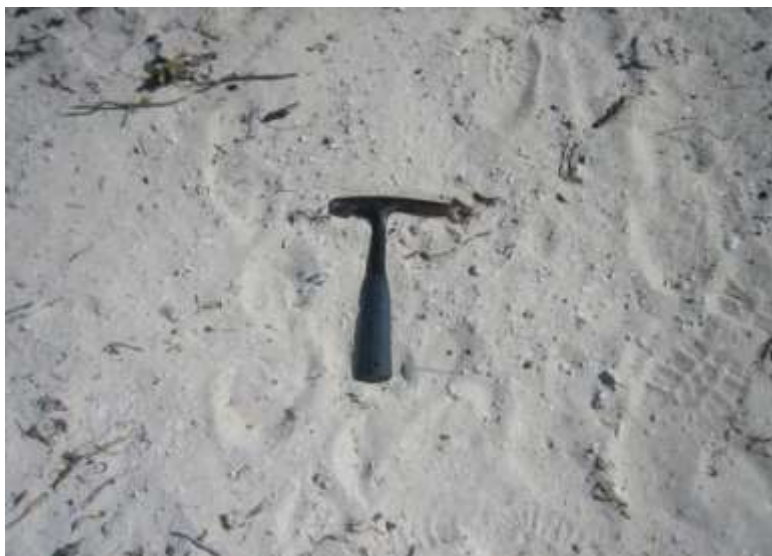
Plate 5.1.7: Beach (carbonate) sand with shell fragments on shoreline

The storm bank is a 0.4m -0.8m thick unconsolidated sediments consisting of a mixture of cobble and pebble size angular rock material and shell fragments embedded in loose grayish brown sandy soil (Plate 5.1.7). The storm bank is extensive on the north eastern section of the site and is observed at varying distances of 8m-21m from the high water mark.

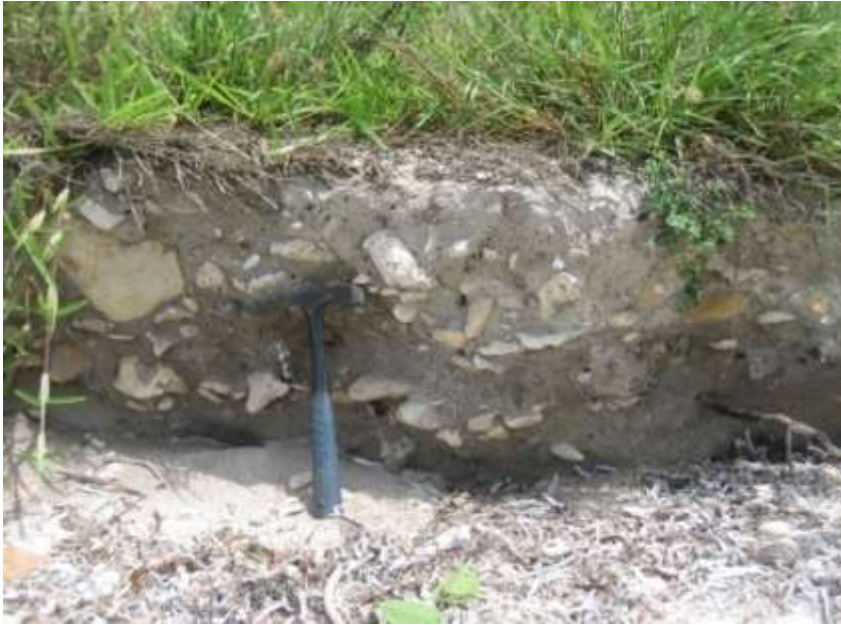
*Plate 5.1.8: Storm bank deposits near the eastern side of shoreline on project site*

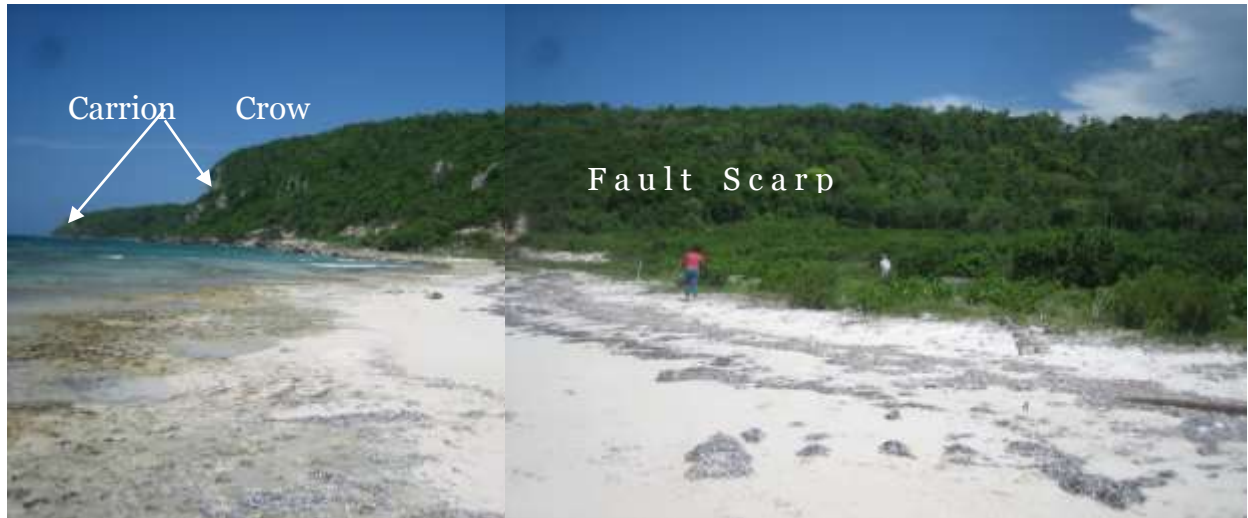
*Plate 5.1.9: Fault scarp which terminates at the coastline as Carrion Crow Cliff*

Parallel Miocene NE – SW geological faults cut the northern coastline between White Bay and Duncans Bay in the parish, resulting in the displacement the older reefs of the Coastal Limestone. One of the faults cuts across the SE section of the property, which has resulting in a ‘down-throw’ block on the NW (Mines and Geology Division Provisional 1:50,000 Metric Geology Map, Falmouth Sheet 4). A fault scarp has been created as a result of movement along this fault and can be traced to the coastline in the form of a cliff (Plate 5.1.9). Movement along the fault has also resulted in the development of large limestone blocks, boulders and cobblestones that dominate the steep hillside.

There is no evidence to indicate that the fault is active as there is no seismic activity recorded on the fault in recent history.

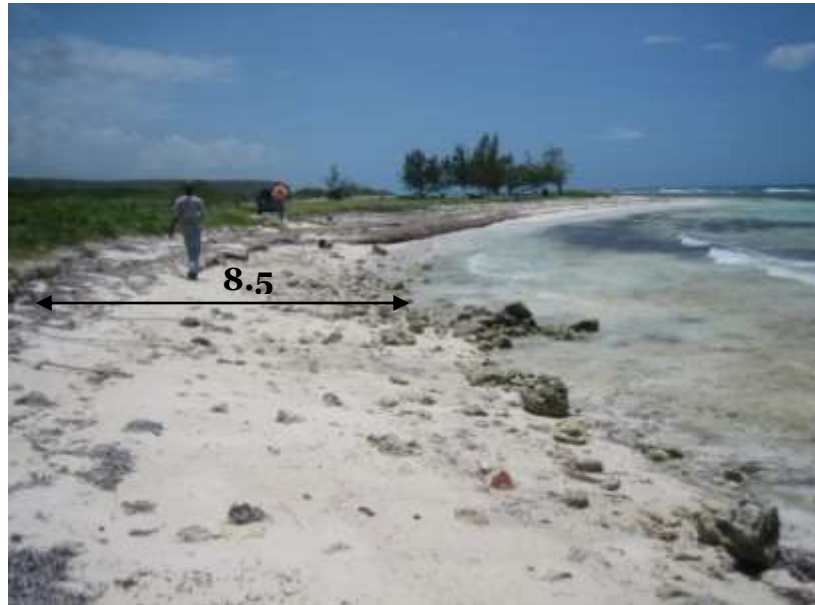
*Plate 5.1.10: Beach front, measuring 8.5m across at its eastern side of the coastline*

near to the coastline. The back beach area extends for about 30 -40 m on the eastern side to about 75m-80 m in the centre and for a distance of over 80m from the HWM. This area has sparse vegetation that is mainly covered with patches of grass.

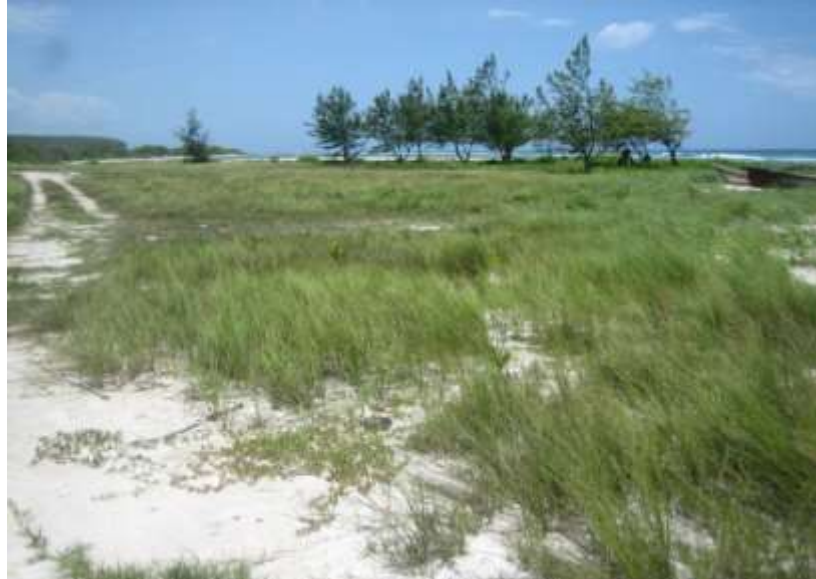
*Plate 5.1.11: Back beach area measuring up to 80m inland from the shoreline*

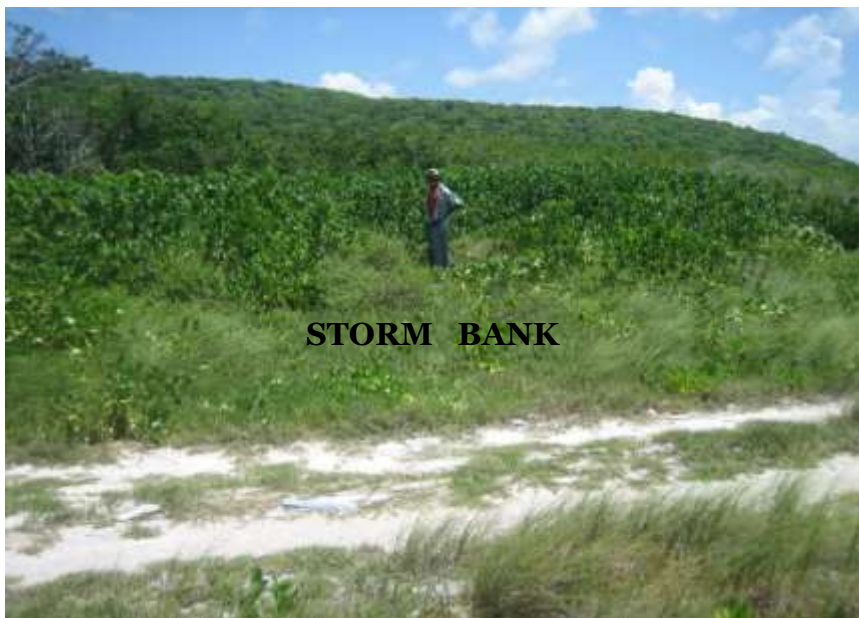
*Plate 5.1.12: Storm bank with growth of low shrubs consisting of sea cotton*

The low small shrub land vegetation is dominant on the storm debris and is identified as vegetation re-growth from the more mature sea cotton trees that are in abundance behind the back beach area (Plate 5.1.12).

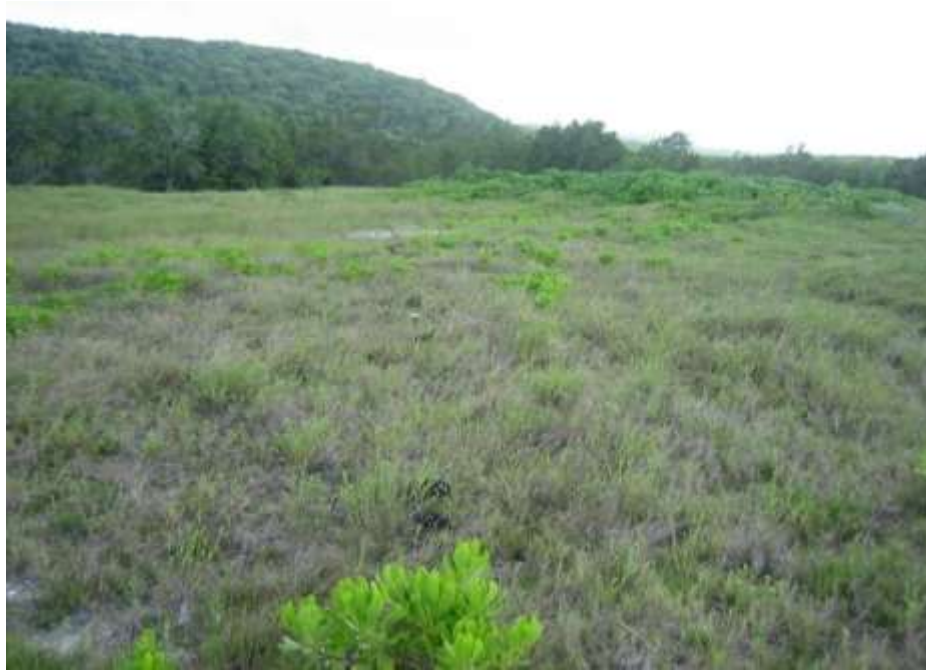
*Figure 5.1.9: Flat to gentle sloping raised platform which stretches from the coastline to the foot of the upland/hilly area in the south.*

The vegetation consists mainly of the more mature sea cotton trees that are dominant on the site. Elevation on the raised platform ranges from 1m to approximately 5m above mean sea level. The storm debris partially sits on top of the raised reef platform.

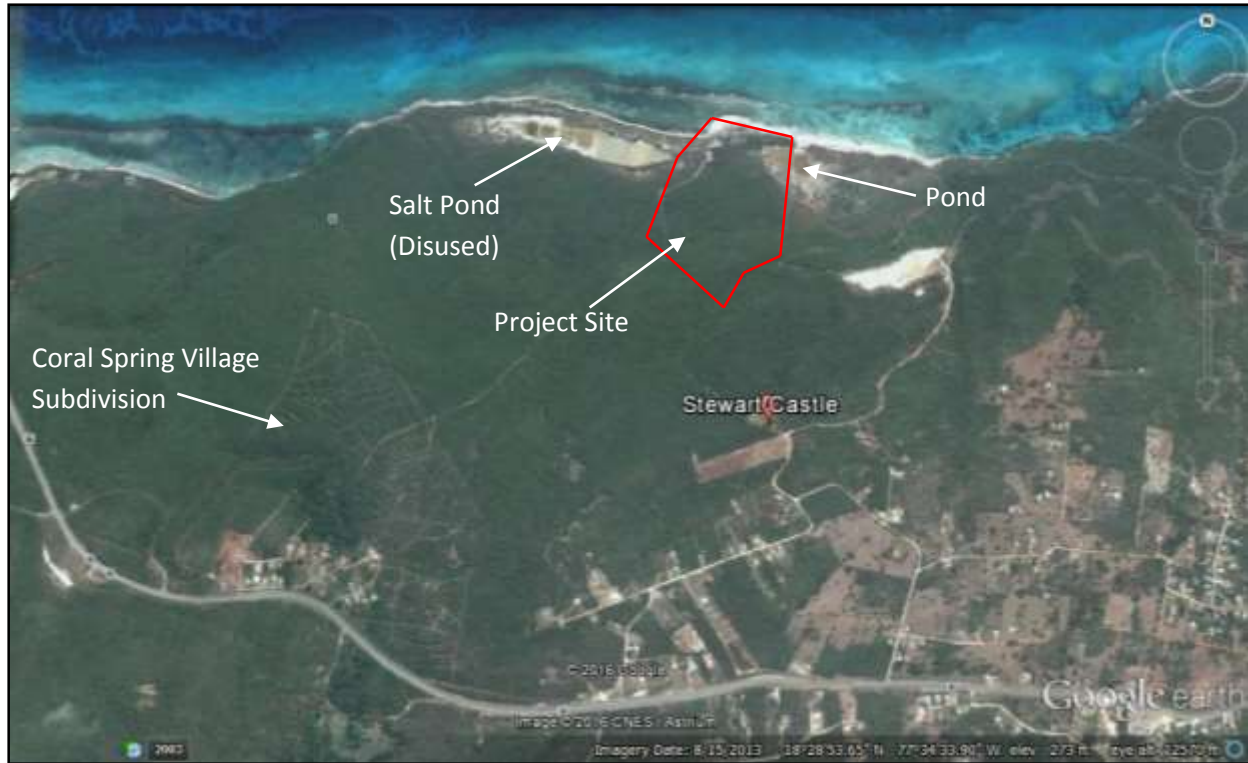
Figure 5.1.10: Google Image of Coral Spring Hotel showing location of ponds (Source: Google Image 2013)

This pond is shallow (<0.75m) and brackish, having very thin to non-existent overlying soils consisting of sparse dry trees and shrubs which probably survived in earlier periods (Plate 5.1.14). The pond covers a distance of 107m from north to south and 214m from east to west. On the Coral Spring Hotel property, the size of the pond has an area of approximately 3 acres. The pond extends beyond the property boundary to the adjoining lands to the east.

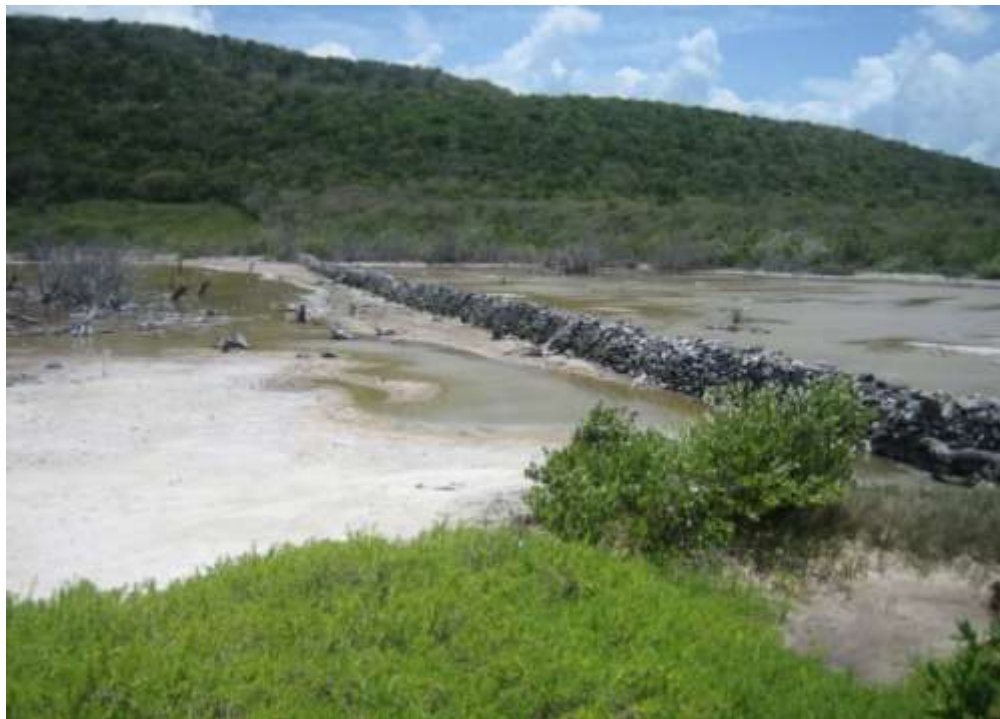
Plate 5.1.13: Pond is separated by a stonewall which forms the east boundary of site

The pond may have been developed as a shallow depression within the low-lying limestone platform and the source of the water is the high water table which intersects the shallow depression leading to the formation of the pond. The pond may have also been influenced by tidal flows within the limestone as the elevation of the pond at the northern section is 0.8m above sea level and at the southern section 5m above sea level. The permeability of the surface rock at that location has allowed for the sea water barrier to extent within the shoreline.

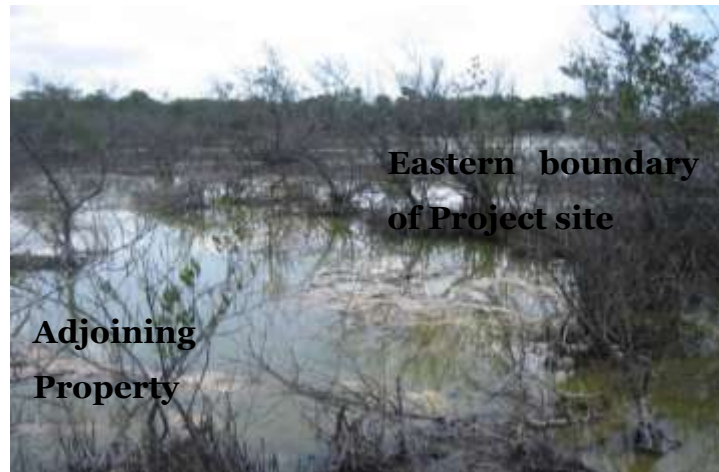
*Plate 5.1.14: Dried vegetation in the pond on the Coral Spring hotel site*

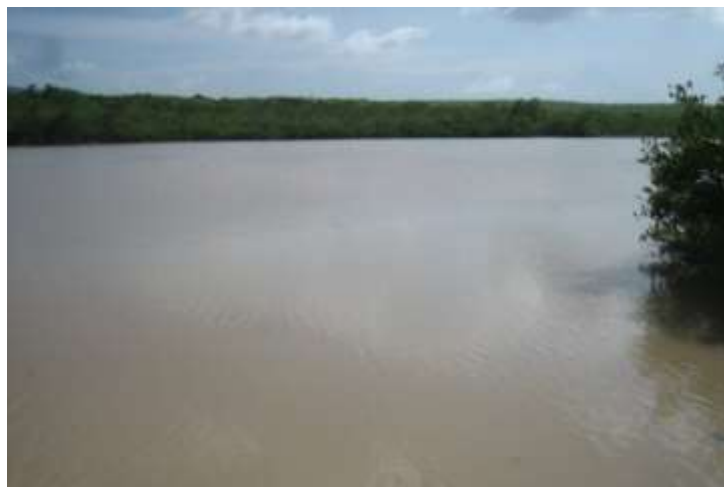
*Plate 5.1.15: Salt Pond located 100m west of the project site*

To the west of the site near the coastline is a large pond which runs almost parallel to the coastline (Plate 5.1.15). This pond, formerly the site for Jamaica Salt Works was used for the extraction of salt in the past. The operation has ceased and the area has remained inactive for many years.
