# ENVIRONMENTAL IMPACT ASSESSMENT

## FOR THE PROPOSED DEVELOPMENT OF A HOTEL RESORT AT, CORAL SPRINGS TRELAWNY, JAMAICA

October 2016

**ENVIROPLANNERS LTD.**

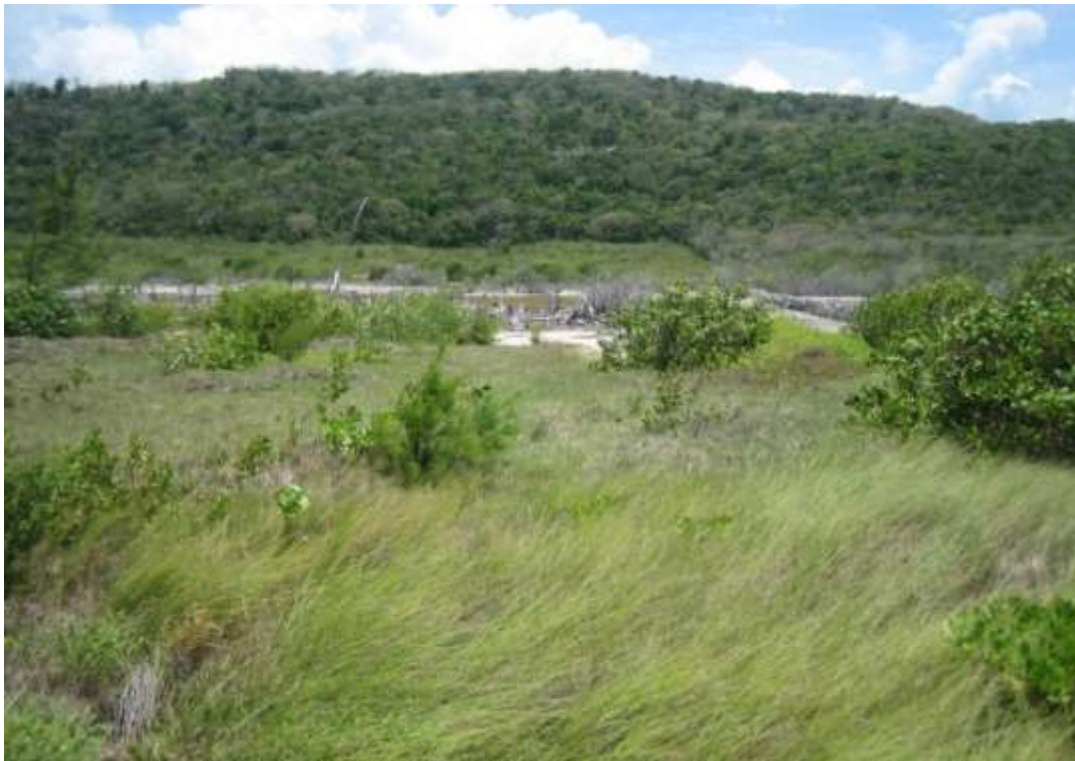
*Plate 5.1.16: Limestone Hills (Background) which forms the upland area on the south of project site*

The limestone escarpment consists of a steep scarp slope on the north facing slope and a gentler slope which decreases gradually south of the site. The scarp slope of the escarpment forms the hilly, upland terrain on the project site (Plate 5.1.16), while the southern slope of the escarpment forms poorly developed karst features consisting of low, semi conical hills and limestone depressions. The southern slope of the escarpment is formed outside the boundary of the project site.

The steep-sided slope of the escarpment takes up approximately 40% of the hotel property on its southern section. The land rises from an elevation of 5m to 83m at its highest elevation. There are two NE-SW linear ridges separated by a narrow valley that forms the limestone hills on the site. The smaller ridge dies out before it reaches the shoreline, while the larger and more southerly ridge continues and terminates at the coastline where it forms the Carrion Crow Cliff on the Stewart Bay coastline as it juts out into the sea (Plate 5.1.17).

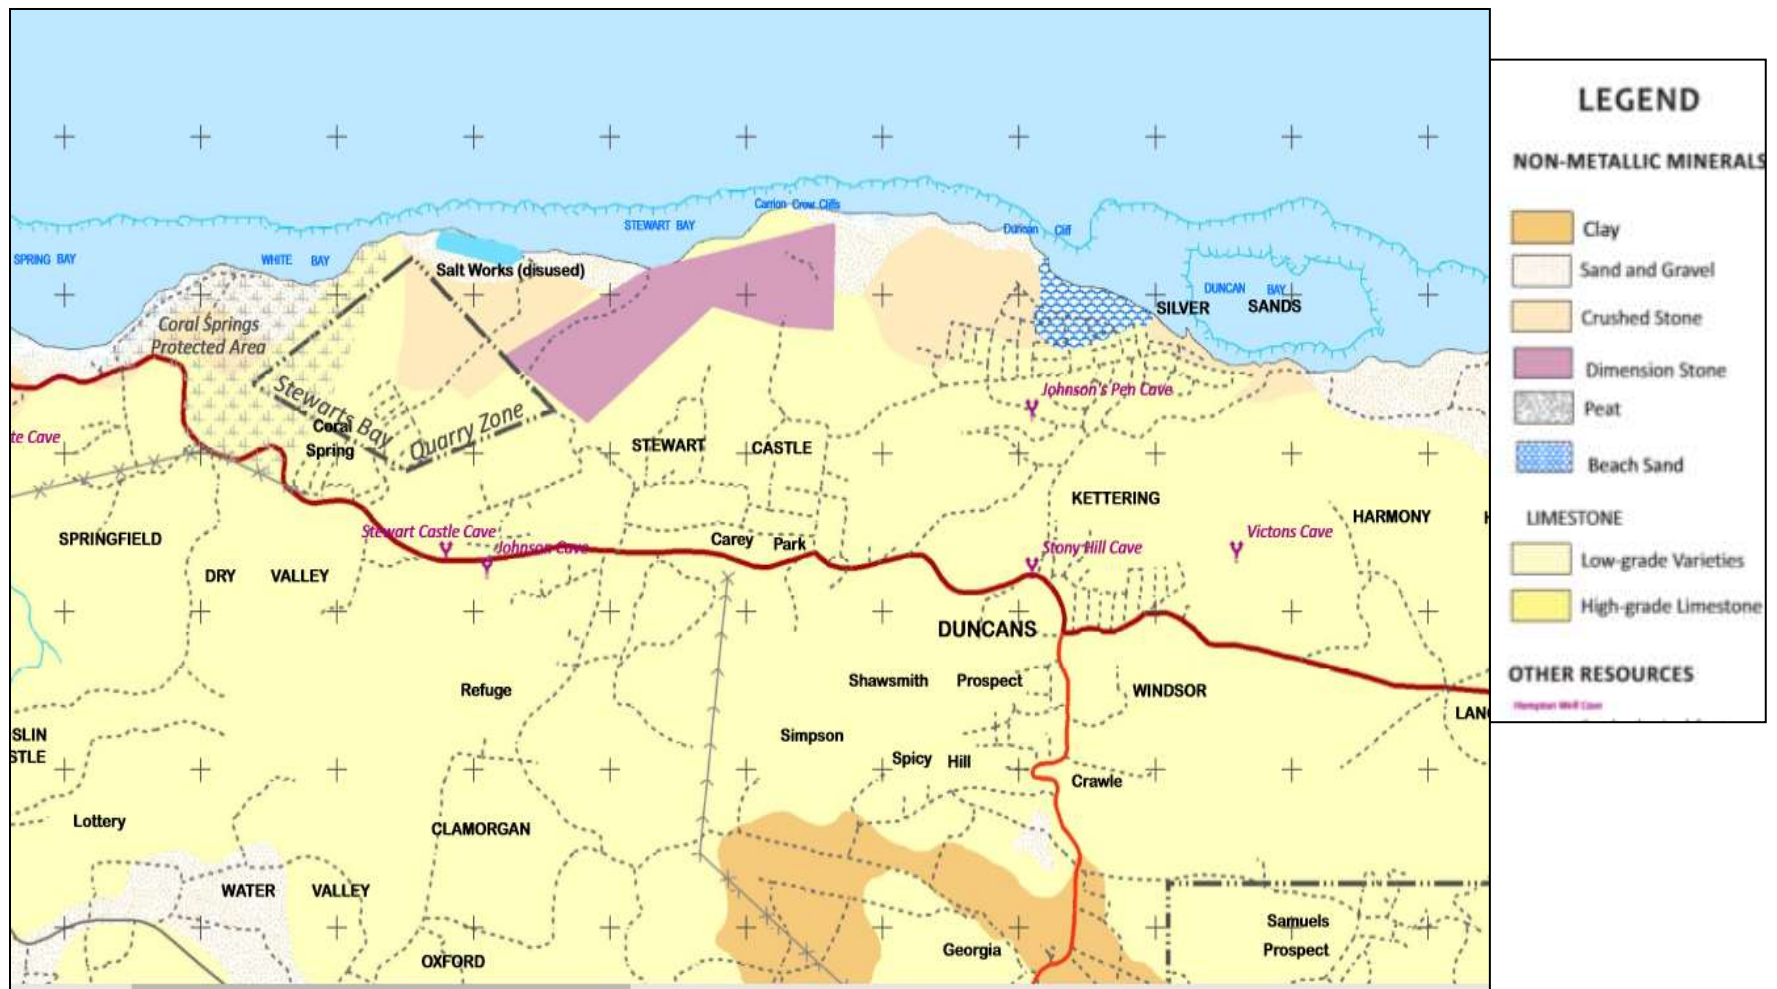
Figure 5.1.11: Mineral Resource Map for the parish of Trelawny. (Source: MGD 2014)

There is a large quarry at approximately 240m east of the site. This quarry supplies limestone aggregate for use in the road and building construction industry in the parish of Trelawny. The Stewart Bay Quarry Zone borders the south western section of the site. The limestone is considered low-grade and can be used as fill-grade material and crushed stone in the construction industry.

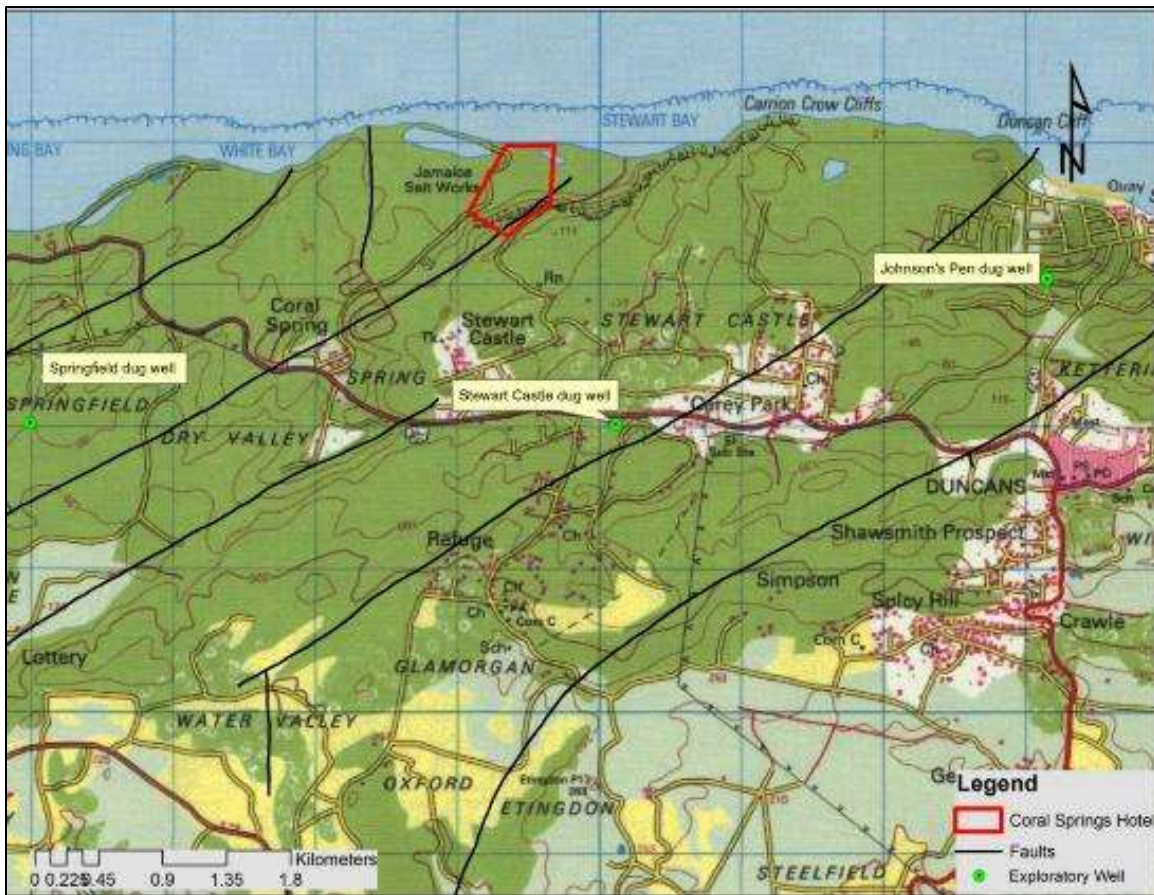
Figure 5.1.12: Topographic Map of Coral Spring Site showing nearest well locations

The region is highly faulted with a SW -NE trending fault traversing the property. The Stewart Castle Well with depth to groundwater of 50m is located approximately 1.5 km south of the site within the Montpelier Formation which was never commissioned due to lack of groundwater resources. The Springfield and Johnson Pen dug wells sunk to a depth of 26.8m and 11m respectfully are located 3.2km east and 3.3km west of the site (Water Resources Authority Hydrological Database: <http://webmapjam.dyndns.pro/>)

(Figure 5.1.12). The marine environment is contiguous with the northern boundary of the site. The site lies in the Martha Watershed Management of the Martha Brae Hydrologic Basin. The Draft Water Resources Development Master Plan (2005) prepared by the Water Resources Authority indicates that the exploitable yield for the Martha Watershed Management Unit is  $12.7 \times 10^6 \text{ m}^3/\text{year}$ .

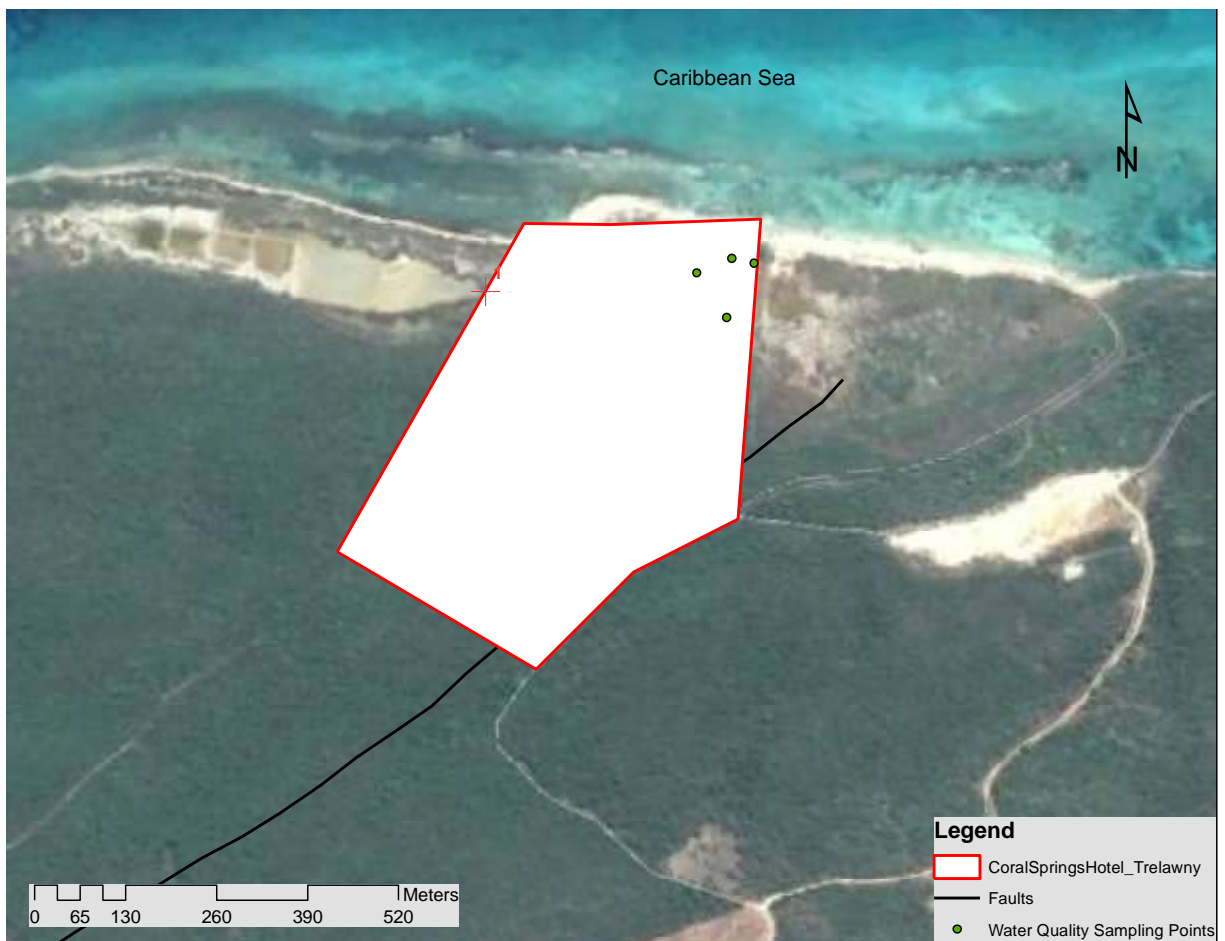
Figure 5.1.13: Google image of Coral Spring showing location of water quality sampling points

Baseline water quality samplings were conducted on June 1 and June 12, 2016 at four sites within the pond for this project. Two samples were collected on the 8<sup>th</sup> of June 2016 at JAD 2001 coordinate points 689702.891E 704204.47N and 689 784.353 E 704219.626N (Appendix 4). The other samples were collected on June 18, 2016 at JAD 2001 coordinate points 689751.2E 704227.204N and 689 744.569E 704141.953N (Figure 5.1.13).

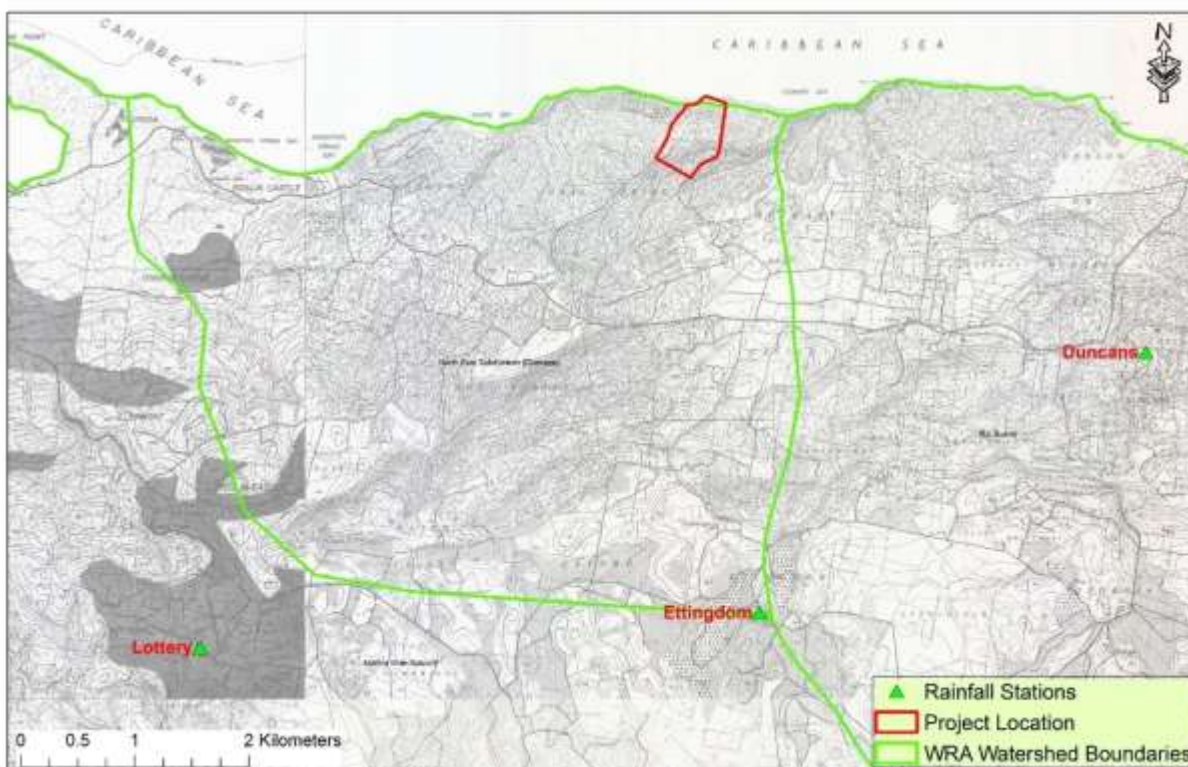
Figure 5.1.23: Location and spatial distribution of rainfall stations for the project site.

Rainfall data was obtained from the Meteorological Office 24-hour rainfall database which is based on data collected over a 50-year period between the 1930s and the 1980s. The Duncans, Ettingdom and Lottery rainfall stations which are closest to the Project site that are likely to have the most impact on the site in terms of storm events (Figure 5.1.23). The arithmetic average of these rainfall totals was used in the runoff calculations. The rainfall data used are presented in Table 5.1.5 below.

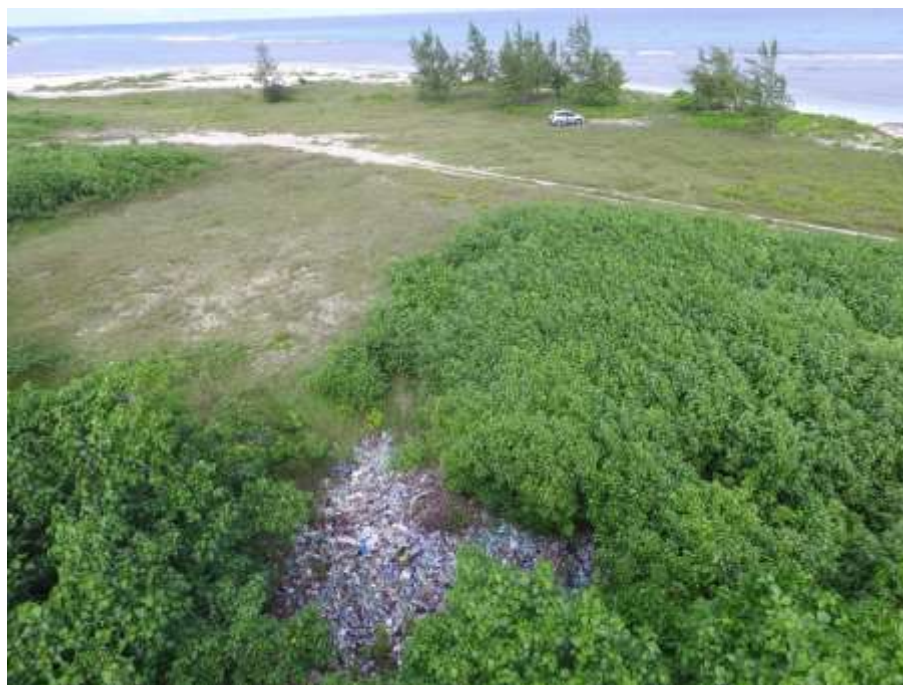
Plate 5.1.18: Oblique aerial drone photo showing disposal of plastics in vegetated area on the proposed site (Photo Credit: CL Environmental Co. Ltd., 17 Nov 2016)

Informal dumping of plastic bottles and other solid waste occurs along the coast near to the start of the vegetation, about 60m from shoreline.

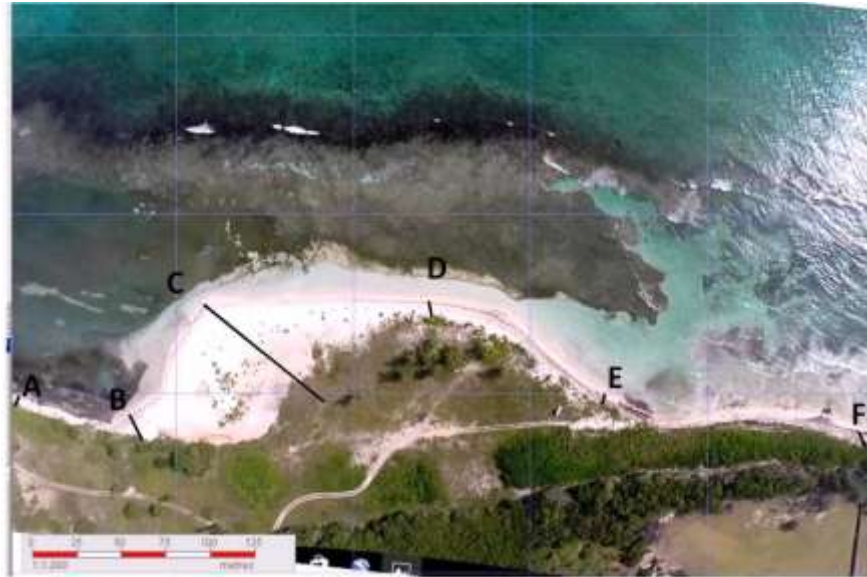
*Figure 5.3.4: Location of Shoreline Cross Section Measurement Sites at the Development Site.*

Figure 5.3.4 along with Plate 5.3.1 through to Plate 5.3.4 illustrates shoreline cross sections measured across the shoreline present within the property's coastal boundary. In light of the fact that there were no pre-existing cross section information for comparison, these cross sections are being represented as a baseline for future shoreline stability comparisons.

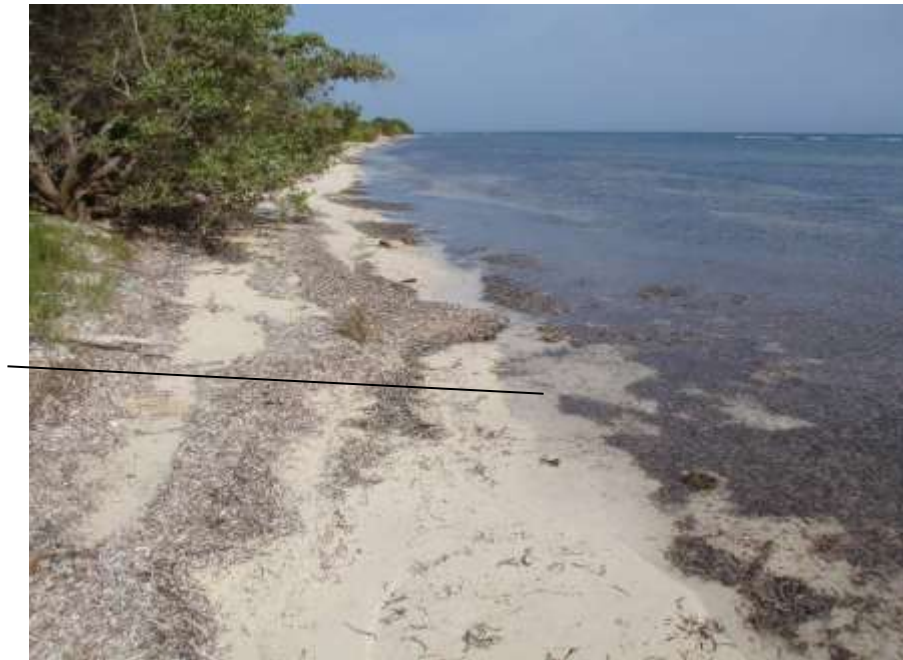
Plate 5.3.1: Image Taken Perpendicular to the Orientation of Cross Section A

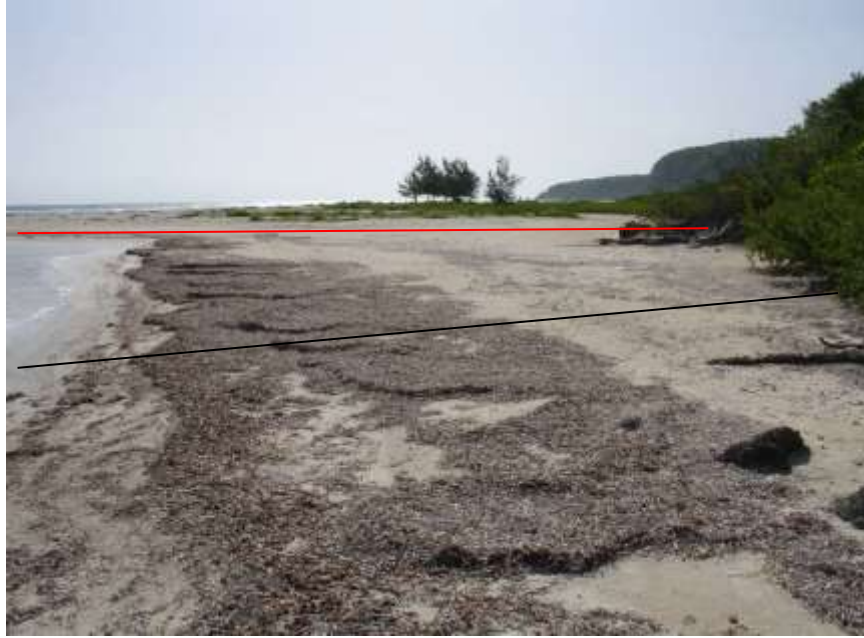
*Plate 5.3.2: Image Taken Perpendicular to the Orientation of Cross Section B (foreground), with Cross Section C in the Background (red line)*

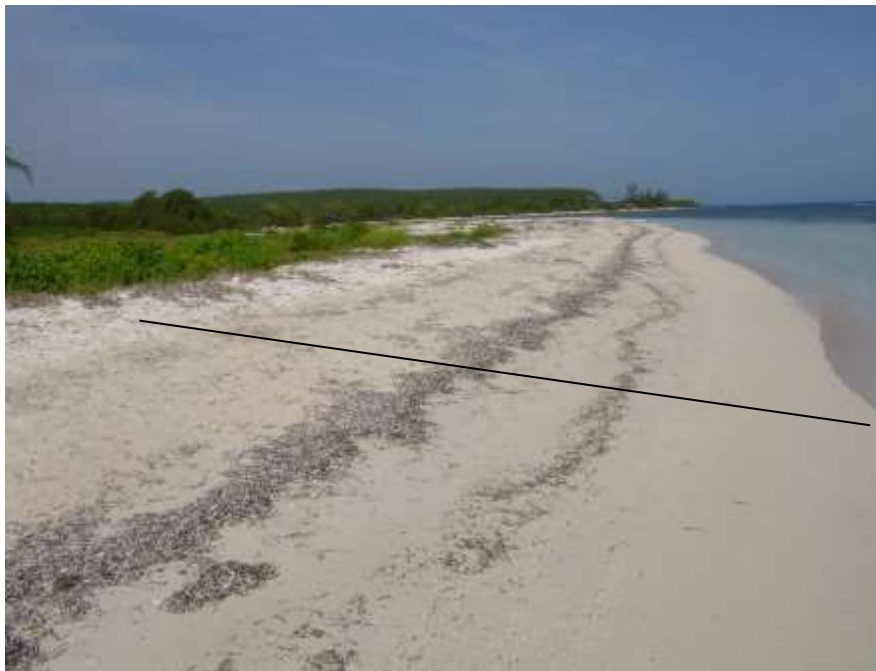
*Plate 5.3.3: Image Taken Perpendicular to the Orientation of Cross Section D*

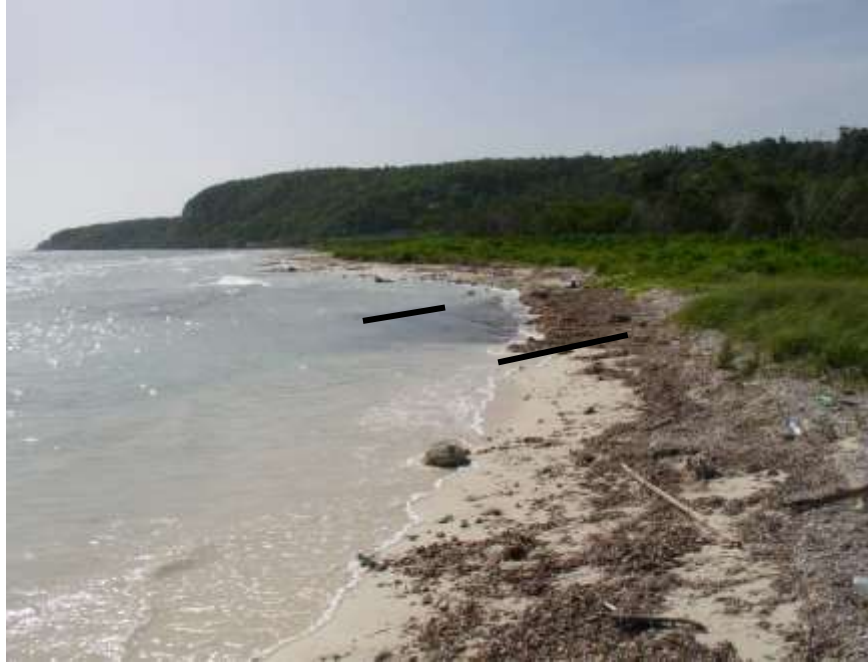
*Plate 5.3.4: Image Taken Perpendicular to the Orientation of Cross Section E (mid foreground) and F (background)*

Though there were no references for temporal comparison, it was obvious that extensive shoreline de-stabilization had occurred in the vicinity of cross section E.

It is theorized that a significant wave event with winds blowing from the north or north east may have resulted in strong waves pushing through the eastern gap in both reefs and seagrasses and impacting on the shore in the vicinity of Cross Section E (see Figure 5.3.5 above). This impact resulted in the erosion of the shoreline seen at this vicinity. Westerly movement of currents resulted in the eroded materials being transported westerly behind the lee of the reef area and depositing itself on the western end of the existing sand deposits (illustrated as the shoreline present in 2013), thus creating the new area of beach sand now seen in 2016.

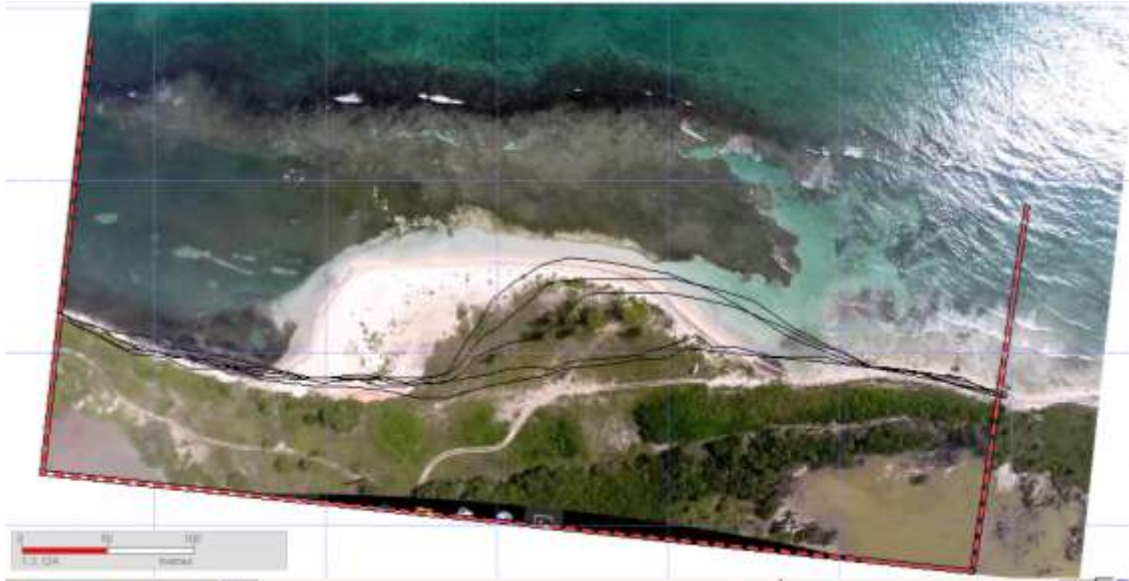
Figure 5.3.6: Shoreline Positions Existing in 2003, 2005, 2010 and 2013 (black lines) Overlaid on top of June 2016 Aerial Imagery

Figure 5.3.6 shows shoreline positions existing in 2003, 2005, 2010 and 2013 overlaid on top of a June 2016 image of the coastal area and shoreline within the boundaries at the proposed development site. Additionally, Figure 5.3.7 summarizes the overlaid shorelines down to those that represent the most significant changes in shoreline orientation over the period 2003-2016. Thus, the shorelines present in 2003, 2013 and 2016 are represented.

Both figures represent a significant increase in the width of the beach area extending from the eastern to the central section of the property's shoreline. However, in 2016, the shoreline showed a significant shift in what can be described as a sandy shoreline prominence towards the western property boundary. A corresponding reduction in the width of the beach area was represented approximately 100 meters west of the eastern property boundary (as illustrated on Figure 5.3.8). This significant shift in the orientation and width of the beach area occurred between the periods of 2013 - 2016.

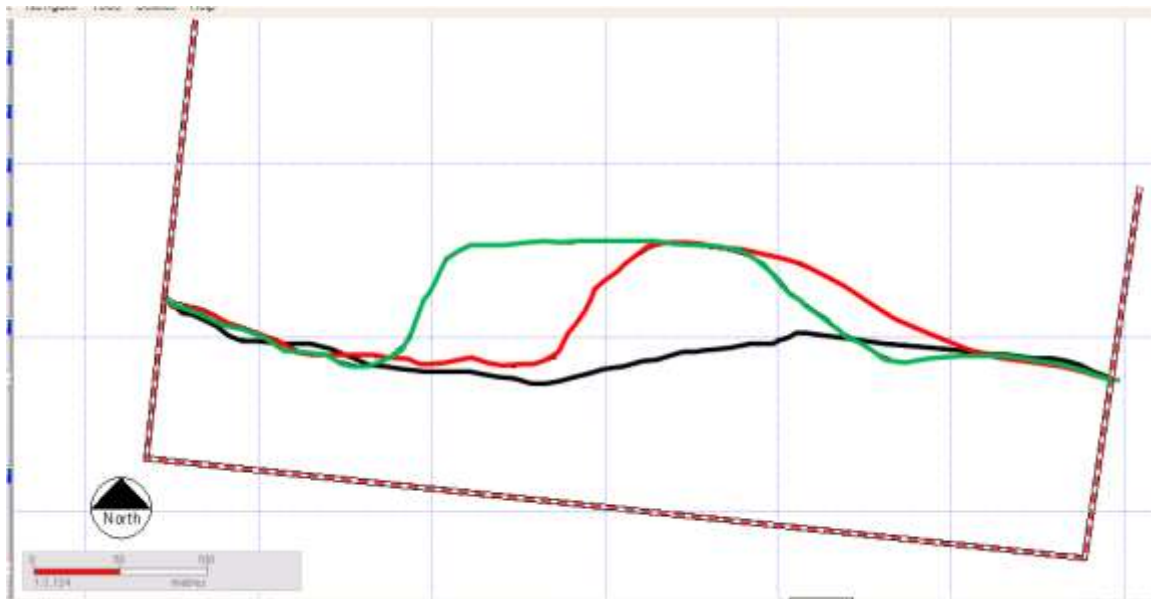
Figure 5.3.7: Shoreline Positions Existing in 2003, 2013 and 2016 Overlaid to Illustrate Shoreline Change

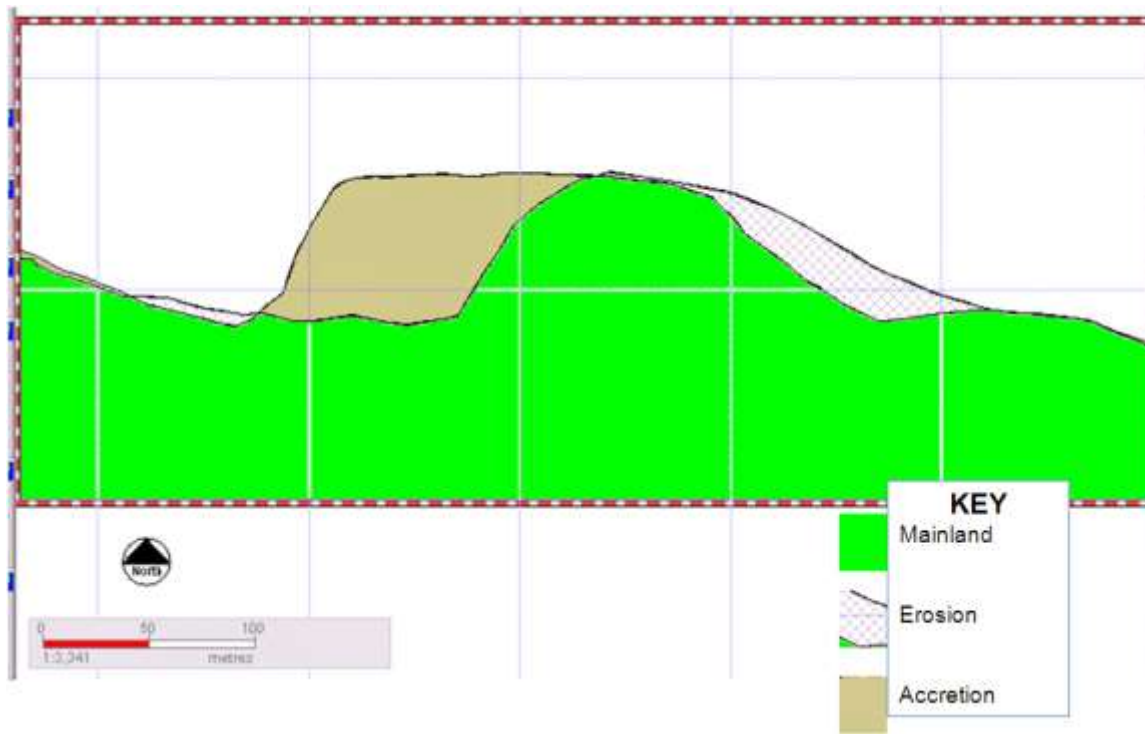
Figure 5.3.8: Areas of Significant Shoreline Accretion and Erosion Occurring Between 2013 and 2106.

It is estimated that 0.7 hectares of new beach area was deposited on the west shoreline and approximately 0.24 hectares of beach area lost over the period 2013-2016. Since the hurricane records show no significant tropical disturbances affecting the area over the period, it can only be concluded that the sudden shoreline variations occurred due to the effects of winter storm events removing sediments from the eastern end of the property shoreline and depositing the sediments on the western end.

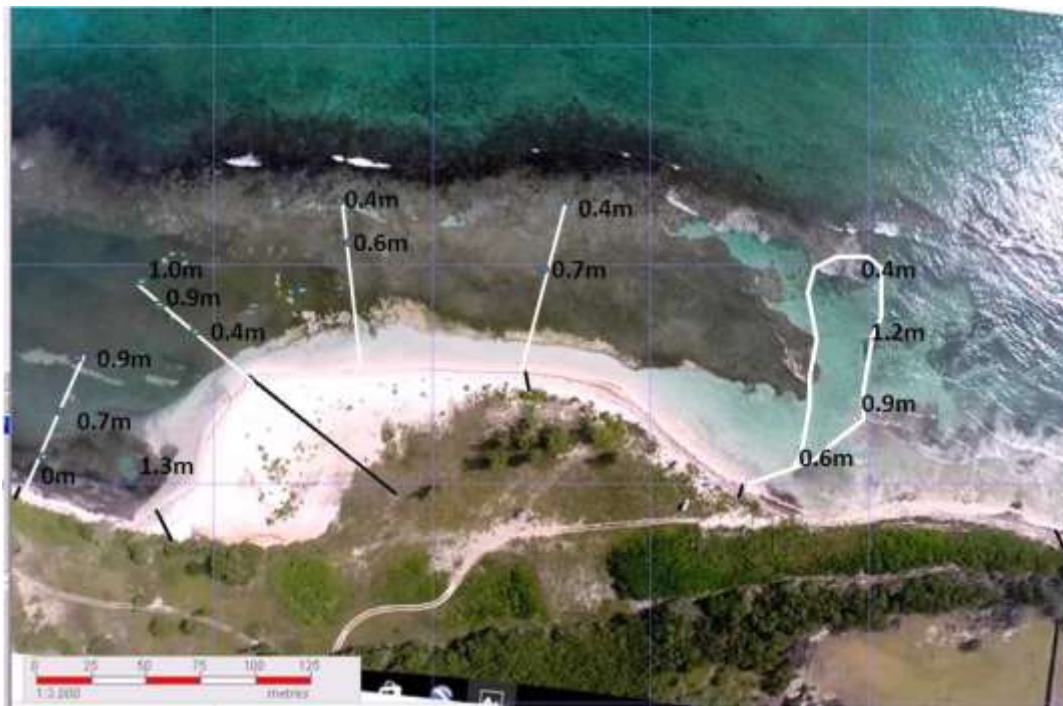
*Figure 5.3.9: Spatial Representation of Depths Existing within 100 meters of the Development Site*

Figure 5.3.9 shows that the seafloor area immediately adjoining the eastern boundary is the deepest area immediately offshore of the eastern and western property boundaries at the site. This area is also the least protected from the onset of wave action, as illustrated in Figure 5.3.10, where significant wave crest presence is seen at the areas highlighted in red, while no such waves exist in the lee of reef areas to the west.

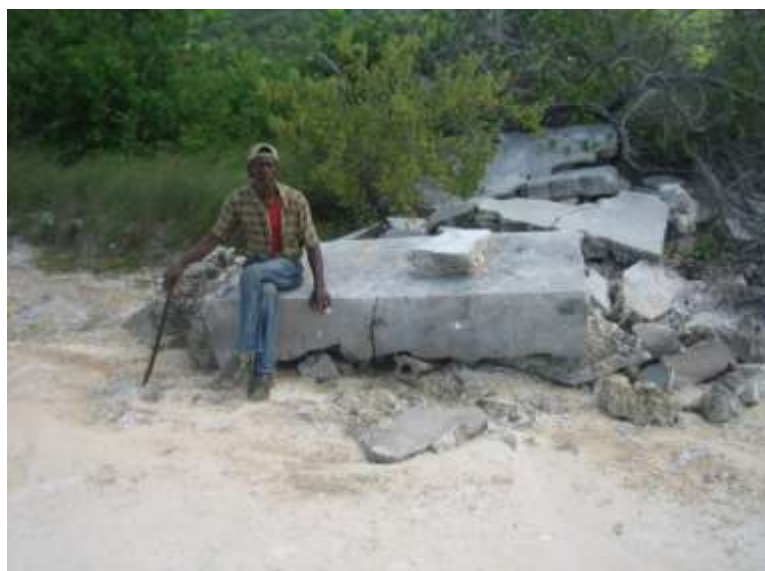
*Figure 5.3.13: Remains of residential structure destroyed by Hurricane Allen –August 1980*

Evidence of storm debris near to the shoreline on the eastern section of the site suggests that storm events would have brought debris from the sea and deposited near the shoreline as a result of high wave action. A Storm Surge Damage Assessment Report prepared by Wilmot Simpson et al (MGD 1980) following the passage of Hurricane Allen in August 1980 estimate storm surge heights and maximum run-up distances of 1.25 m (5 ft) and 18m (60ft) at Silver Sands-Duncans, (4.7 km east of project site) and 1.8m and 136m at Falmouth in Trelawny, respectively. There is also evidence of a concrete residential structure near to the western boundary on the coastline which was destroyed by wave action (Figure 5.3.13). Anecdotal evidence suggests that the house was destroyed by Hurricane Allen in August 1980. The hurricane passed between Jamaica and Hispaniola as a Category 4 and caused significant damage to Jamaica's northern and north eastern coastline.

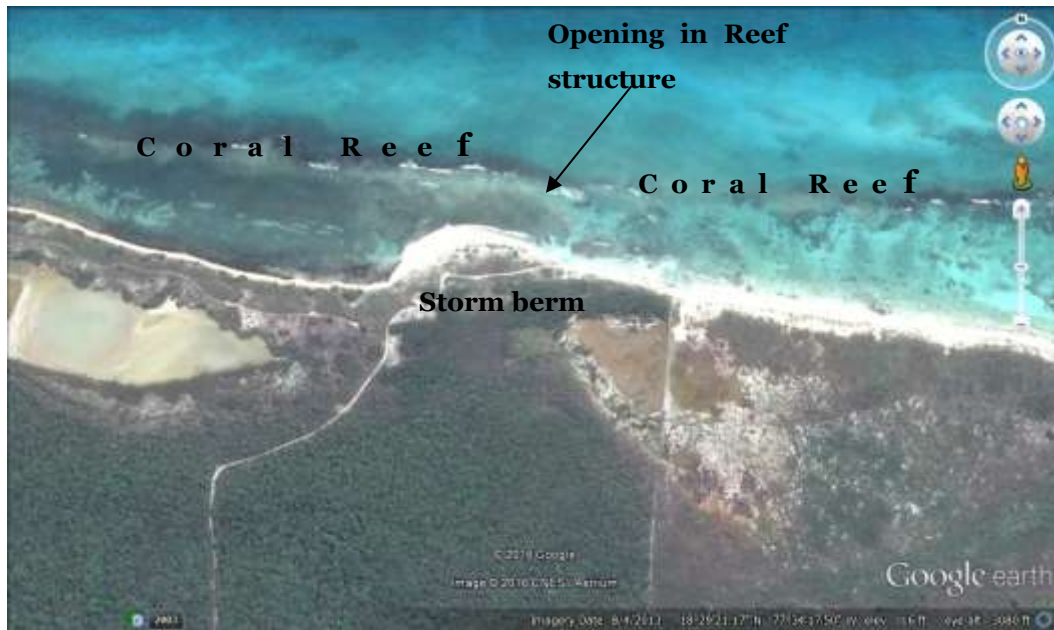
Figure 5.3.14: Coral Reef stretching across the seafloor with a gap in the reef structure

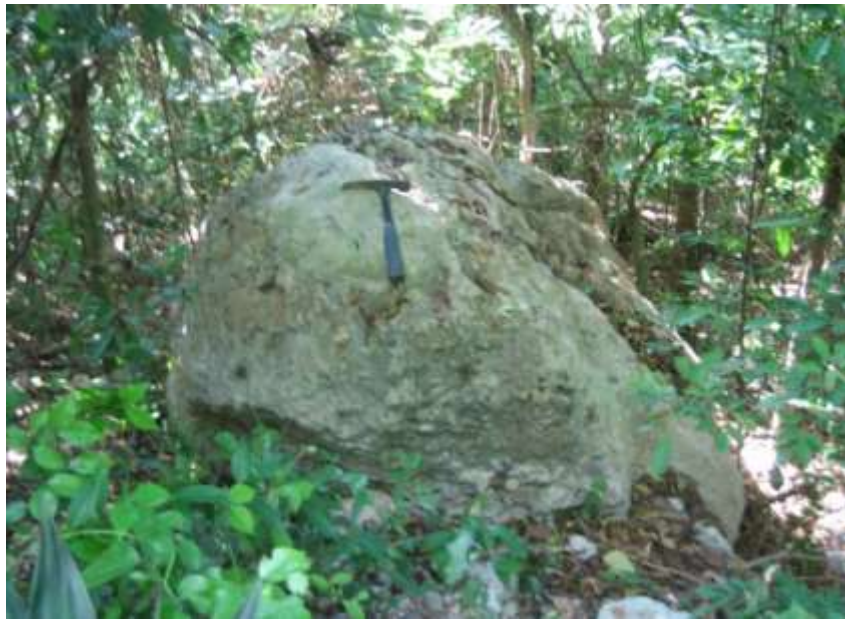
*Plate 5.3.5: Large boulder on the scarp slope near the south eastern boundary of site*

The large boulders are more prominent on the upper section at higher elevations on the slope and there is evidence that a number of boulders perched on the slope come to rest on the trunks of slender trees which prevent them from being mobilized down slope.

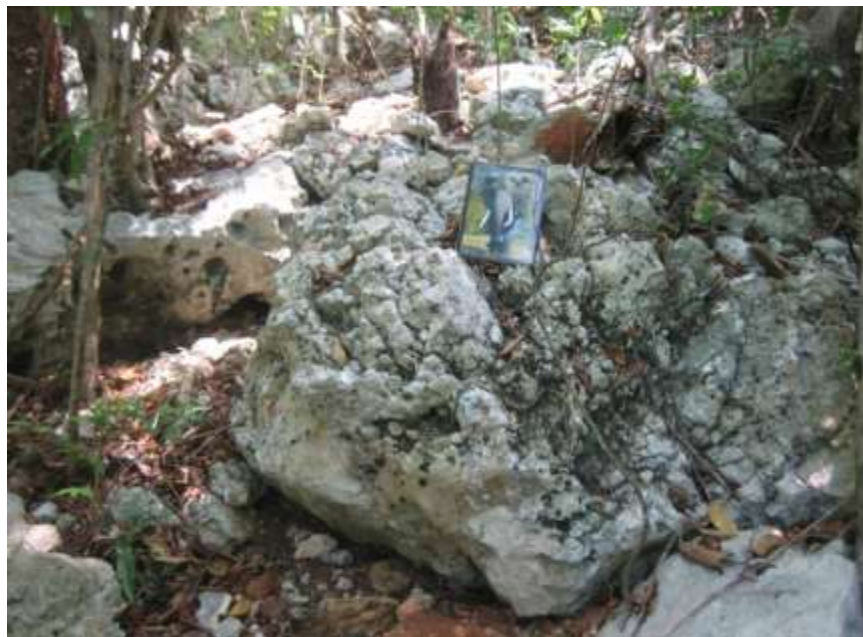
*Plate 5.3.6: Large boulders on the south western side of the limestone hills in the south*

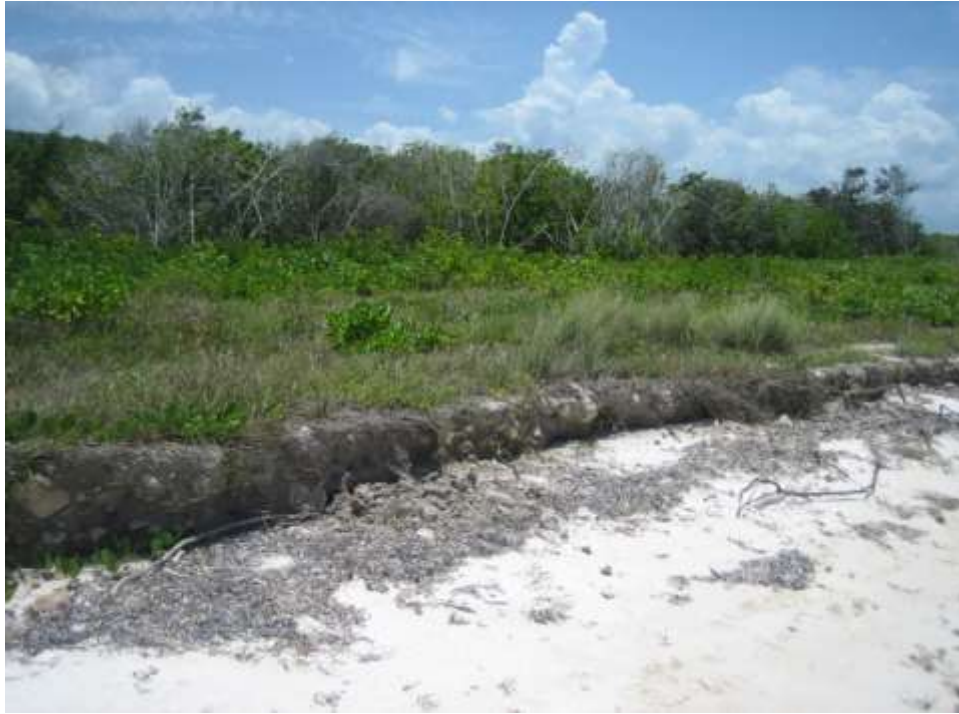
Plate 5.3.7: Erosion of coastline sediments on the eastern side of the shoreline on the site

The 2013 Google Image was compared with present morphology<sup>2016</sup> of the coastline, based on a recent site inspection. It shows that there are areas of erosion and deposition/accumulation of sediments on the coastline on the site. Coastal sediments are eroded on the eastern side of the shoreline (Plate 5.3.7), is transported by the sea currents and deposited on the western side. The coastline at the site is dynamic based in the episodes of erosion and deposition at short distances along the shoreline. This has resulted in a change in morphology as a result of erosion on the east and deposition on the west along the coastline at the site. This coastal dynamic has been corroborated by residents with knowledge of the area, which suggests that deposition of beach sediments on the western side has been recent.

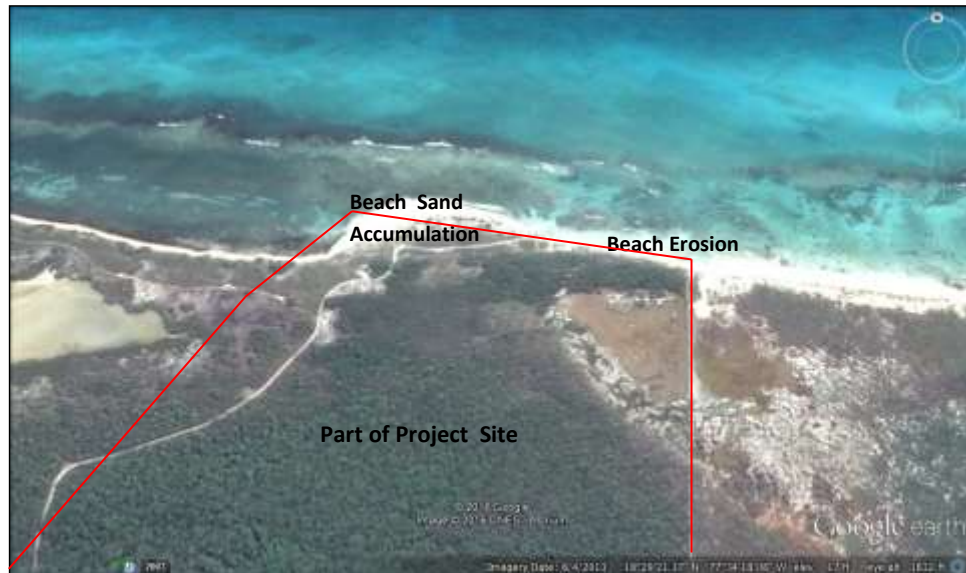
Plate 5.3.8: Google Image (2013) depicting areas of beach erosion and accumulation on the project

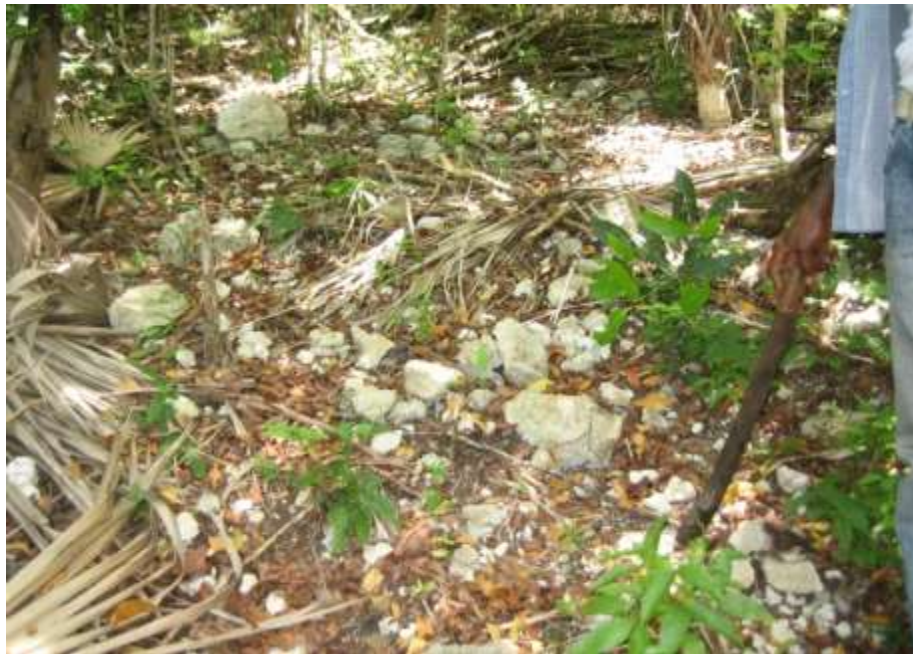
Plate 5.3.9: Small boulders and cobblestones strewn on the hillside located on site

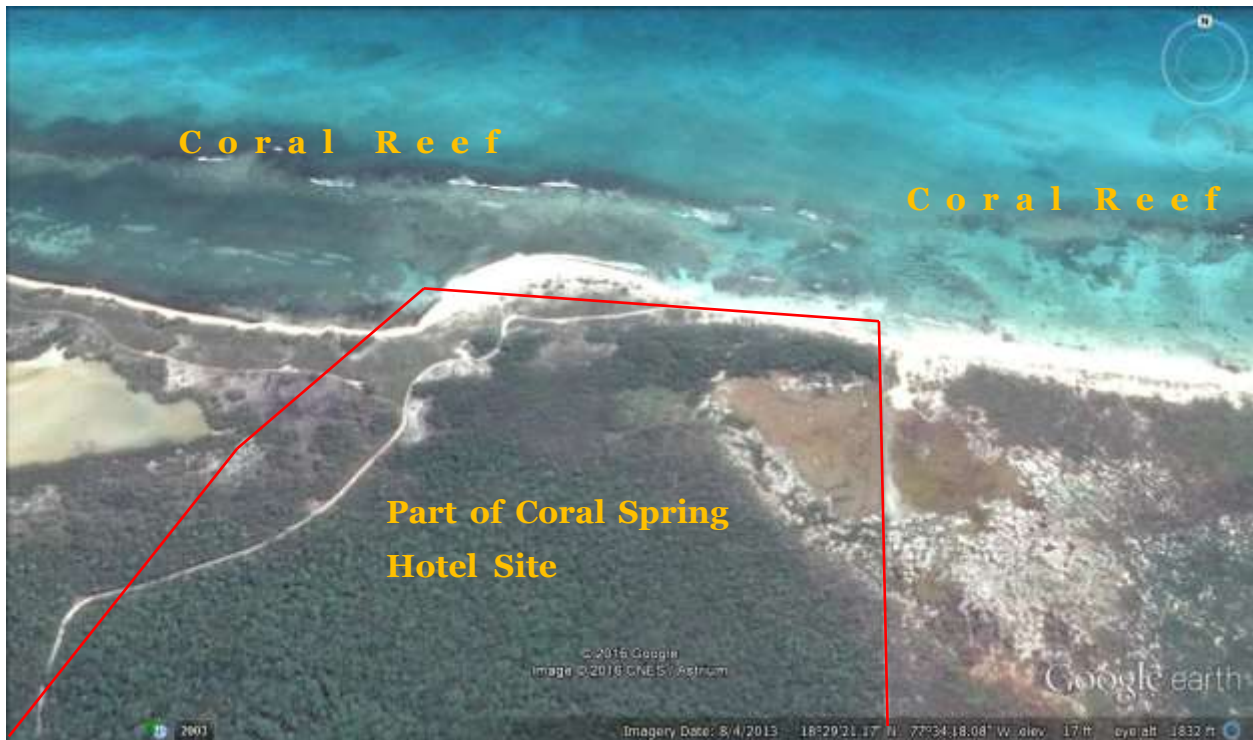
Figure 5.4.15: Coral reefs in the shallow sea water near to the northern coastline

Coral reefs form a linear, shallow underwater structure composed of skeletons of corals which are marine invertebrate animals. The reefs are located approximately 68m-150 m from the northern coastline and are aligned parallel/near-parallel to the shoreline (Figure 5.4.15). These coral reefs tend to thrive in tropical waters because they extract calcium carbonate from the sea water to create a hard exoskeleton to protect their soft sac-like bodies ([www.livesciences.com/40276-coral-reefs](http://www.livesciences.com/40276-coral-reefs)). Coral reefs provided a variety of ecosystems services, including tourism, fisheries and shoreline protection. They are

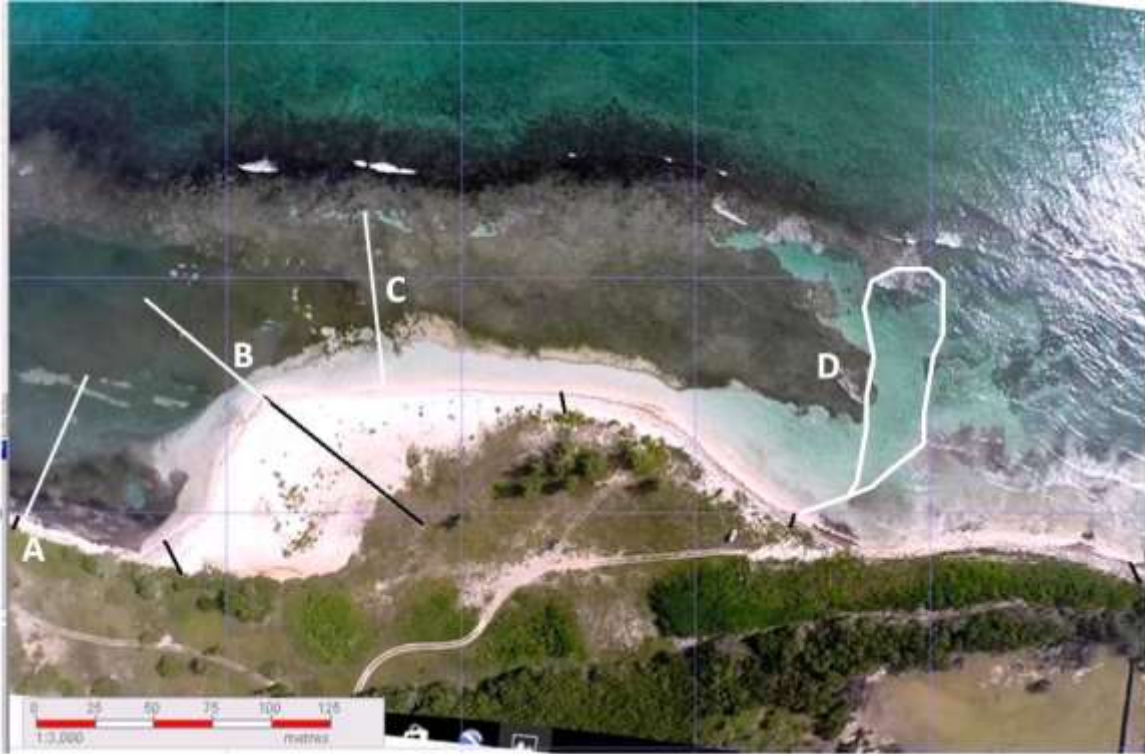
Figure 5.4.16: Position of Marine Transect Lines in the Study Area (white lines)

Video recordings taken along each of the transects deployed were then used to confirm spatial characterizations interpreted for marine substrates and benthic lifeforms within a 100 meter distance from the shoreline of the proposed site. Additionally, presence/absence descriptions of all fauna observed within the area were also recoded. **No interpretations of lifeform population statistics or diversities were attempted.** Assessments were confined to a representation of what was spatially interpreted from the aerial images and what was seen and identified during transect surveys.

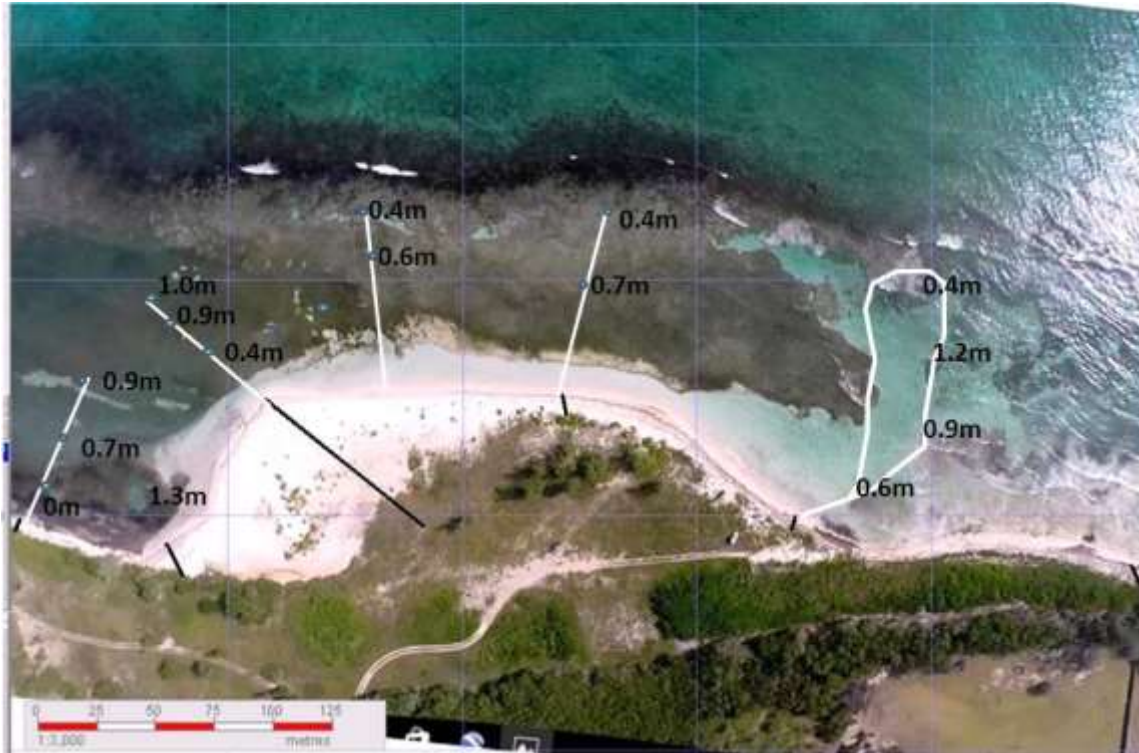
Figure 5.4.18: Spatial Representation of Depths Existing Within 100 meters of the Development Site
