# ENVIRONMENTAL IMPACT ASSESSMENT

## FOR THE PROPOSED DEVELOPMENT OF A HOTEL RESORT AT, CORAL SPRINGS TRELAWNY, JAMAICA

October 2016

**ENVIROPLANNERS LTD.**

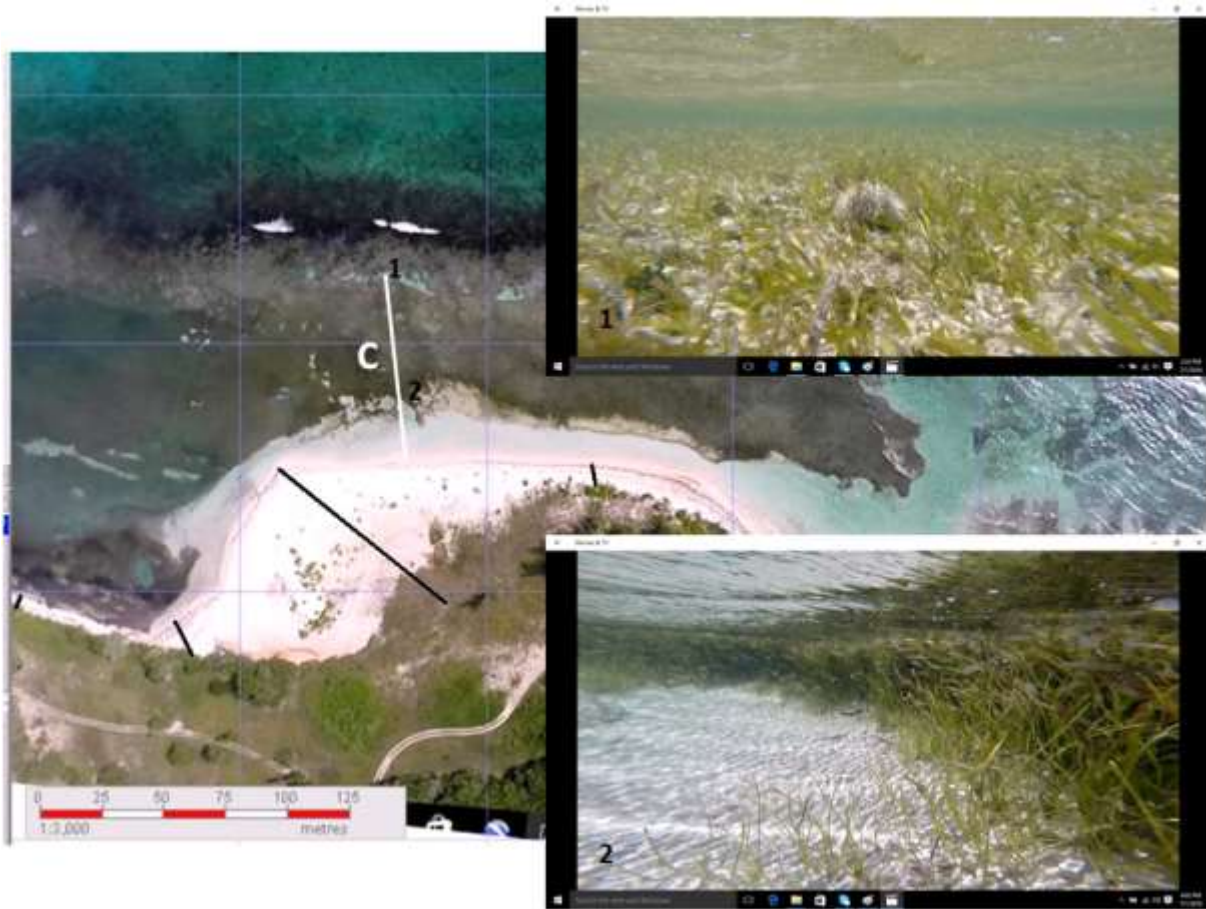
Figure 5.4.23: Illustration of Seagrass Resources Present Along Study Transects (1 –seagrass on sand/hard bottom substrate, 2- seagrass on sand/growth limited by erosion feature.

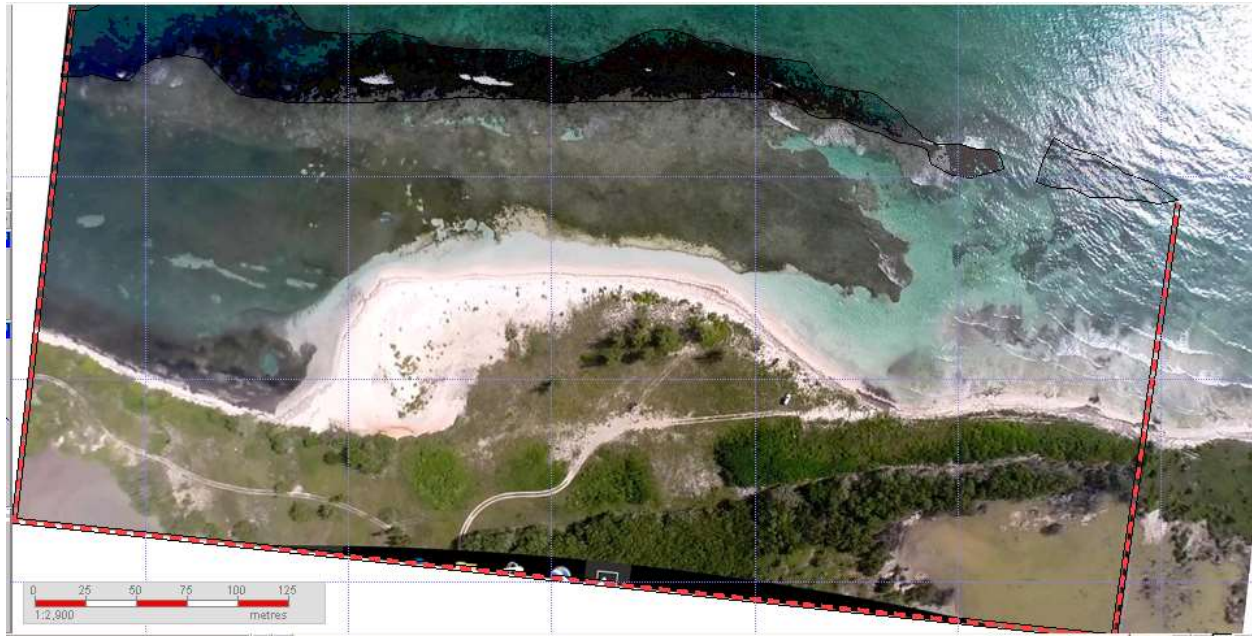
Figure 5.4.24: Location of Reef Resources Present Within the Study Area (black/grey polygon).

Figure 5.4.24 illustrates the spatial distribution of reef resources within the study area. A detailed evaluation of the status of the reef resources present on the windward side (outside of the 100 meter seaward boundary) of the study area was not done. However, an indication of the status of reef resources on the leeward side was obtained during an examination of the eastern most study transect, as well as the northern extents of the other transects surveyed.

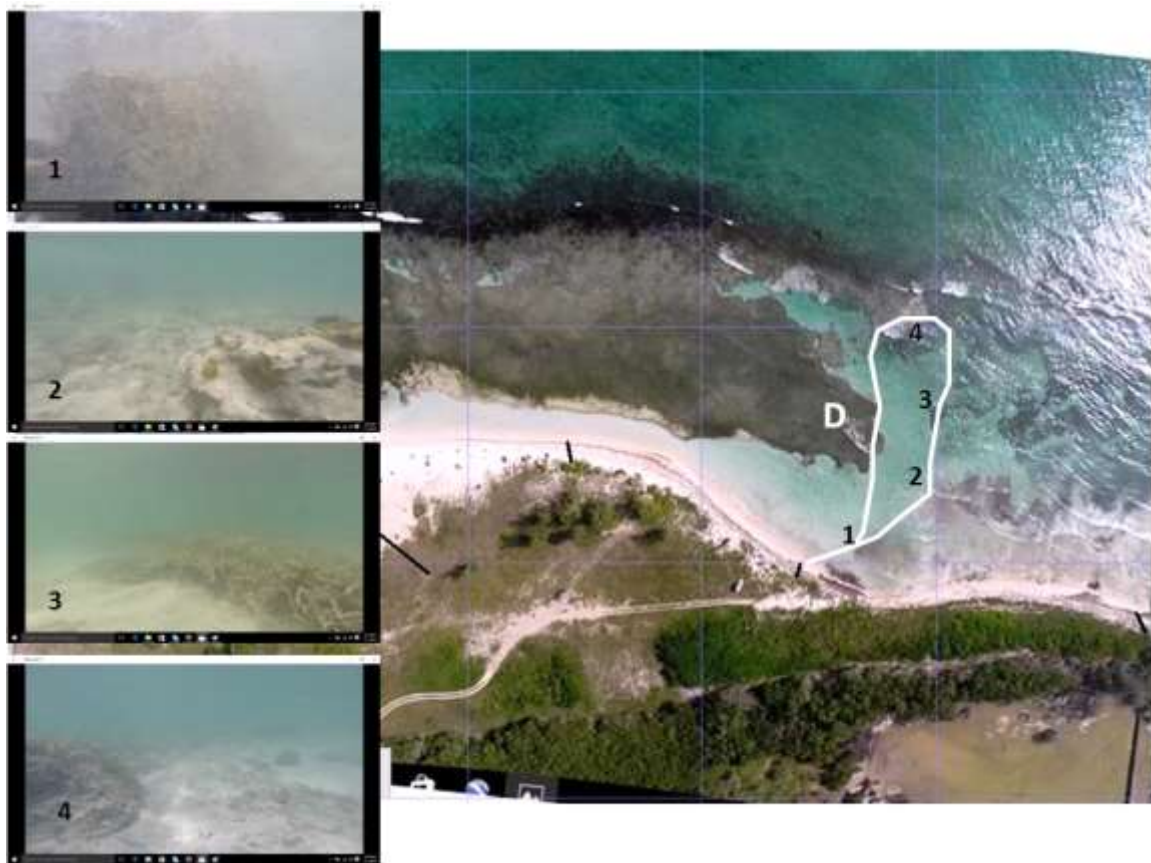
Figure 5.4.25: Seagrass and Reef Resources Present Within the Study Area.

For the most part, reef resources observed at the northern extent of the transect surveyed (see Figure 5.4.25 below) were devoid of excessive macro-algae growth. Coral resources were sparsely distributed within the area surveyed and were comprised primarily of small (less than 15cm in diameter) heads of Smooth Starlet Coral (*Siderastrea radians* – see Figure 5.4.25: insert 2 below) and Fire Coral (*Millepora sp*).

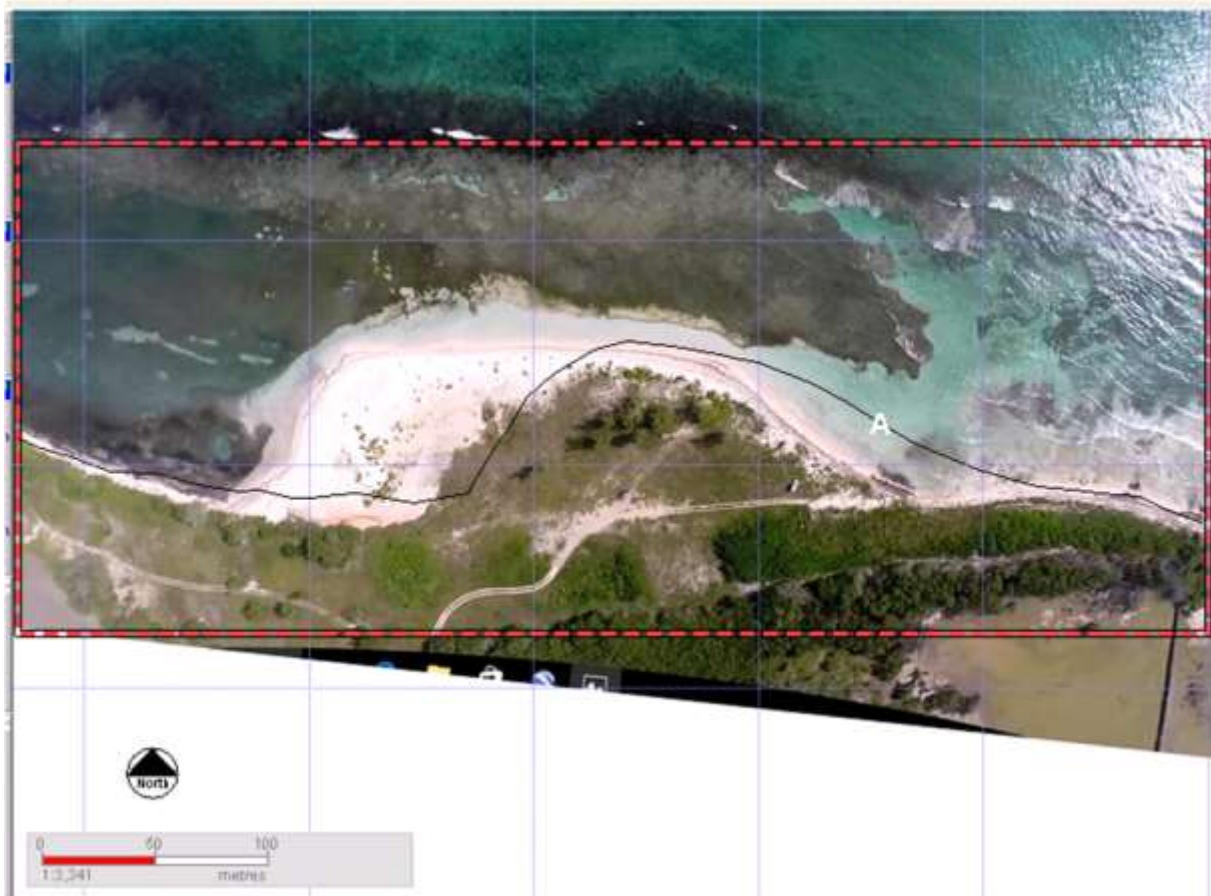
Figure 5.4.26: Shoreline Change Experienced Over the Study Area Over the Period 2013-2016 (A-shoreline position in 2013).

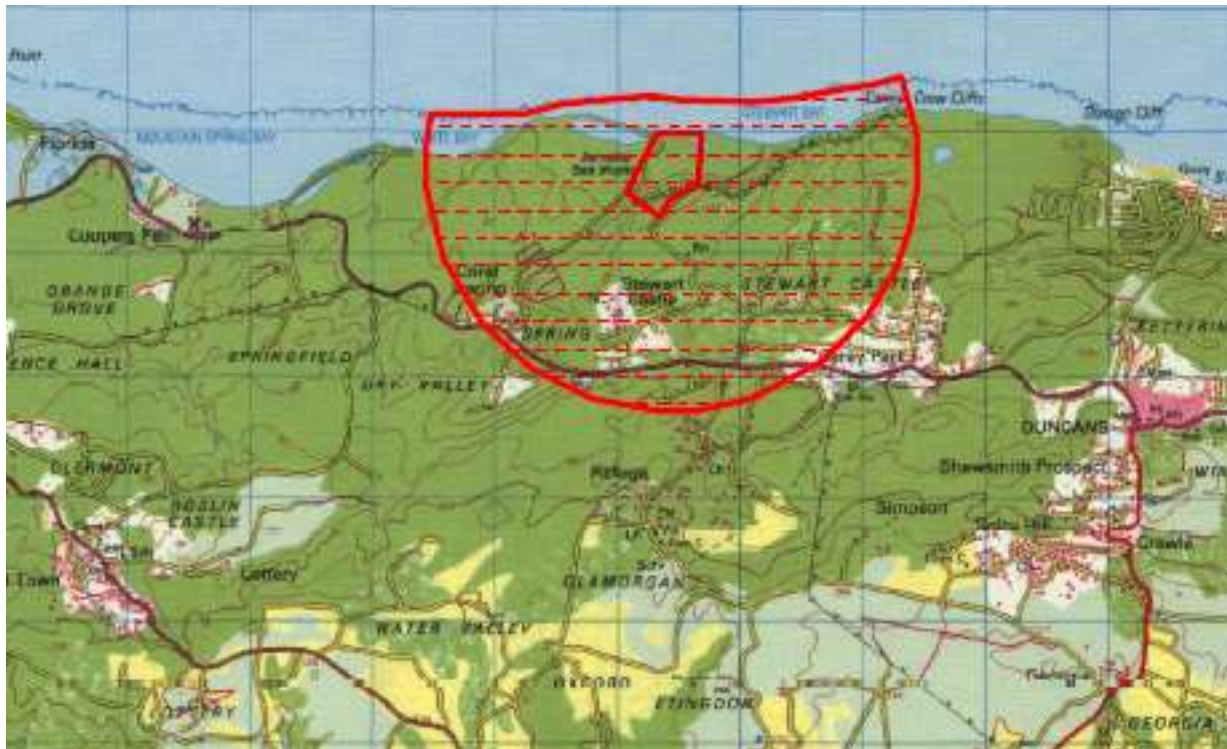
Figure 5.6.1: 2 km Zone of Immediate Influence

For the purpose of this assessment the zone of socio-economic impact will focus on the geographical areas which are within a 2 km radius of the project site. There are no residential communities within 1 km of the project and the communities within the 2 km sphere of influence are; Coral Spring, Stewart Castle and Carey Park (Figure 5.6.1). Other communities which although not within the 2 km zone but was included in the assessment are Coopers Pen, Retreat Heights and Duncans.

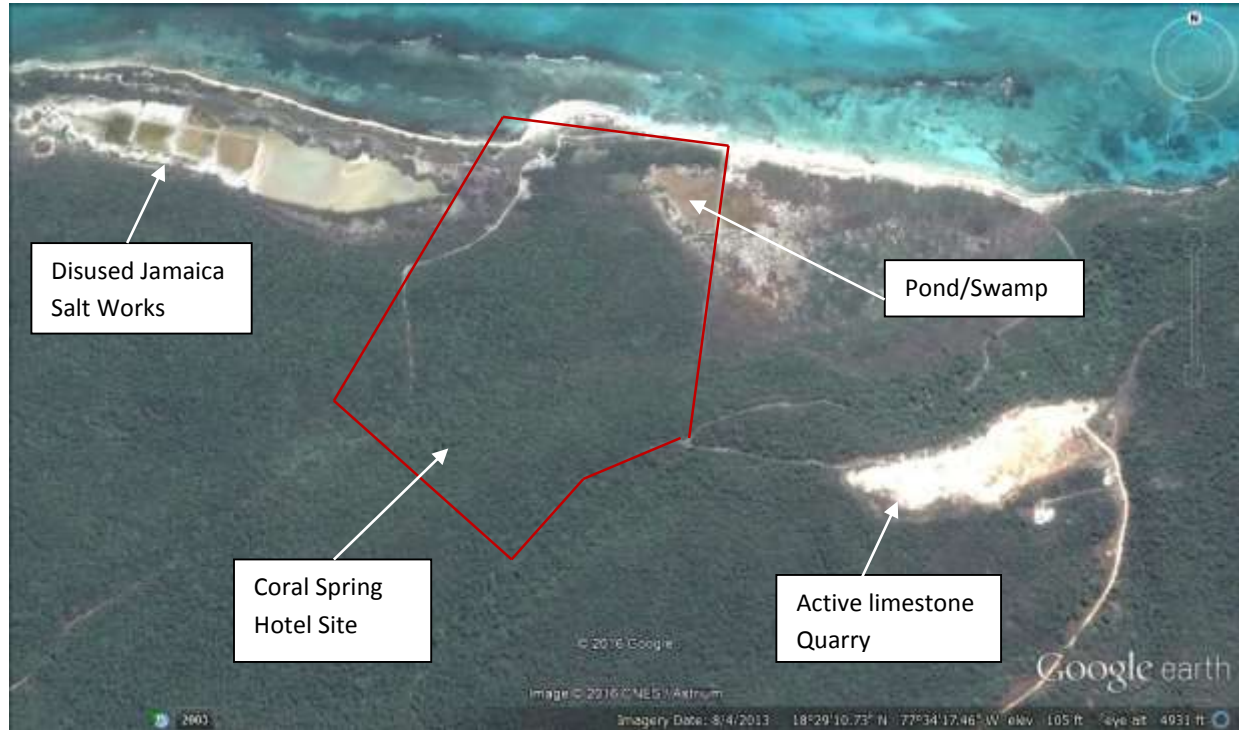
Figure 5.6.6: Google map showing mineral resource locations in relation to Coral Spring Hotel site

fishing beach to the project is at Rock. It should also be mentioned that the Jamaica Salt Works<sup>37</sup> is approximately 100m to the west of the project site, however operations from the evaporation process at the pond has ceased and is inactive (Figure 5.6.6).

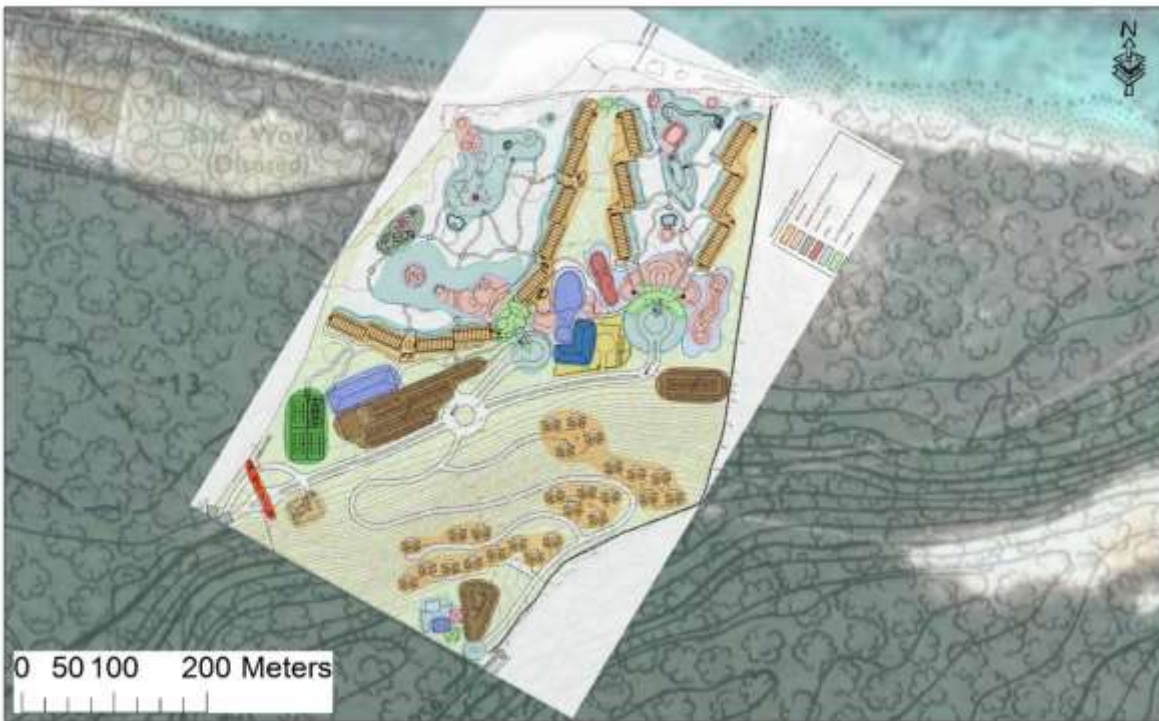
Figure 7.4.1: Map showing post-development conditions of the site

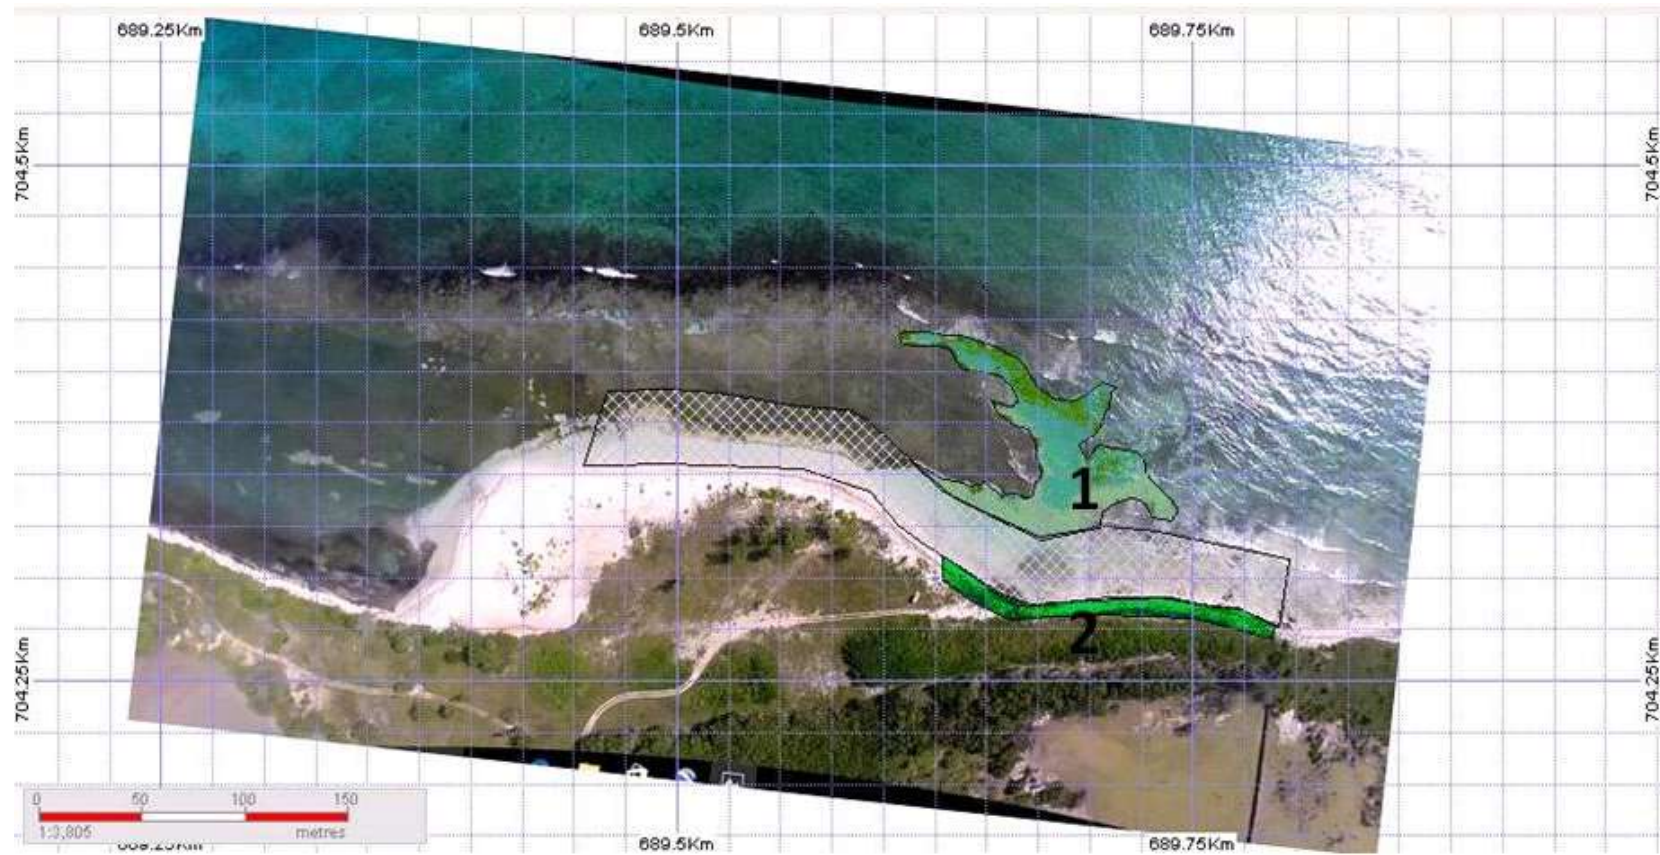
Figure 8.1.1: Proposed Mitigation Areas of Seagrass within Proposed Wading Area that will Require Mitigation (1) seagrass mitigation area, (2) dredged sand disposal area – reclamation of eroded shoreline

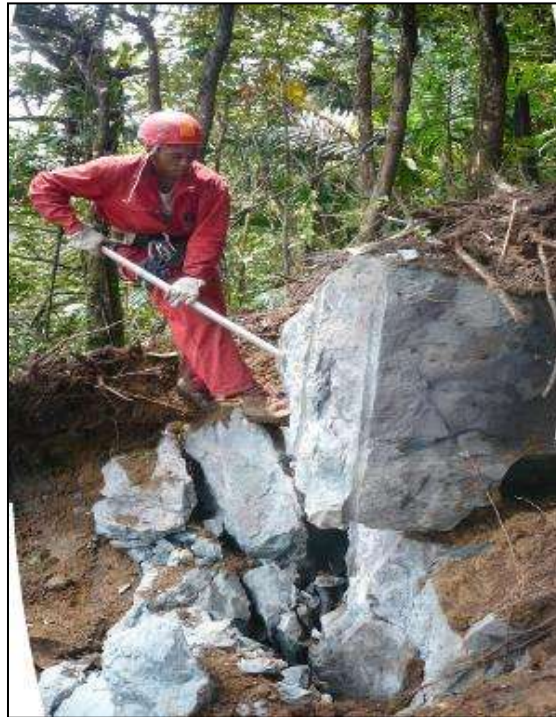
*Figure 8.2.1: Manual Elimination using a miner's bar to break and remove smaller pieces of rock down the slope (Courtesy of the General Council of Martinique)*

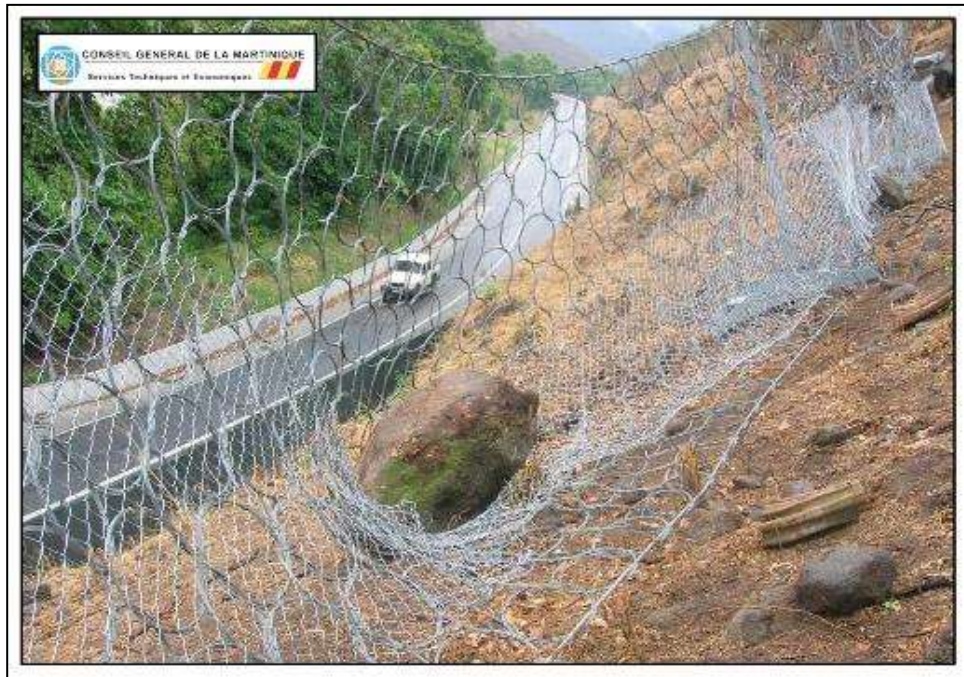
*Figure 8.2.2: Example of Block Wall Net Screens for trapping boulders which are mobilized from the upper slope (Courtesy of the General Council of Martinique)*

Reducing rockfalls will include manual eliminations using a minor's bar to break and remove small loose rock ( $< 5 \text{ m}^3$ ) on the slope (Figure 8.2.1) as well as engineering and

structural methods for rockfalls protection such as rock berms, wire/net mesh and block wall net screens to control rock falls on the slope (Figure 8.2.2).

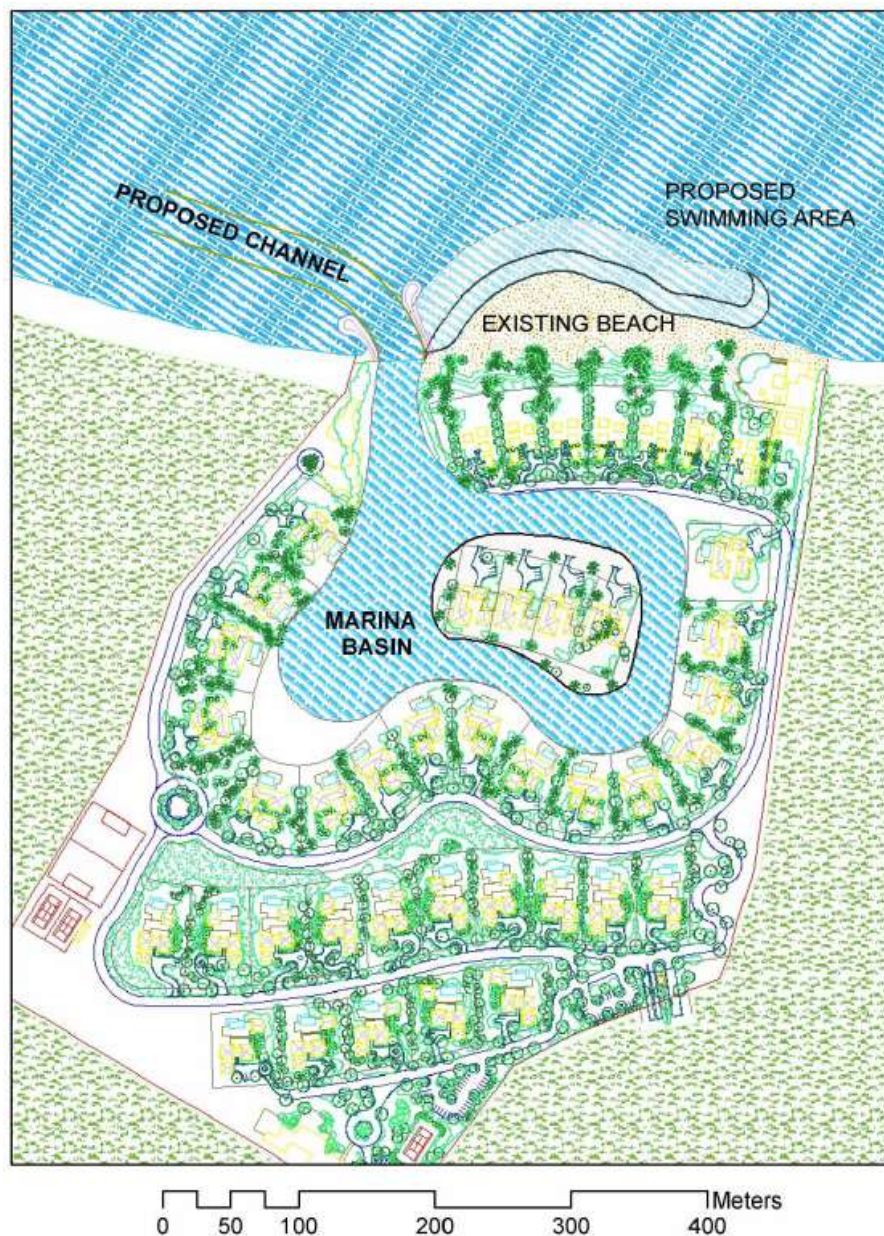
Figure 10.3.1: Layout of proposed marina and villas development

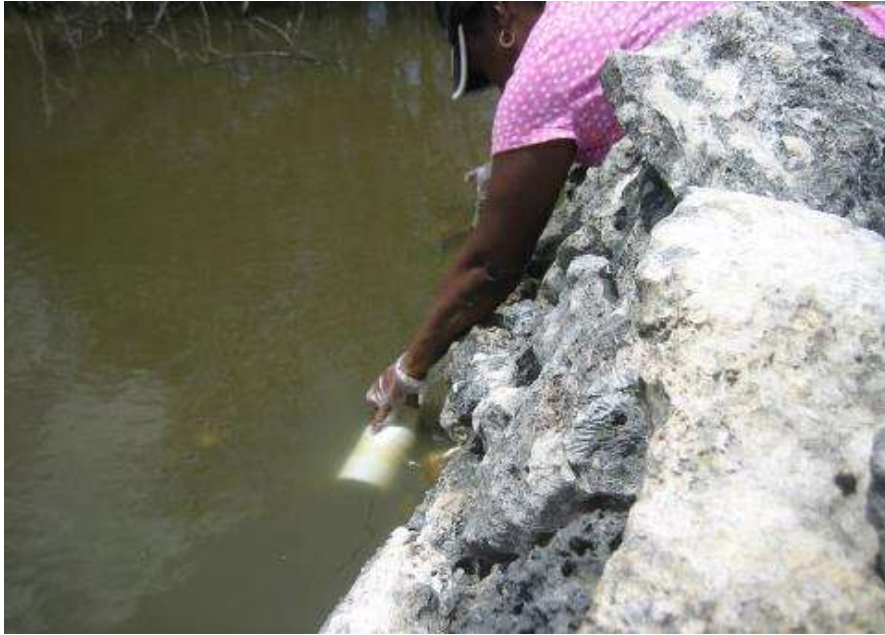
**A:** Sample collection at JAD 2001 coordinate points 689702.891E 704204.47N

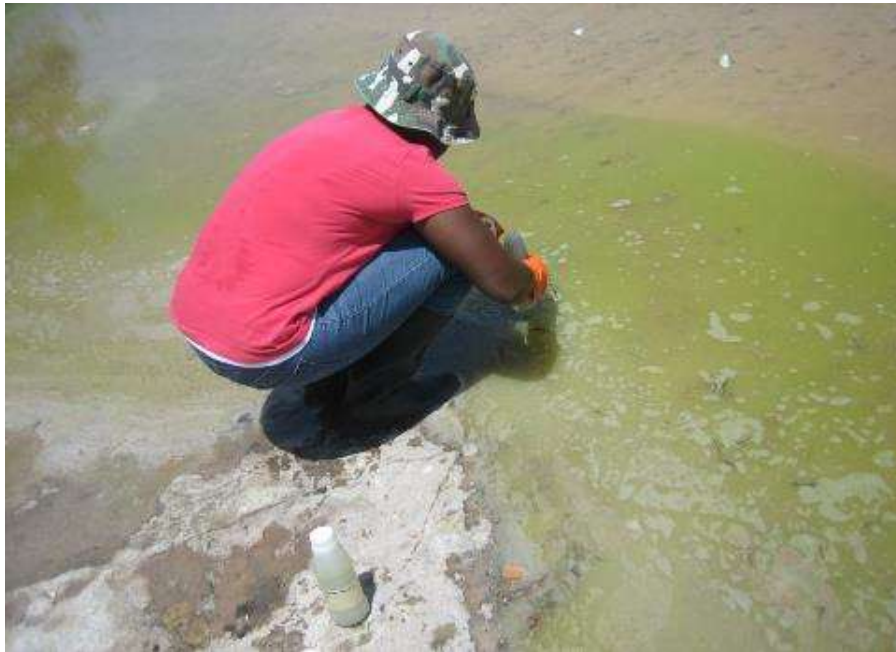
**B:** Water sample collection at JAD 2001 coordinate points 689 744.569E 704141.953N
