Technical Report

Construction and Maintenance of Overwater Structure

Whitehouse, Westmoreland

April 2017

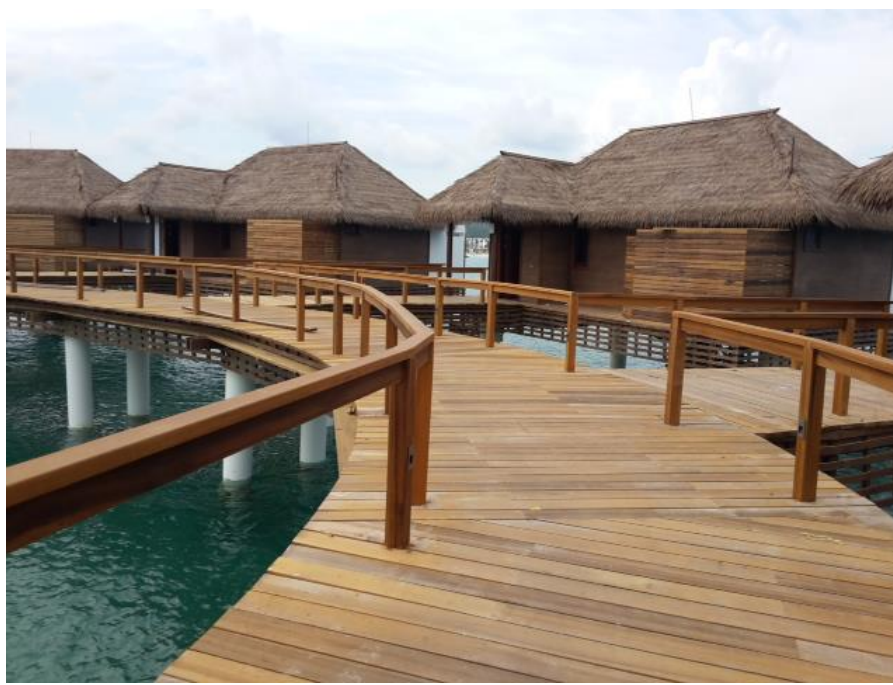
The exterior wall will be built with Resysta synthetic wood and the roof will be covered by ViroThatch synthetic fibre (see Figure 4.8 showing structure below). Stainless steel nails and screws will be used to secure wood and wood product. The walls and ceilings of the structure will be well insulated to reduce sounds, water and air intrusion and thermal energy. Turtle approved lighting will be used so as not to impact turtle nesting to the west of the building. Gravity feed sewage system would be installed, with sewage proceeding below the protected boardwalk to lift station on land.

Figure: 4.8. Showing Overwater Structure at SRC

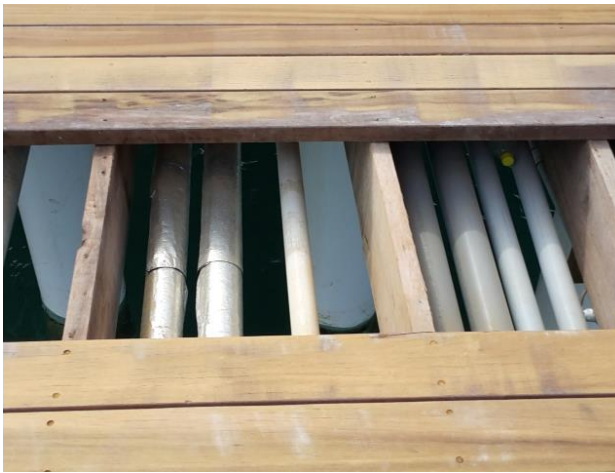
Figure: 4.10 Photo, showing utilities under boardwalk at SRC

All the required utilities that are expected in a typical hotel room will be provided to the rooms of this structure. The conduit for all utilities will run under the boardwalk as required by the planning guidelines for the overwater structure (See figures 4.10 and 4.11 below). All the pipelines and cables rest on the 2" x 8" Greenheart joist girder, except the Sewage pipelines which will rest on a specially built bracket. Resysta siding will shield both sides of the boardwalk, providing an additional shield of protection. The conduits are well protected from environmental elements within the boardwalk and cannot be easily reached accidentally. The following conduits are found under the boardwalk;

- 2" PVC Conduit for Cable Television
- 2" PVC Conduit for Data/Voice
- 2" PVC Conduit Fire Protection Cable
- 1 1/2" PVC Schedule 40 cold water supply
- 1 1/4" CPVC Schedule 40 hot water supply (insulated)
- 1" CPVC Schedule 40 hot water return (insulated)

- Two (2) x 25mm PVC Conduits for walkway lighting
- Eight (8) – 35mm 4 Core XLPE electrical cables
- Two (2) - 50mm 4 Core XLPE electrical cables
- Two (2) – 25mm 4 Core XLPE electrical cables
- 4” and 6” PVC schedule 40 Sewage pipelines

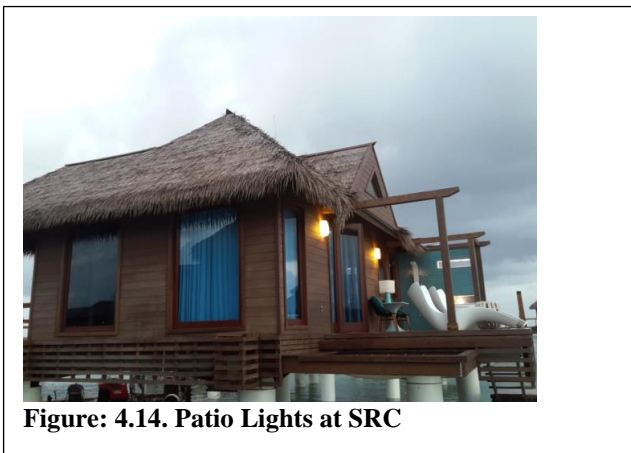
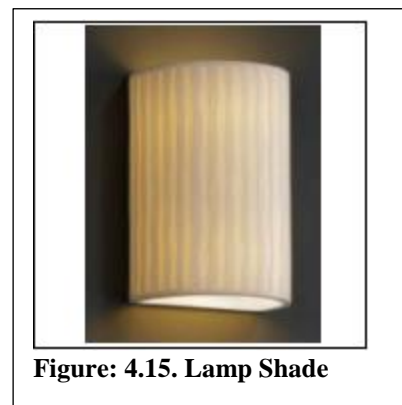
The buildings are designed with 4 main external lighting. Two (2) of these would be the entry lights to the rooms, coming off the boardwalk. The other two (2) outside light will be either side of the patio door. All of these lights would have the required lamp shade as shown in Figures 4.14 and 4.15 below.

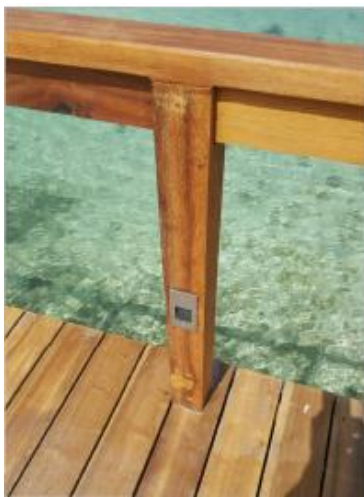
Figure: 4.17. Showing Light installation at SRC

The boardwalk will be lit with a low impact red LED light that is recessed within the Greenheart studs along the boardwalk. The boardwalk light as designed will not focus behind the boardwalk. (See current installation at SRC in Montego Bay in Figures 4.17 and 4.18.

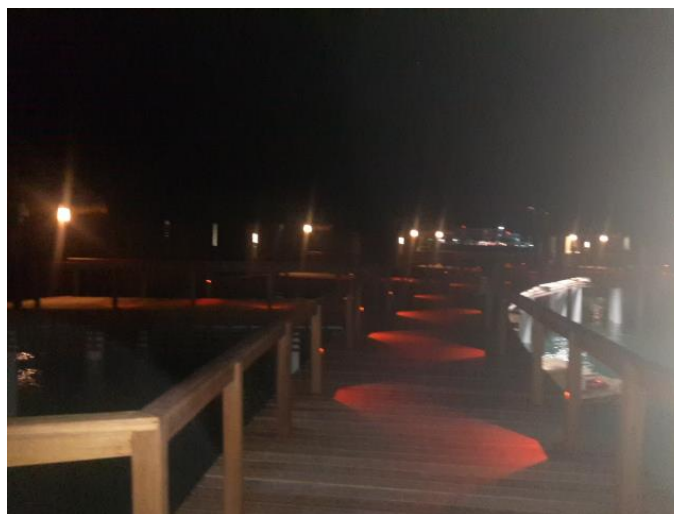
Figure: 4.18. Showing light along boardwalk and general light impact at SRC

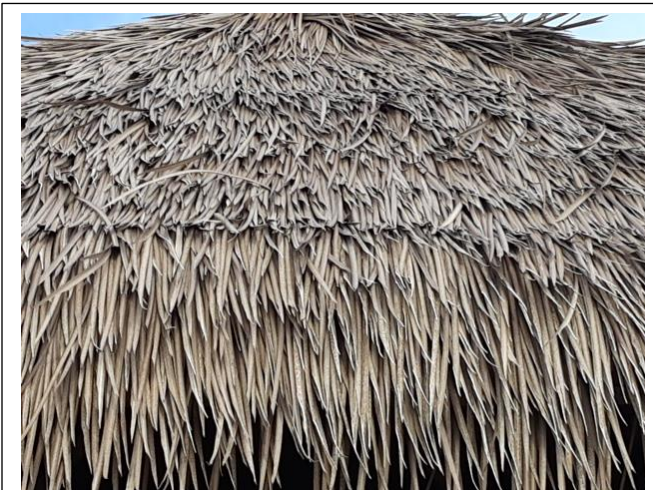
- Maintenance Free, Will not remold, rot, or shed.
- Resists termites, birds and other pests that normally infest and breakdown natural thatch.
- Virothatch is 100% waterproof and weatherproof.
- No season shortages because it is factory produced.
- 100% recyclable. Made of HDPE, high-density polyethylene.
- Built-in fire retardant.
- Virothatch will not fade or discolor. Each strand varies in color from brown to honey, giving Virothatch a very natural authentic look.

Figure: 4.21. Showing Virothatch on roof at SRC

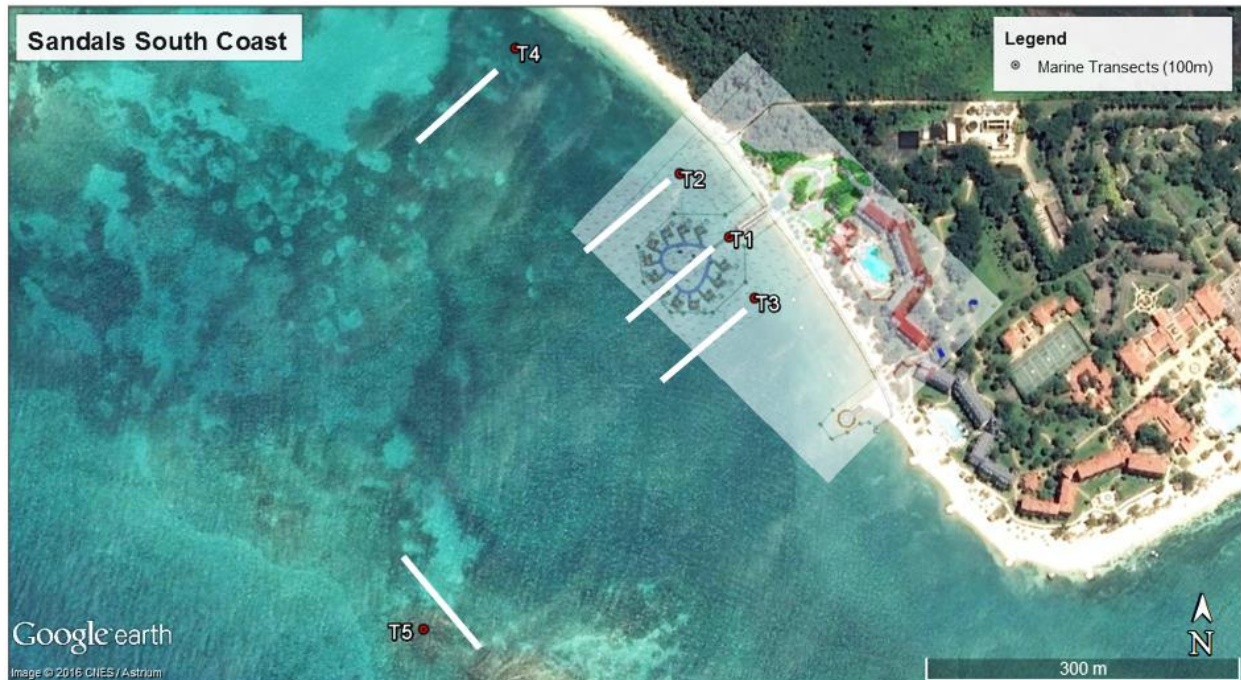
Figure 5.1 Location of fish, invertebrate and seagrass survey transects in and around the project area.

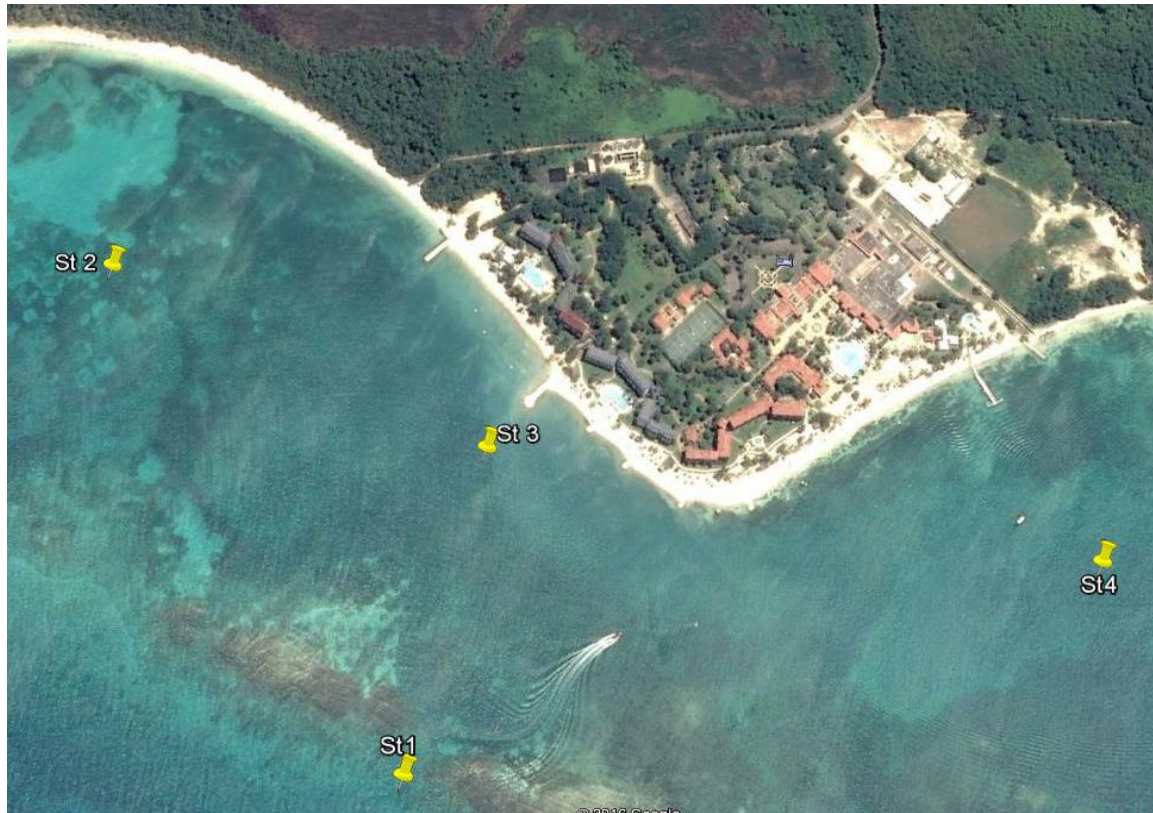
at the bottom of the water column. Field measurements were also conducted at the Water Sports pier and in the pond just east of the resort.

Figure 5.2: Water Samplings Points

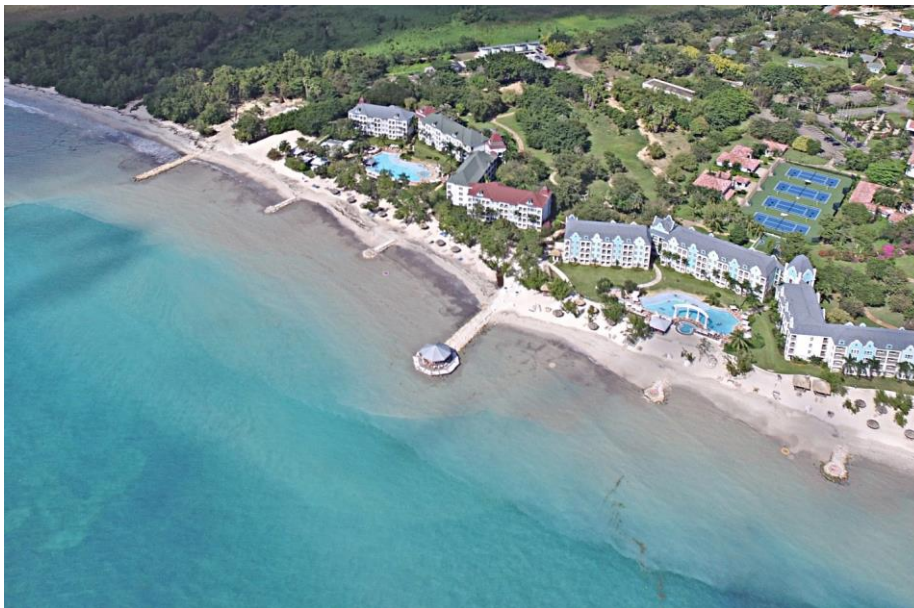
Figure 5.5 Aerial view of groynes placed along French and Dutch Beach segments of the beach. Inshore turbidity following days of rough weather (TEMN 2017 Aerial Photo).

Groynes have been placed along the shoreline in order to minimize coastal erosion due to storm waves. The placement of these groynes has been successful in building up the beach, particularly along the eastern side however, there is concern that the presence of the long “bar” groyne, may in fact, be preventing natural circulation of water circulation immediately to the west (**Figure 5.5**).

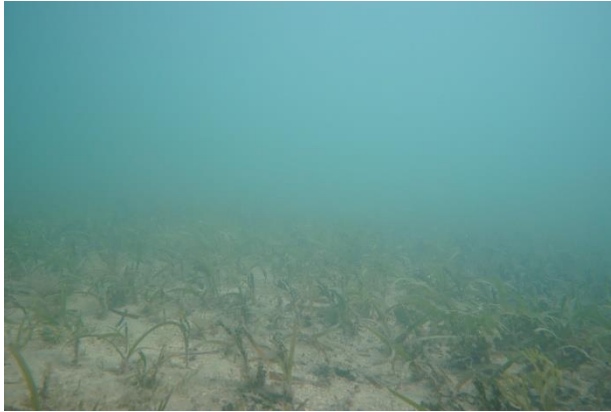
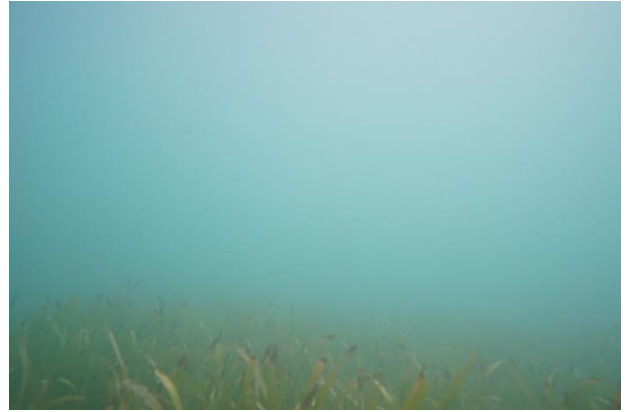
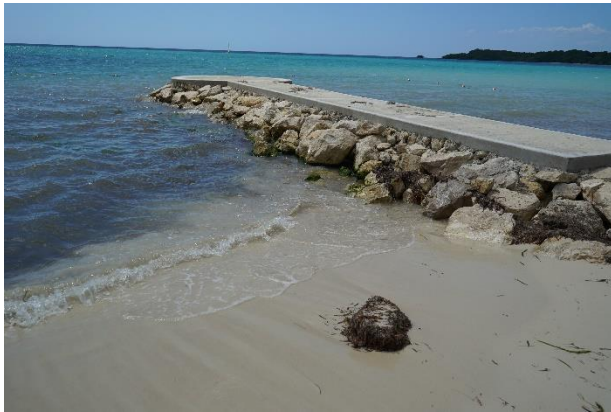
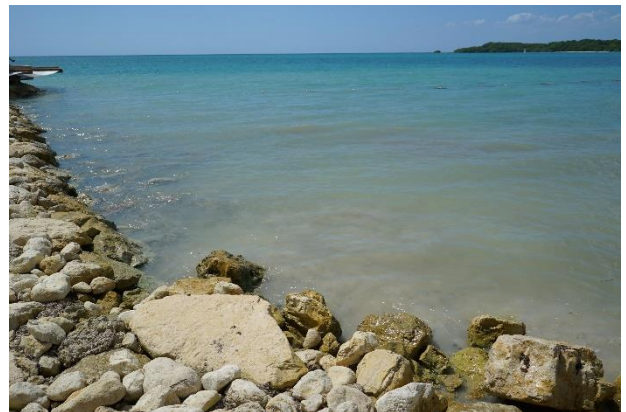
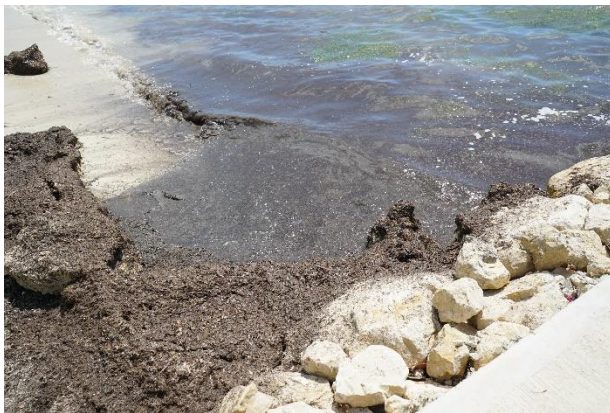
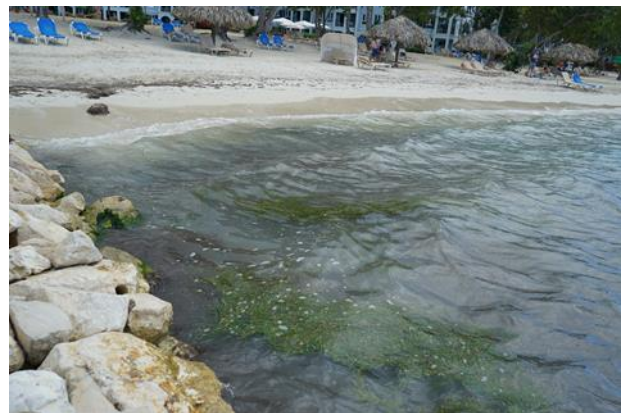
.6. Turbidity in the shallow nearshore waters. Accumulation of organic debris at the base of the groynes.

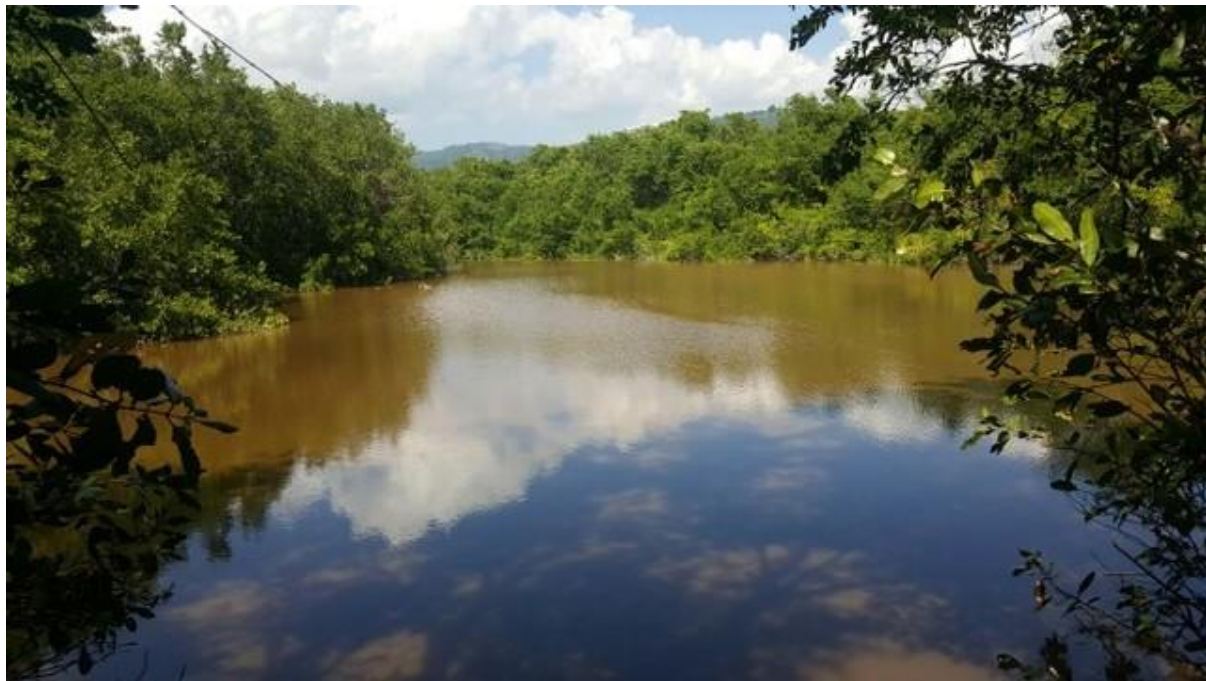
Figure 5. 12. The Large natural pond located near Sandals Hotel.

The natural pond was located near the Sandals Hotel property (lat17.868012, long-76.908714). It is surrounded by mangroves with a salinity of 8 ppt. The salinity indicates that the pond is influenced by sea water (see **Figure 5.12**).

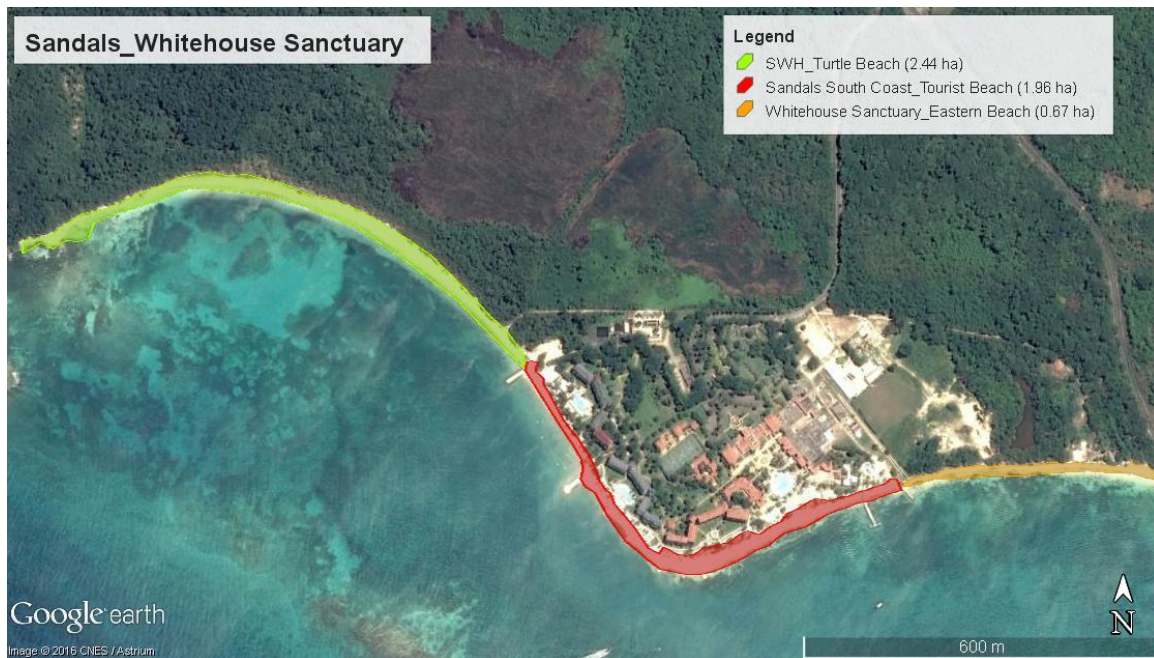
Figure 5.19. Whitehouse Beach is a 2.4 km stretch of sandy beach which includes the Sandals South Coast Resort tourist beach area (~0.8 km RED), a natural beach to the west of the resort where most of the turtle nesting occurs (~1 km in GREEN), and a small beach area (~0.5 km ORANGE) to the east of the resort.

For the purpose of this analysis ‘Whitehouse Beach’ refers to the 2.4 km stretch of sandy beach (**Figure 5.19**) which includes the ~0.8 km Sandals South Coast Resort tourist beach, highlighted in Red, a natural ~1 km beach to the west of the resort highlighted in green and a small beach (~0.5 km) to the east of the resort highlighted orange.

It is important to note that for 2016, nests were only reported on the natural part of the beach (Error! Reference source not found.17-Turtle beach in GREEN), to the west of the security post. Nests were spread out along this part of the beach, with no apparent clustering.

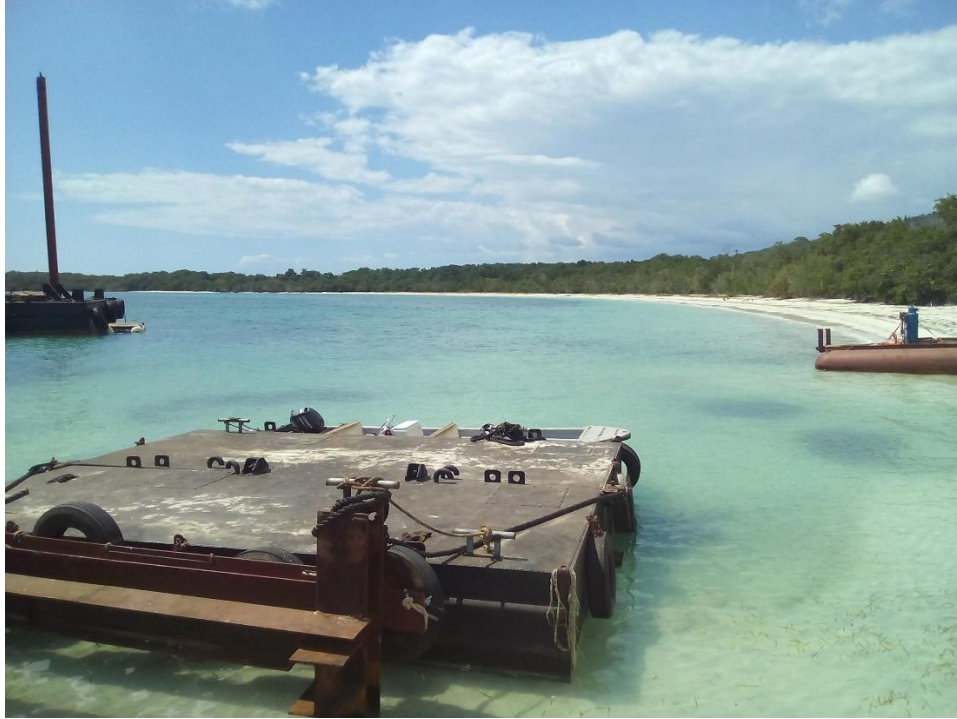
Figure 5.21. Barges placed into the water for the construction of overwater bungalows.

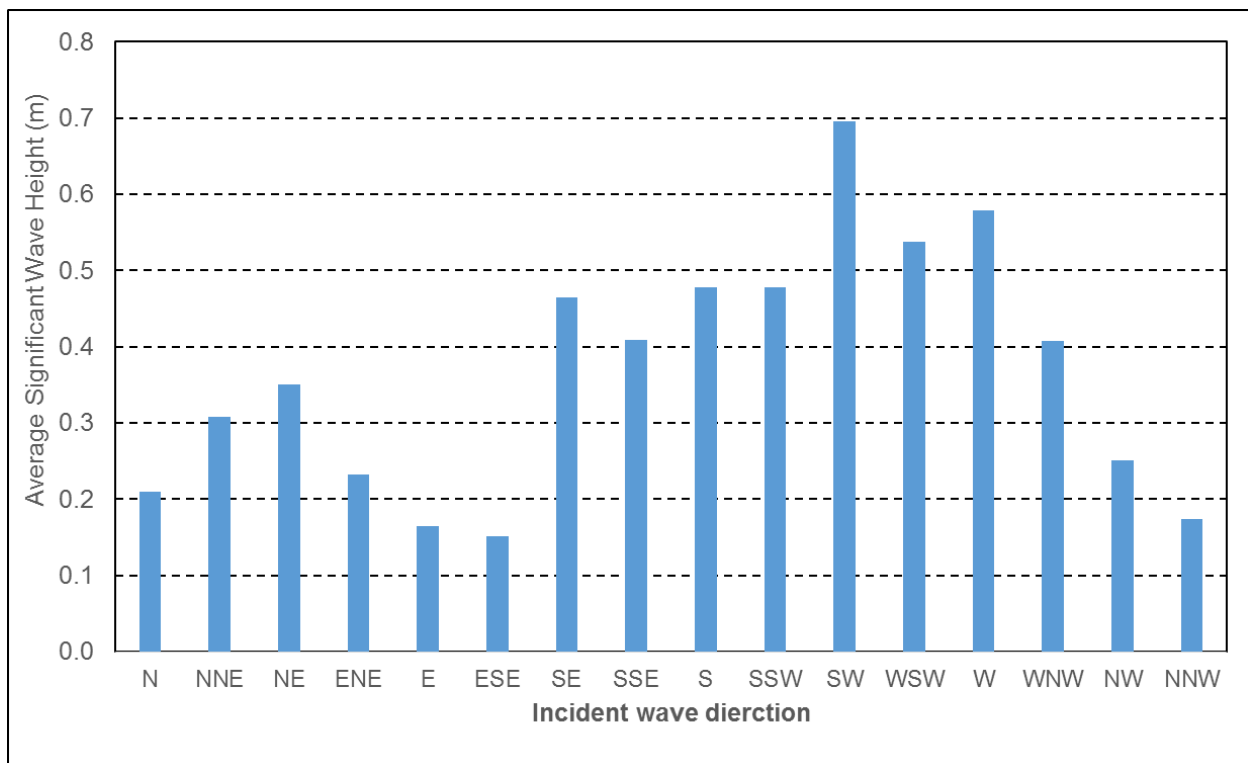
Figure 5.27. Average significant wave height waves approaching from different directions.

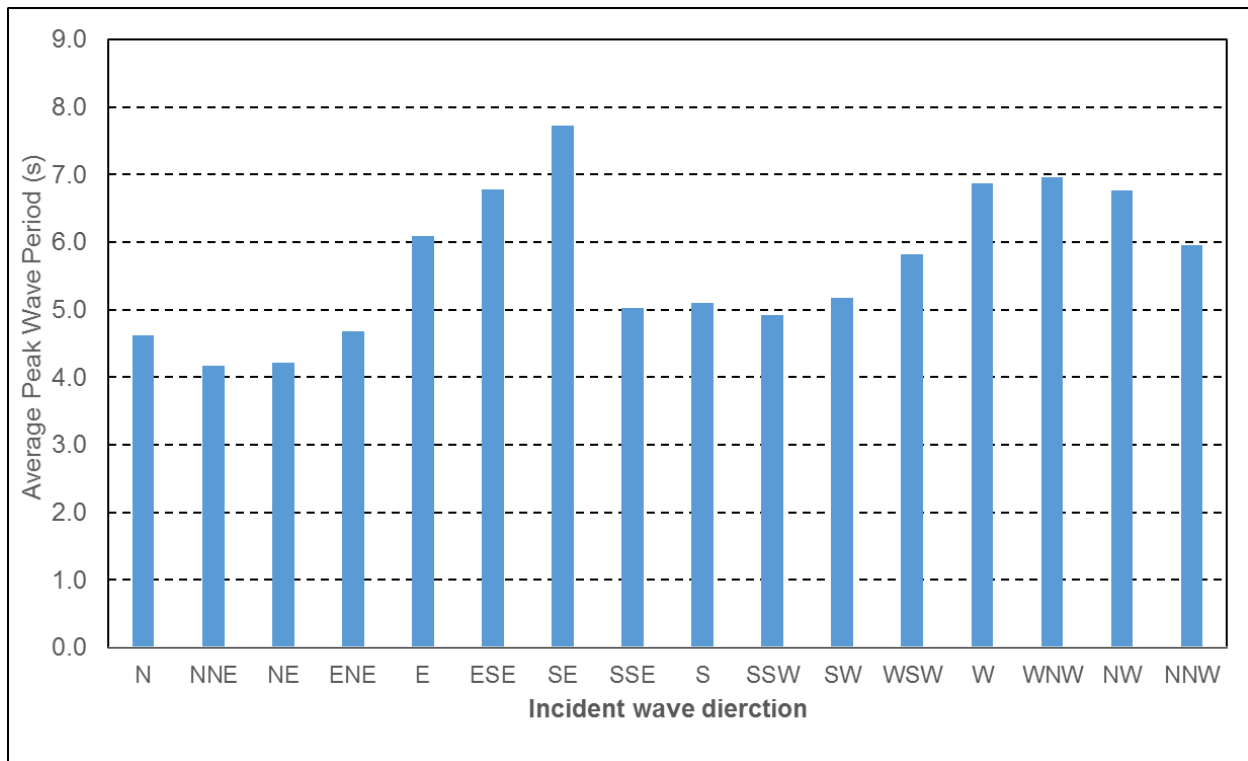
Figure 5.28. Average peak wave period waves approaching from different directions.

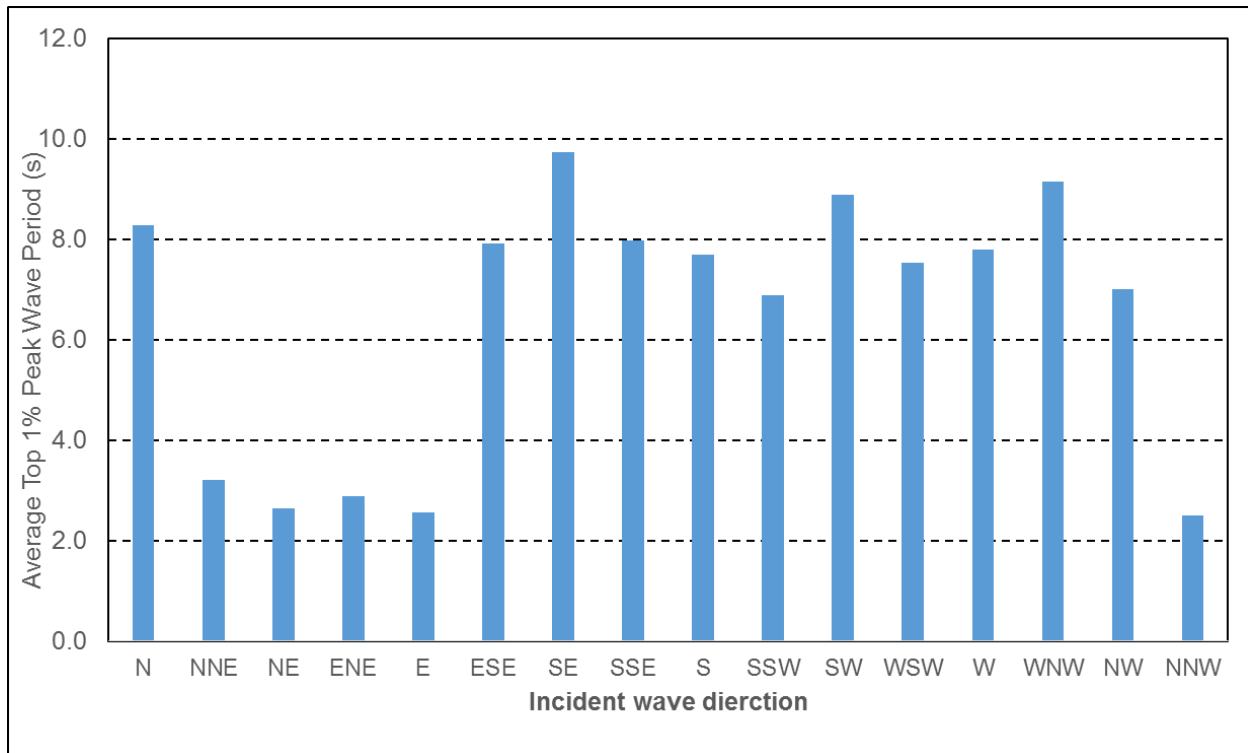
Figure 5.32. Average peak wave period of top 1% highest waves approaching from different directions

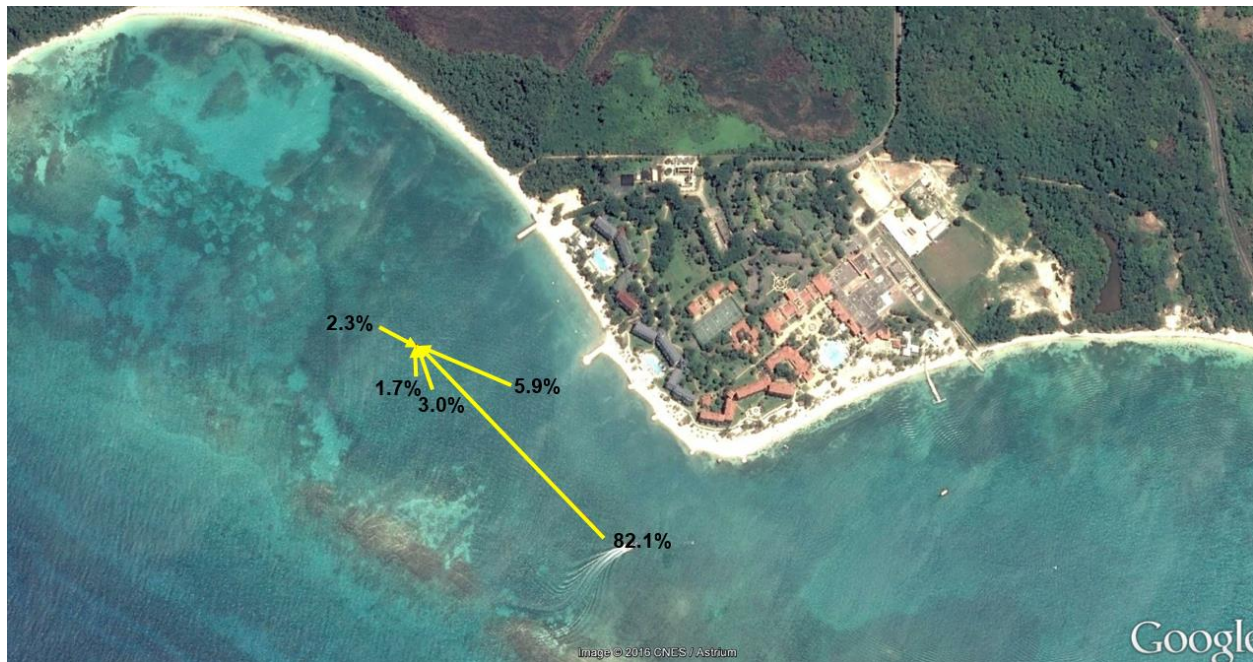
Figure 5.33. Most frequently occurring incident wave directions.

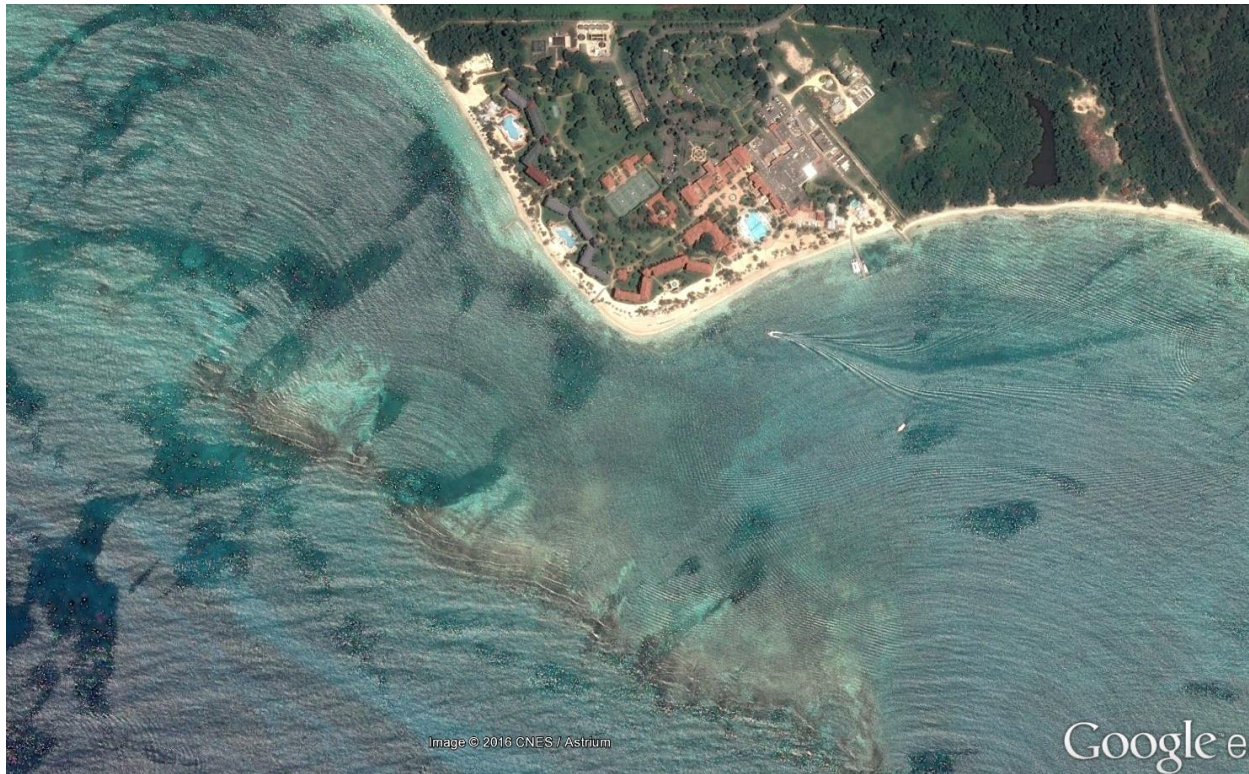
Figure 5.44. Waves converging at the headland due to the diffraction around the ends of the barrier reef results in the wider beach at the tip of the headland.

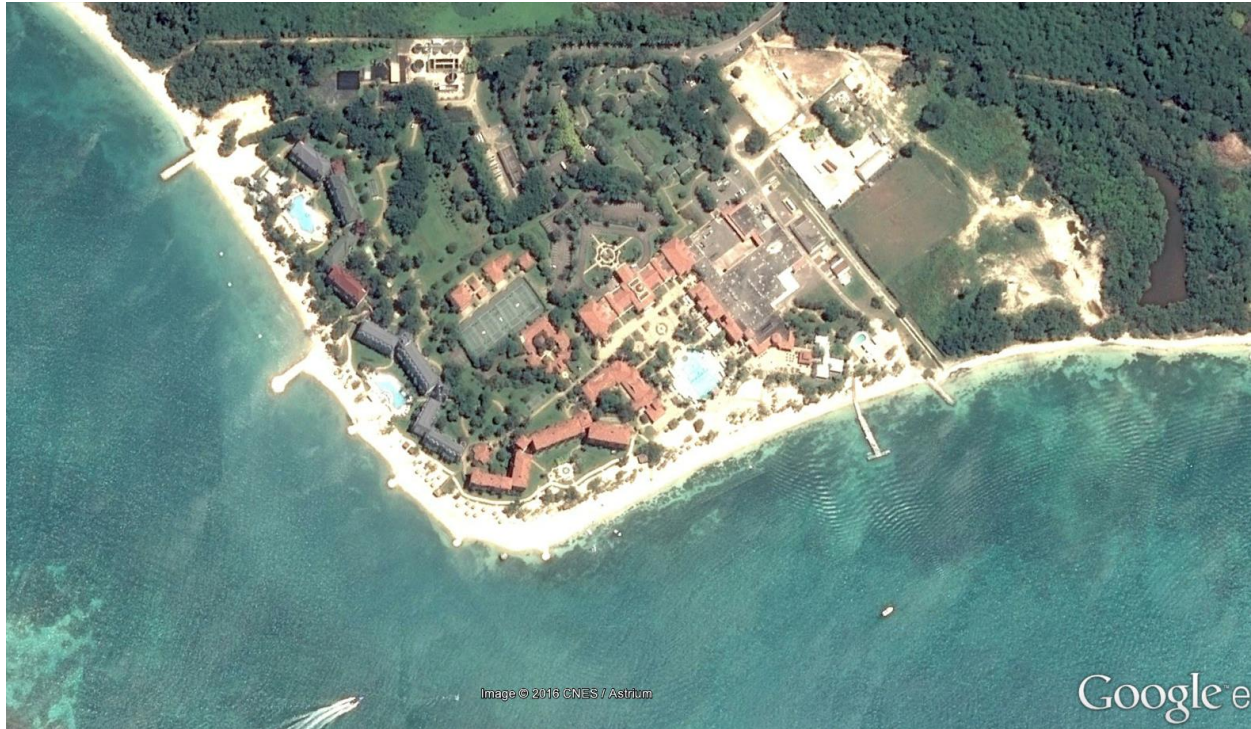
Figure 5.45. Groins around the Sandals Whitehouse headland, note the sand accumulation along the east side of the groin and erosion along the west side.

Several groins were constructed around the Sandals Whitehouse headland, as can be seen on a recent aerial photo shown in **Figure 5.45**. Sand accumulation along the east side of the groin and erosion along the west side is apparent, especially at the long groin to the west of the headland. This offset pattern, although not very significant at the shorter groins, suggests a westward longshore sand transport, which is likely driven by the persistent easterly trade wind generated waves near the shoreline. The relatively small offset indicates that the net rate of sediment transport is not large. As a matter of fact, when comparing the Google Earth photos for the last 10 years since the site was developed, the shoreline at the Sandals Whitehouse site has been relatively stable.

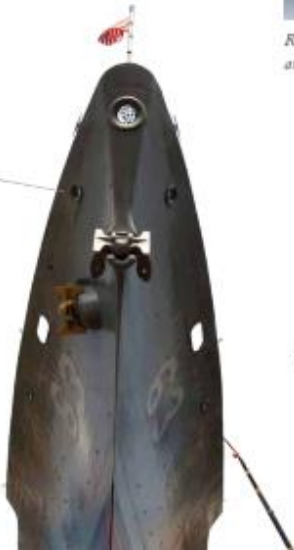
Traditional Methods	RUST GRIP®
Installation	Requires lengthy sandblasting.	Minimal surface preparation.
Application	Involves multiple coats.	Paint directly on rust and firmly bonded paint.
Moisture Prevention	Limited protection from mold and mildew.	Stops water vapor transmission through electro-chemical freezing.
Longevity	Shorter lifetime endurance.	Penetrates deep into pores of surfaces.
Corrosion	Not effective at blocking long-term degradation.	Adds strength to weakened surfaces.
Repair and Maintenance	Requires continual repair or complete overhaul.	Reduced surface preparation and efficient application yields cost savings.
