Conrad Douglas & Associates Limited
14 Carvalho Drive
Kingston 10
Jamaica W.I.

FibraLink Jamaica Limited
24-26 Grenada Crescent
Kingston 5

Environmental Impact Assessment for Establishment of a Fibre Optic Cable Network from the Bahamas to Jamaica

Document N^o: CD*PRJ 1009/04

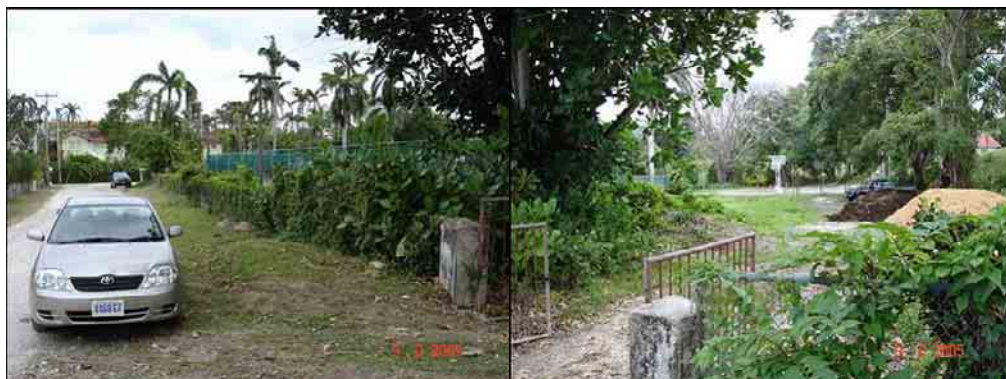
The proposed location of the building is within the fenced boundary of the existing Couples Resort property. This location is approximately 400m from the landing site at an elevation of 6-8m above sea level. There are no obvious obstructions between the landing site and the building site and the location has existing 24 hour security.

The location of the building will not interfere with any operations at the resort. It is anticipated that the cable will be laid in a narrow trench from the landing site to the building.

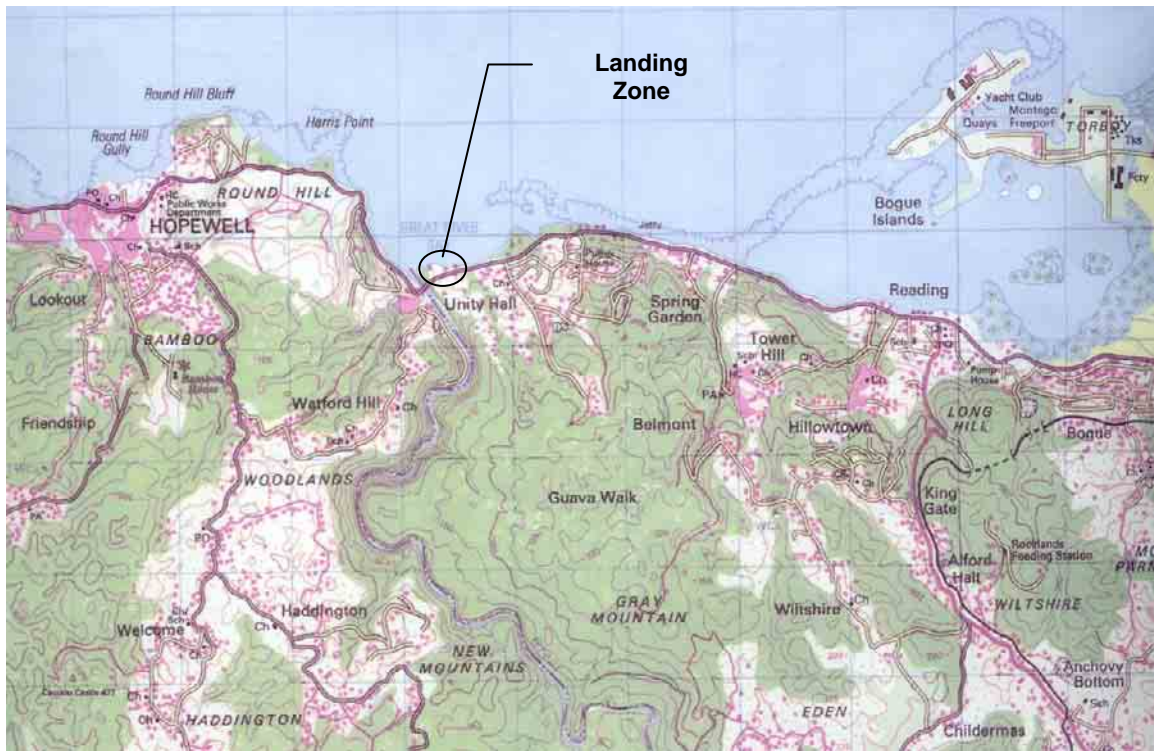
FIGURE 1-14: MONTEGO BAY CABLE LANDING ZONE

1.3.2.3.1 Physical Description

The landing site proposed for the Montego Bay area is just east (within 200m) of the mouth of the Great River approximately 4.5 km to the west of Montego Bay on Highway A1. The landing site has been selected due to the fact that large pathways of silt and sand on coral reefs or sea grass beds are located around the mouth of the river which is most suitable for the laying of cable of this type. This is most likely due to the inflow of fresh water and sedimentation which occurs in the area.

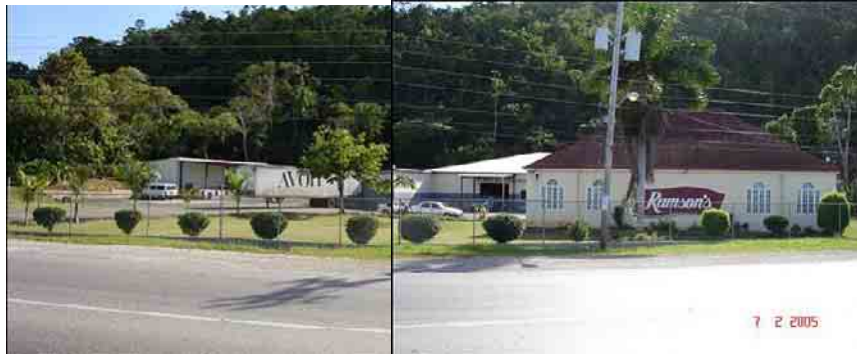
FIGURE 1-16: PROPOSED BUILDING LOCATION IN READING

At present, the proposed building location is in Reading within the property of the Chas O. Ramson Limited facility. The site is approximately 2.5 km west of Montego Bay and approximately 2 km east of the landing site at coordinates 18°26.742'N, 077°57.369'W. The site is approximately 5-6 meters above sea level, has 24 hour security and electricity is available within 50 m of the site. It is proposed that Fibralink will work with the relevant property owners and regulatory agencies to gain the necessary access and easements required to extend the cable from the landing site to the equipment building.

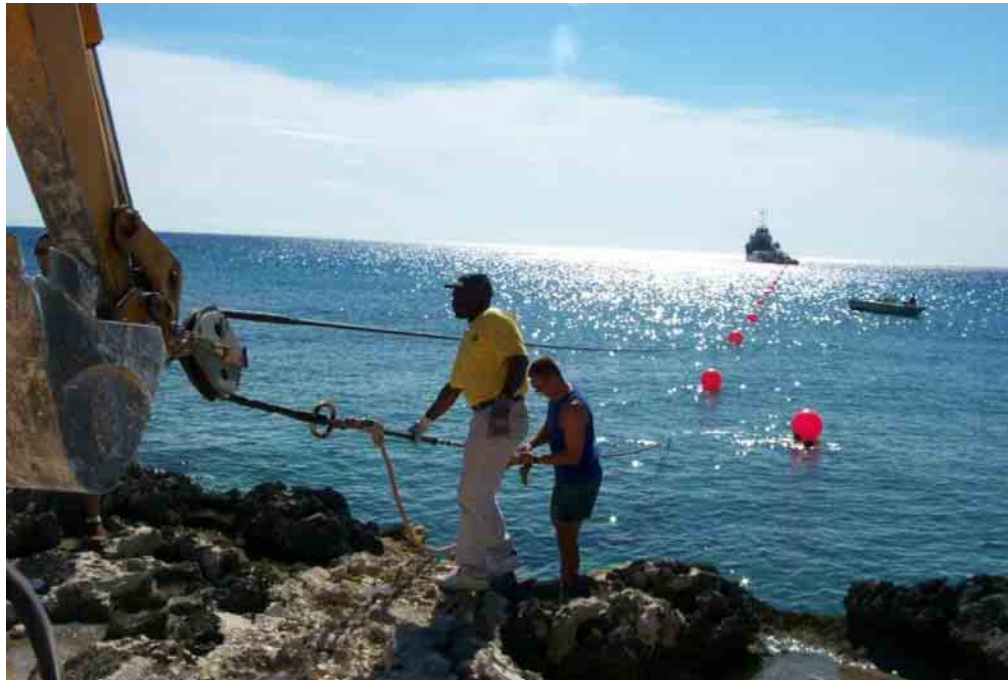
FIGURE 1-18: ILLUSTRATION OF INSTALLATION FROM SHIP WITH A SHEAVE

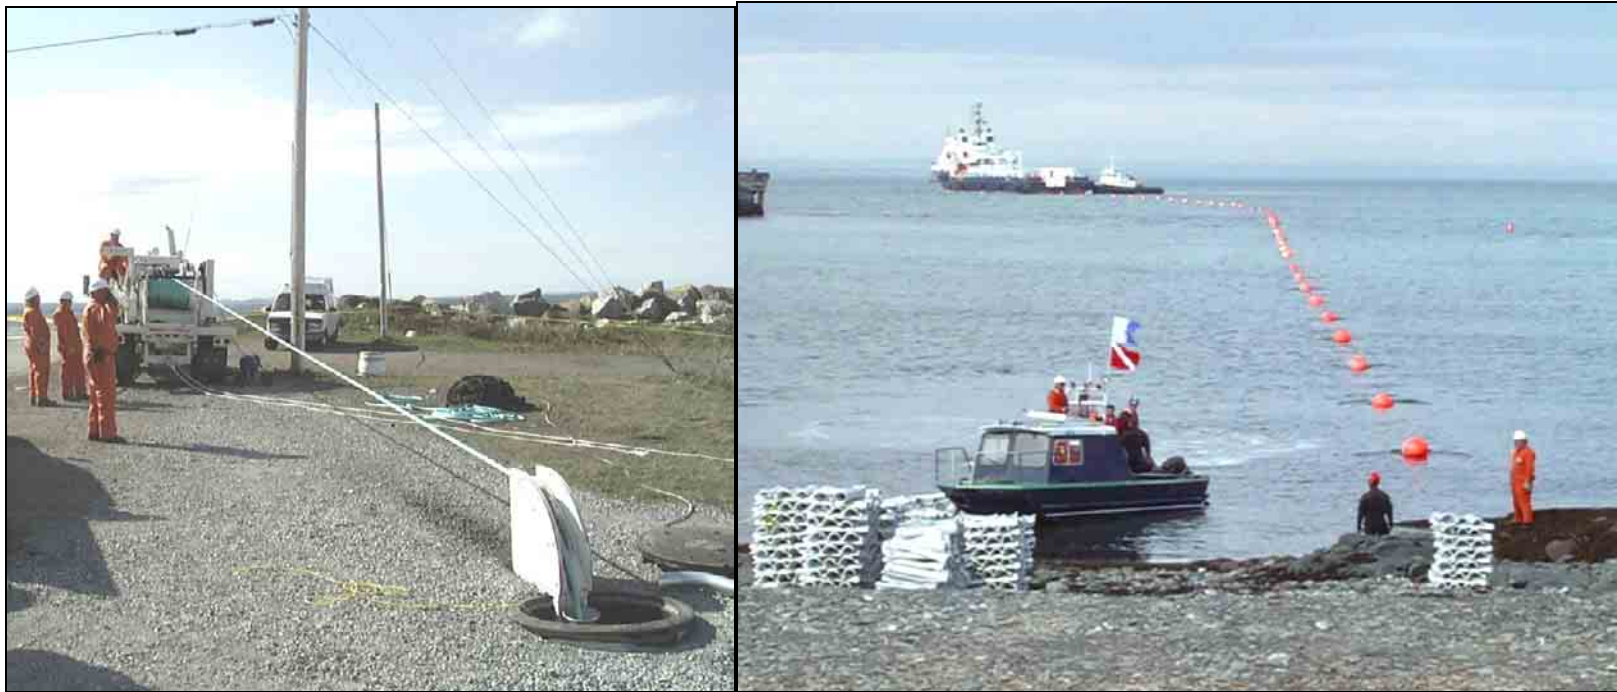
FIGURE 1-19: ILLUSTRATION OF INSTALLATION WITH A WINCH ON THE SHORE; BUOYED CABLE ON THE RIGHT

The main lay vessel will be positioned near the seaward end of the directionally drilled pipe, in approximately 11 meters of water. The pull wire in the pipe will be retrieved by the diver and handed off to the dive boat who will in-turn pass the line to the ship. A 1½" uniline will be attached to the pull wire and pulled ashore using the winch stationed near the manhole (See Figure 1-19 and Figure 3-16). When the uniline is secured on shore, the ship will be advised. The deck crew will attach the cable to the uniline using a 6000lb Miller or similar swivel and a Yale cable grip. The deck crew will then advise the shore-end superintendent that pulling can proceed. The divers will follow the cable end to the pipe and ensure that the cable enters the pipe smoothly. The deck crew aboard ship will closely monitor payout tensions and draw speed as the cable is pulled into the manhole.

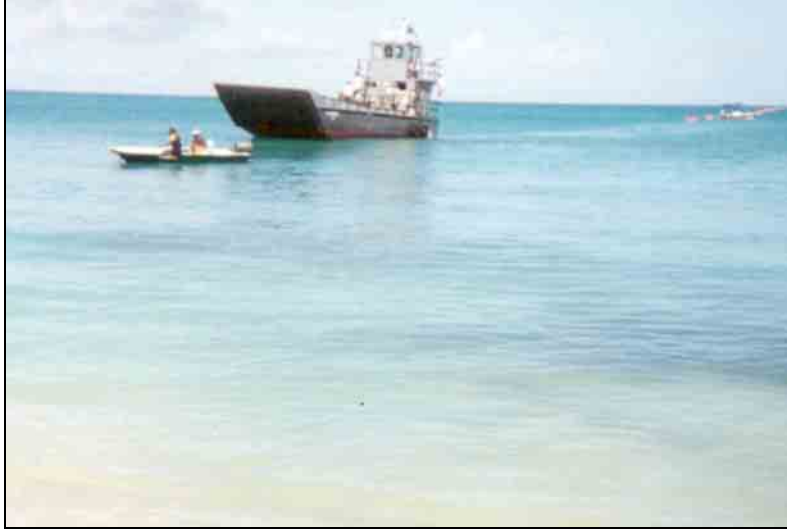
FIGURE 1-24: ILLUSTRATION OF INSTALLATION USING A LANDING CRAFT

When the cable reaches the shore and sufficient cable slack has been brought ashore the cable will be stoppered off to the line vehicle. The ship will make ready to start laying cable and move off at a speed of approximately 1.0 knots. Cable will be surface laid throughout the route.

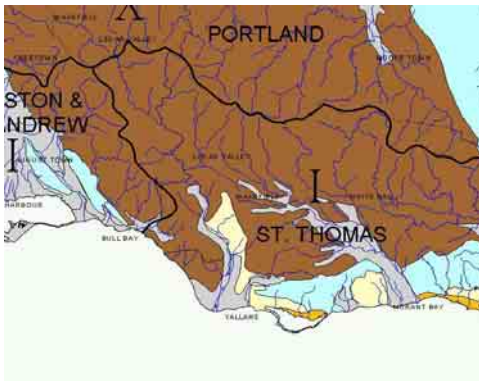
FIGURE 3-13: HYDROSTRATIGRAPHIC MAP OF BULL BAY SITE
