**Rapid Rural Appraisal
of the Rio Grande
Watershed**

Ridge to Reef Watershed Project

RAPID RURAL APPRAISAL OF THE RIO GRANDE WATERSHED

March 18, 2002

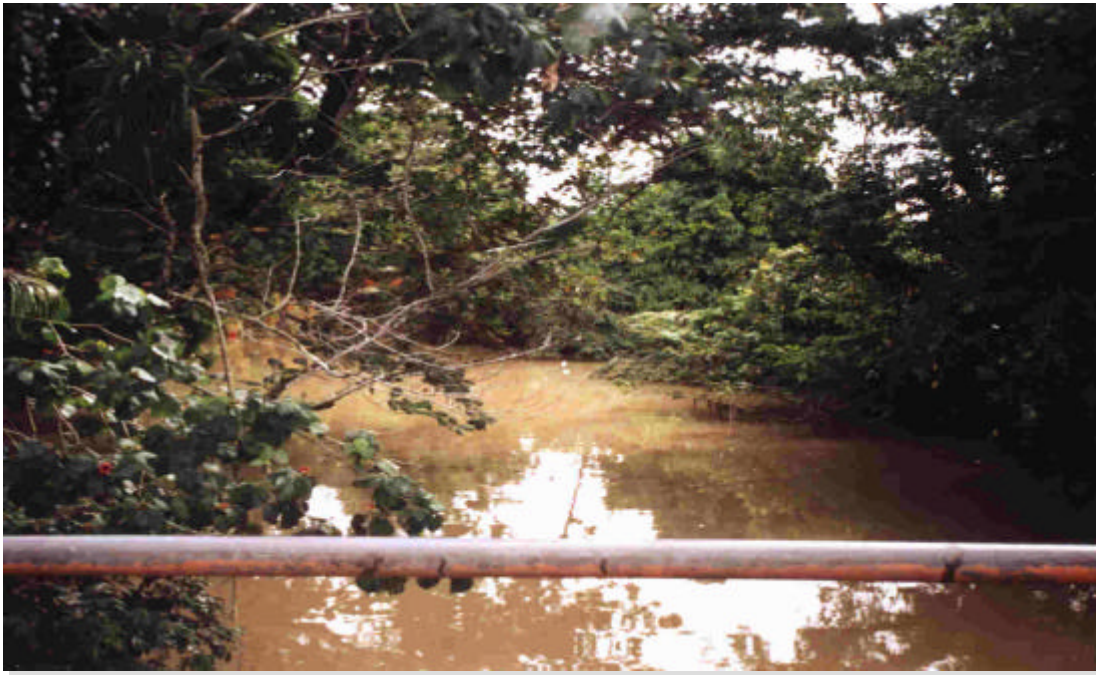
East Town River (River Pollution) - Dec. 2001
