**FINAL REPORT**  
**Preliminary Assessment of**  
**Beach Erosion at St. Margaret's**  
**Bay Portland, Jamaica**

# **Ridge to Reef Watershed Project**

## **Preliminary Assessment of Beach Erosion at St. Margaret's Bay Portland, Jamaica**

June 20, 2003

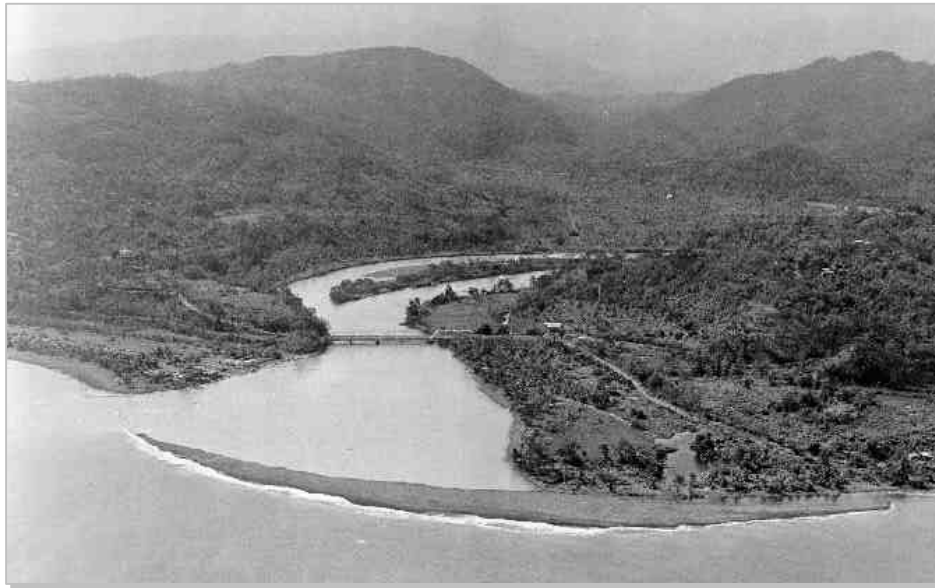
**Figure 2** Oblique air photograph, August 7, 1980, taken immediately after the passage of Hurricane Allen showing large rivermouth bar (J. Tyndale-Biscoe).

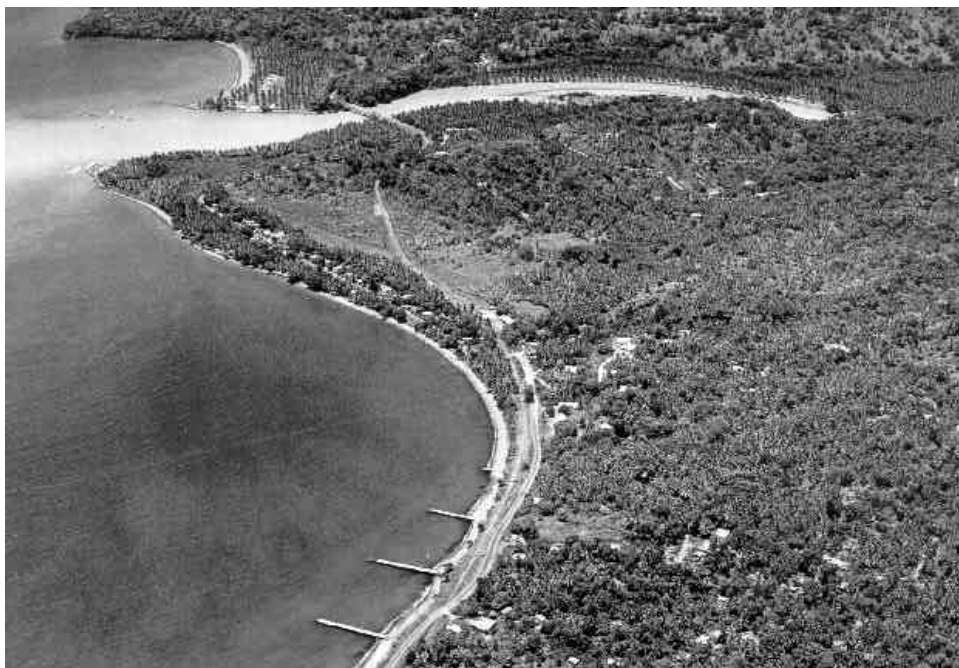
**Figure 3** Oblique air photograph, June 18, 1969, showing S. Margaret's Bay. The area with trees between the sea and the morass is the current coast of concern (J. Tyndale-Biscoe).

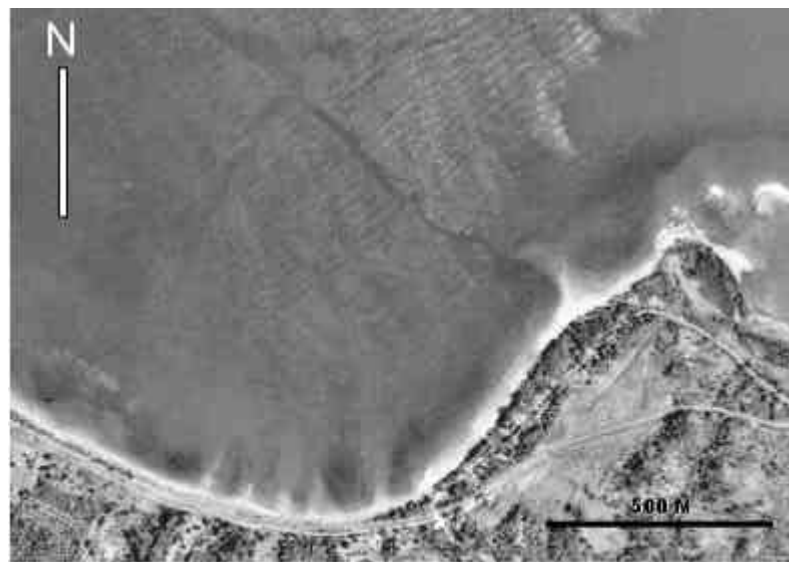
**Figure 5** Air photograph taken in winter 1961, showing wave trains from the northwest.

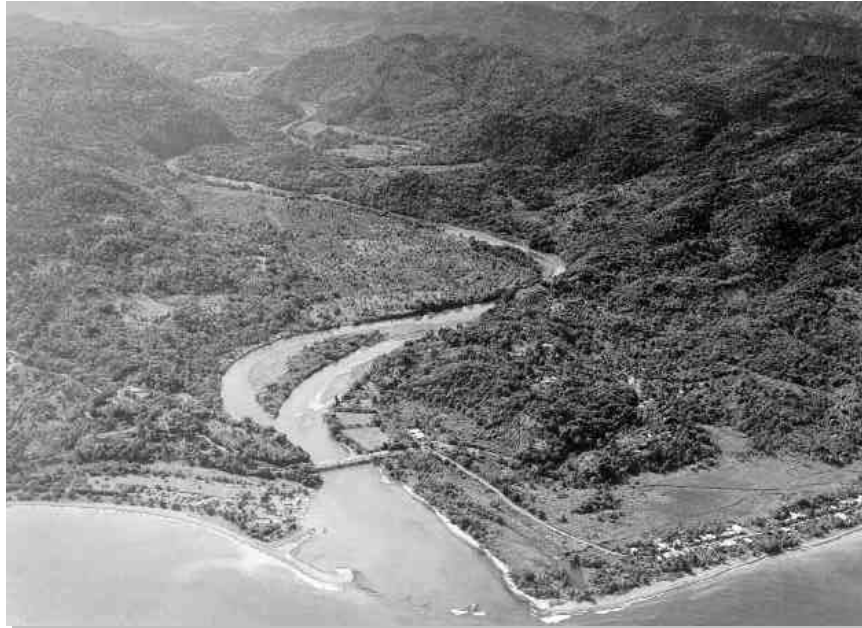
**Figure 6** Oblique air photograph, September 28, 1984, showing straightened beach (right-hand edge of photo) following Hurricane Allen (J. Tyndale-Biscoe).

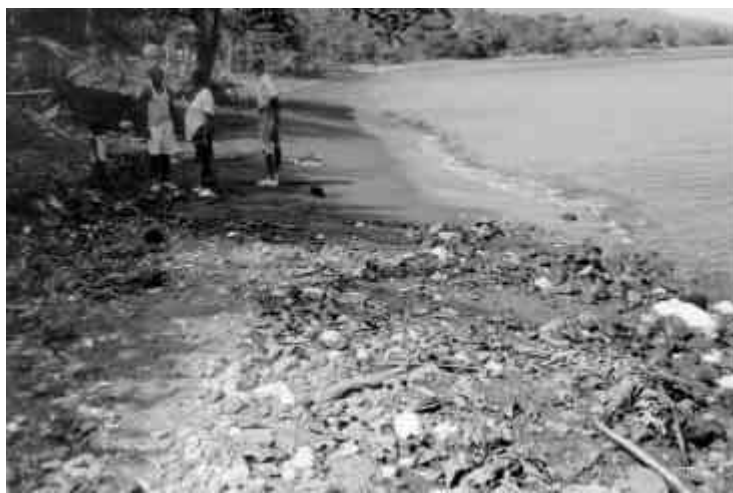
Photo 1

A sandy beach, pebbly at and below the waterline narrows from this area extending northeast along the shore. Waves (from the northeast on the day of the traverse) hit the shore at an angle. It is backed by an eroded sandy berm platform. Walking along the beach an abrupt change from sand to gravel was observed just east of the point where the road turns sharply towards the shore. The beach also becomes narrower. **Photo 1.**

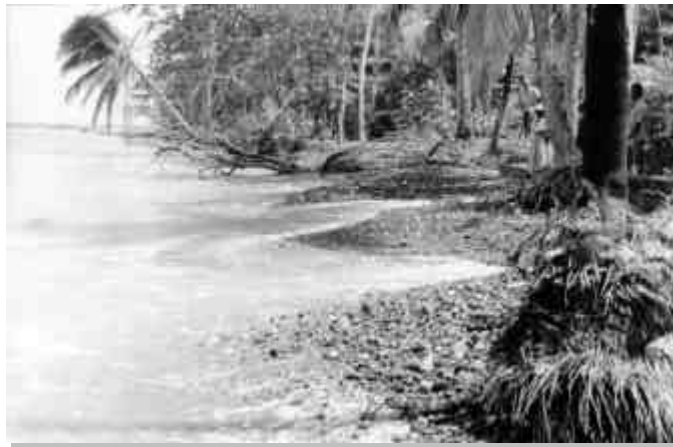
Photo 2

- Residents used to be able to play football games on the beach behind their homes. They are presently not able to do so because their playing area has been taken away by the sea.
- The area from the beach to the coast road used to be predominantly sand but now consists of pebbles and cobbles. **Photo 2**
- Backyards and play area has disappeared.
- The gully which carries water from the morass is cleaned on a regular basis but is periodically blocked by refuse supposedly from a garage upstream; bottles; household items; long logs that are washed ashore by the sea.
- Almond trees that used to line the shore lost due to erosion. **Photo 3**

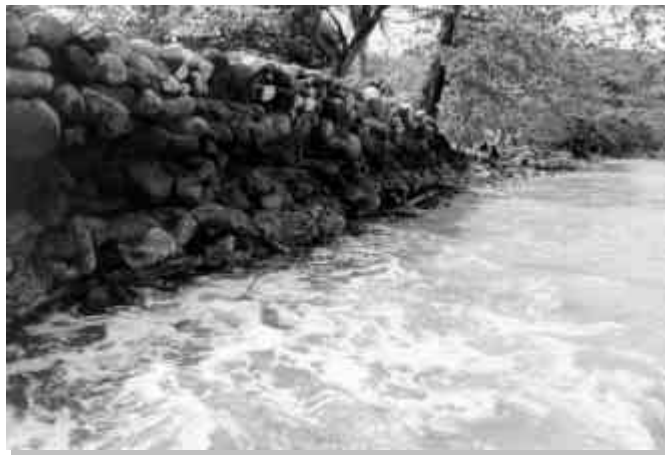
Photo 4

The sea wall is made up of stacked boulder-sized blocks of limestone. It is being undermined by wave action and the mortar used to hold the rocks together has been washed away. The sand immediately behind the wall is being excavated as the water now passes through the once mortar-filled cavities in the wall. Mrs. Spence's house is approximately 3 metres behind the sea wall. Even with a calm sea, we observed that the wave action became more pronounced as we walked north eastward along the shore.

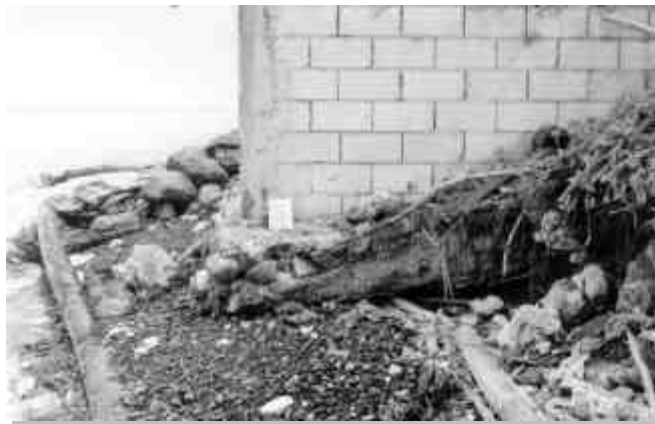
Photo 5

In the water there are limestone boulders which the residents say are what remain of a defensive measure against erosion, put in place by the Parish Council some 20-25 years ago  
**Photo 5**

Trucks used to drive out onto the beach to dump the building material. At the time we observed them, the limestone blocks were scattered in up to 60 cm of water and continued up the beach. At low tide the sea is at the level of the blocks and covers them completely at high tide.

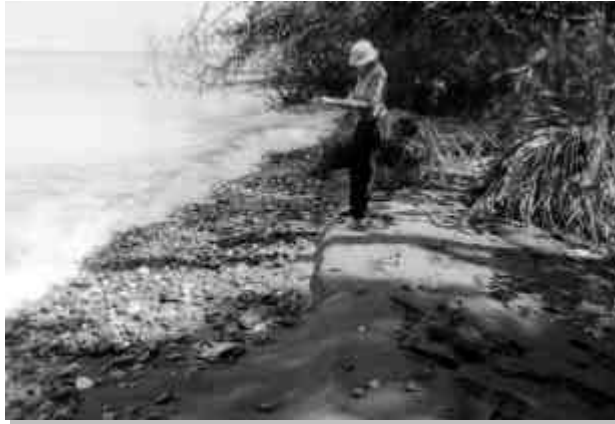
Photo 6

Four drowned coconut trees...stumps visible in sea. There was approximately 6 metres of beach and berm separating the sea from the house. **Photo 6**

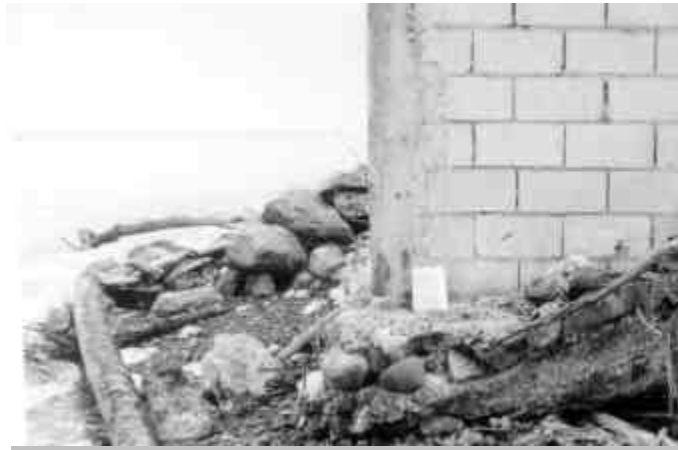
Photo 7

- During the heavy rains the sea covers both the beach terraces and comes to a halt immediately in front of the house.
- He placed tyres packed with rocks to create a buffer but heavy seas, two months ago, took away the rocks. He surmises that bigger boulders are the answer to halting the erosion problems. **Photo 7**
- Were told that the sea floor is mostly mud offshore of this region.
- Just beyond this locality trees have fallen over in the past week.

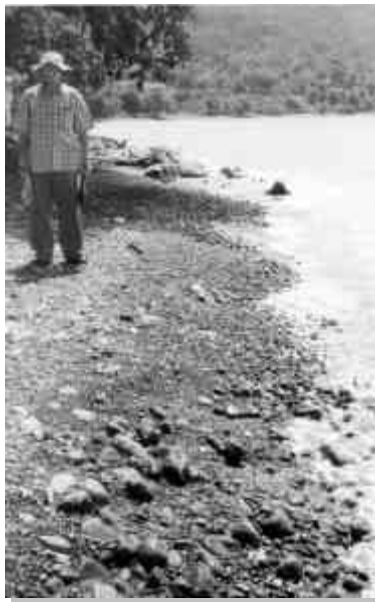
Photo 8

On a large scale, this part of the beach is cusped and alternated from sand- to pebble- and cobble-sized particles **Photo 8**

On a smaller scale the sand-sized particles are seen in the curved sections of small cusps with larger-sized particles in the pointed sections. Again, the sand is probably derived from recent erosion of the berm platform and may be sheltered from further transport by the large boulder field mentioned previously.

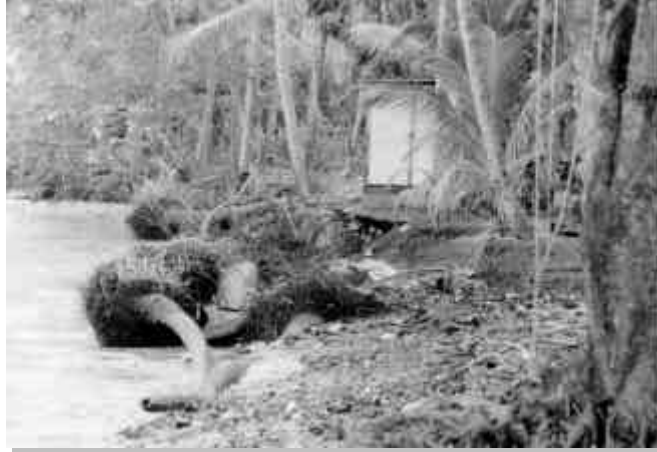
Photo 9

A large old wooden building on stilts. Foundation of latrine being undermined by wave action.

- One month ago the latrine was stable as the sea was further out.
- Undermining now takes place at high tide.
- Latrine is no longer in use. **Photo 9**

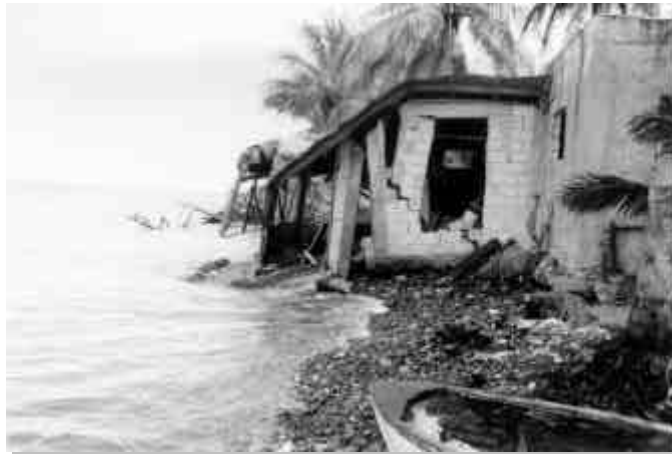
Photo 10

This is a property with a bus, which backs on to the beach now. Section of house facing sea being undermined with partial collapse. There is evidence of an attempt to patch cracking where the back wall has now parted from the side walls. **Photo 10**

- Main damage occurred between November and December 2002 (Tropical Storm Lili) and the rough seas at Christmas.
- Within a two year period the sea has encroached some 30 m onto the land, the beach used to be “way out, as far as the first line of buoys”

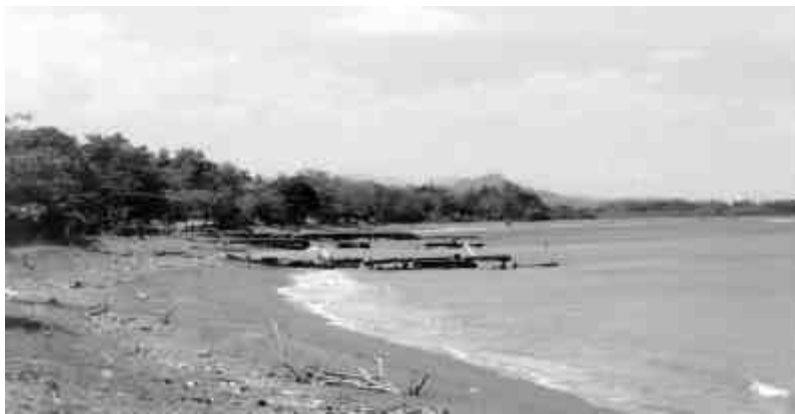
Photo 11

Miss Moore then took us to look at the beach occupied by the groynes. Marley and Plant built the original groynes. The groynes are in a state of disrepair and the fourth, easternmost groyne seems to have disappeared. **Photo 11**

They seem to have done their job as the beach on which they are located shows no significant sign of erosion. The beach here is much wider than that along the region of concern reported on above. The beach here is mostly sand with pebbles along the shoreline.

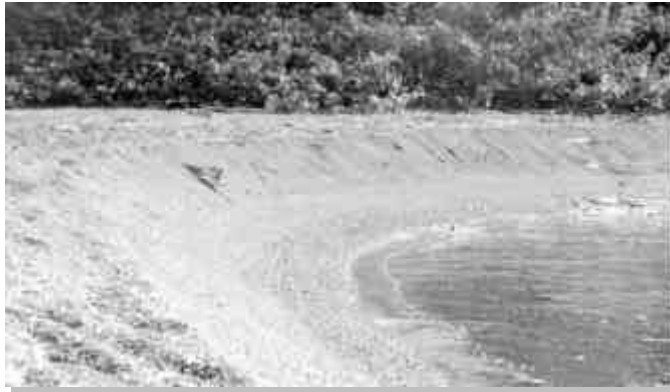
Photo 12

Well-sorted to moderately well-sorted gravel beach grading to sand at the shoreline. Approximately 150 m of gravel forming the tombolo. Beach very steeply dipping on side facing north. **Photo 12**

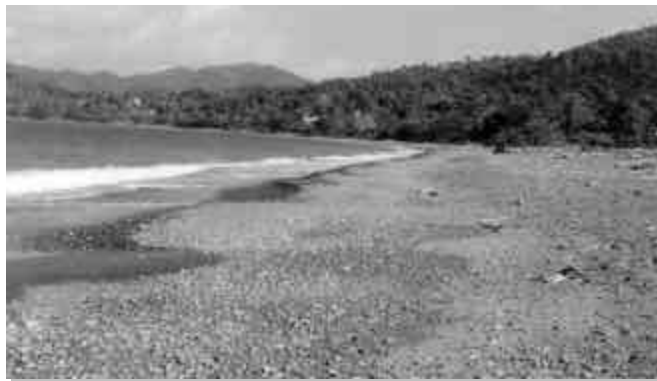
Photo 13

Grain size of larger beach material increases along the shore, from Welsh Woman's Point towards the aerodrome. Cuspate pebble bar forms edge of terrace closest to water. Wind system produces a ridge of sand behind the pebble bar. Low-lying dunes formed on aerodrome terrace, which seems to be an extended berm platform. **Photo 13**

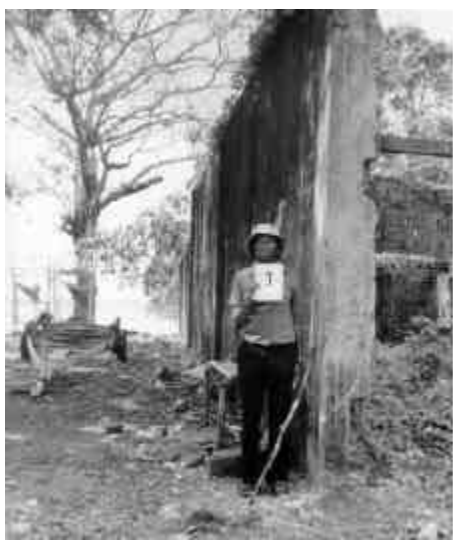
Distance from Reference Point to Edge of Berm Platform:                      27.6m

Distance from Reference Point to Swash Zone:                      32.0m

Southern end of Traverse 1

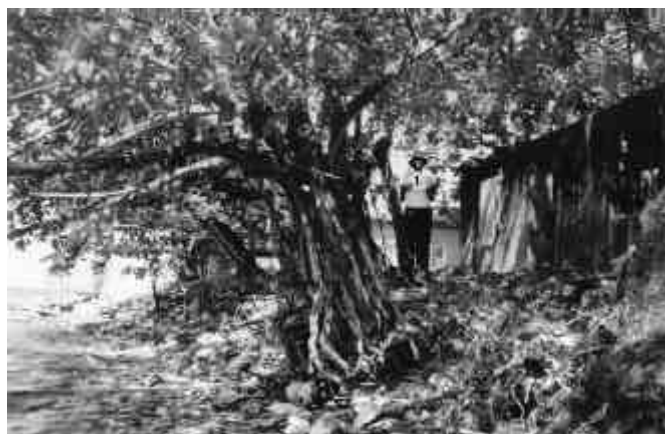
Northern end of Traverse 1

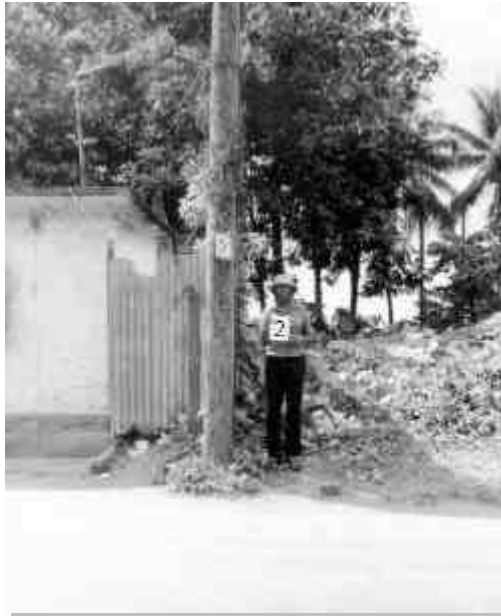
**Traverse # 2                      Across the Street from Carpenter's Shop**

Reference Point:              Pillar at south end of wall of incomplete garage

Distance from Road to Reference Point:	0.7m
Distance from Reference Point to Edge of Berm Platform:	33.9m
Distance from Reference Point to Centre of Modern Berm:	37.8m
Distance from Reference Point to Swash Zone:	42.6m

Northern end of Traverse 2

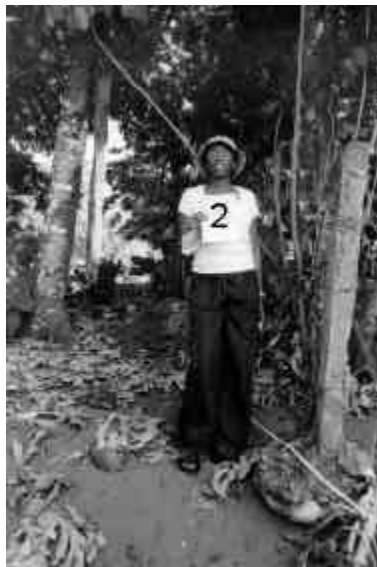
Southern end of Traverse 2

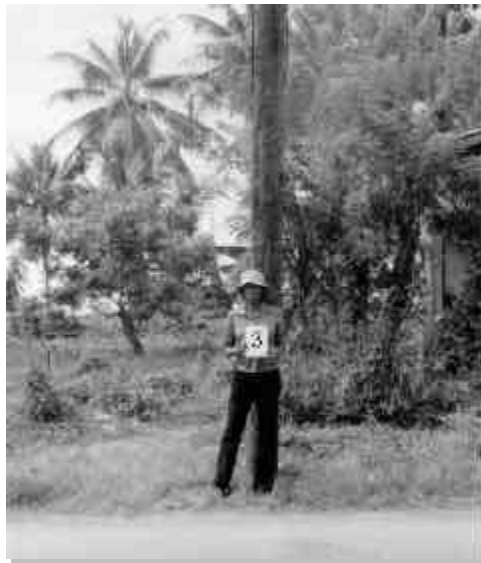
Distance from Reference Point to front of house on the right:	6.43m
Distance from Reference Point to back of house on the right:	19.10m

Southern end of Traverse 3

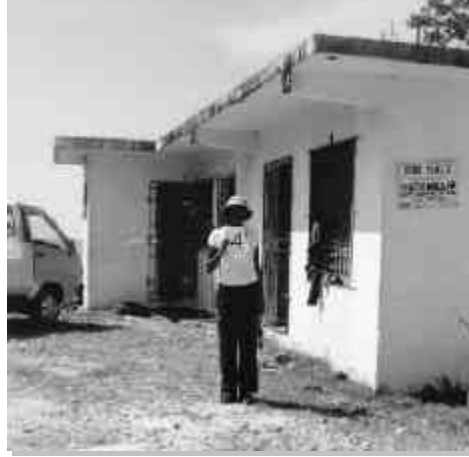
**Traverse # 4                      Garage Across the Street from St. Margaret's Bay Basic School**

Reference Point: Front Wall of building on right

Distance from Road to Reference Point:	6.4m
Distance from Road to Edge of Berm Platform:	18.6m
Distance from Reference Point to Edge of Berm Platform:	12.2m
Distance from Road to Sea Wall:	19.6m
Distance from Reference Point to Sea Wall:	13.2m

Southern end of Traverse 4

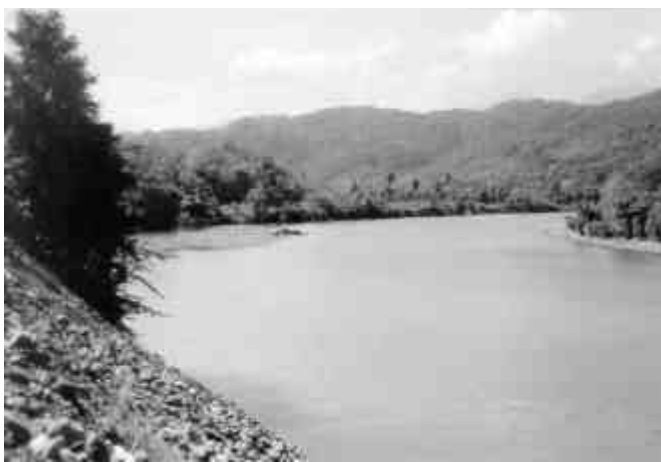
Photo 14

Water clear, shoal visible. River channel deeper here than under the bridge. **Photo 14**

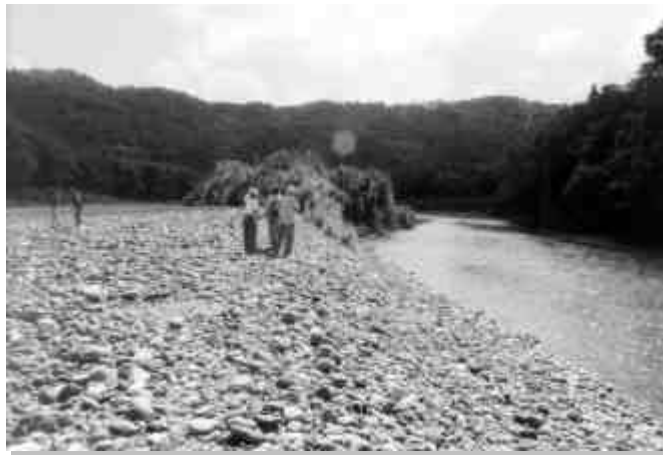
Photo 15

Based on the plastic bags stuck in the trees on the opposite bank, the river is approximately 3m higher when in spate. This is also about the height of the floodplain on the eastern side of the river. **Photo 15**

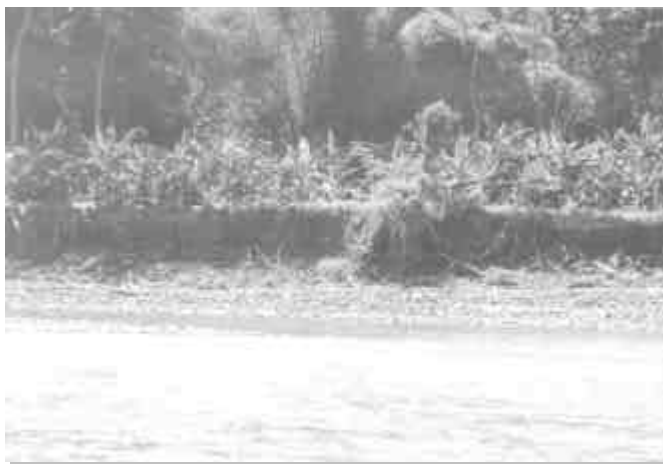
Photo 16

Banana farm being eroded by river. **Photo 16**

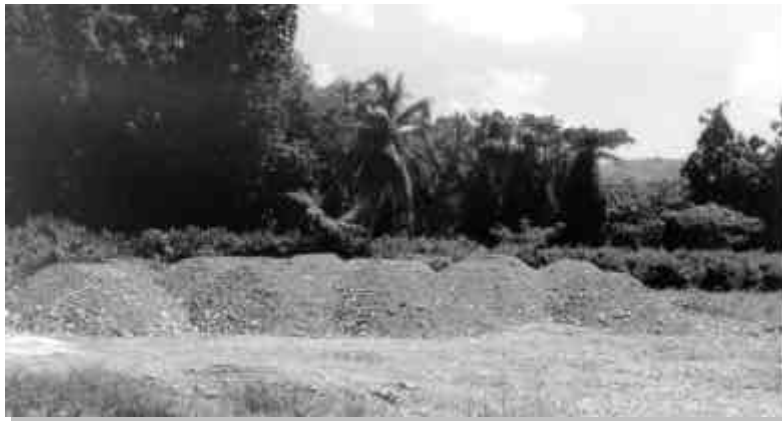
Photo 17

- 1/2" and 3/8" gravel produced by sifting and crushing. **Photo 17**
- Crusher capable of producing 300 cubic yards of sand in a 10 hr day.
- Stockpile of washed sand seen in yard was approximately 1000 cubic yards and represented 2 days work. **Photo 18**

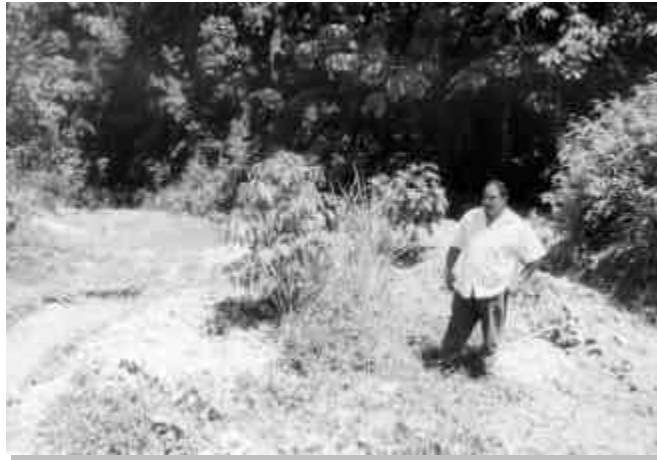
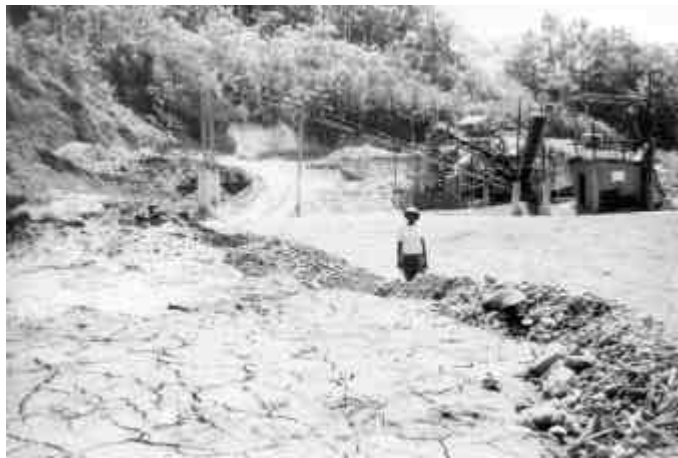
- Muddy water from production is passed through a U-shaped mud-settling pond (~1m deep). Gravity filtered water is allowed to flow back into the river. **Photo 19, Photo 20**
- Mr Mangaloo suggests that last years dredging/dumping operations in Portland to create the new marina has contributed significantly to the coastal erosion.
- His father in Orange Bay has lost approximately 2m of beach as a result of erosion. The Public Beach in Orange Bay has disappeared.
- He does not think the sand mining activities have brought about the coastal erosion problems.
- Entire operation consists of the mining and production of sand and gravel and agriculture on a reduced scale. The company employs 30 persons including security.

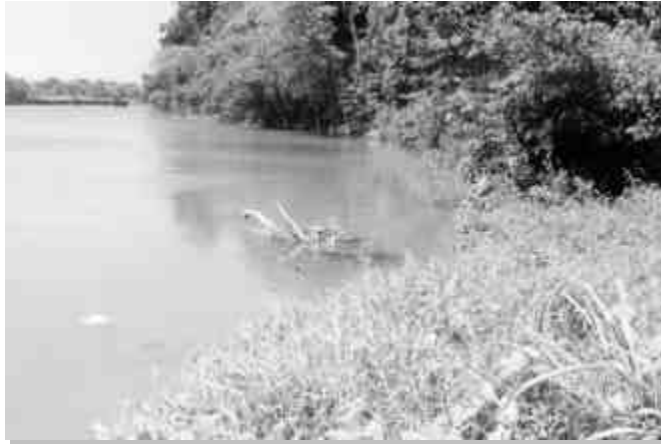
Photo 21

The road has been undercut by erosion; now reduced to footpath; used to extend to point where a tractor (property of the mining company) now lies submerged in the river. Trees submerged. **Photo 21**

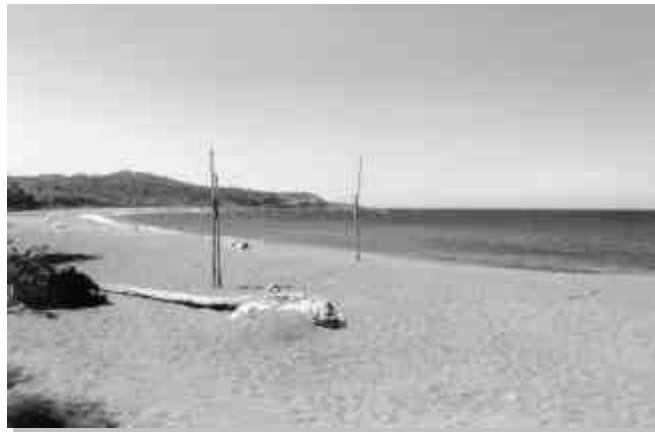
Photo 22

No signs of erosion; very wide beach in comparison to St. Margaret's Bay. **Photo 22**

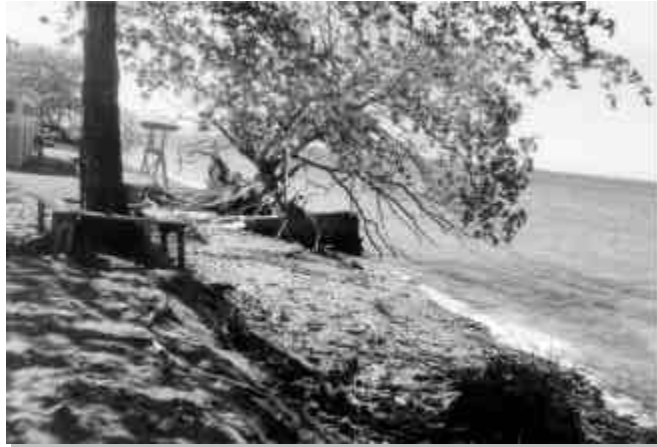
Photo 23

Pebble and sand beach. Water clear. Waves coming in from the north-east. Drowned coconut trees. In what seems to have been a recent event, the beach has been eroded right up to the lawn. **Photo 23**

The sanitary conveniences are ~2m away from becoming undermined. Almond tree toppled but still growing. One beach structure now in the tidal zone.

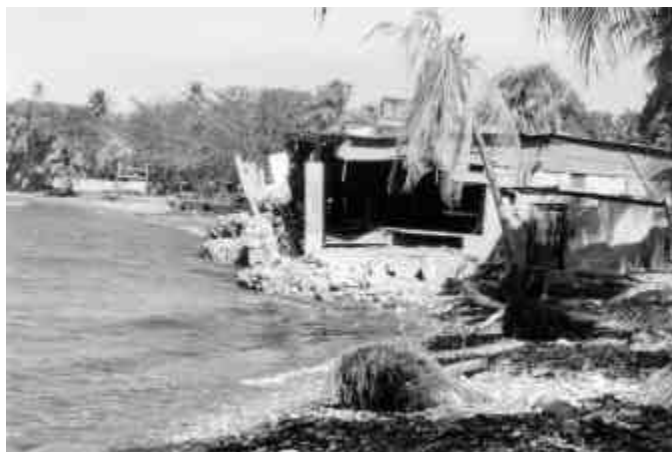
Photo 24

Next door the sea wall has been destroyed and the front porch of the building it was protecting demolished. The foundation is still being undermined. **Photo 24**

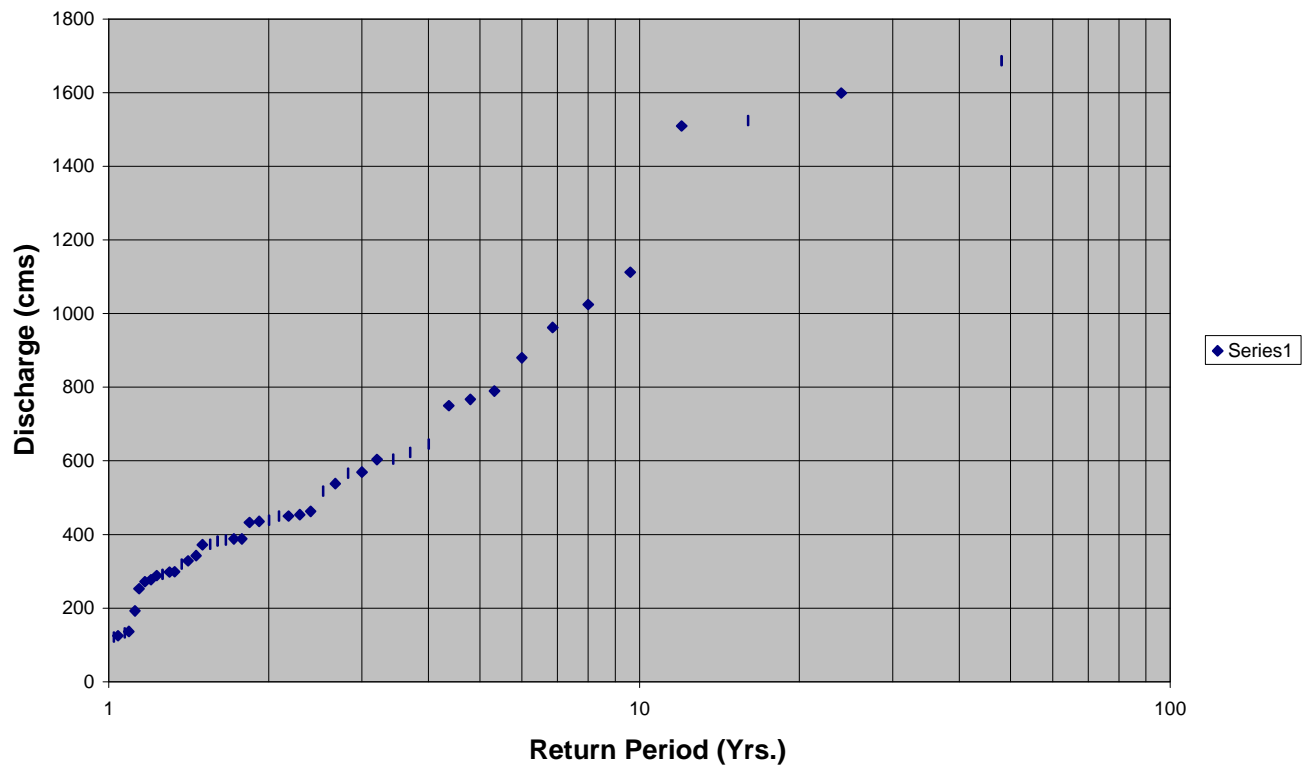
## Flood Frequency Graph for the Rio Grande
