**Beach Erosion at St. Margaret's  
Bay, Portland Jamaica  
REPORT TO THE CITIZENS**

# Ridge to Reef Watershed Project

## Beach Erosion at St. Margaret's Bay Portland, Jamaica

Deborah-Ann Rowe  
Edward Robinson  
Shakira Khan  
University of the West Indies

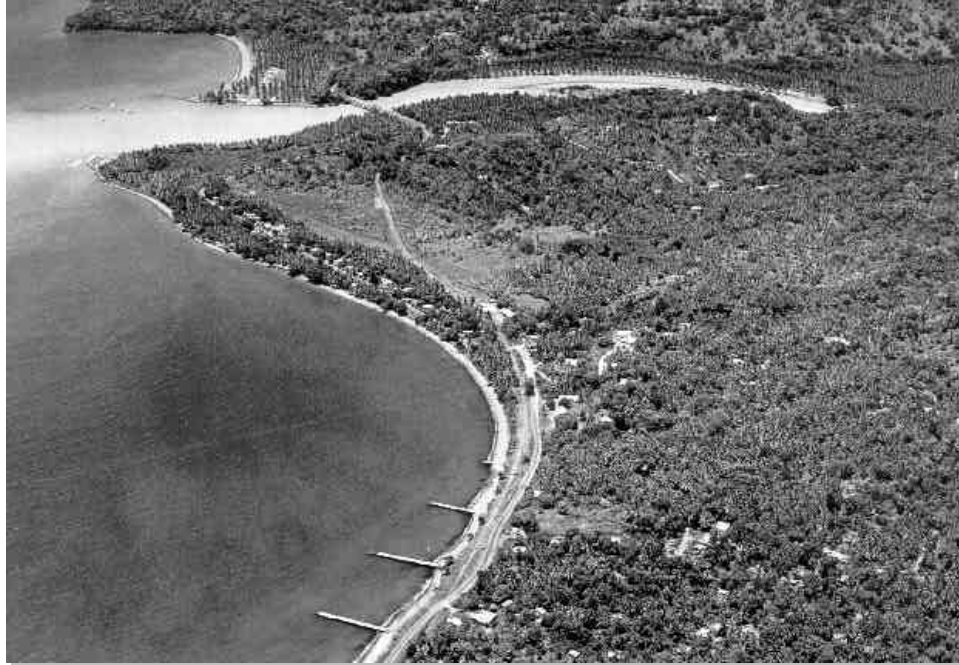
**Figure 2** Oblique air photograph, June 18, 1969, showing St. Margaret's Bay. The area with trees between the sea and the morass is the current coast of concern (J. Tyndale-Biscoe).

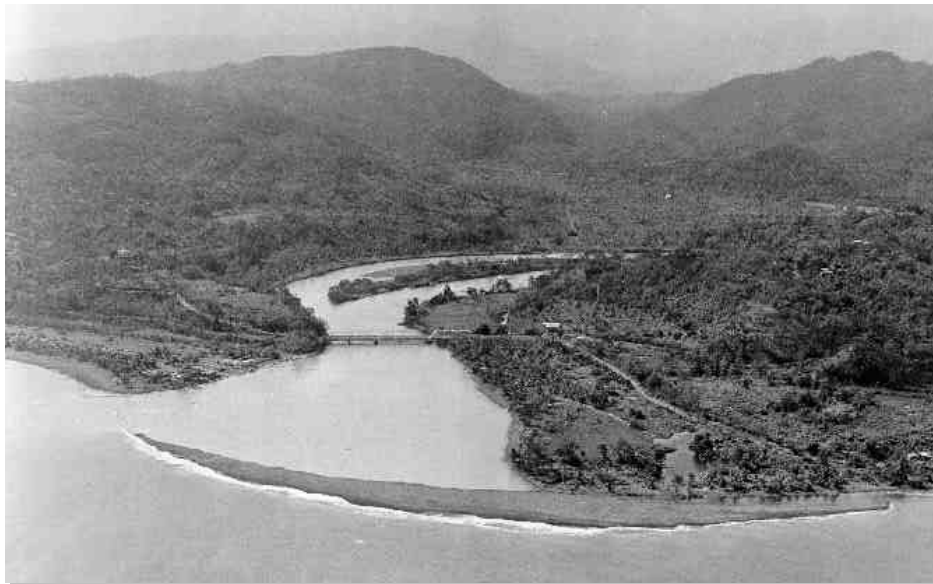
**Figure 3** Oblique air photograph, August 7, 1980, taken immediately after the passage of Hurricane Allen showing large rivermouth bar. (J. Tyndale-Biscoe).

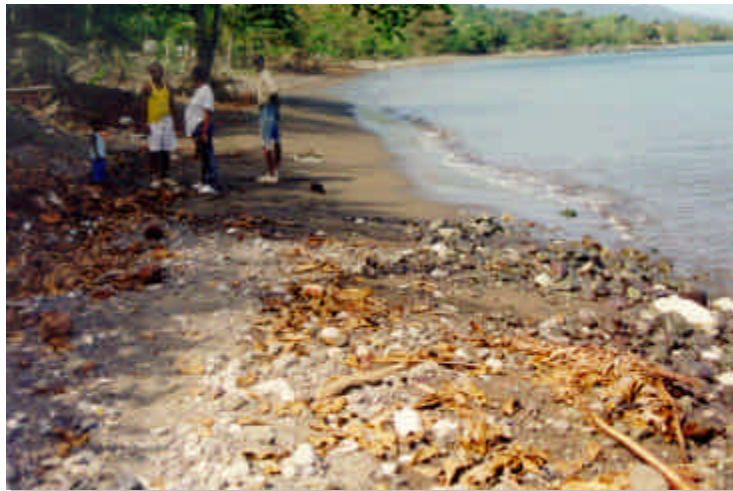
**Figure 4**

A sandy beach, pebbly at and below the waterline narrows from this area extending northeast along the shore. Waves (from the northeast on the day of the traverse) hit the shore at an angle. It is backed by an eroded sandy berm platform (a ridge of sand or gravel built up by waves just above the high tide area). Walking along the beach an abrupt change from sand to gravel was observed just east of the point where the road turns sharply towards the shore. The beach also becomes narrower. **Figure 4.**

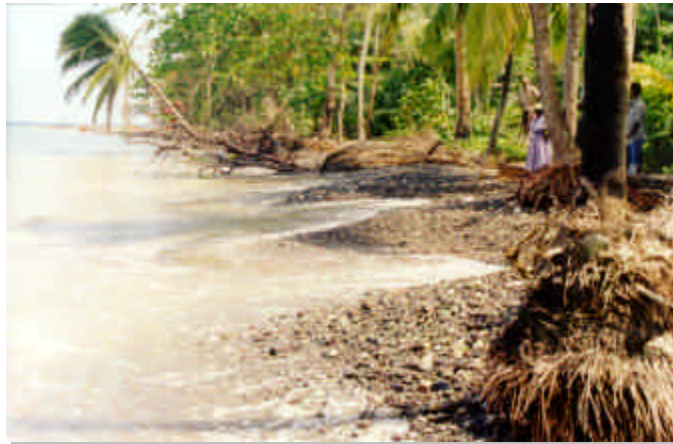
**Figure 5**

- The area from the beach to the coast road used to be mainly sand but now consists of pebbles and cobbles. **Figure 5.**
- Backyards and play area have disappeared.
- The gully which carries water from the morass is cleaned on a regular basis but is periodically blocked by refuse supposedly from a garage upstream; bottles; household items; long logs that are washed ashore by the sea.
- Almond trees that used to line the shore have been lost due to erosion. **Figure 6.**

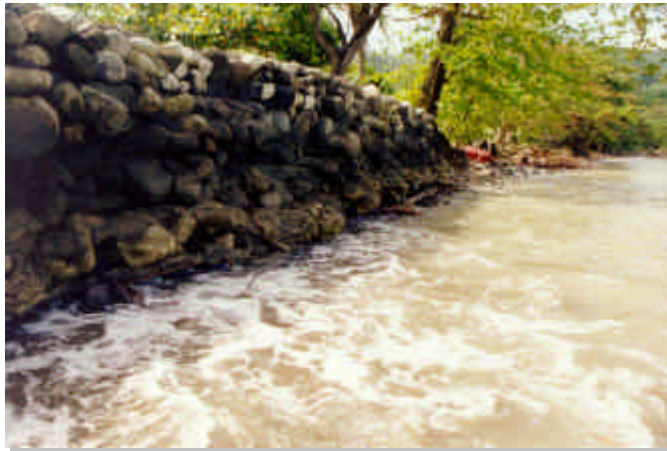
**Figure 7**

### **Mrs. Spence's Sea Wall (Figure 7)**

The sea wall is made up of stacked boulder-sized blocks of limestone. It is being undermined by wave action and the mortar used to hold the rocks together has been washed away. The sand immediately behind the wall is being excavated as the water now passes through the once mortar-filled cavities in the wall. Mrs. Spence's house is approximately 3 metres behind the sea wall. Even with a calm sea, we observed that the wave action became more pronounced as we walked north eastward along the shore.

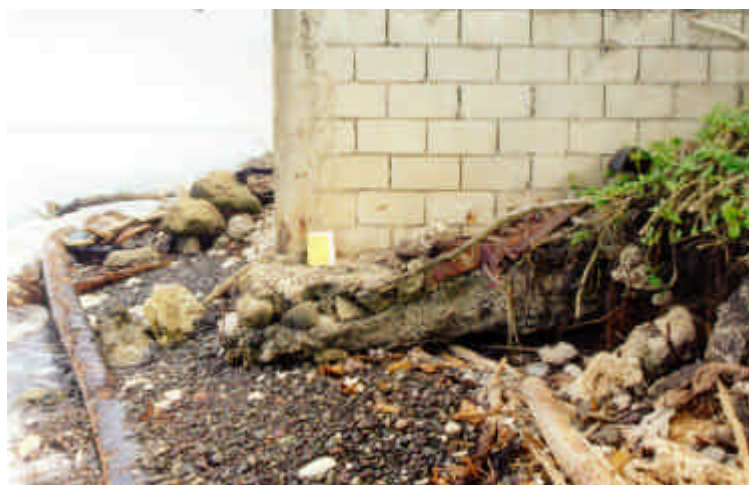
**Figure 8**

In the water there are limestone boulders which the residents say are what remain of a defensive measure against erosion, put in place by the Parish Council some 20-25 years ago **Figure 8**.

Trucks used to drive out onto the beach to dump the building material. At the time we observed them, the limestone blocks were scattered in up to 60 centimetres of water and continued up the beach. At low tide the sea is at the level of the blocks and covers them completely at high tide.

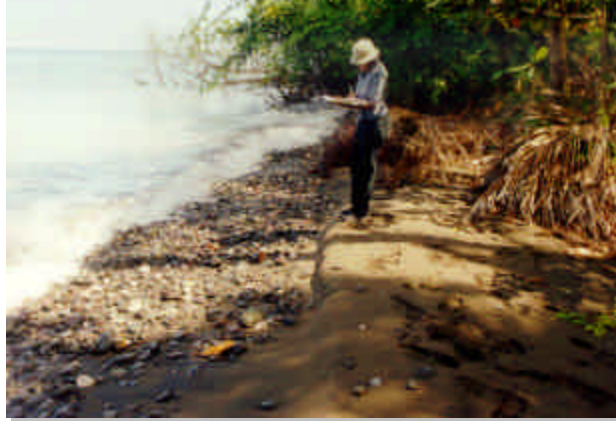
**Figure 9**

Four drowned coconut trees...stumps visible in sea. There were approximately 6 metres of beach and berm separating the sea from the house. **Figure 9.**

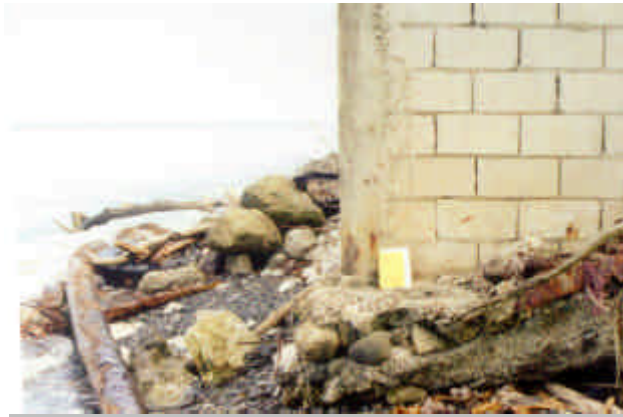
**Figure 10**

Bally Betty said that during the heavy rains the sea covers both the beach terraces and comes to a halt immediately in front of the house. He placed tyres packed with rocks to create a buffer but two months ago, heavy seas, took away the rocks. He suggested that bigger boulders were the answer to halting the erosion problems. **Figure 10.**

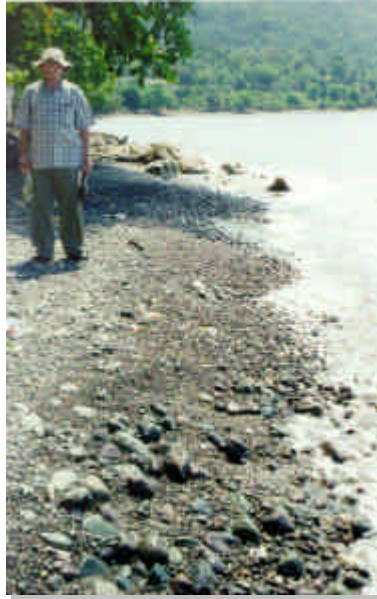
**Figure 11**

On a large scale, this part of the beach is cusped (looking like a series of crescents) and alternated from sand- to pebble- and cobble-sized particles **Figure 11**.

On a smaller scale the sand-sized particles are seen in the curved sections of small cusps with larger-sized particles in the pointed sections. Again, the sand probably comes from recent erosion of the berm platform and may be sheltered from further transport by the large boulder field mentioned previously.

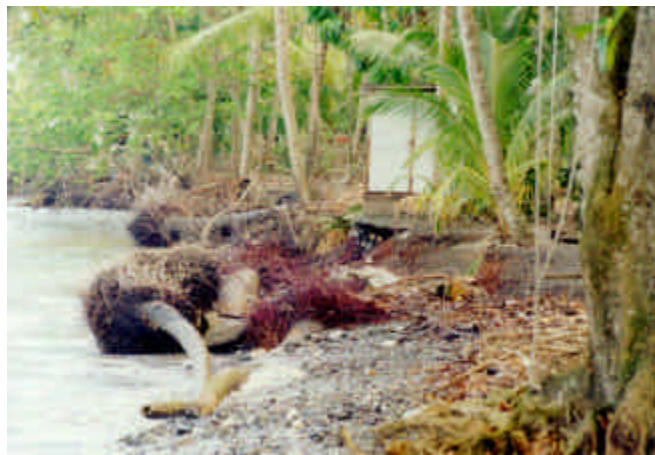
**Figure 12**

The foundation of the latrine is being undermined by wave action. Mrs. Cameron told us that one month ago the latrine used to be stable as the sea was further out. Undermining now takes place when the sea is at high tide. The latrine is no longer in use. **Figure 12**.

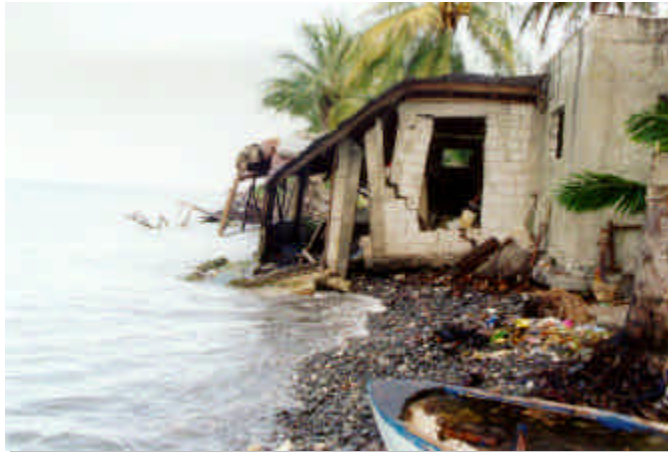
**Figure 13**

The section of house facing sea being undermined with partial collapse. The owners, who still live in the house are trying to patch the crack where the back wall has now parted from the side walls. **Figure 13.**

The residents told us that the main damage to the house occurred between November and December, 2002 (Tropical Storm Lili) and the rough seas at Christmas. They said that within a two year period the sea has come in some 30 m onto the land, the beach used to be “way out, as far as the first line of buoys.” Based on the aerial photographs, it has taken about twenty years for the sea to come in this far.

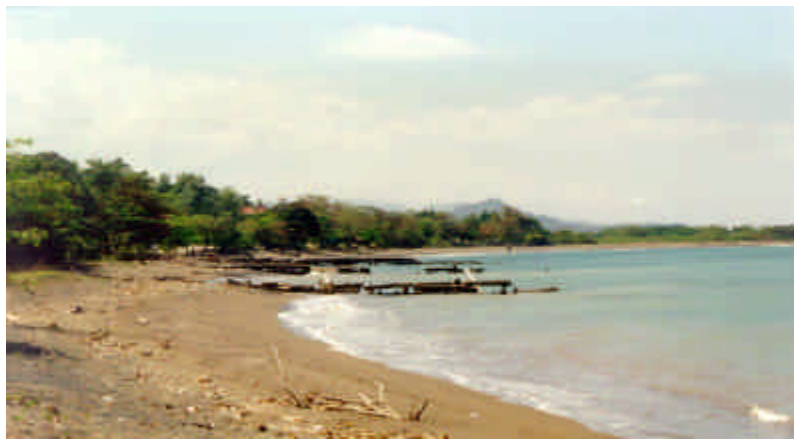
**Figure 14**

Miss Moore then took us to look at the beach occupied by the groynes. Marley and Plant built the original groynes. The groynes are in a state of disrepair and the fourth, easternmost groyne seems to have disappeared. **Figure 14.**

They seem to have done their job as the beach on which they are located shows no significant sign of erosion. The beach here is much wider than that along the region of concern reported on above. The beach here is mostly sand with pebbles along the shoreline.

- One of the four groynes has disappeared. The remaining three are in poor condition. All were in place in 1969.
- Having lost these protective structures there would be some effect.

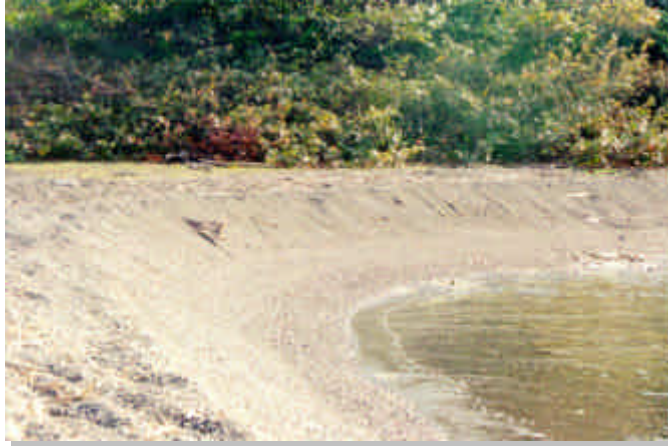
**Figure 15**

This beach consists of well sorted to moderately well sorted gravel beach grading to sand at the shoreline. Approximately 150 m of gravel forms the tombolo. The beach is very steep, dipping on the side facing north. **Figure 15.**

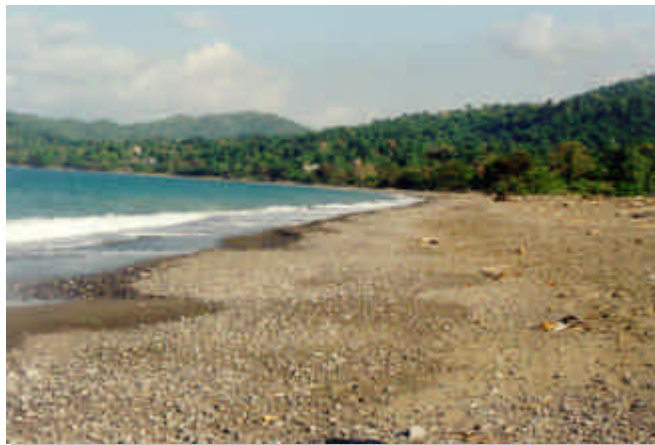
**Figure 16**

Grain size of larger beach material increases along the shore, from Welsh Woman's Point towards the aerodrome. Cuspate pebble bar forms edge of terrace closest to water. Wind system produces a ridge of sand behind the pebble bar. Low-lying dunes formed on aerodrome terrace, which seems to be an extended berm platform. **Figure 16.**

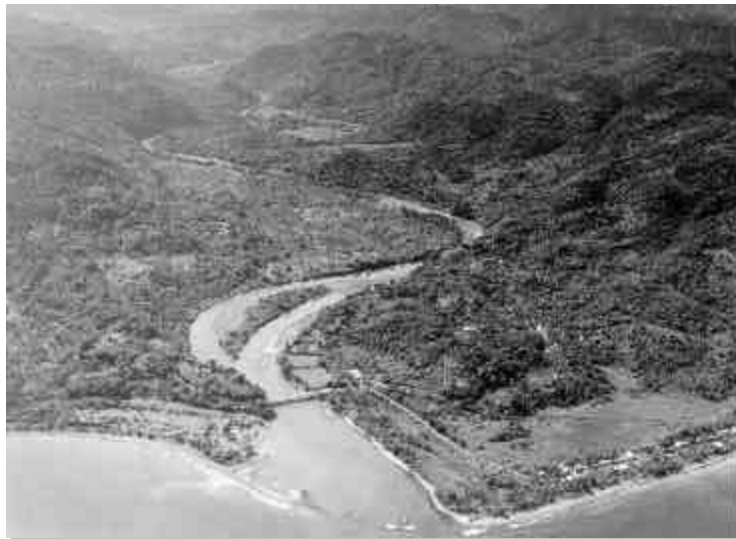
**Figure 17** Oblique air photograph, September 28, 1984, showing straightened beach (right-hand edge of photo) following Hurricane Allen (J. Tyndale-Biscoe).

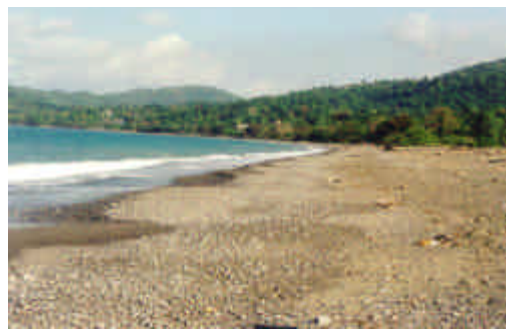
**Figure 22** Beach near Ken Jones Airport.

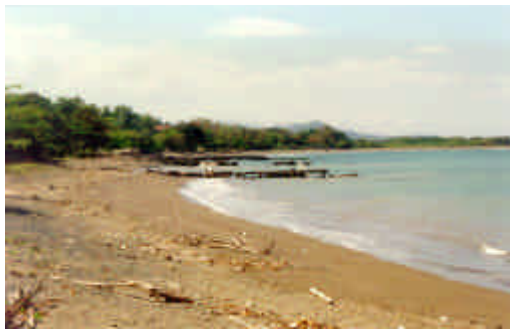
**Figure 23** Beach at Groyne area

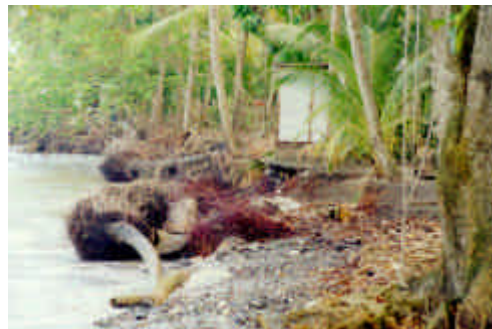
**Figure 24** Beach eroded in area of concern

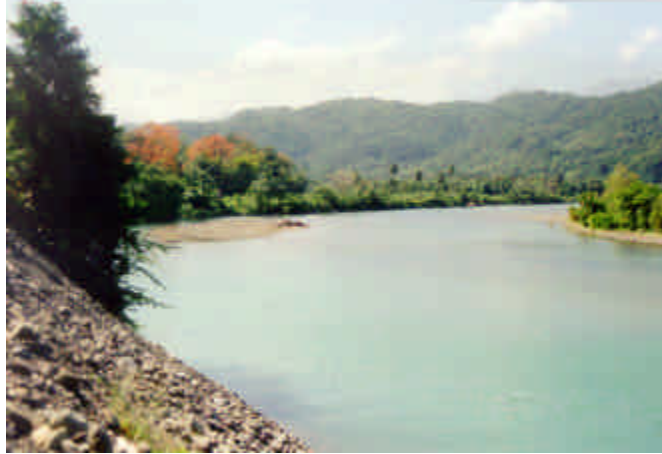
**Figure 26**

The water is clear, with a shoal visible. The river channel is deeper here than under the bridge. **Figure 26.**

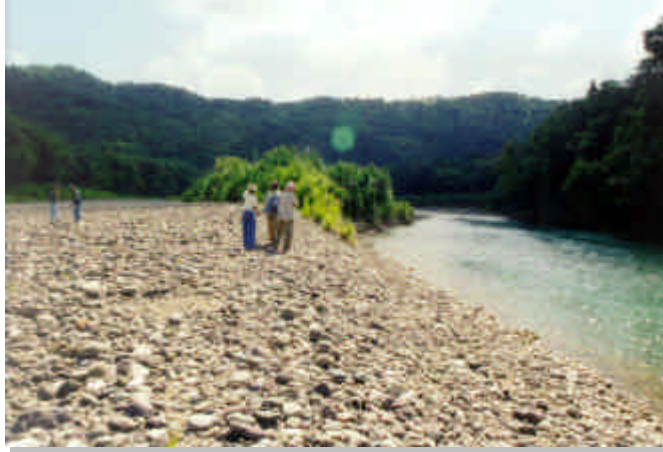
**Figure 27**

Based on the plastic bags stuck in the trees on the opposite bank, the river is approximately 3m higher when in spate. This is also about the height of the floodplain on the eastern side of the river. **Figure 27.**

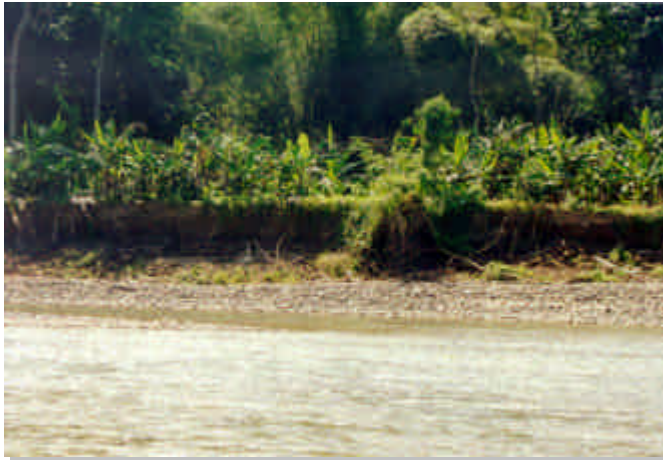
Banana farm being eroded by river. **Figure 28**

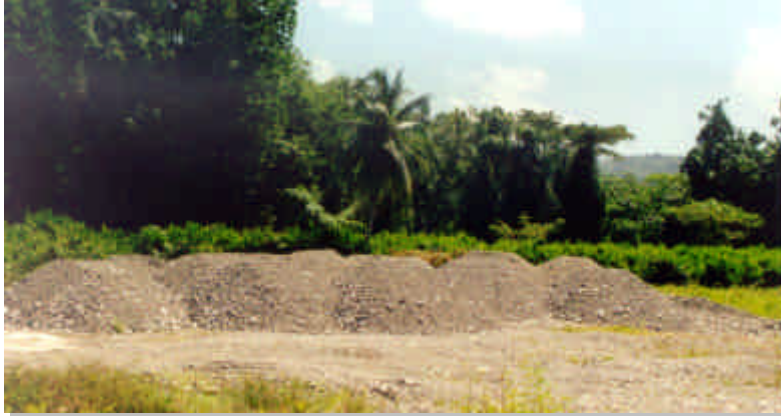
**Figure 29**

- 1/2" and 3/8" gravel produced by sifting and crushing. **Figure 29.**
- Crusher capable of producing 300 cubic yards of sand in a 10 hr day.
- Stockpile of washed sand seen in yard was approximately 1000 cubic yards and represented 2 days work. **Figure 30.**

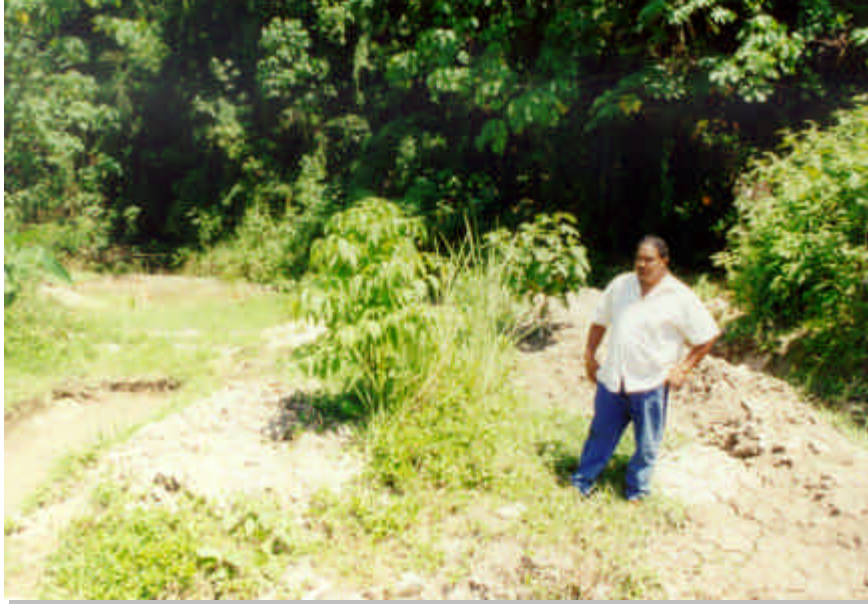
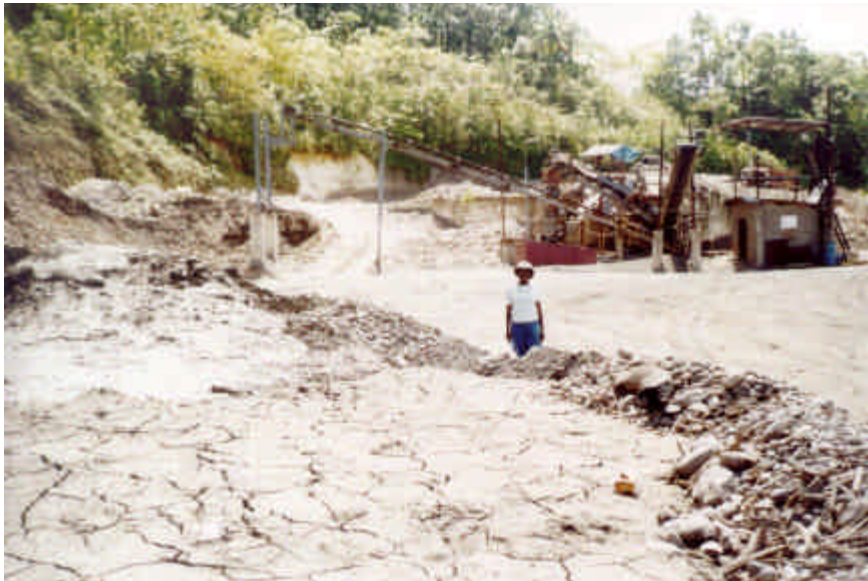
- Muddy water from production is passed through a U-shaped mud-settling pond (~1m deep). Gravity filtered water is allowed to flow back into the river. **Figure 31, Figure 32.**
- Mr Mangaloo suggests that last years dredging/dumping operations in Portland to create the new marina has contributed significantly to the coastal erosion.
- His father in Orange Bay has lost approximately 2m of beach as a result of erosion. The Public Beach in Orange Bay has disappeared.
- He does not think the sand mining activities have brought about the coastal erosion problems.
- Entire operation consists of the mining and production of sand and gravel and agriculture on a reduced scale. The company employs 30 persons including security.

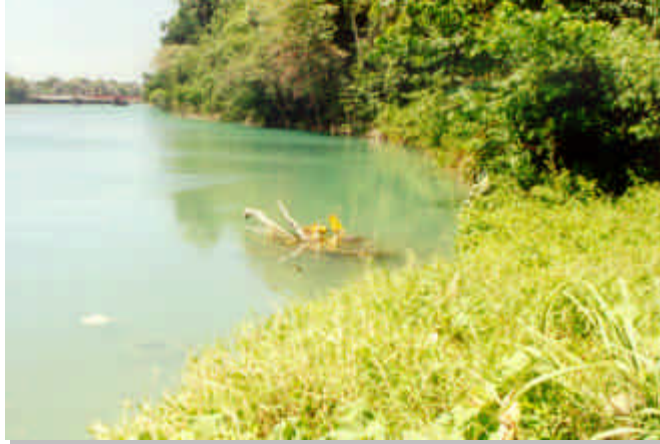
**Figure 33**

The road has been undercut by erosion; now reduced to footpath; used to extend to point where a tractor (property of the mining company) now lies submerged in the river. Trees submerged. **Figure 33.**

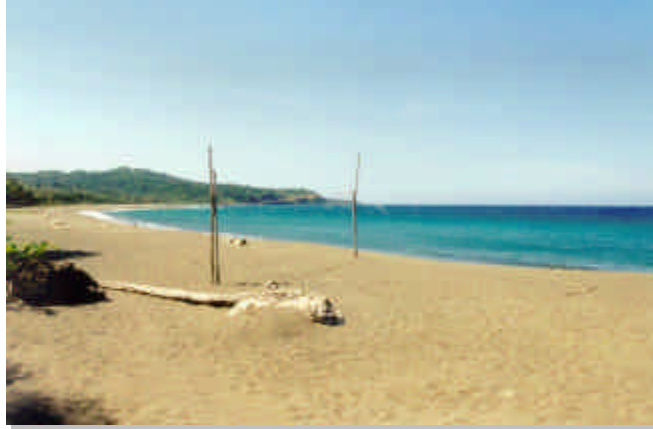
**Figure 36**

This beach shows no signs of erosion, it is very wide in comparison to St. Margaret's Bay.  
**Figure 36.**

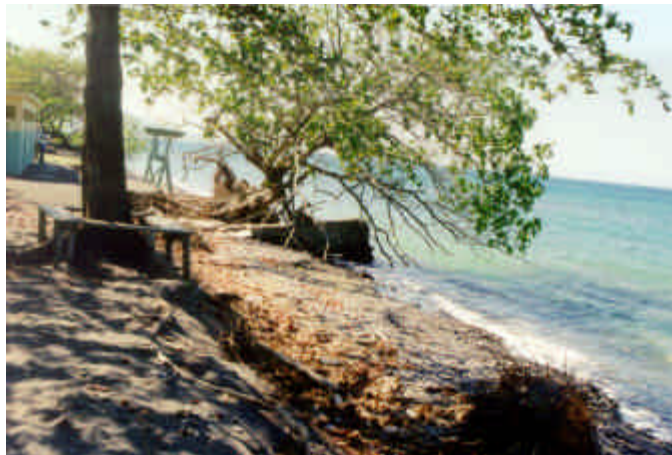
**Figure 37**

This is a pebble and sand beach. The water is clear. Waves come in from the north-east. There are drowned coconut trees. In what seems to have been a recent event, the beach has been eroded right up to the lawn. **Figure 37.**

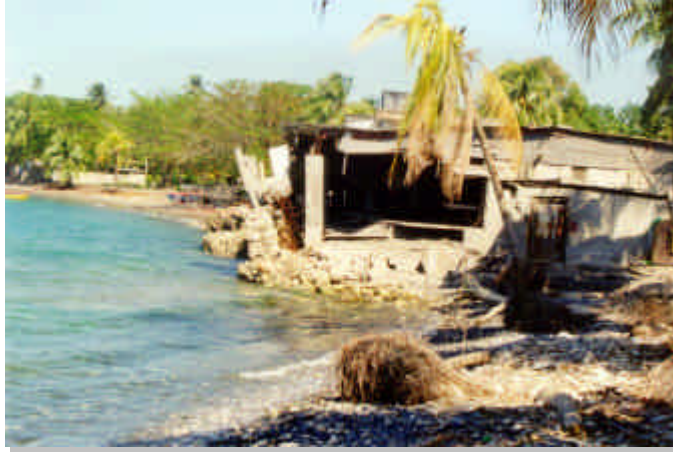
Figure 38

Next door the sea wall has been destroyed and the front porch of the building it was protecting demolished. The foundation is still being undermined. **Figure 38.**
