**FINAL REPORT**

**EIA and EIS**

**FOR RESORT DEVELOPMENT AND SUB-DIVISION**

**OF LOTS AT FONT HILL, ST. ELIZABETH**

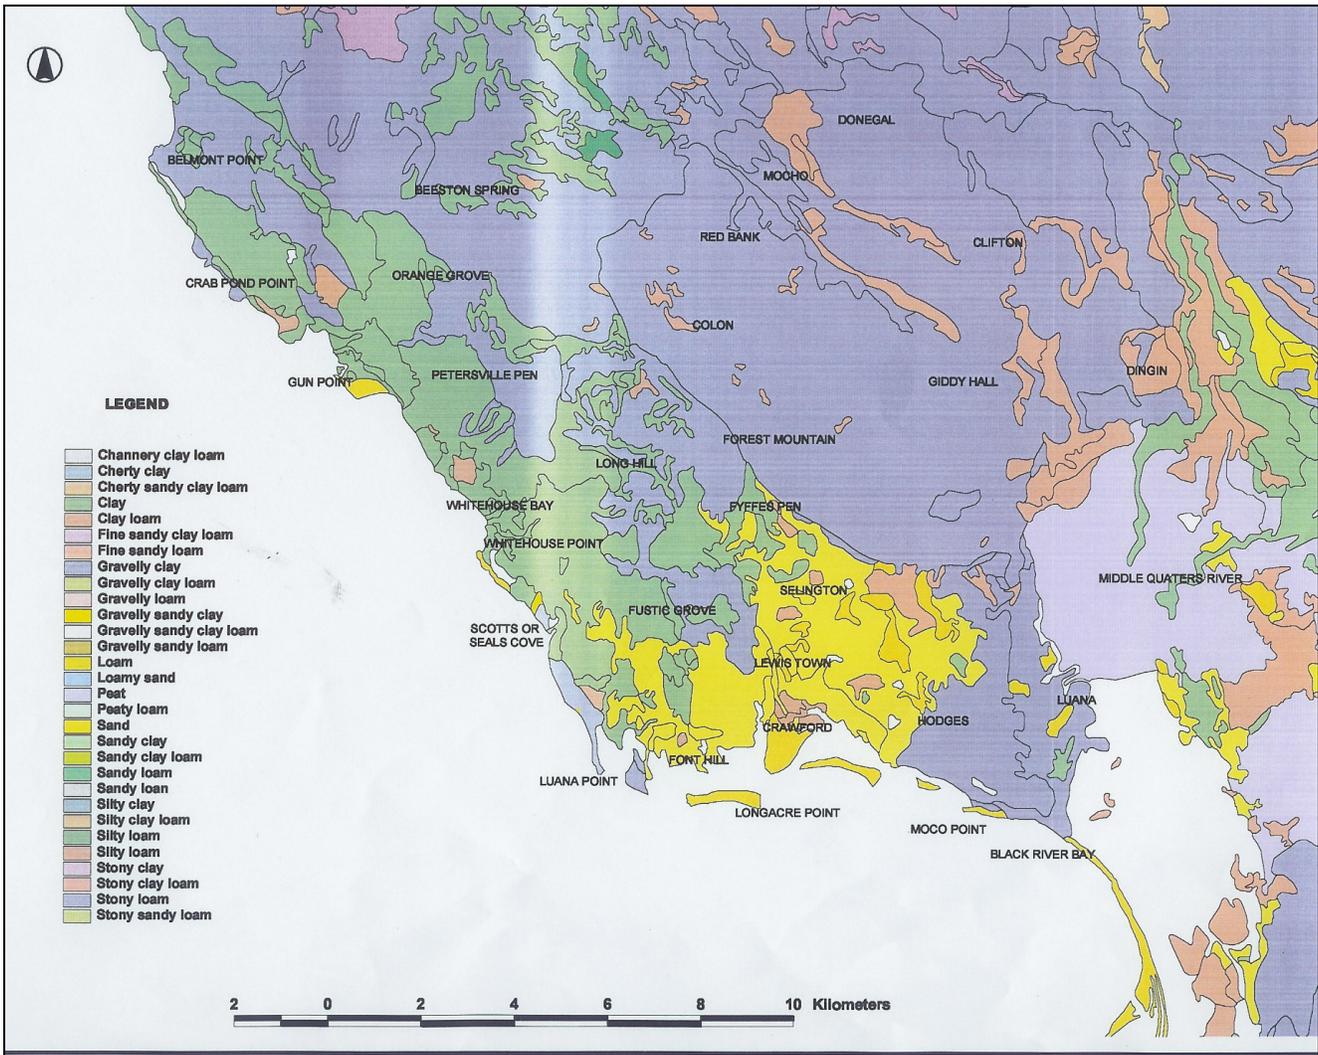
**Figure 1-5: Upper Layer Soil Texture Map of South West Jamaica**

Determinations on soils and subsurface conditions were made based on field investigations and literature surveys. Hard limestone rock appears to be the predominant type of material seen in outcrops at the surface. Other than limestone rock, there appears to be thin layers of sand and alluvial soils on the surface which are depicted on Figure 1-5: Upper Layer Soil Texture Map of South West Jamaica. As the formation deepens the soils transition from a gravelly sandy loam to a more silty loam (Figure 1-6: Mid Layer Soil Texture Map of South Jamaica) and becomes a stiff clay at the lower layers (Figure 1-7: Lower Layer Soil Texture Map of South-West Jamaica).

area (see Figure 1-5, Figure 1-6, and Figure 1-7) is largely impervious. The volume of the ponds and their water quality vary as a function of the level of rainfall. There is an alluvial aquiclude in this area which forms a natural barrier to the sea, preventing intrusion of salt water and escape of water from the aquifer north of the property. This aquifer is recharged through infiltration of rain water and not through ground water recharge (Figure 3-1).

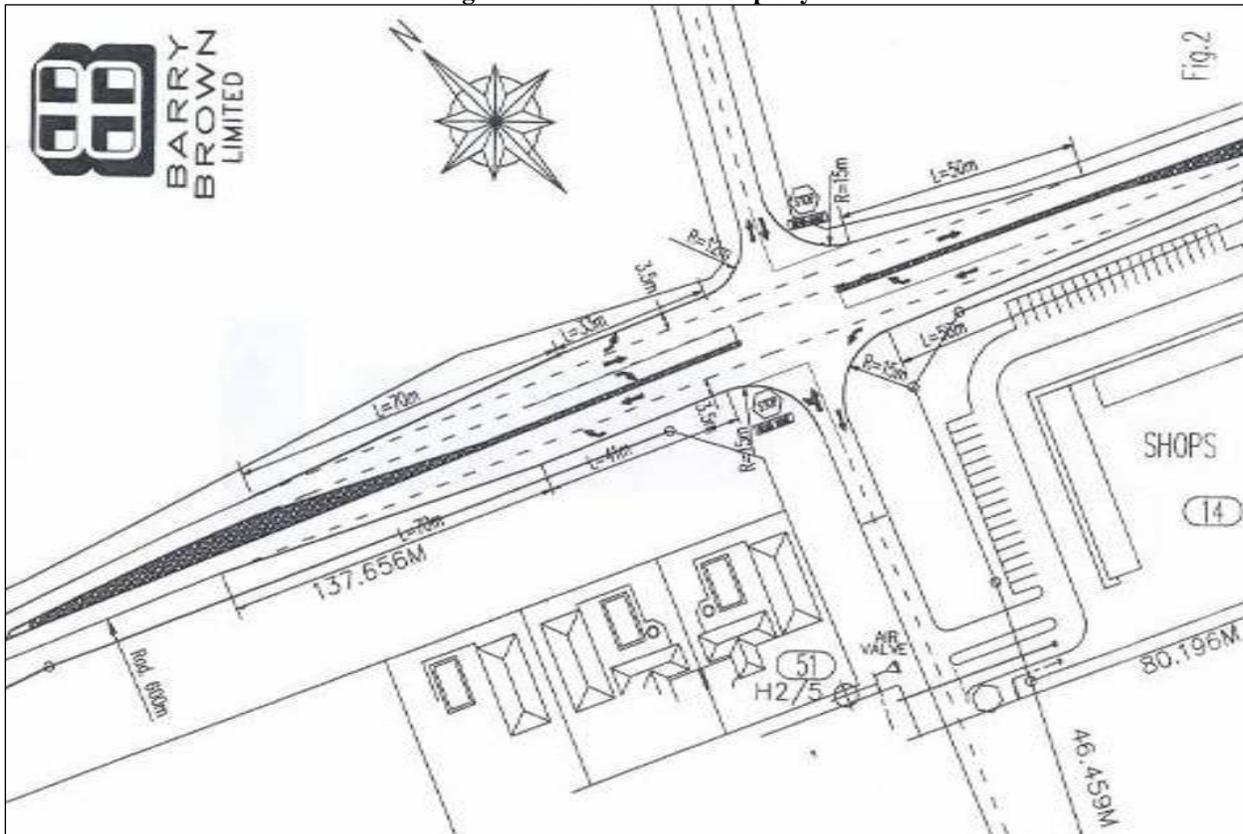
Figure 1-8: Entrance to Property

Recommendations for the approval for the geometry of the proposed subdivision entrance road to connect with the Mandeville – Whitehouse main road has been given by the National Works Agency (NWA) (See APPENDIX IV). The designs have incorporated all of NWA’s requirements, including a single entry roadway to the subdivision (Figure 1-8), and addresses the issue of safety regarding ingress and egress.

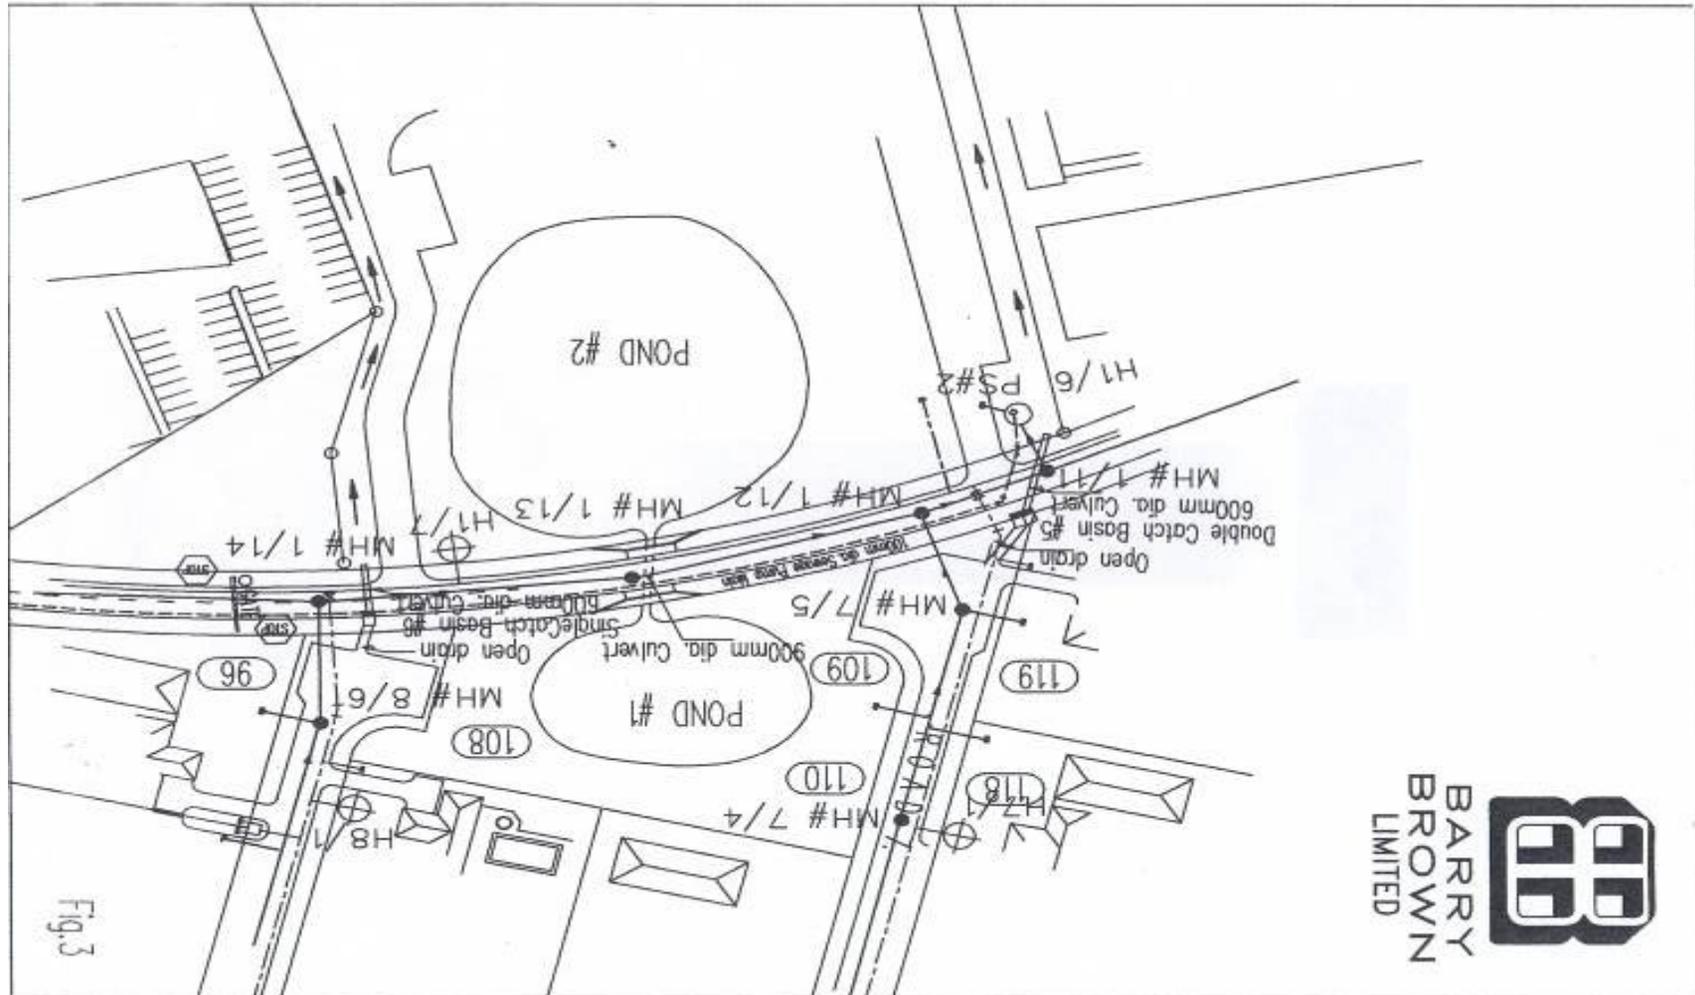
Figure 1-9: Drainage System

Road # 1 has been located between the two ponds near to the Beach Park. These ponds will be connected by one 1200mm diameter concrete culvert (Figure 1-9). All roads in the subdivision will have a marl base with asphaltic concrete surfacing. Concrete kerbs will border both sides of the roadway to provide the boundaries for an elevated grassed verge and a kerbed gutter. Roads with slopes in excess of 3.5% will have paved concrete gutters. Subdivision roads will be 6.1m wide with reservations 12.2m wide, with the exception of the main entrance roadway (Road #2). Road #2 will have its reservation widened to 36.0m. Roadways that are not through-roads all end in cul-de-sacs to the N.W.A. specifications. Only pedestrians will be allowed access from any cul-de-sac to an adjacent roadway.

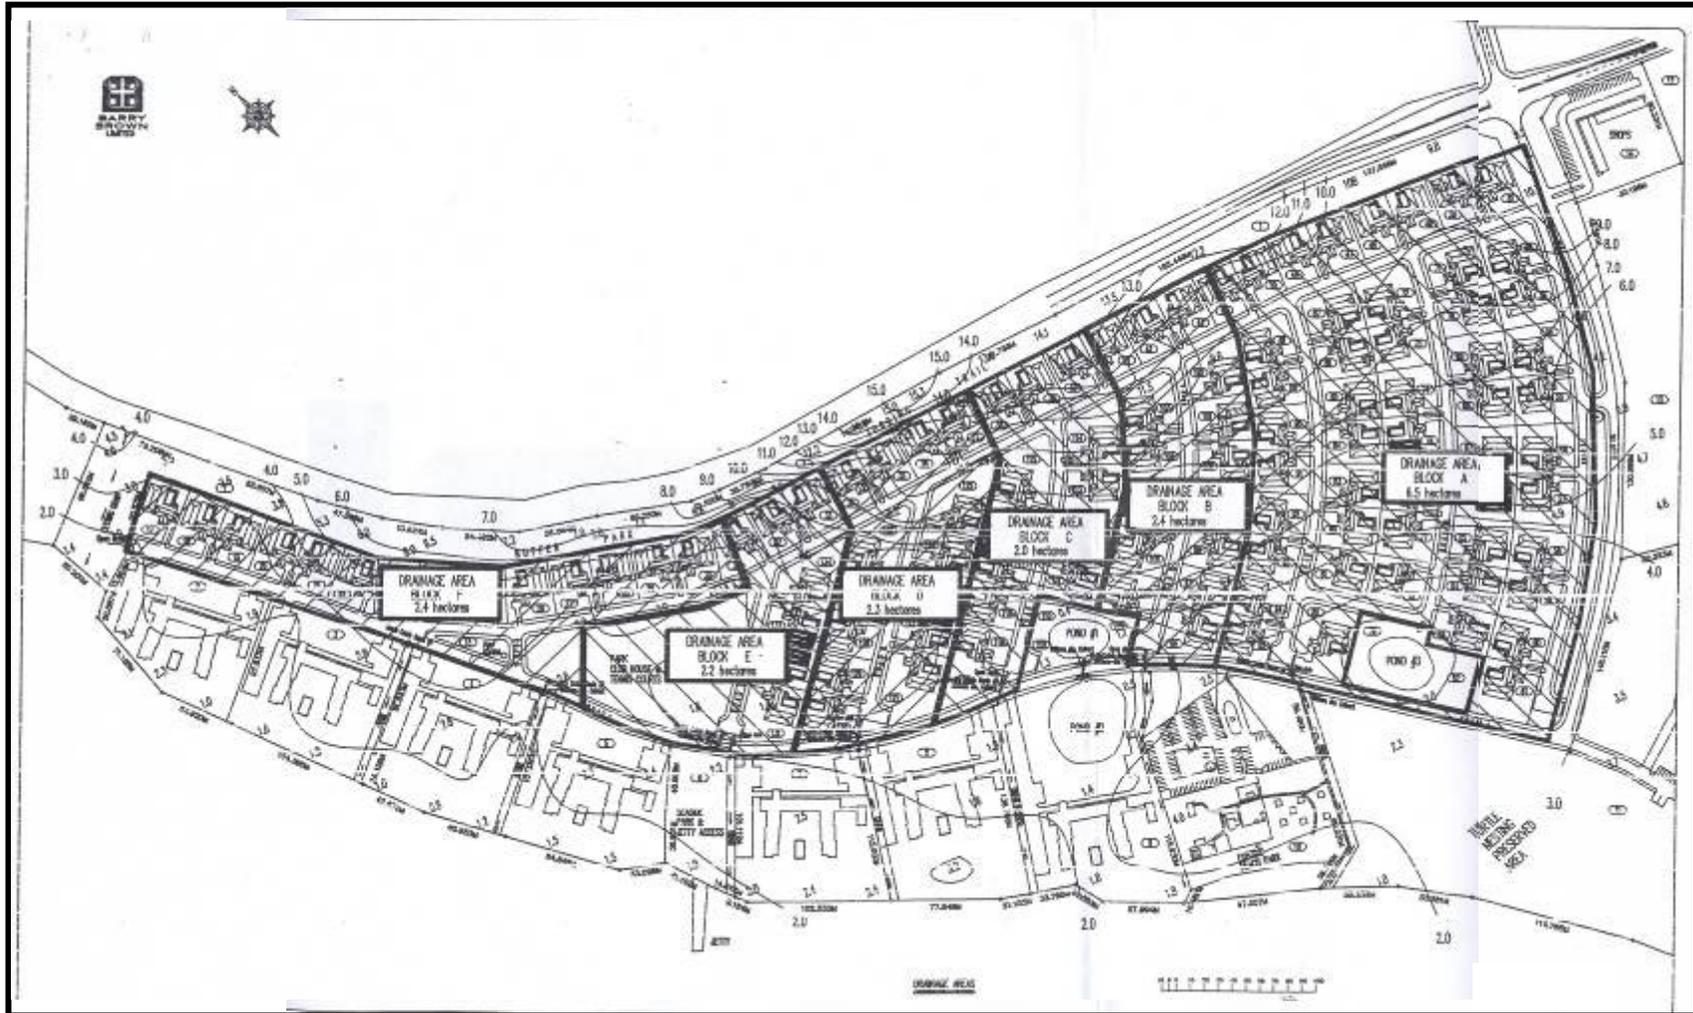
Figure 1-10: Site Drainage System and General Infrastructure Layout

- Area A - 6.5 hectares with estimated flows  $Q = 1.4\text{m}^3/\text{sec}$ .
- Culverts 900mm diameter. RCP,  $d=50\%$ ,  $n= .012$ ,  $v=4.2\text{m}/\text{sec}$  and  $s=0.0167$ . Open block wall drain 900 x 750mm deep,  $d=64\%$ ,  $v=3.2\text{m}/\text{sec}$  and  $s = 0.01$ .
- Area B - 2.4 hectares with estimated flows  $Q = 0.6\text{m}^3/\text{sec}$ .
- Culverts 600mm diameter. RCP,  $d=52\%$ ,  $v= 3.14\text{m}/\text{sec}$  and  $s= 0.0167$ .
- Open block wall drain 600 x 700mm deep,  $d=55\%$ ,  $v=2.5\text{m}/\text{sec}$  and  $s= 0.01$ .
- Areas E through F are designed for Area B flows. Design estimates of flows are based on a 24-hour rainfall at 180mm for a 1: 10yr. return period.

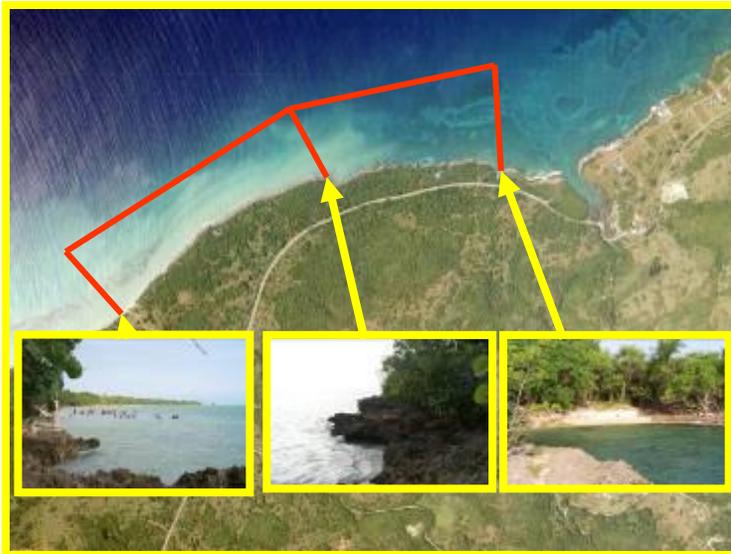
**Figure 3-6: Demarcation of Font Hill oceanographic Marine Bethink Study**

The area defined for the oceanographic and benthic assessment was selected using the property's boundaries as the eastern and western limits. The island shelf, which was located approximately 500 meters offshore, was used as the southern limit, while

the shoreline demarcated the study area's northern limit (*see* Figure 3-6).

It was proposed that ground truthing be conducted along three long visual transects traversing the area from shore to the island shelf (*see* Figure 3-6, Figure 3-7 *and* Figure 3-8) and three running along and parallel to the shoreline. Transects were defined with a 20 meter surveyors tape measure. If seafloor character changes were observed, assessments were then conducted along a 20 meter transect deployed perpendicular to the main transect. This was done so that an assessment of the lateral continuity of the character change could be determined. These types of transect deployment also served to identify any substrate type or character changes, which may be governed by depth.

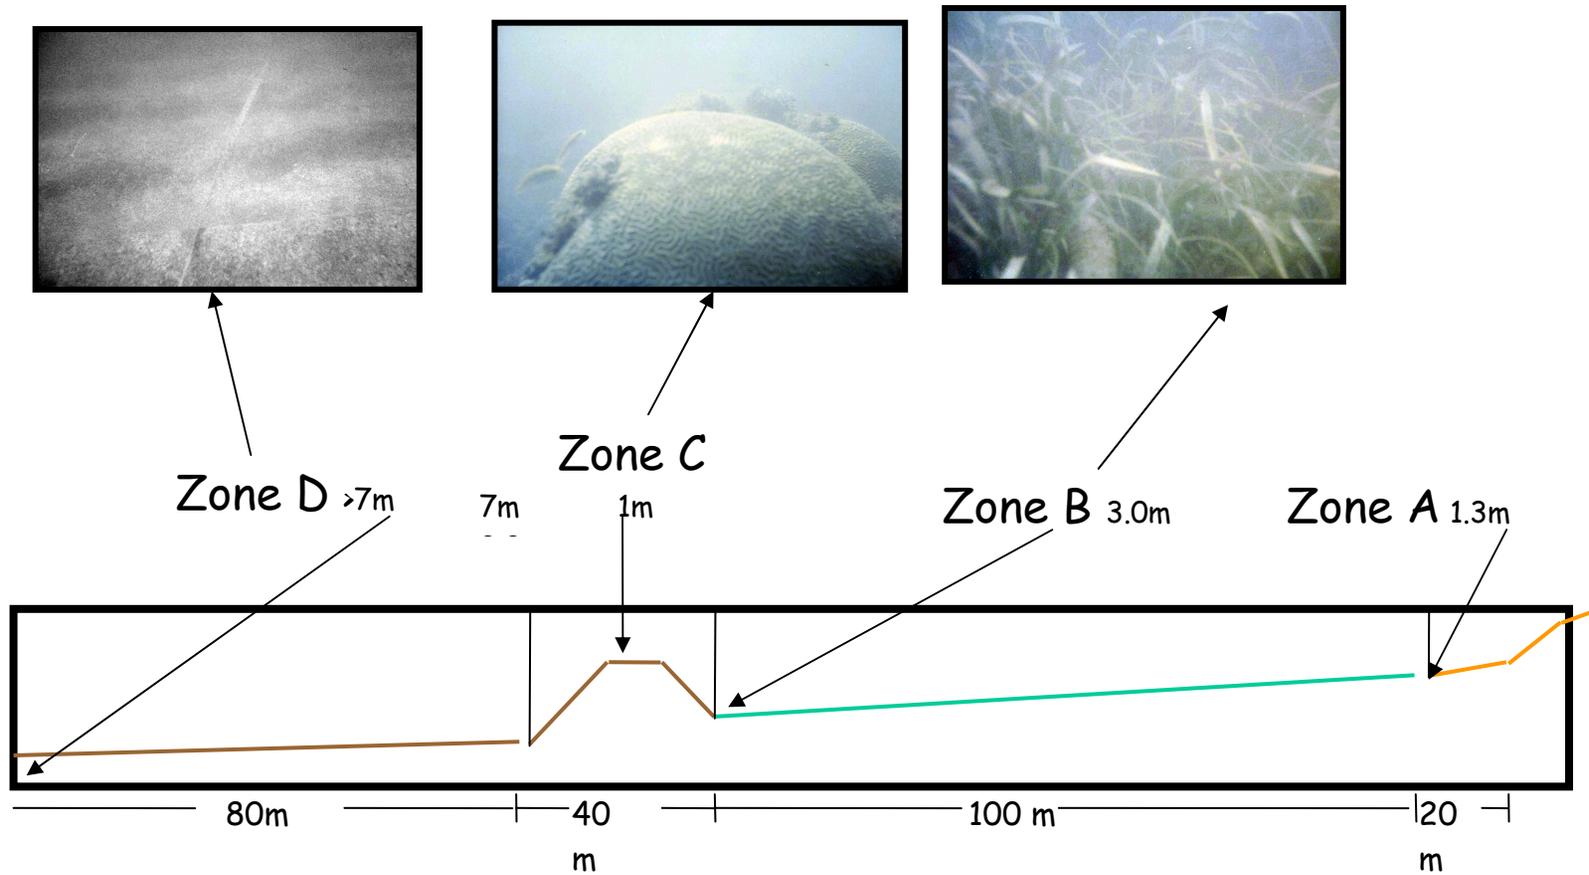
Figure 3-9: Bottom Profile, Substrate and Life form Character - Transect 1

*Fig 4 and 5* outline cross-section summaries of the observations made along the two main transects deployed within the study area. Both hard and soft bottom substrate characteristics were observed.

Four zones were identified. These are described as follows:

This zone extended from the shoreline to about 20 meters seaward and to a depth of 1.3 meters. Coarse to medium grained marine sand was located on the seafloor within this zone, emerging above the waterline at the shore as the beach at the Font Hill Beach Park. No marine life forms of a benthic or mobile nature were observed within the area defined by both the main transect and the perpendicular transect deployed.

This zone extended from the seaward limit of Zone A for a distance of approximately 100 meters and to a depth of approximately 3 meters. Fine grained marine sand and silt was the dominant substrate found within this zone. The dominant marine life form found within this area was sea grass, specifically Turtle Grass (*Thalassia testudinum*).

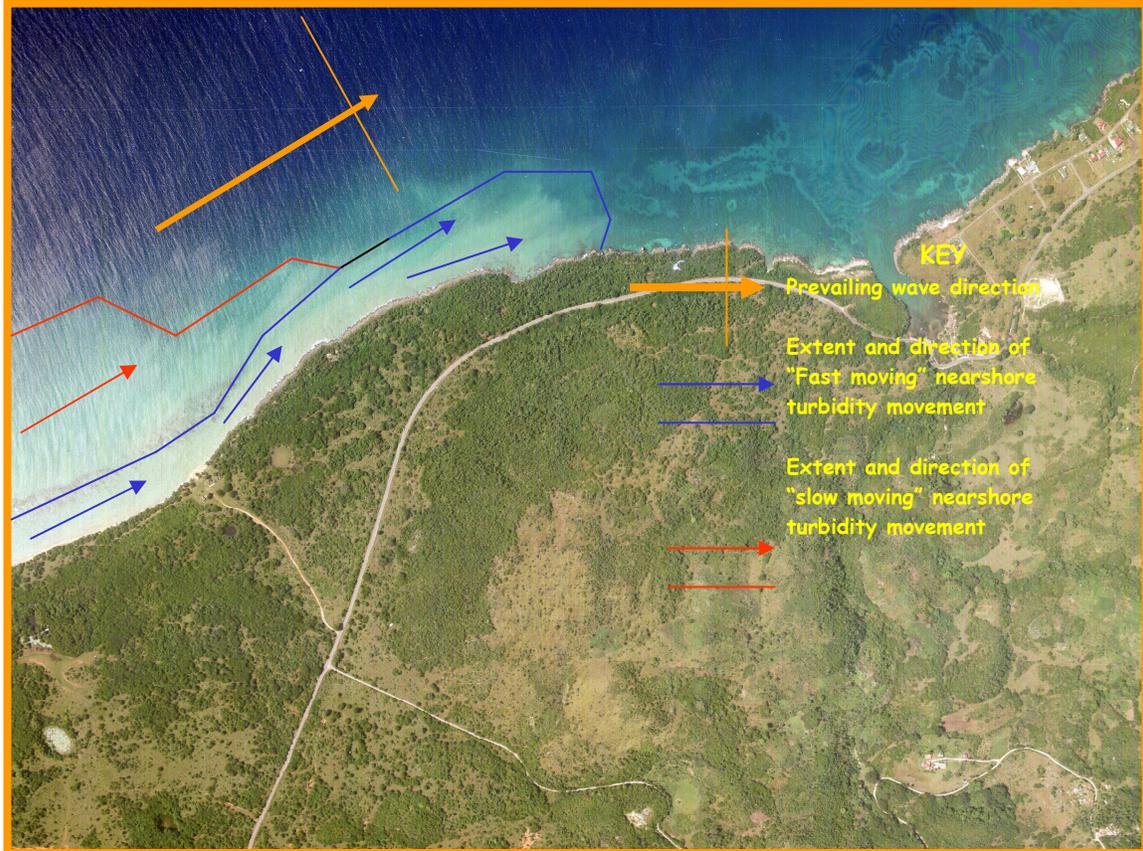
**Figure 3-14: Current Movement as interpreted from turbidity movement - image source, Survey Department**

The 1991 aerial photos of the study area were useful in the determination of the manner in which sea currents moved in the vicinity of the study site. The 1991 photos showed water turbidity, possibly originating from either the disturbance of seafloor sediments in Malcolm Bay or discharges from the Black River. Both sources lie to the east of the study area.

Current movement was generally towards the North-north west. Surface water current movement was determined to be a factor of wind movement. The contour of the seafloor would have an influence on the final direction of movement, once close to shore.

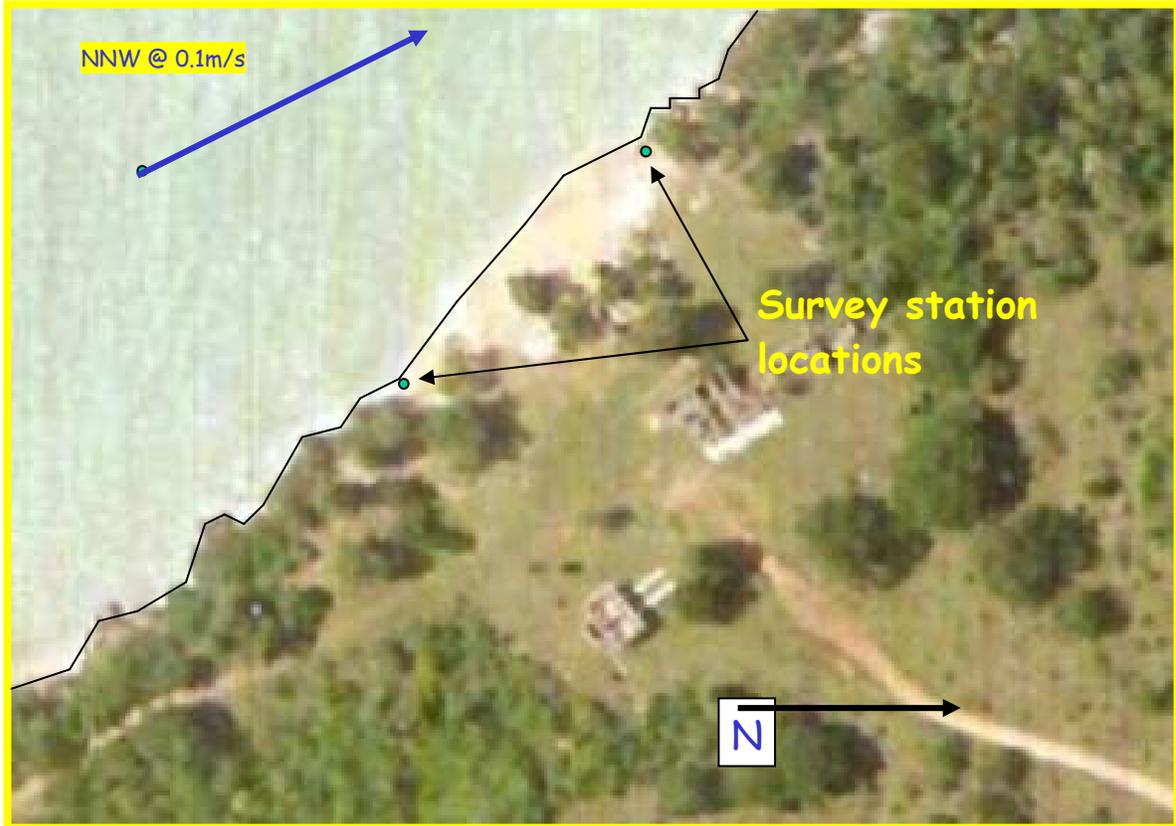
**Figure 3-15: Current Speed and Direction as measured by Drogues - Image Source Survey Department**

Drogue measurements for surface currents conducted at the study site revealed movement in a direction consistent with that of the wind. Wind direction at the time of the study, however, was from the south-southeast. Surface currents were tracked moving in a west northwesterly direction at speeds of 0.1 m/s (See Figure 3-15 and Figure 3-16). A drogue deployed at the entrance of what is called Joseph's Cove, at the western section of the study area, revealed currents moving into the cove. This was an expected observation, since a process of wave refraction was occurring at this location, leading waves and, as a consequence, currents into the cove<sup>9</sup>. This process of refraction was also evident at the location of transect 1. At zone D, wave like structures were observed on the seafloor

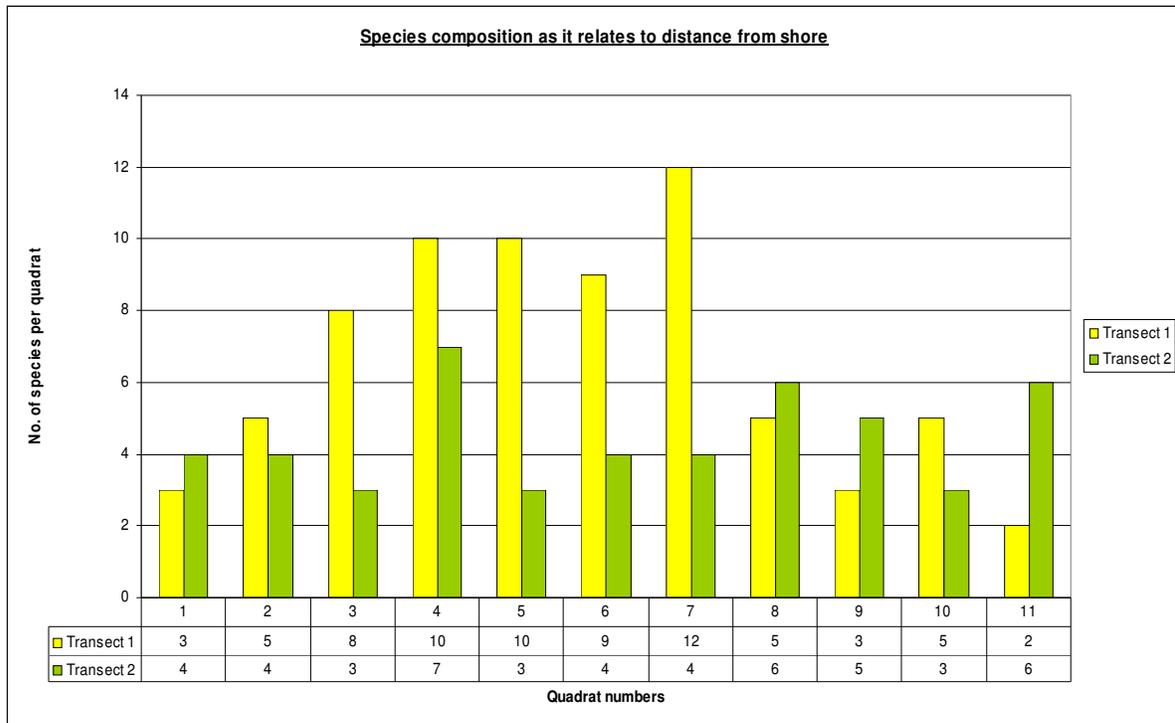
**Figure 3-19: Species composition as influenced by distance from the sea**

- Transect 1 – Quadrats were laid out in the following order; 7, 21, 49, 63, 77, 112, 147, 287, 357 m - NW of beach
- Transect 2 – Every 30m between 0-300m and every 60m between 300-425m - NE of beach

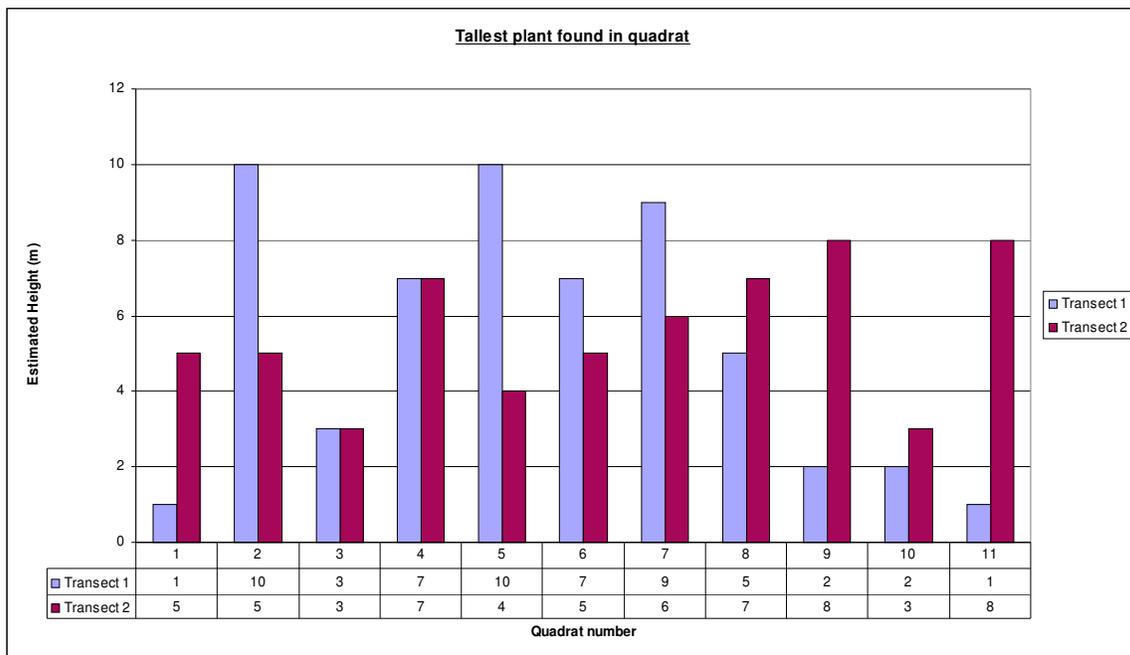
**Figure 3-20: Tallest Plant found in Quadrat**

- Transect 1 – Quadrats were laid out in the following order; 7, 21, 49, 63, 77, 112, 147, 287, 357 m - NW of beach
- Transect 2 – Every 30m between 0-300m and every 60m between 300-425m - NE of beach

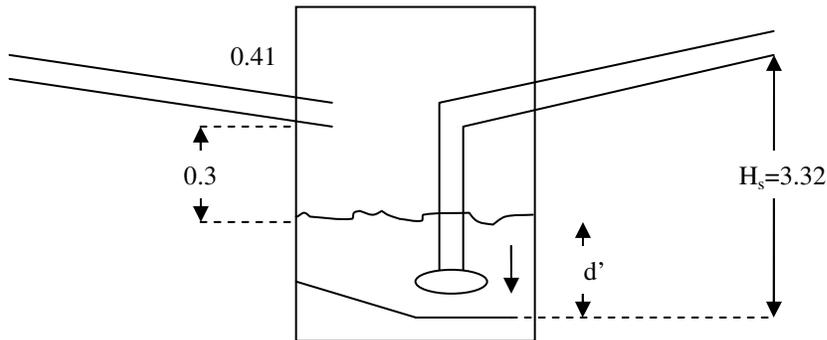
### ***Pump Design***

Influent Invert = **0.41** m

Effluent Invert = **2.72** m

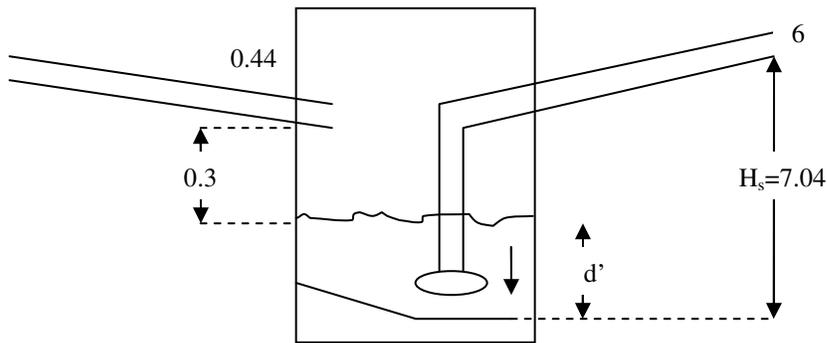
***Pump Design***

Influent Invert = **0.44** m

Effluent Invert = **6** m
